**Bat Survey**  
**Ciara & Declan Kerins**  
**Creevymore**  
**Cliffony**  
**Co. Sligo**  
**2026**

**Ecological Services**

Barbara McNerney

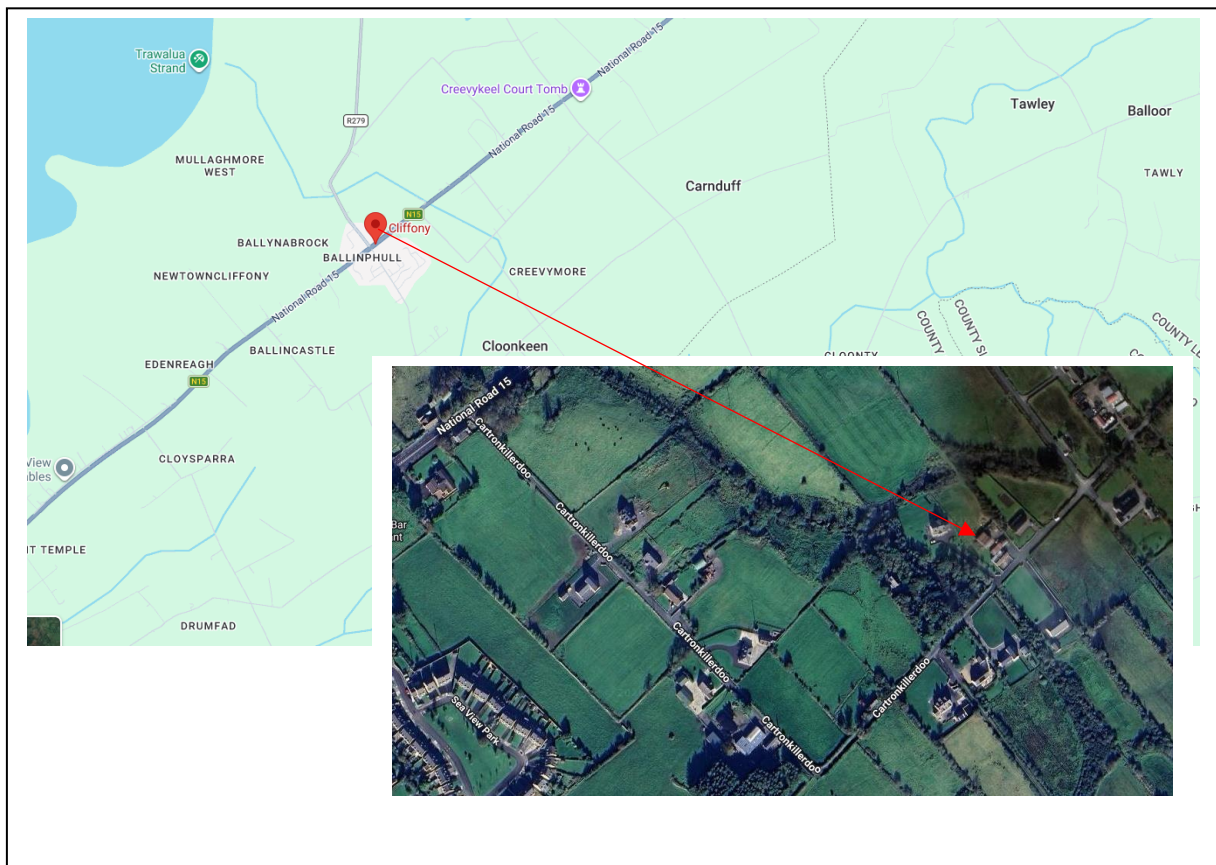
*Fig 1: Location of the property in Creevymore, Cliffony County Sligo.*

*Irish grid reference: G 71366 53717 ITM: 571319 853730.*

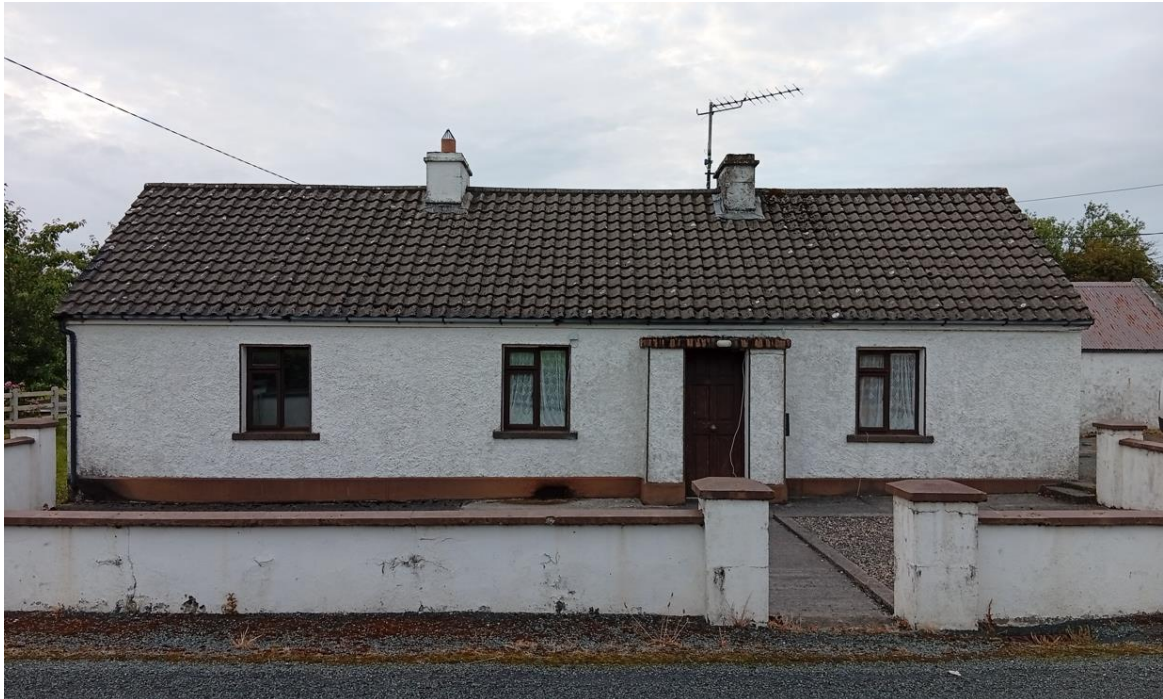
*Fig 2: View of the cottage (south east face) proposed for renovation at Creevymore, Cliffony County Sligo.*

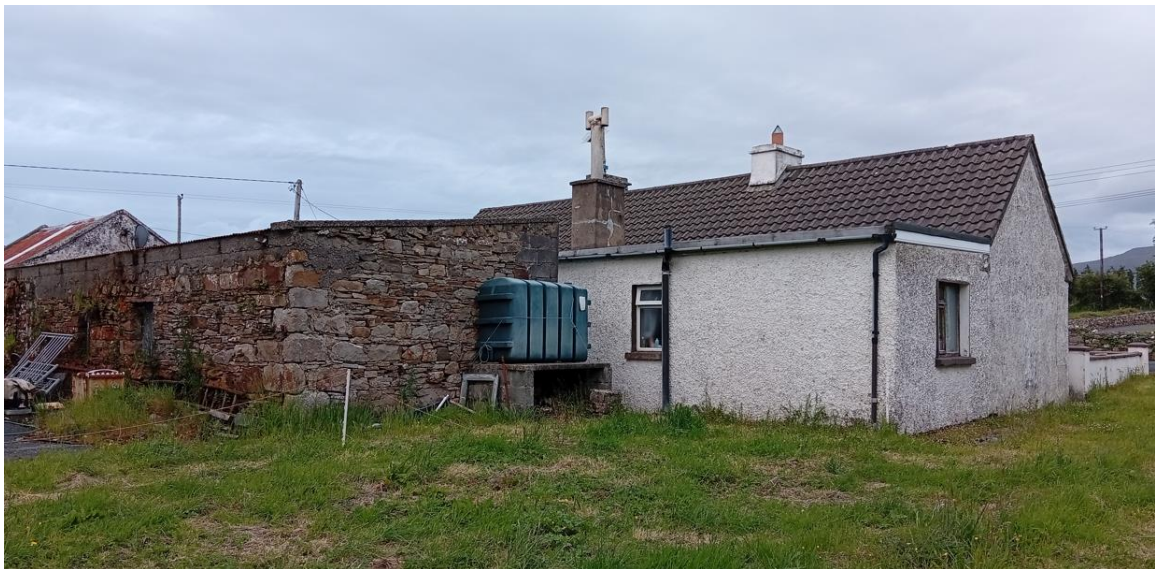
*Fig 3: Rear view (south west) of the cottage with shed behind.*

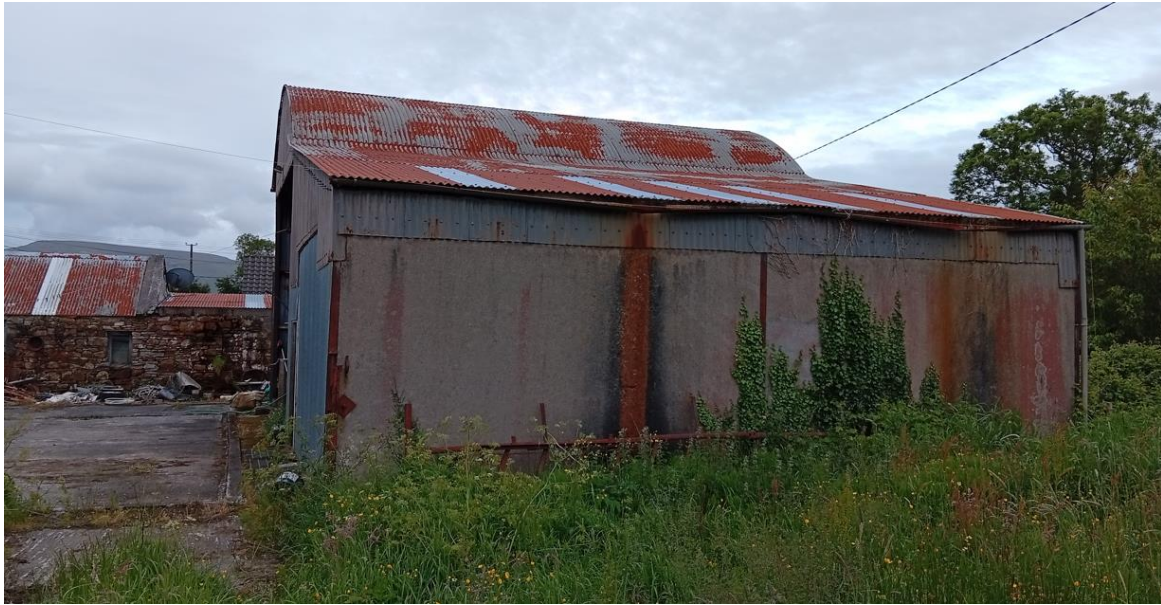
Fig 4: The hay barn and shed at Creevymore, Cliffony.

The attic had no bat droppings visible and the ridge board was covered in cobwebs. No droppings or dead bats were found in the sheds or hay barn.

Swallows were nesting in the stone shed in one section and two juvenile robins were also present. Pigeons were roosting in the hay barn.

As part of the proposed development in Creevymore, Cliffony, Co Sligo, the sheds and hay barn would be removed to make way for a cottage extension and garage. It is proposed that the hayshed will be removed in the winter months when both bats will have left and two bat bricks will be incorporated into the garage when built to provide alternate roosting locations for the bats found in the hay barn.

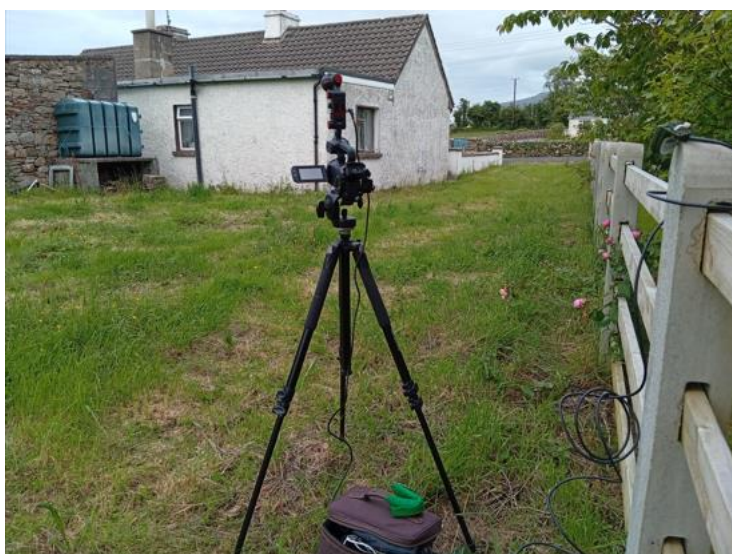
An infra-red camera was set to record during the survey to the west capturing the house and shed gables and roofs. Fig 7. A second camera was placed with a view of the rear stone wall of the shed.

*Fig 7: Infra-red camera recording footage of the west gable of the cottage and shed along with SM4 7285.*

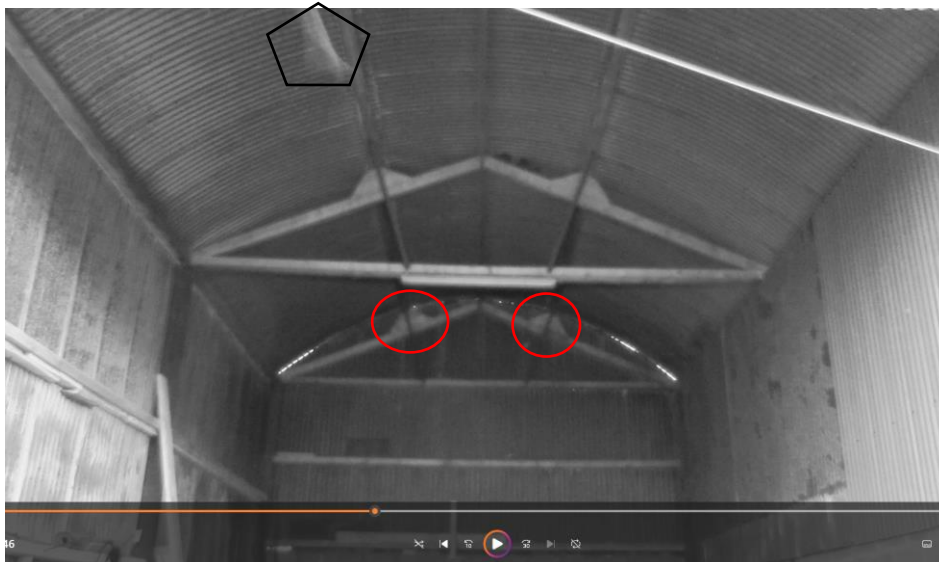
Camera 1 captured a Leisler's bat emerging from the south west or back wall of the barn. It was behind a triangular bracket near the roof top on the left. Ten minutes later a Soprano Pipistrelle emerged from the matching bracket on the right hand side of the rear wall of the hay barn. Fig 9.

*Fig 9: Location of roosting bats at the hay barn in Cliffony. Leisler's on the left and Soprano Pipistrelle on the right. See the blurred still, captured from video footage of the emerging Leisler's bat. 🏠*

Four species of bat were recorded from the site at Creevymore, Cliffony, Co Sligo. Two of these species, Soprano Pipistrelle and Leisler's bat were both roosting in the hay barn. There was one of each bat. No other roost location was determined.

Depending on the finish of the garage various options are available. The bricks should be installed as high as possible and on the south and/or west aspects.
