# **Bat Mitigation Strategy**

Proposed Development at Montpelier Hill,  
Arbour Hill, Dublin 7

14 May 2026

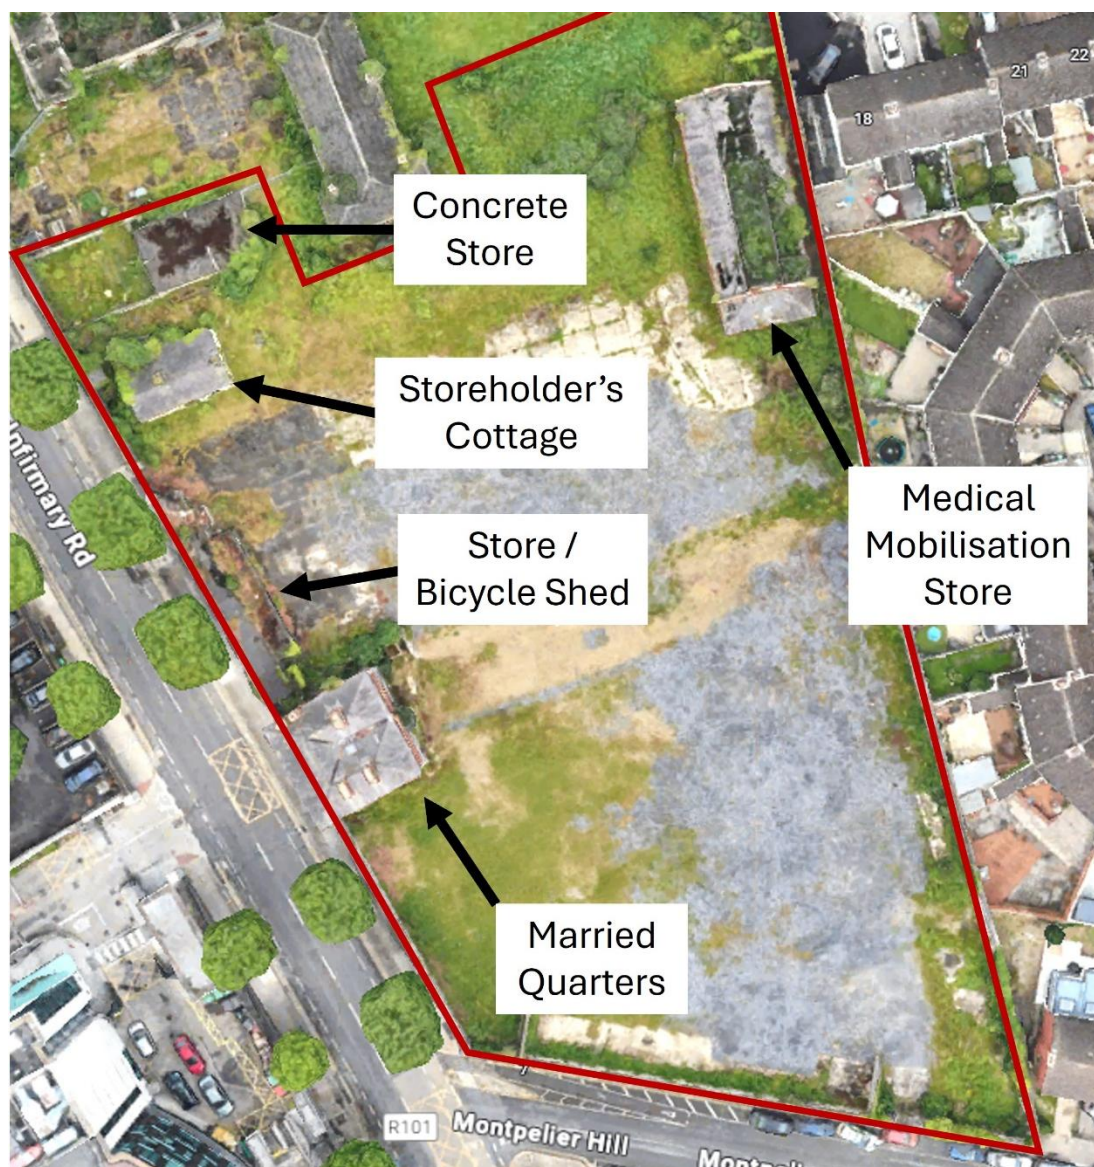
**Figure 1. Locations of buildings**

Buildings within the Site are shown in Figure 1 and described below:

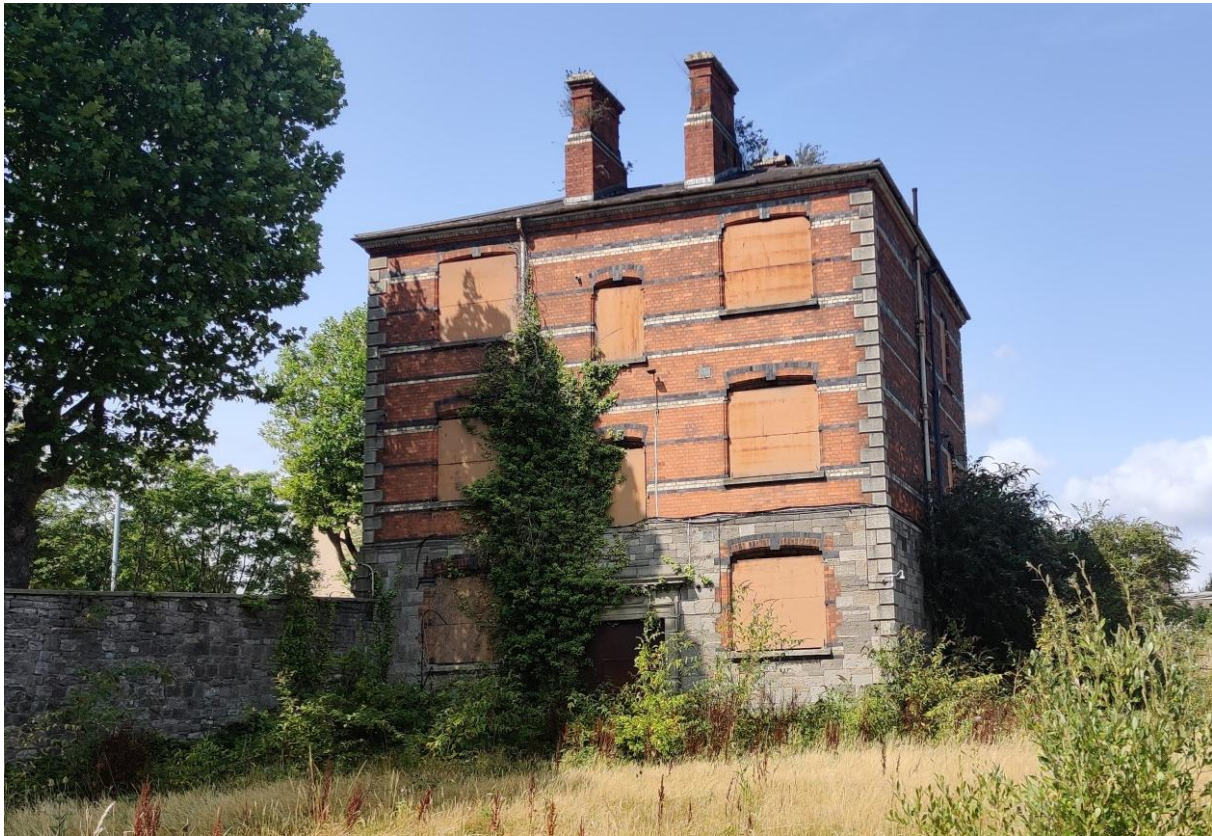
**Figure 2: The Married Quarters building**

- Married Quarters (Figure 2). A three-storey red-brick structure built in 1883. The roof consists of slate and is in poor condition, with several missing slates and gaps in flashing. All external doors and windows have been boarded up. The western side of the building is illuminated by streetlights along Infirmary Road, but the other sides of the building are not illuminated. The structure was considered to have moderate suitability for roosting bats

Two soprano pipistrelle bats were observed emerging from the southern side of the Married Quarters. The exact emergence point was not clear, but one appeared to be from the roof and the second from eaves level. Based on these results, the building is considered most likely to be a day roost, i.e. a place where individual or small groups of bats take refuge during daylight, but not used for breeding purposes.

One soprano pipistrelle was observed emerging from the Married Quarters, apparently from roof level. As before, this structure is considered to be a day roost.

The interior of the Married Quarters building was inspected on 1 May 2026. Parts of the building had water damage and were unsafe, but most areas could be observed. No bat droppings were observed within the building, suggesting that the roosting bats are confined to the upper roof structure, likely under roof tiles. There is no indication that they use any other part of the building.

The Married Quarters supports a small day roost of 1 – 2 soprano pipistrelles in the upper roof structure, likely under slates, ridge tiles or flashing. The poor condition of the building prevents further detailed survey of these locations. Due to the small number of bats it is extremely unlikely that they breed within the Site; they are considered most likely to be solitary male bats.

The scientific agent (Nick Marchant) will supervise the lifting of tiles and installation of the breathable membrane, and will manually remove any bats uncovered during this process. He will be in close proximity to the roofing team during this process, working either from a scaffold or mobile elevated working platform.

Any bats removed from the structure will be kept in a cotton holding bag and moved to a bat box. The bat box will be installed on or close to the exterior of the building before works commence.

The roof of the structure will need to be replaced. The scientific agent will supervise the stripping of the roof using the methods outlined above.

An alternative roost space will be provided in the refurbished structure. As only 1 – 2 bats are present, this could be achieved using a relatively small roost space(s), e.g. a bat access slate or modified ridge tile. The building is a protected structure and there will be restrictions on the materials that can be used, so the scientific agent will liaise with the conservation architect to identify suitable designs.

Lighting proposals for the refurbished Married Quarters building will be reviewed by the scientific agent to ensure that there will be no illumination of the roost or access points. No uplighters or other external feature lighting will be permitted on the building. External security / access lights and pedestrian lighting in landscaped areas will be directed downwards towards the ground, ensuring no light spill above the horizontal. Where feasible, lights will be fitted with motion sensors and / or timers to provide light only when necessary.
