# **Bat Derogation Licence Supporting Document**

Kingston Knocknacarra  
West LRD

Document Title: **Bat Derogation Licence Supporting Document**

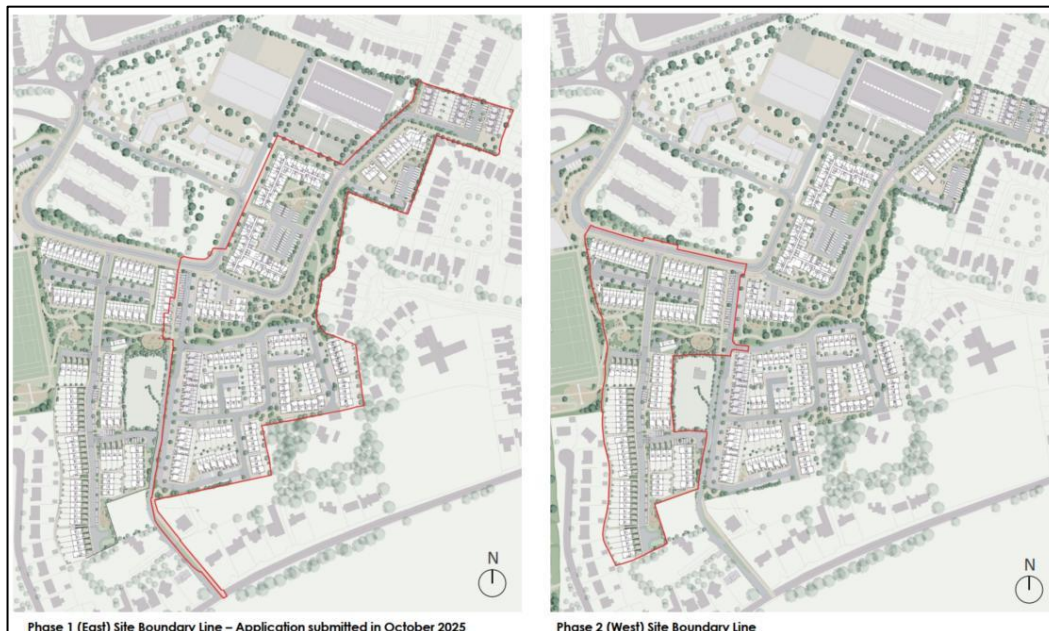
Plate 3-1 Masterplan Phase boundaries

This LRD forms Phase II of this wider masterplan (Plate 3-1).

The area of surveys undertaken spans across the entire Knocknacarra site, including Phase I and II shown in Plate 3-1 above.

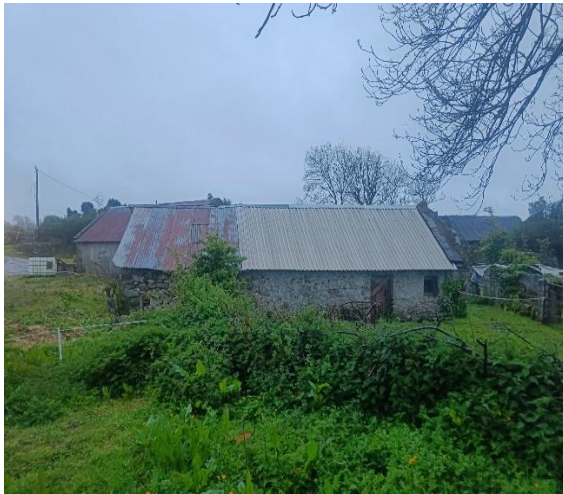
Plate 5-1 Stone Shed 1 northern aspect

Stone Shed 1 is a derelict old stone dwelling with a corrugated roof located within the farmyard (IG Ref: M 26647 24686) (Plate 5-1). Multiple potential access points were identified within crevices in the stone walls, and in gaps in the roof and doorways (Plate 5-2). Evidence of feeding remains in the form

of butterfly wings were found within the structure (Plate 3-3, Plate 5-4). It was assigned a *Moderate* roosting potential. The shed was subject to a dusk emergence survey on the 2<sup>nd</sup> of May and 4<sup>th</sup> September.

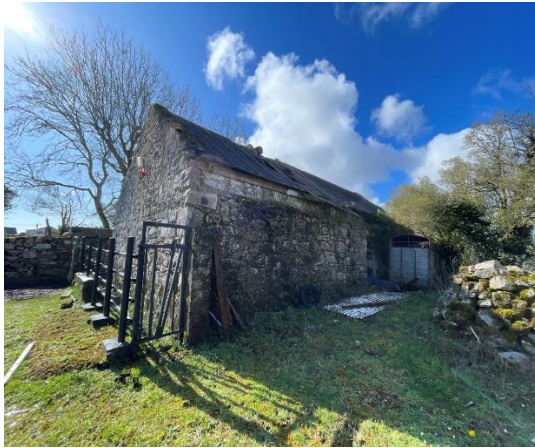
Plate 5-5 Stone Shed 2 northern aspect

Stone Shed 2 is a derelict stone shed with a partially collapsed asbestos roof located to the southwest of Stone Shed 1 (IG Ref: M 26631 24667) (Plate 5-5 and 5-6). No evidence of roosting bats was found within the derelict shed during the inspection, however numerous potential access points and a number of gaps suitable for crevice dwelling bats were identified (Plate 5-7, Plate 5-8). Thus, it was assigned a *Moderate* roosting potential. The shed was subject to a dusk emergence survey on the 20<sup>th</sup> May and 3<sup>rd</sup> of July.

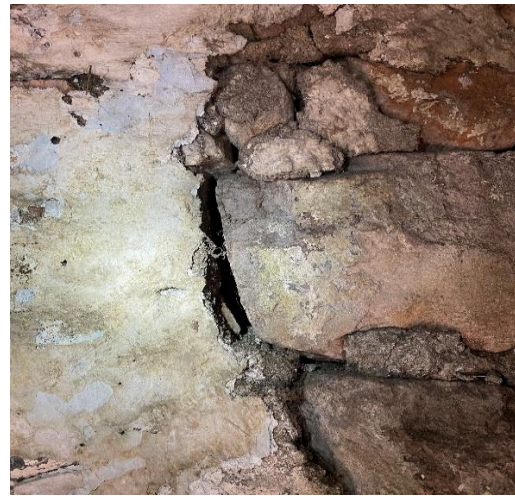
Plate 5-8 Large crack in interior stonework

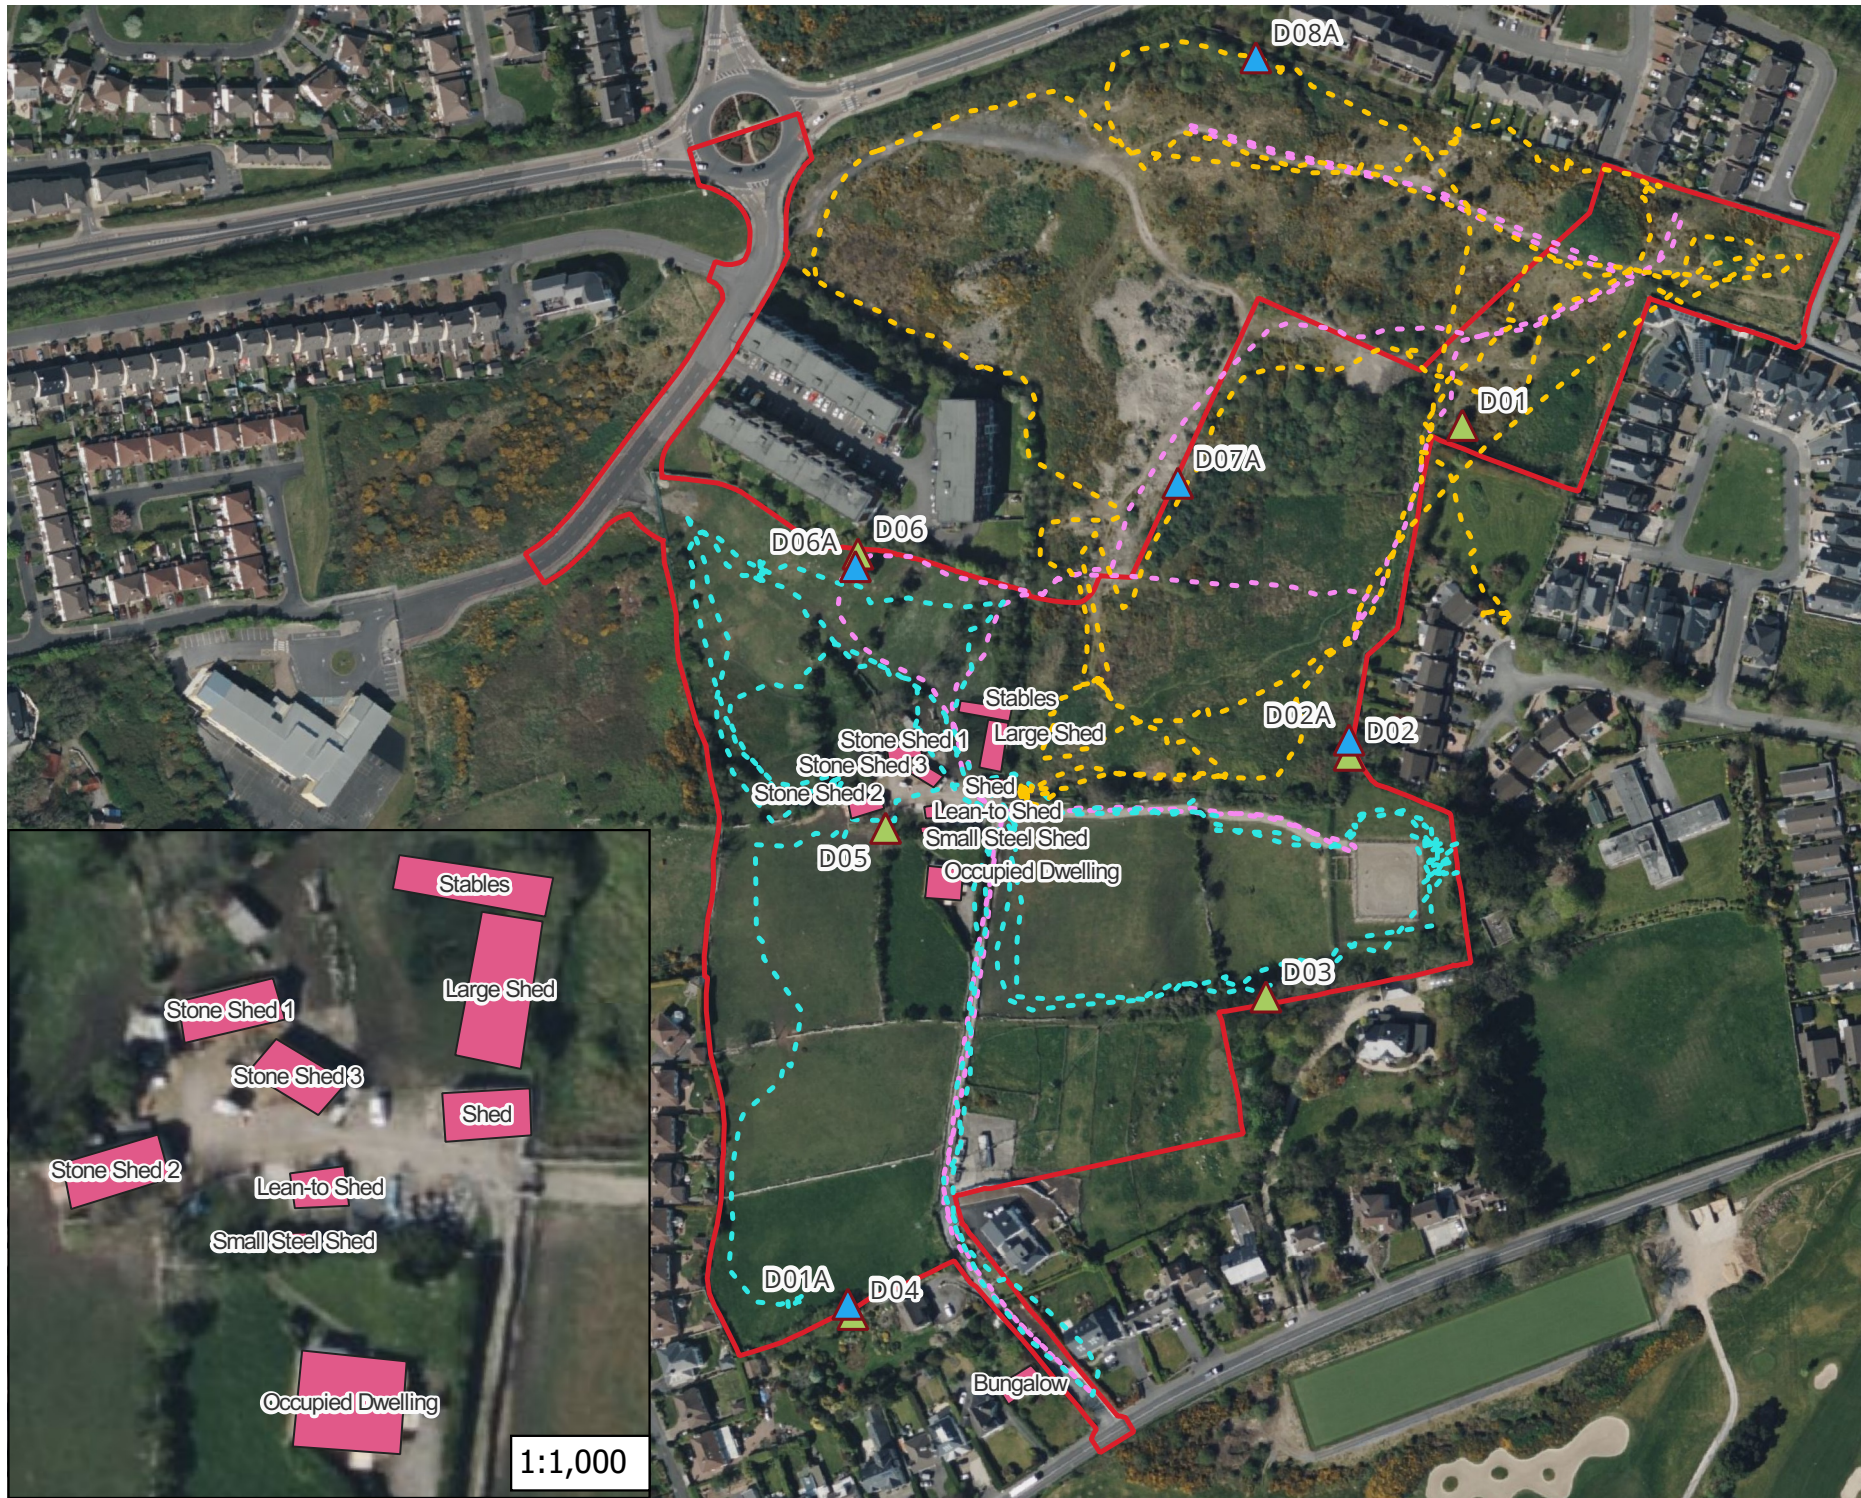
Manual activity surveys included presence/absence surveys focusing on features identified as having potential for roosting bats, as well as night-time bat walkovers (NBW). For each of the surveys, surveyors were equipped with active full spectrum bat detectors, Batlogger M (Elekon AG, Lucerne, Switzerland). Where possible, species identification was made in the field and any other relevant information was also noted, e.g., numbers, behaviour, features used, etc. All bat echolocation was recorded for subsequent analysis to confirm species identifications. The survey effort is summarised in Table 5-8 and presented in Figure 5-1.

Settings used were those recommended by the manufacturer for bats, with minor adjustments in gain settings and band pass filters to reduce background noise when recording. Detectors were set to record from 30 minutes before sunset until 30 minutes after sunrise. The Song Meter automatically adjusts sunset and sunrise times using the Solar Calculation Method when provided with GPS coordinates. Static detector locations are shown in Figure 5-1 and presented in Table 5-9.
