# Derogation Licence Application - Supporting Information

Proposed Residential Development

Bride Street, Kildare, Co. Kildare

Report Number  
2522-DLASI-F-2026.05.18

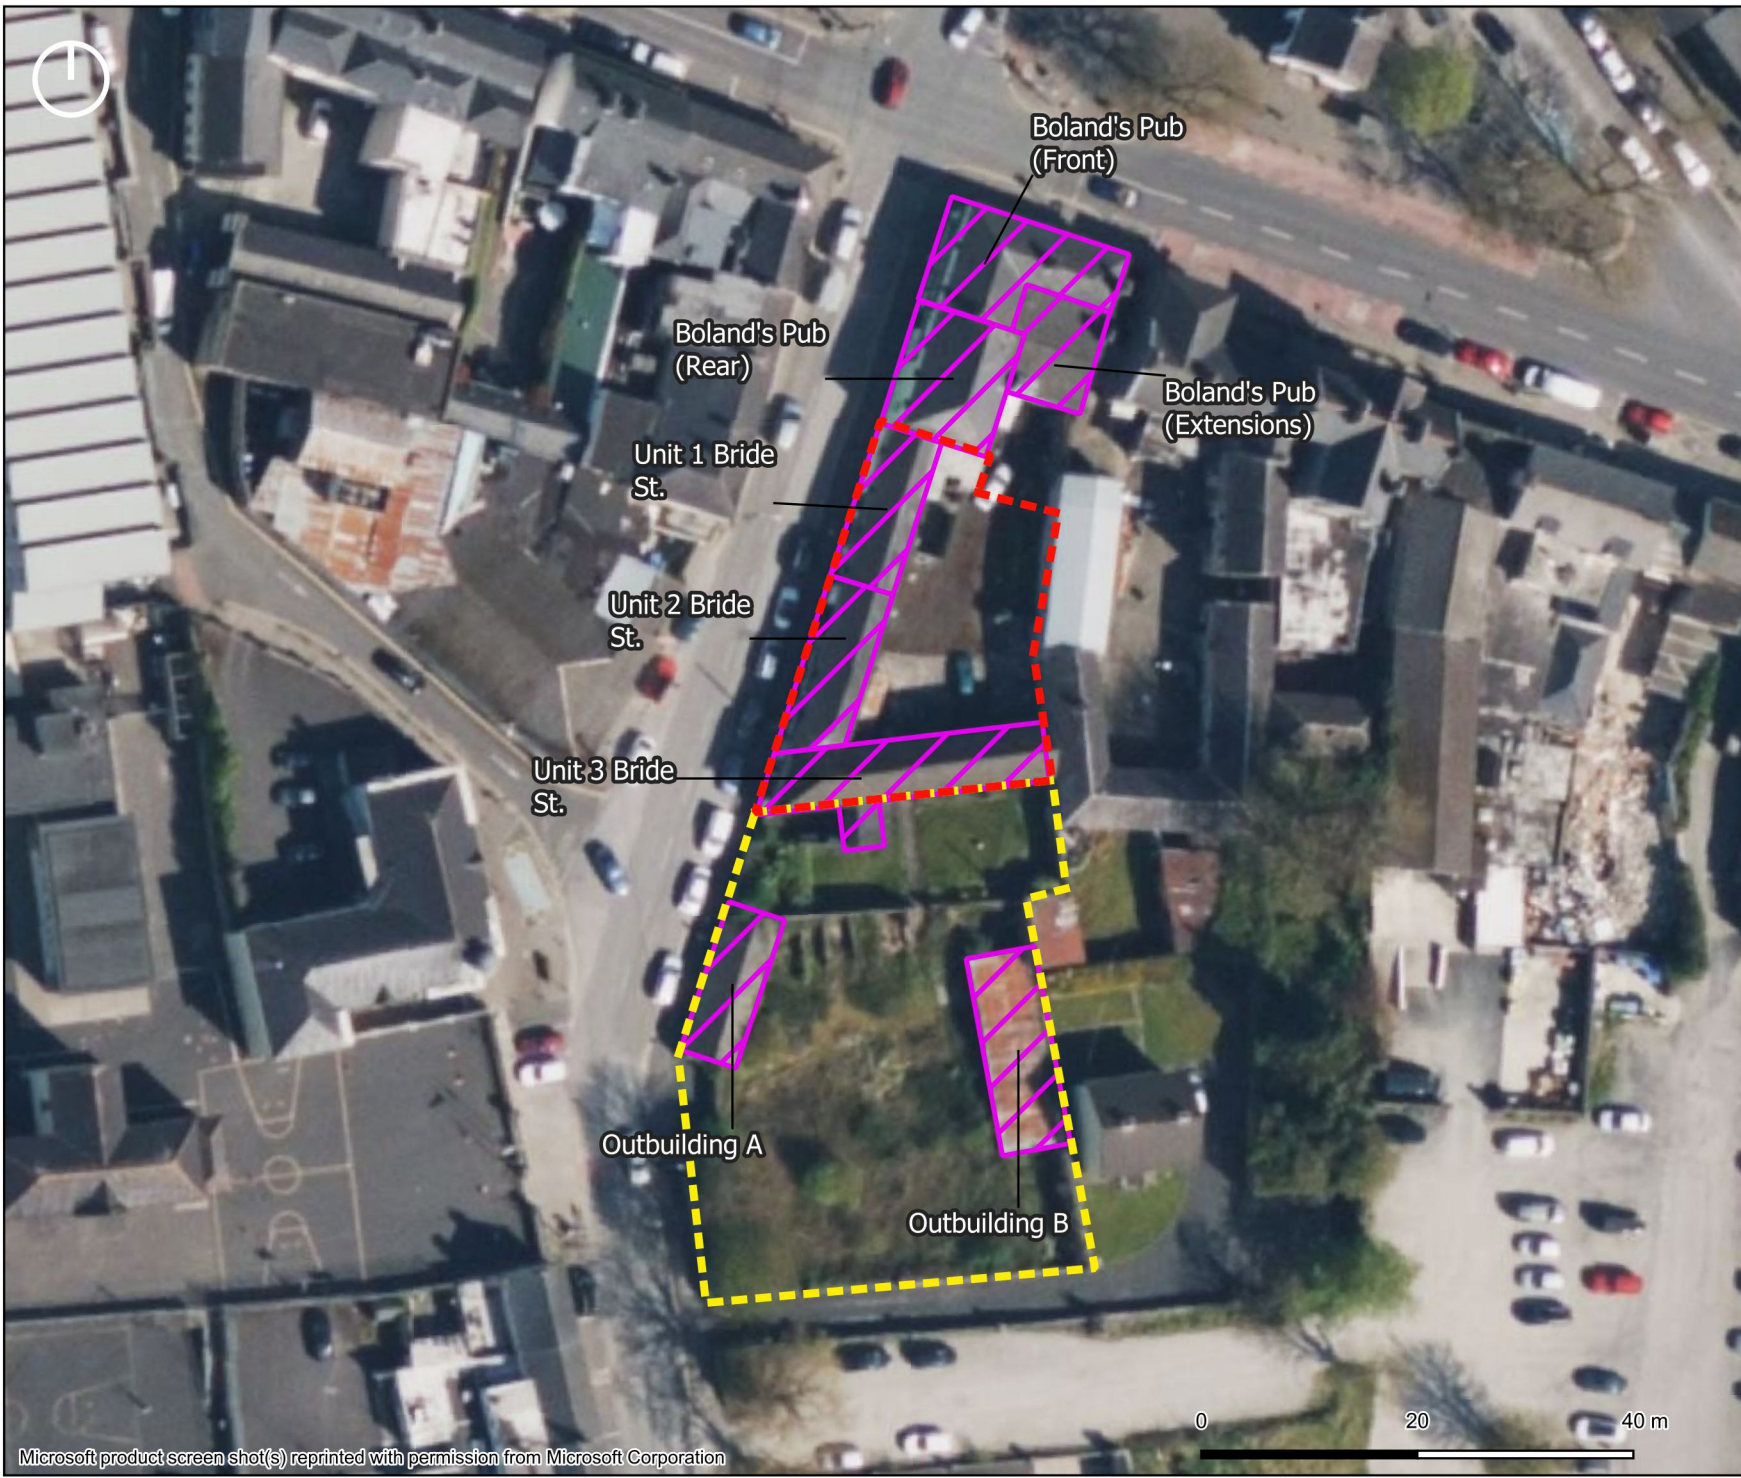
Figure 1-1.  
Existing layout of subject site.

- Upper Site
- Lower Site
- Buildings

3-xvii The subject site contains a series of connected buildings, associated extensions and two separate out-buildings (Boland's Pub, Units 1-3 Bride Street and Outbuildings A & B, as shown in Figure 1-2 further above).

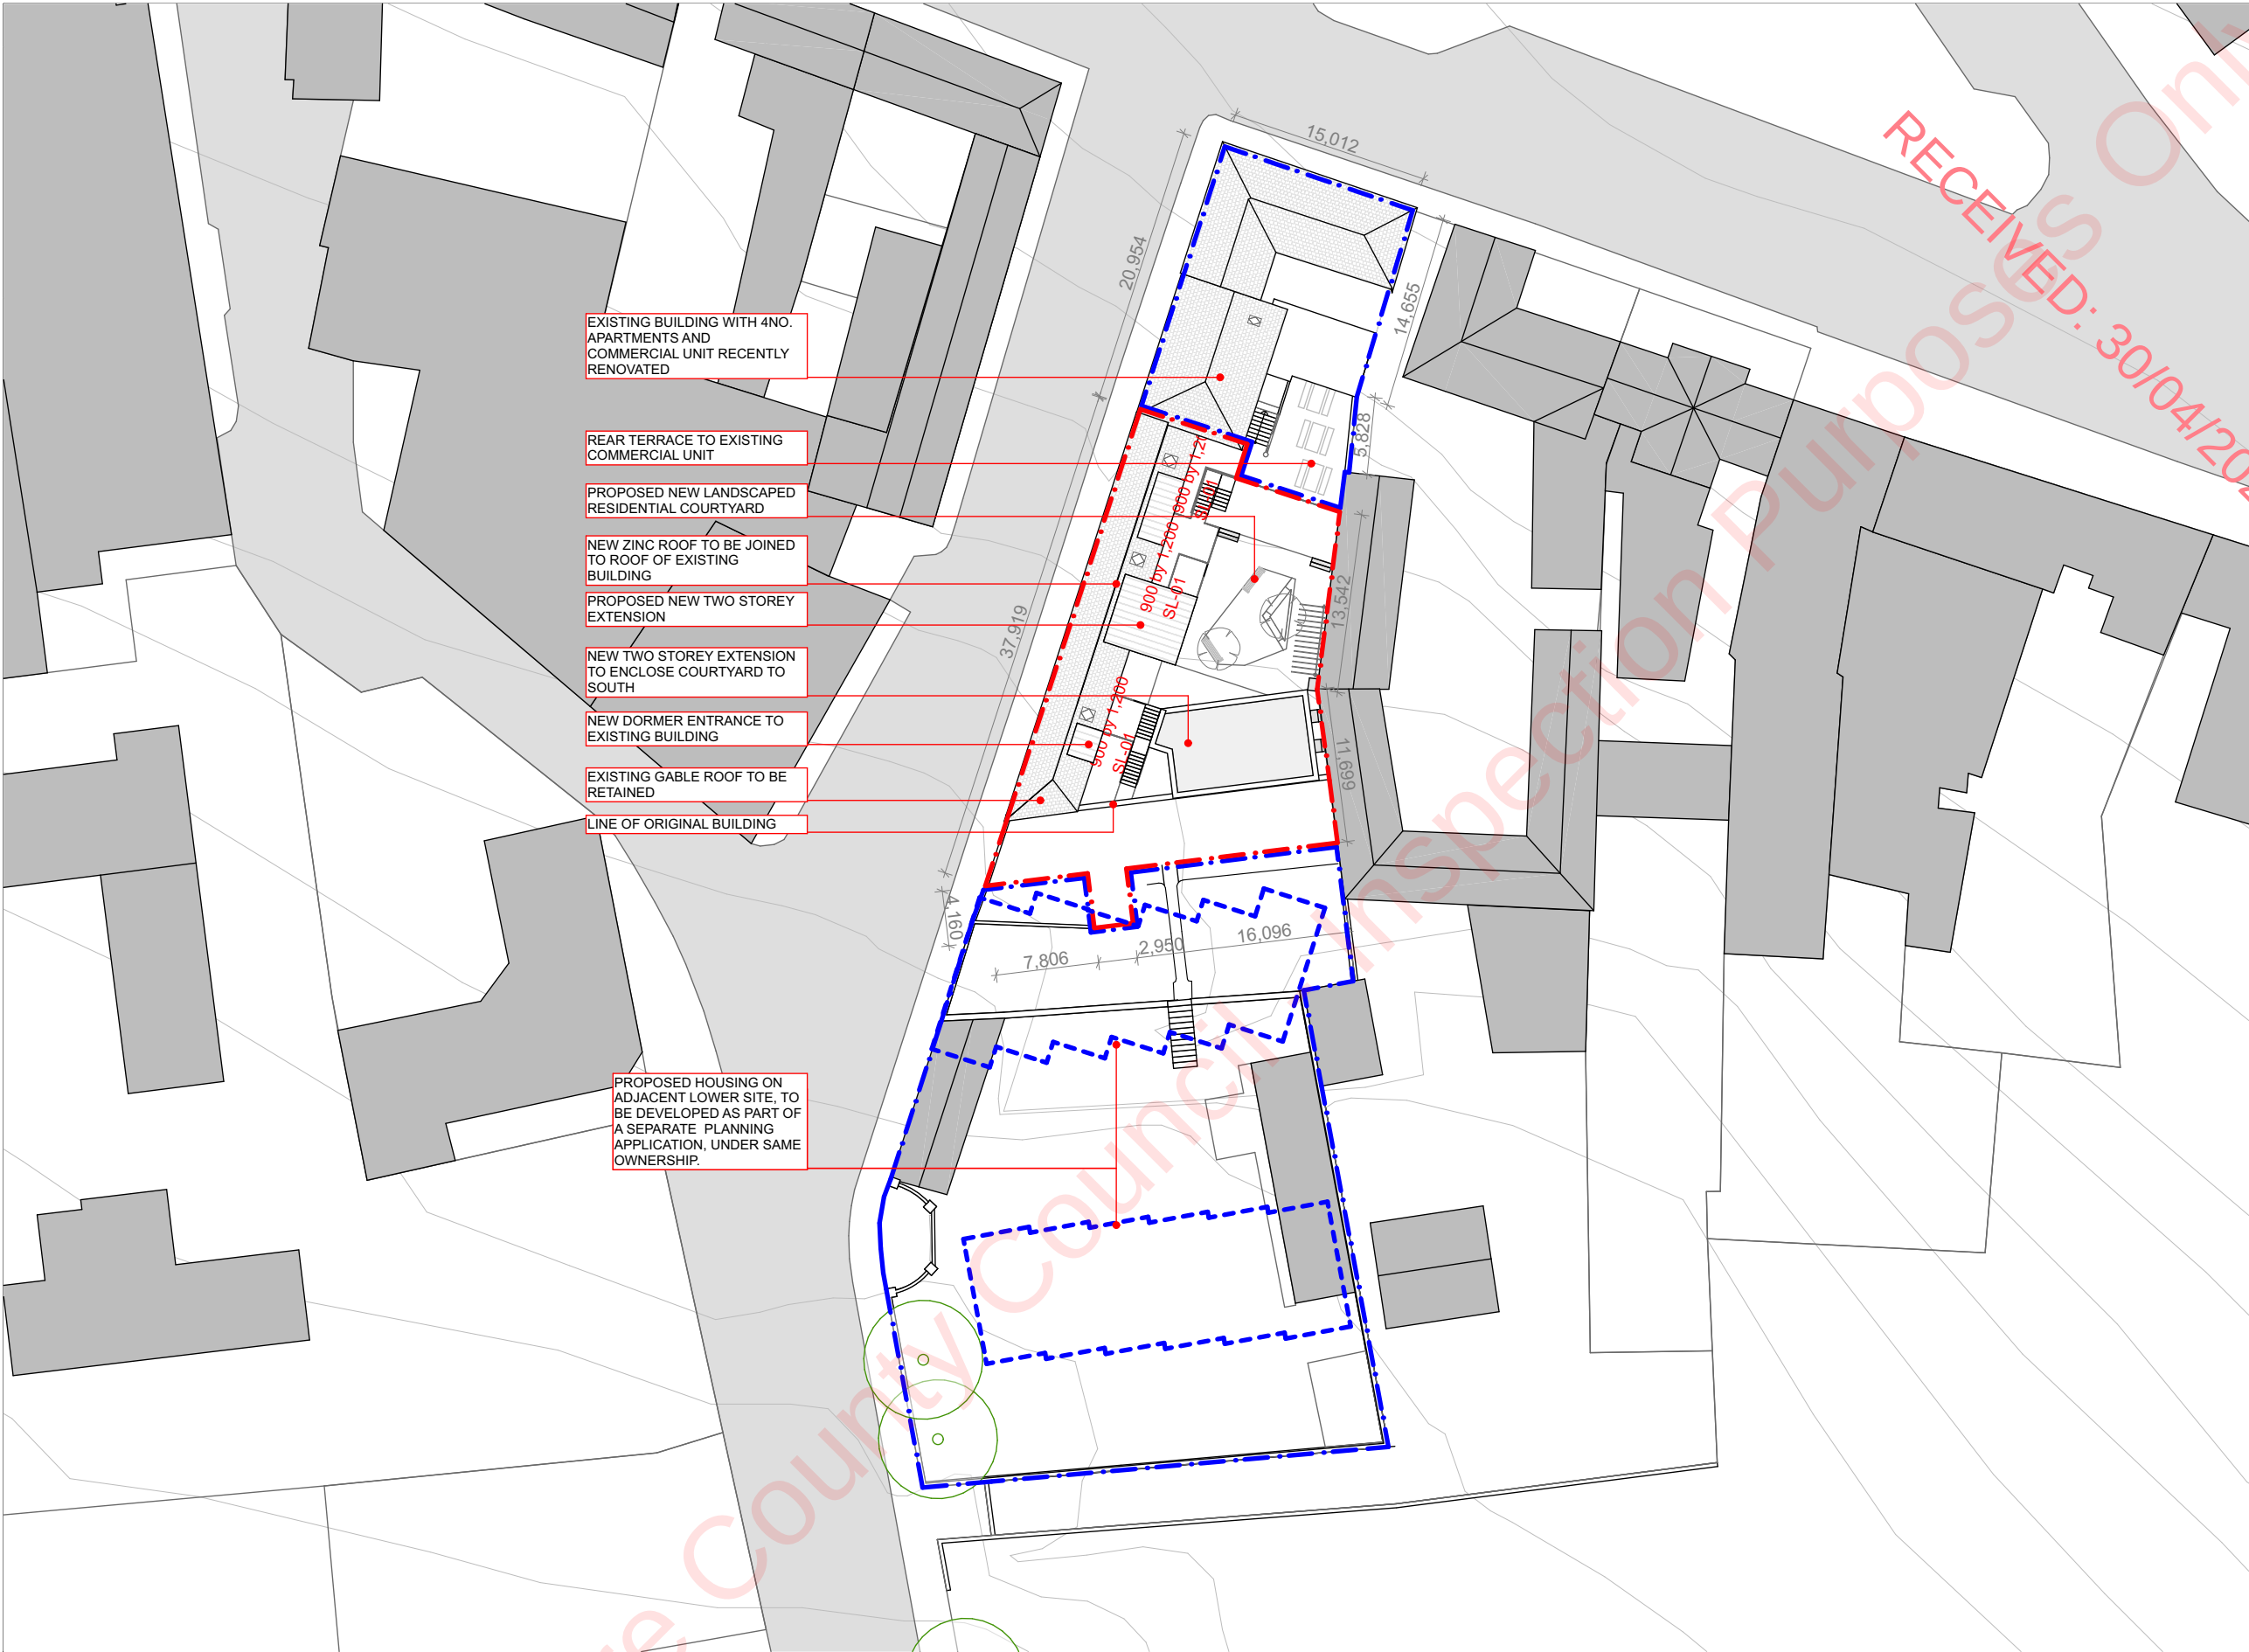
| DRAWING TITLE:<br>PROPOSED SITE PLAN | REV NO.:<br>PL-01 |

EXISTING BUILDING WITH 4NO. APARTMENTS AND COMMERCIAL UNIT RECENTLY RENOVATED

NEW ZINC ROOF TO BE JOINED TO ROOF OF EXISTING BUILDING

PROPOSED NEW TWO STOREY EXTENSION

NEW TWO STOREY EXTENSION TO ENCLOSE COURTYARD TO SOUTH

EXISTING GABLE ROOF TO BE RETAINED

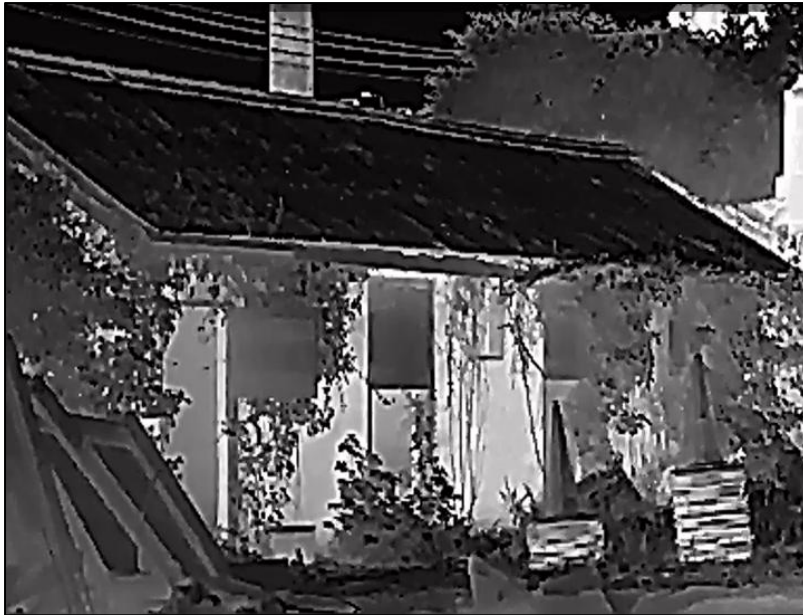
**Plate 3-1.** Example of thermal imaging camera footage captured during emergence survey (Outbuilding A).

- 3-ix A high-sensitivity thermal imaging camera was also utilised as a survey aid, as per Fawcett Williams (2021). Thermal imaging significantly improves the detectability of bats emerging/re-entering roost sites, as the camera is not restricted by the available visible light. Footage was then reviewed following the survey to ensure no potential emergence was missed during the survey.

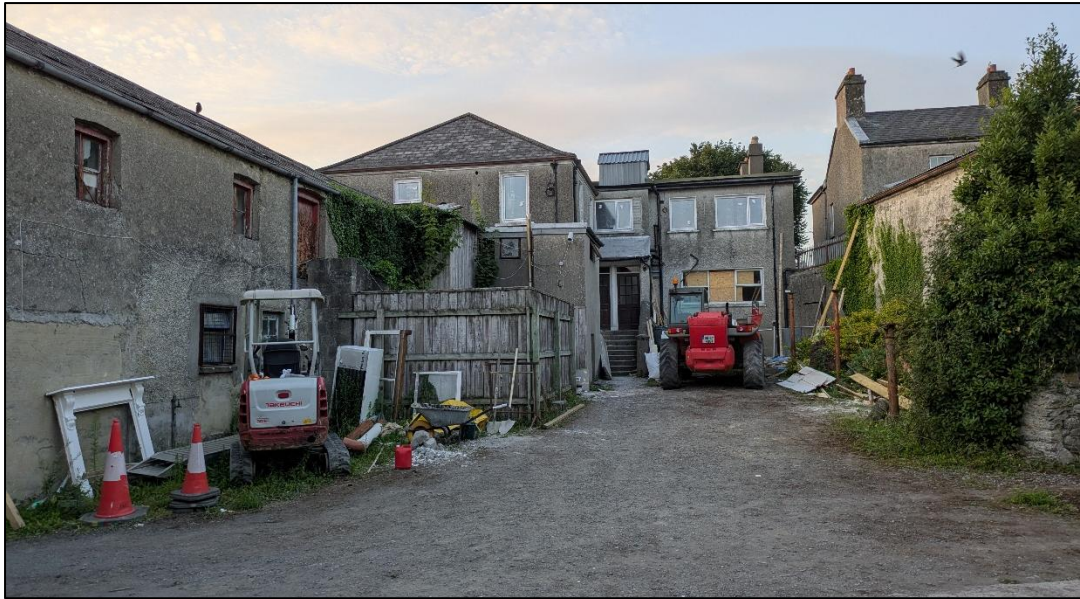
**Plate 3-2.** Rear of Boland's Pub and Unit 1.

3-xviii At the north of the site, fronting onto Market Square and Bride Street is the former Boland's Pub. This comprises a two-storey building dating from c.1890<sup>c</sup>. The ground floor (former pub) has been stripped out. Recent renovation works have been undertaken in the upper storey. There is an adjoining building to rear which also comprises part of the former pub (Boland's Pub Rear). This is similarly a two-storey structure likely dating to mid-nineteenth century. The roof of both these structures has been replaced in the past (c.1980), now comprising an artificial slate roof. The majority of the windows across the two structures are original timber-frame sash windows. There are some modern flat-roofed extensions to the rear of the eastern half of Boland's Pub. No dropping or other evidence of bat presence was recorded in Boland's Pub during roost inspection survey.

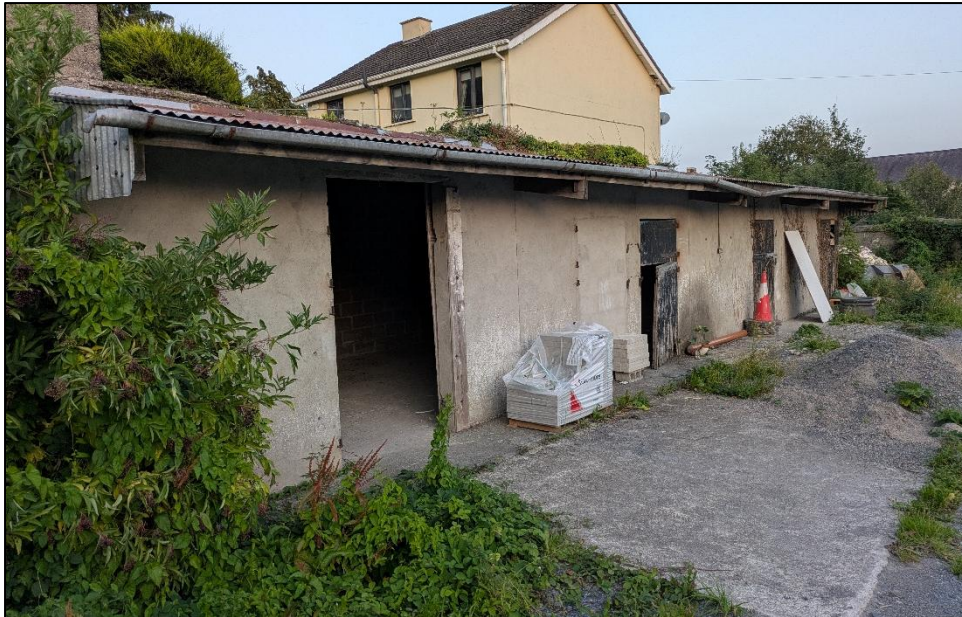
**Plate 3-6.** Outbuilding B.

There are two outbuildings situated in the rear yard of the subject site. Outbuilding A comprises a former stable building with wooden panelled roof topped with corrugated metal sheeting. The structure is derelict and partially overgrown with ivy and bramble. Outbuilding B comprises a second former stables but appears to be of more modern construction, with concrete-based walls and render with corrugated metal roof.

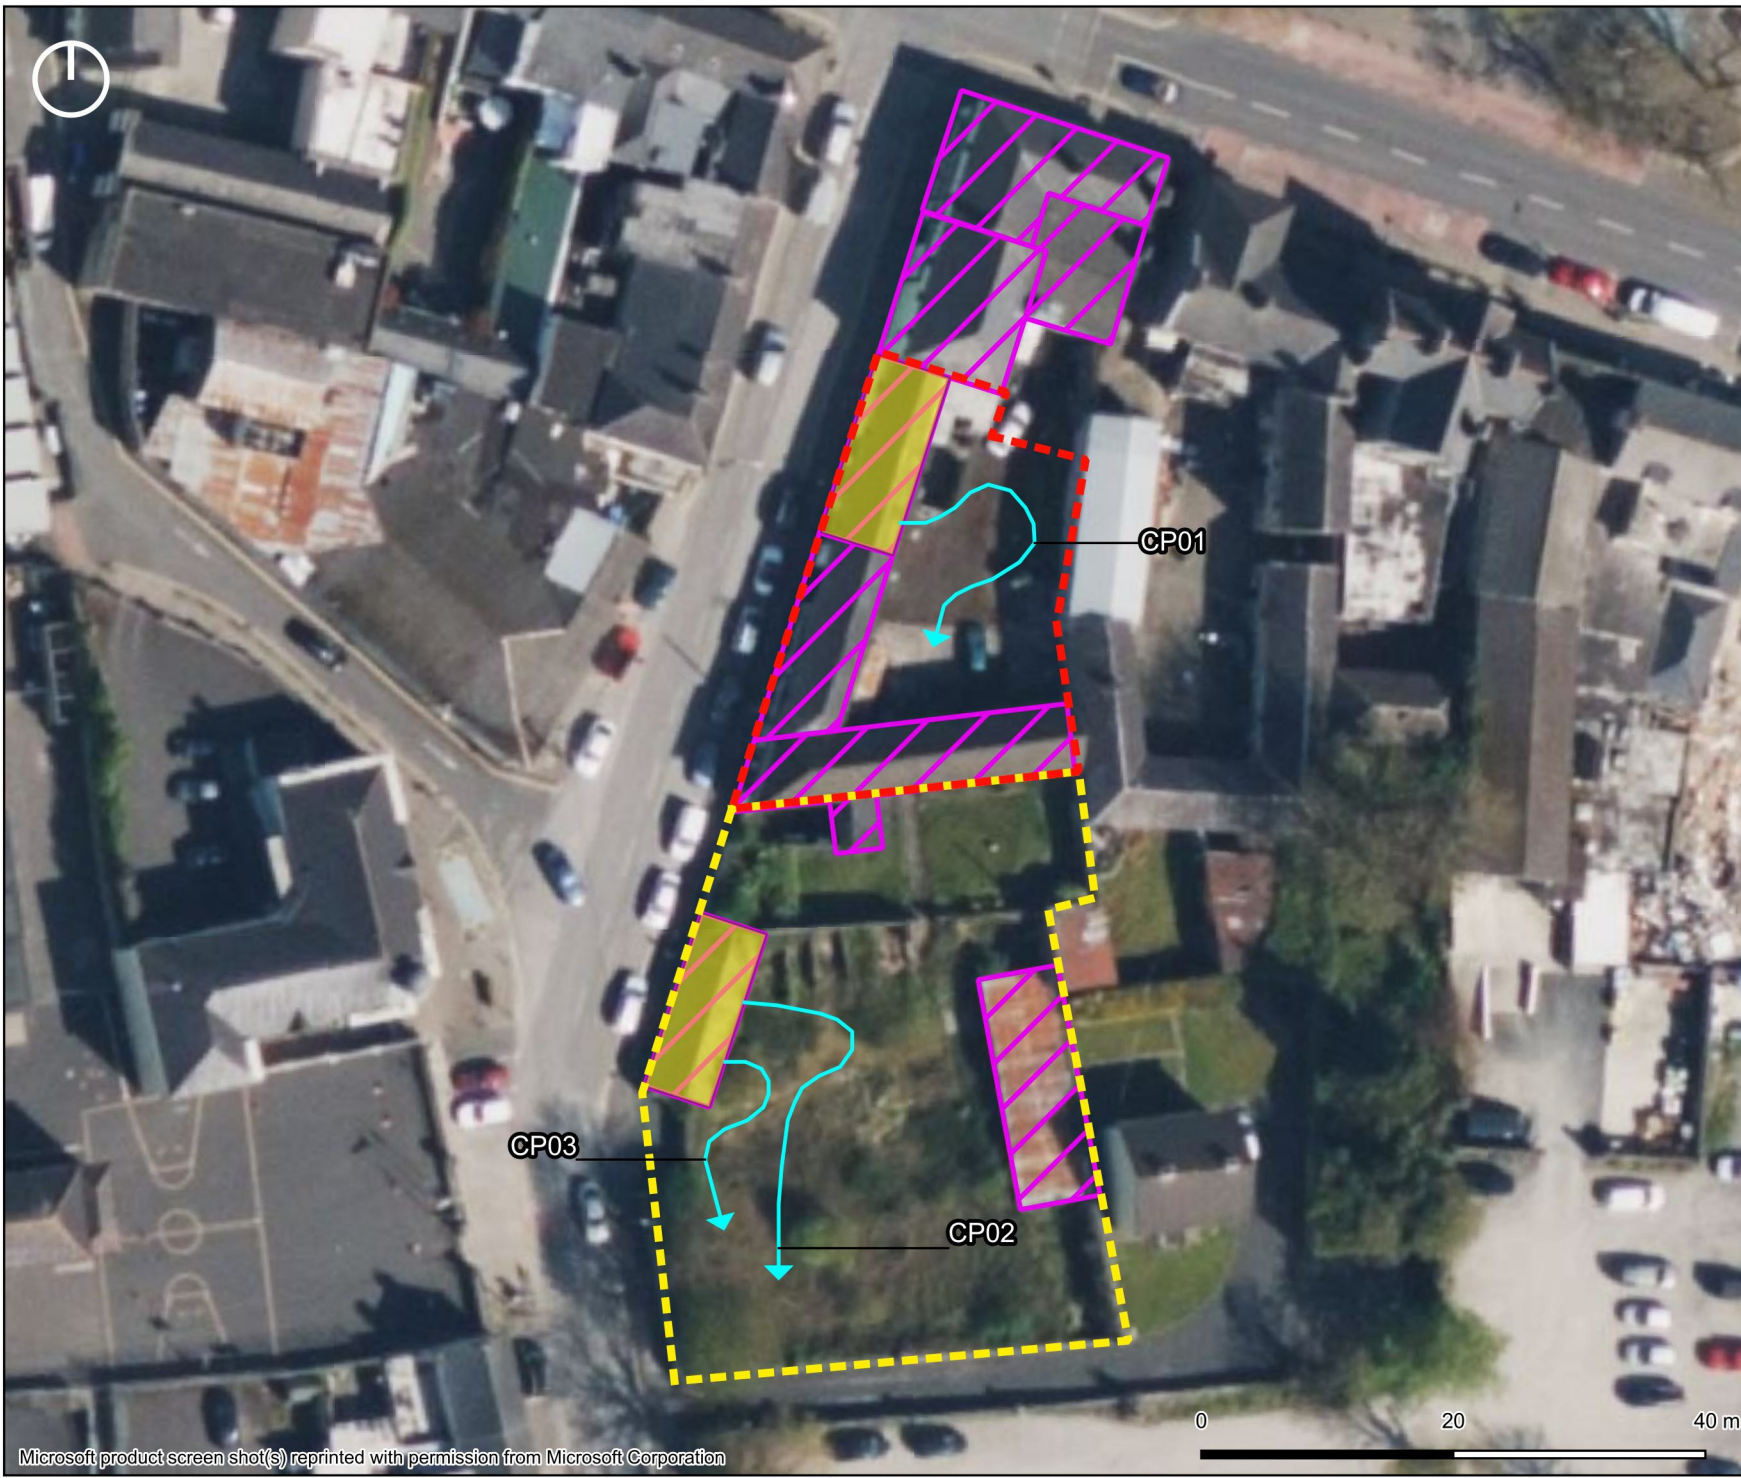
**Total bats recorded emerging:** 4no. common pipistrelle from Outbuilding A, 1no. common pipistrelle from Unit 1.

- Upper Site
- Lower Site
- Buildings
- Bat Flights
- Roost Locations
