# Kilpipe

## CONSERVATION MANAGEMENT PLAN

CMF23-2-WI002

November 2023

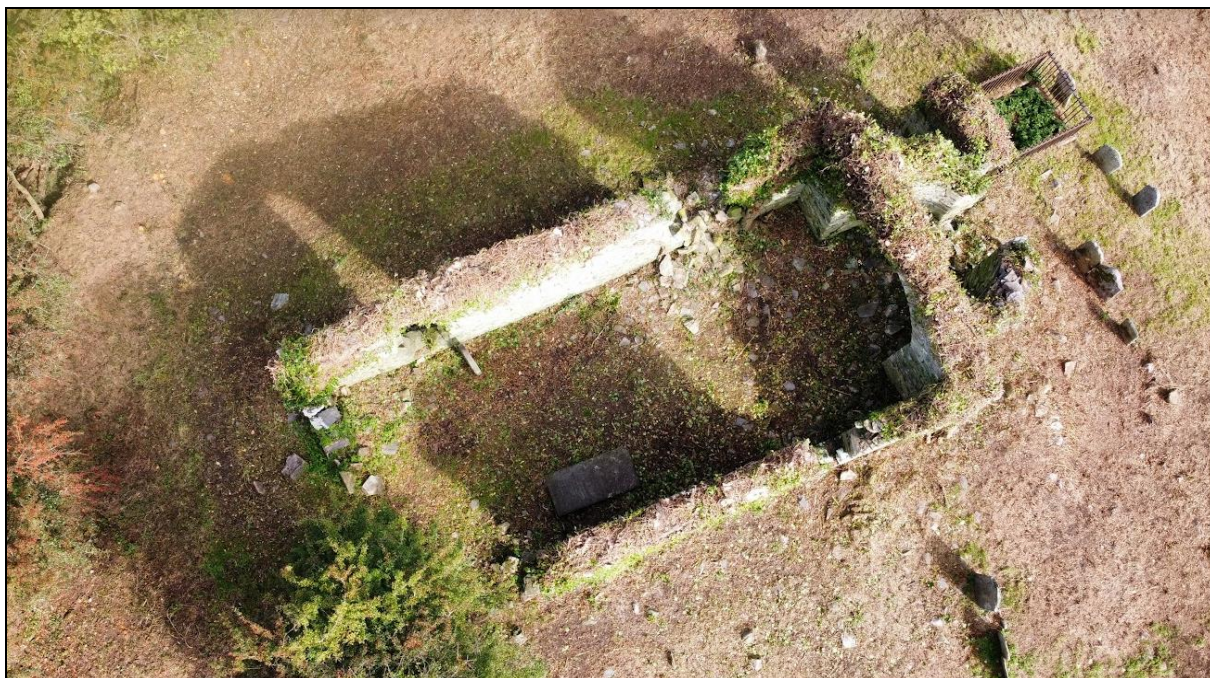
Plate 1: Overview of church after vegetation removal.

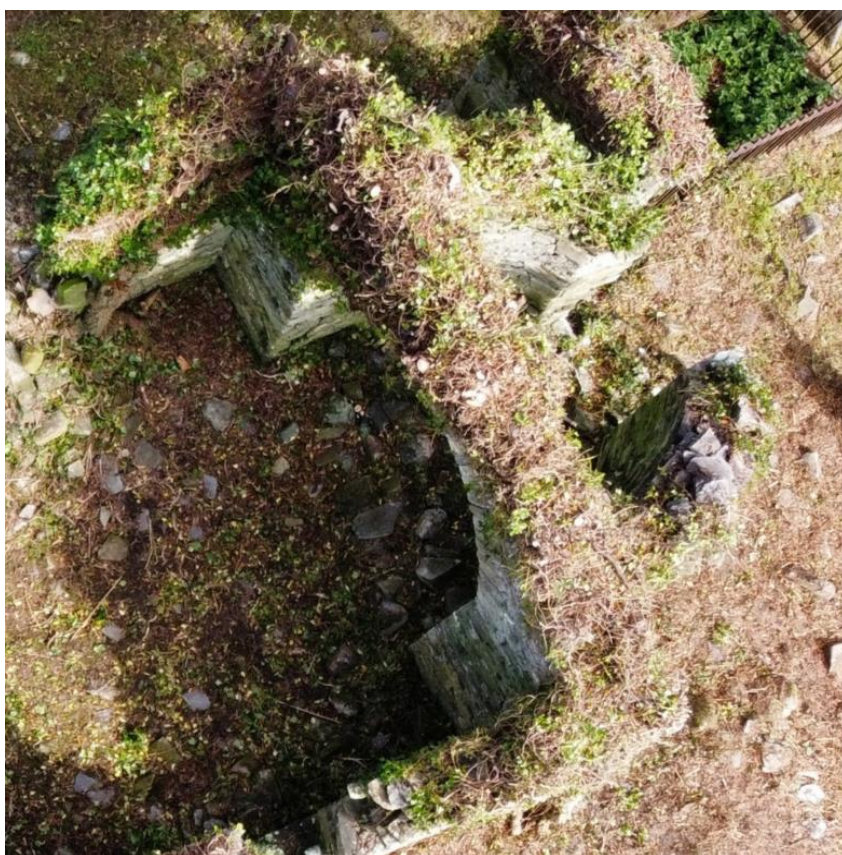
Plate 2: Overview of chancel and apsidal chamber of church.

Chancel arches served as a division between the chancel and the nave of a church. The chancel was the area near the altar reserved for the clergy, while the nave was the space for the congregation at the west end of the church.

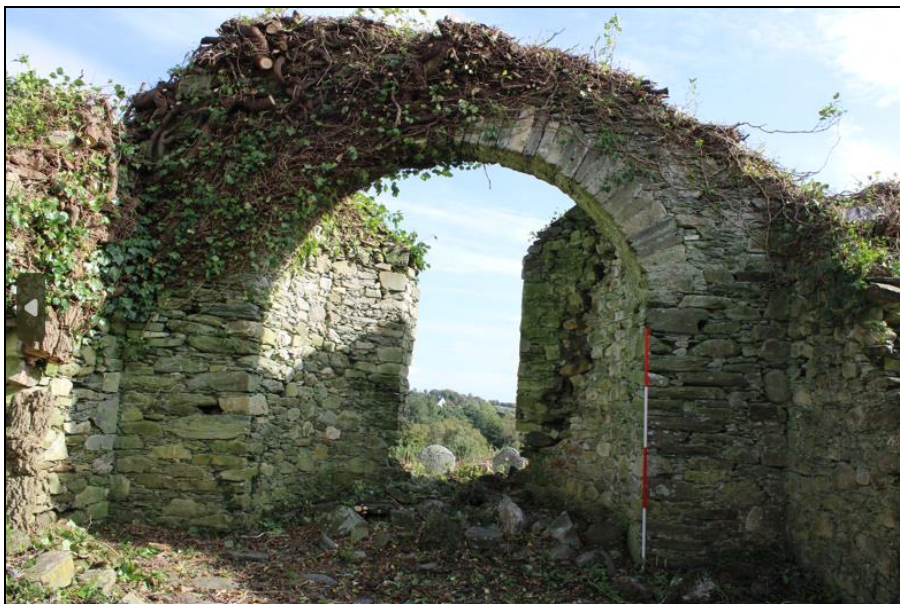
Plate 3: Chancel arch facing east.

The entire church appears to have been built in a single phase. The chancel arch opening is 3.43m in width and is 4.25m high to existing ground level. The arch itself is 0.50m in width. The arch was constructed by a series of cut wedge-shaped blocks—i.e., ones in which the upper edge is wider than the lower edge, flanked closely together and bound with mortar, which results in an arch. These cut wedge shaped stones are called voussoirs which are carefully cut so that they press firmly against the surface of neighbouring blocks and conducts loads uniformly. The central voussoir is called the keystone. The voussoirs where the arch rises from its vertical supports is known as the springer stone, or springing line. During construction of an arch, the voussoirs require support from below until the keystone has been set in place; this support usually takes the form of temporary wooden centring. There is traces of mortar on the underside of the arch with possible plank centering visible.

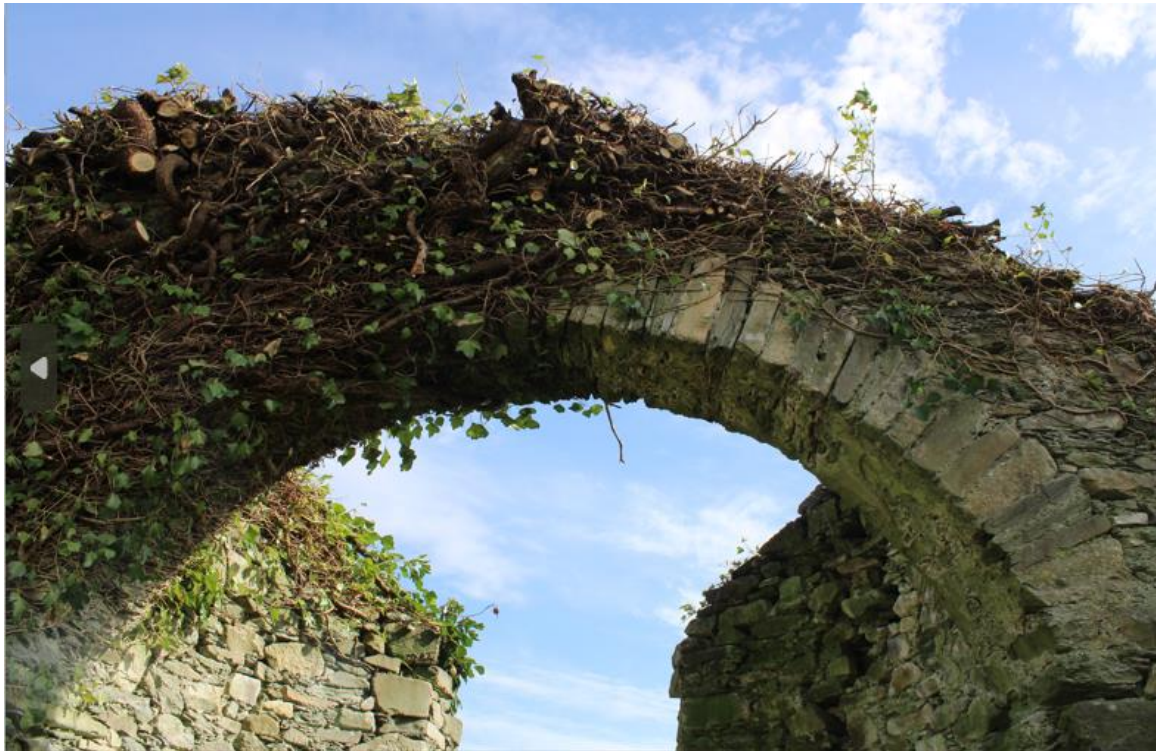
Plate 4: Voussoir construction of chancel arch.

The northern half of the arch is covered in ivy which has been treated and the arch is very well preserved. Its construction comprises cut sandstone voussoir, the keystone is not visible.

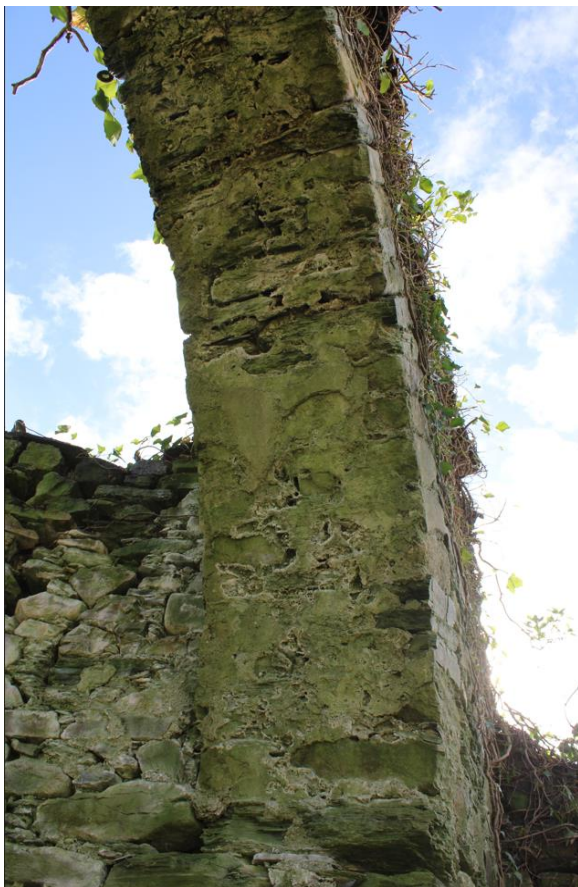
Plate 5: Mortar underneath chancel arch with possible plank centering visible.

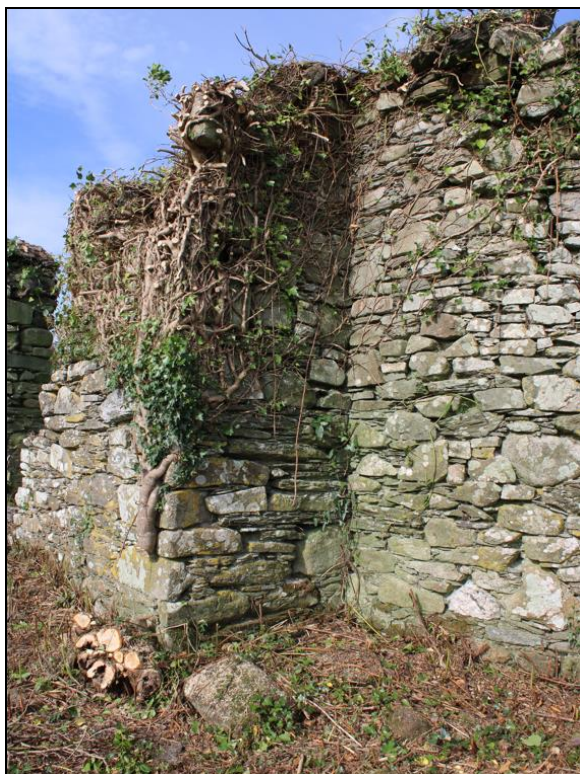
Plate 6: View of apsidal chamber and south wall of church, note how the walls appeared to have been constructed at the same time, the walls are 'knitted' together.

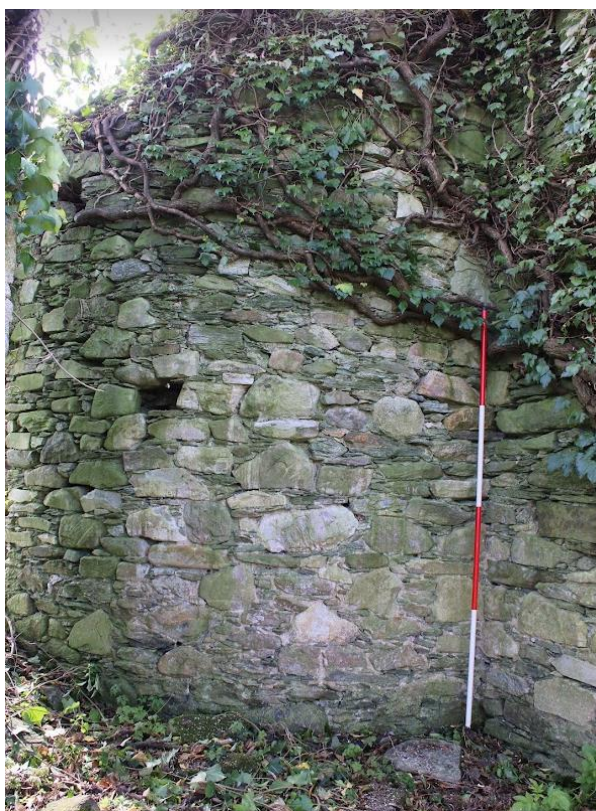
Plate 7: North wall of apsidal chamber, noted the small square hole in the wall.

The apsidal chamber which adjoins the chancel arch is semicircular in plan, 2.34m in depth, has an internal diameter of 3.43m and external diameter of 4.69m. A collapsed window opening which is described as round headed in the SMR files has collapsed and it was an opening of 0.66m externally which splays to an internal width of 1.3m and it has a remaining height of 2.1m. The roof of this structure has collapsed into the chamber and a large crack is visible in the south wall of the chamber. The walls of this chamber are semi-circular in plan with an opening for the window. A small square hole is built into the north wall of the chamber and is of unclear function (Plate 7).

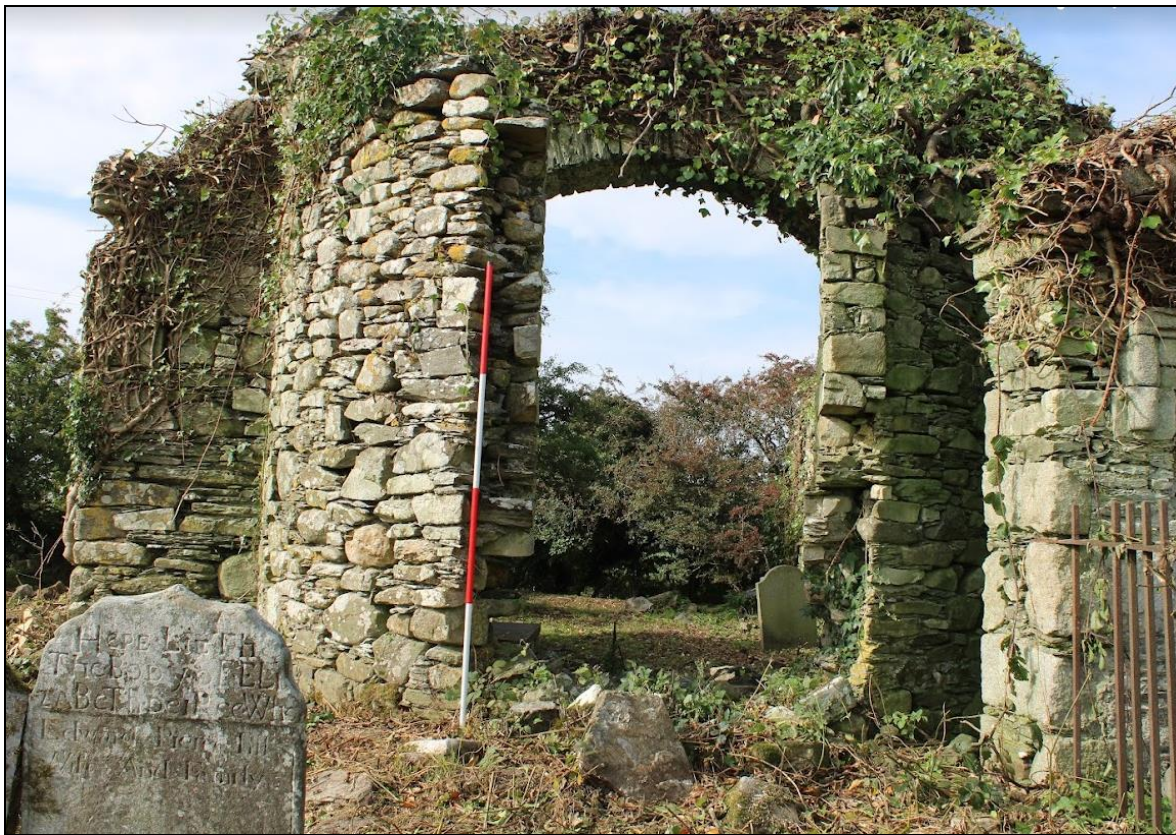
Plate 8: View of window opening in the apsidal chamber facing southwest, note how there is a small projection of masonry from the north wall.

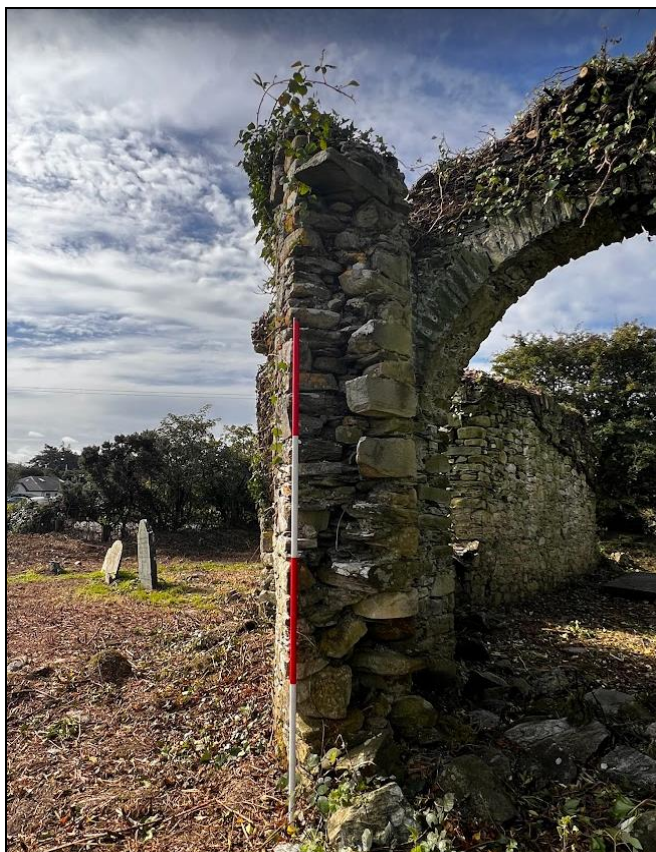
Plate 9: Southern wall of apsidal chamber which window has collapsed, facing southwest.

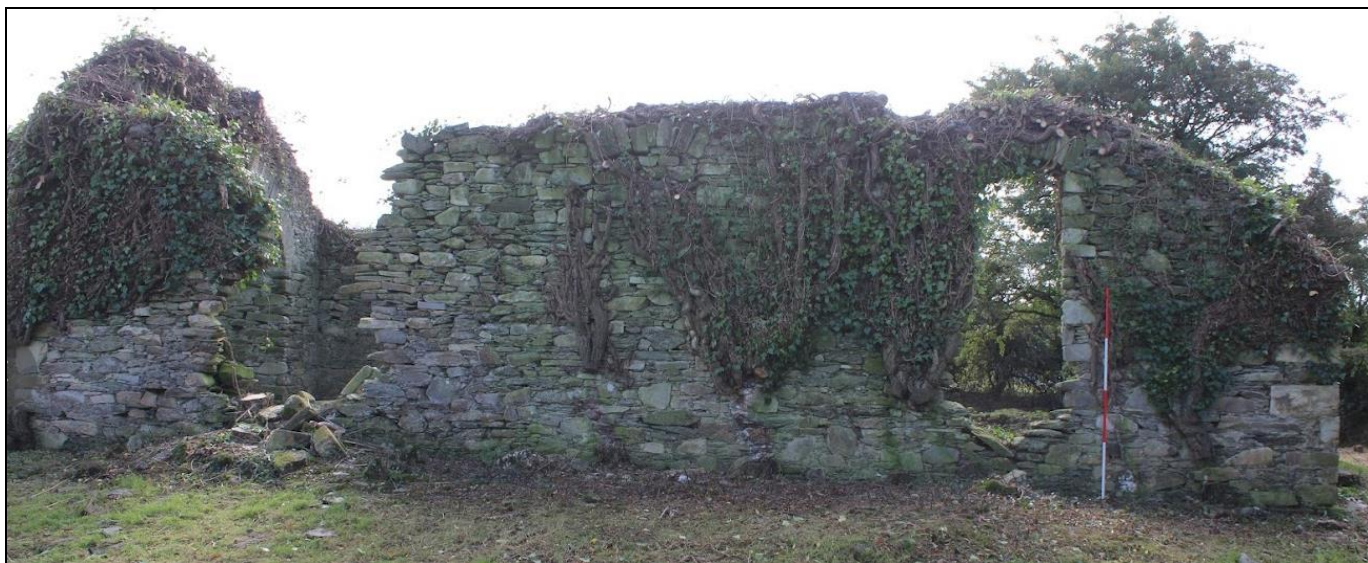
Plate 10: External northwest elevation.

The north wall of the church has an external length of 3.71m and an internal length of 12.40m in width. It has a maximum surviving height of 4.45m, the walls are 0.65m in width. Three windows are visible in this wall, one has been blocked up, the most westerly is the best-preserved window in the church and the most northeasterly has collapsed.

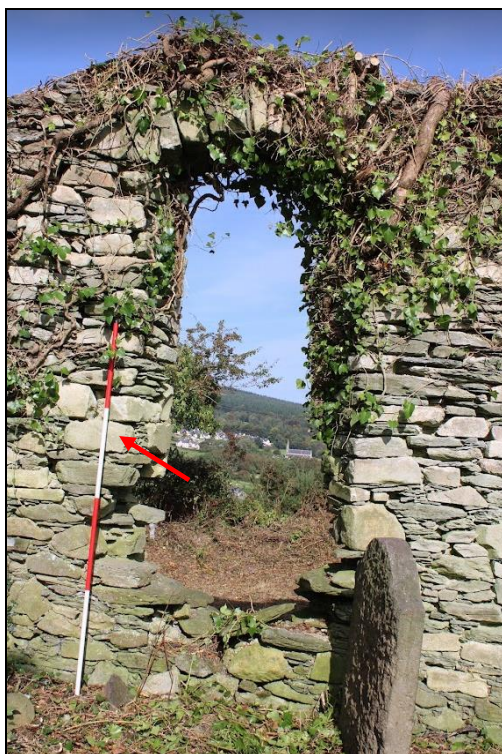
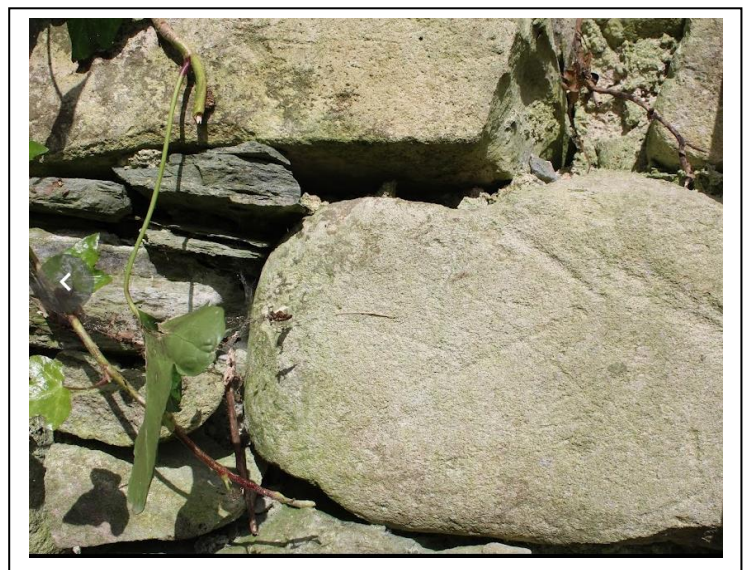
Plate 11: Window in NW elevation of church and possible mason's mark, red arrow illustrates location of this mark.

The most westerly splayed round headed window has a width of 1m on the outside which splays to 1.3m internally and is 2.3m in height. The round headed window is comprised of voussoir and thin slate stones. The sill of the window has been robbed out. Dressed stone is visible forming the sides of the window and a possible masons mark is visible on the western jamb of the window.

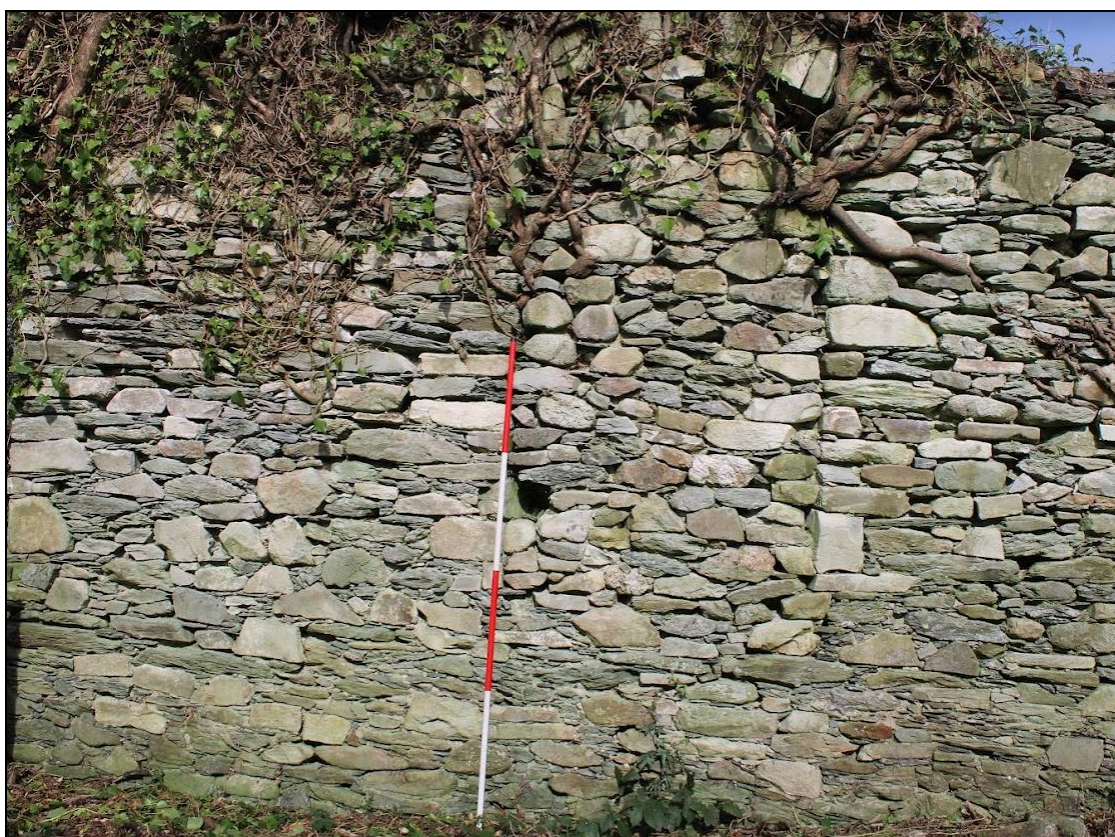
Plate 12: Blocked up window in N wall of church.

The central window has been blocked up in the northern wall of the church as has been also done in the south wall of the church. The window measures 1.34m in max width and is 2.3m in height. This window is also rounded headed of voussoir construction and is framed by cut sandstone. The sill of this window has also been robbed out.

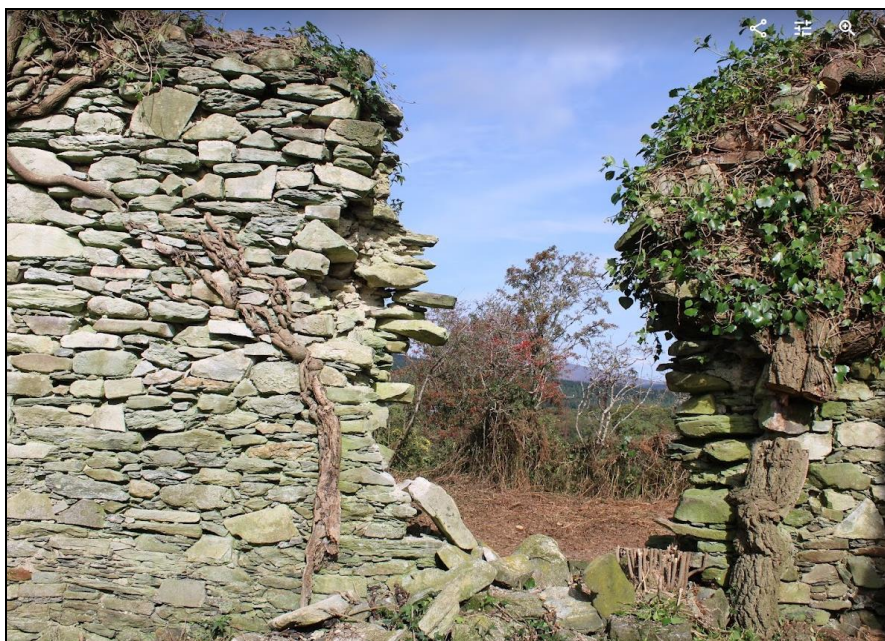
Plate 13: Collapsed window opening in N wall of church.

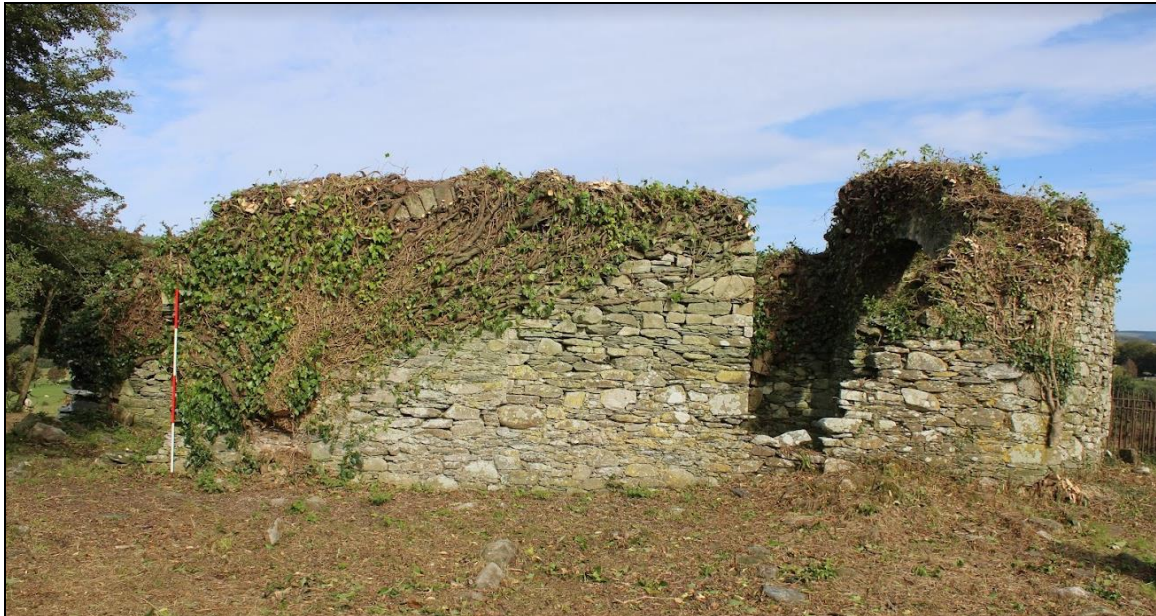
Plate 14: Southeast elevation of church.

The southeastern wall of the church has an external length of 13.71m and an internal length of 12.40m in width. It was a max surviving height of 4m, the walls are 0.63m in width. Three windows are visible in this wall, the central one has been blocked up, the most westerly has collapsed completely and the most easterly is partially collapsed. The central blocked up window is 1.3m wide on the internal elevation of the church and is 2.3m in height. It is fraed by cut sandstone quoins.

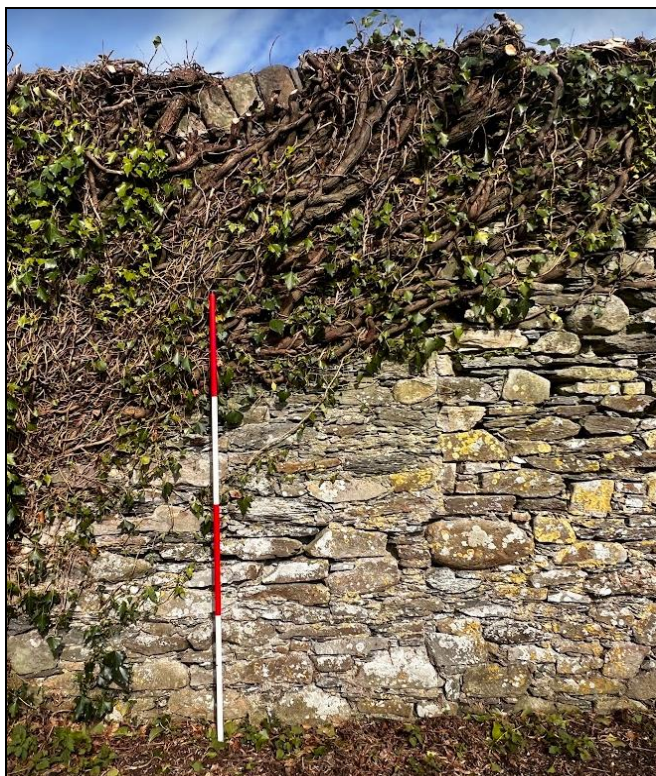
Plate 16: Blocked up window on external elevation of church.

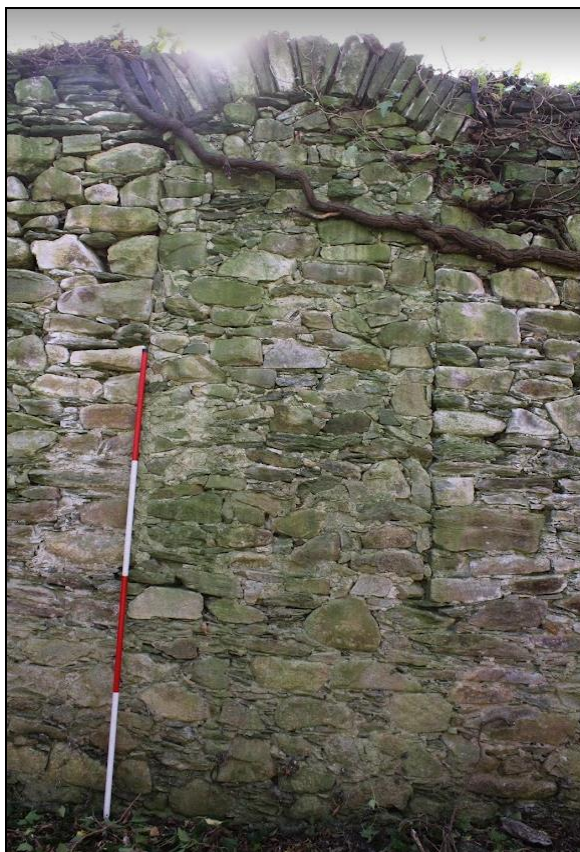
Plate 17: Central blocked up window, internal elevation of south wall of church.

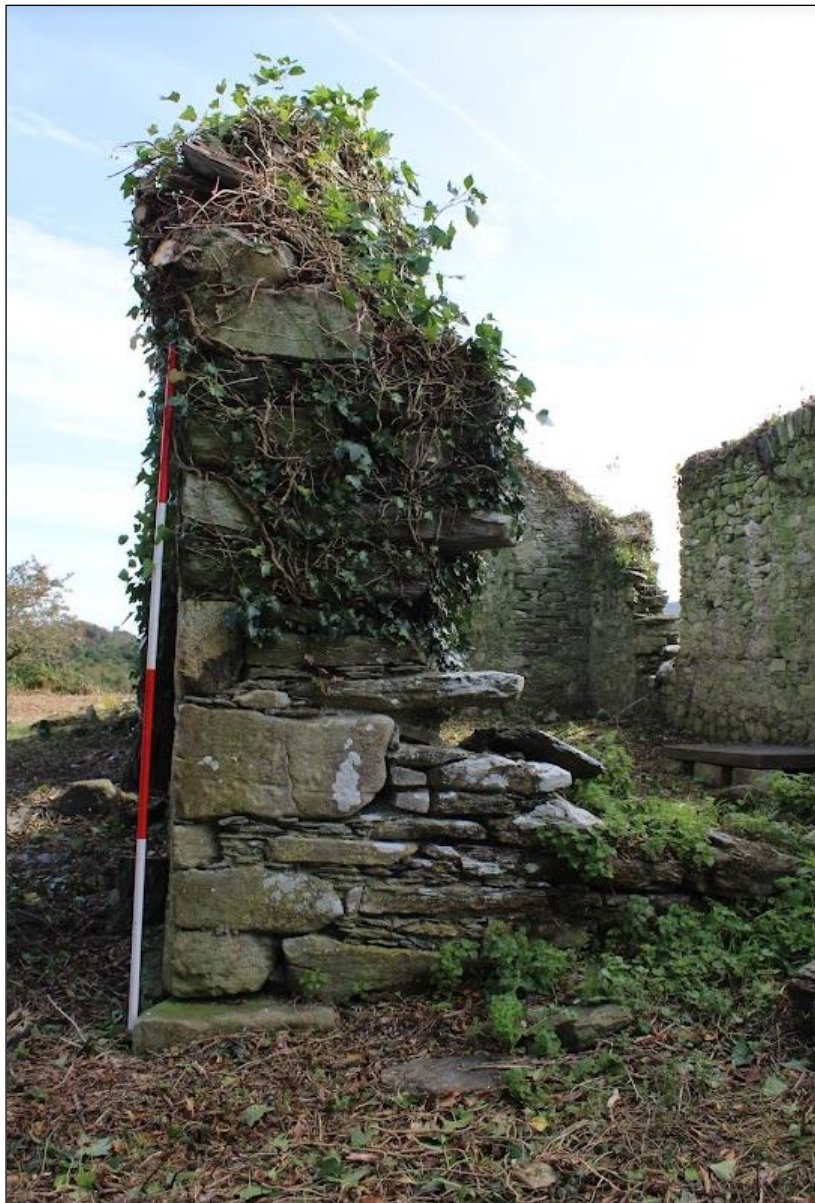
Plate 18: West view of church with sandstone quoins.

The west wall of the church has collapsed, and the wall survives to a maximum height of 0.63m and a minimum height of 0.13m. The entrance gap for the doorway is 1.2m wide.

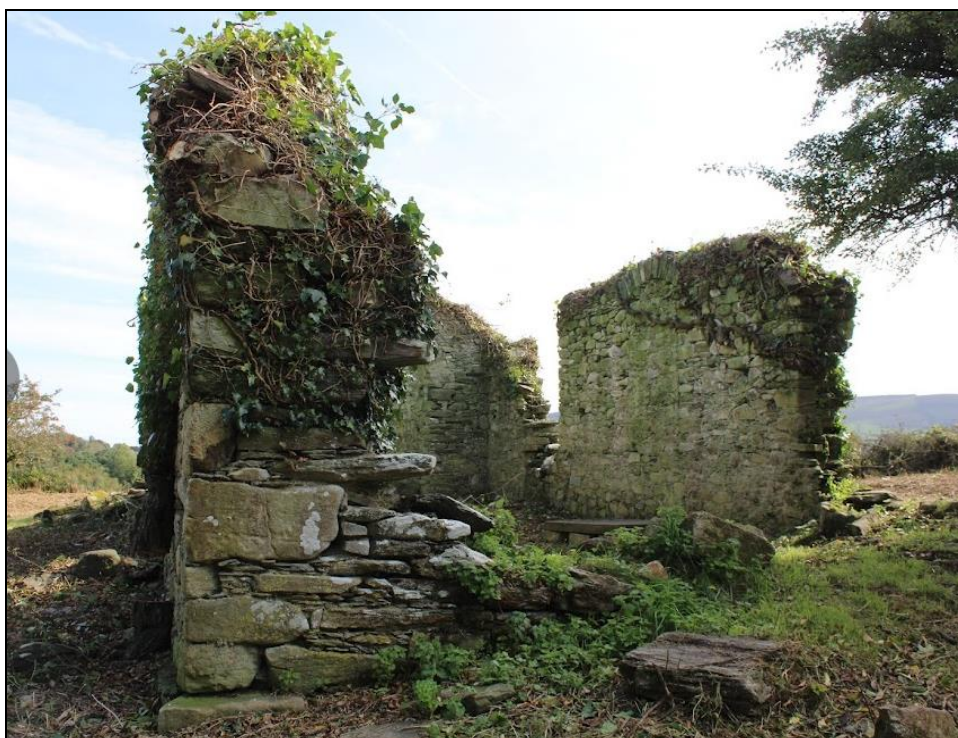
Plate 19: West gable of church.

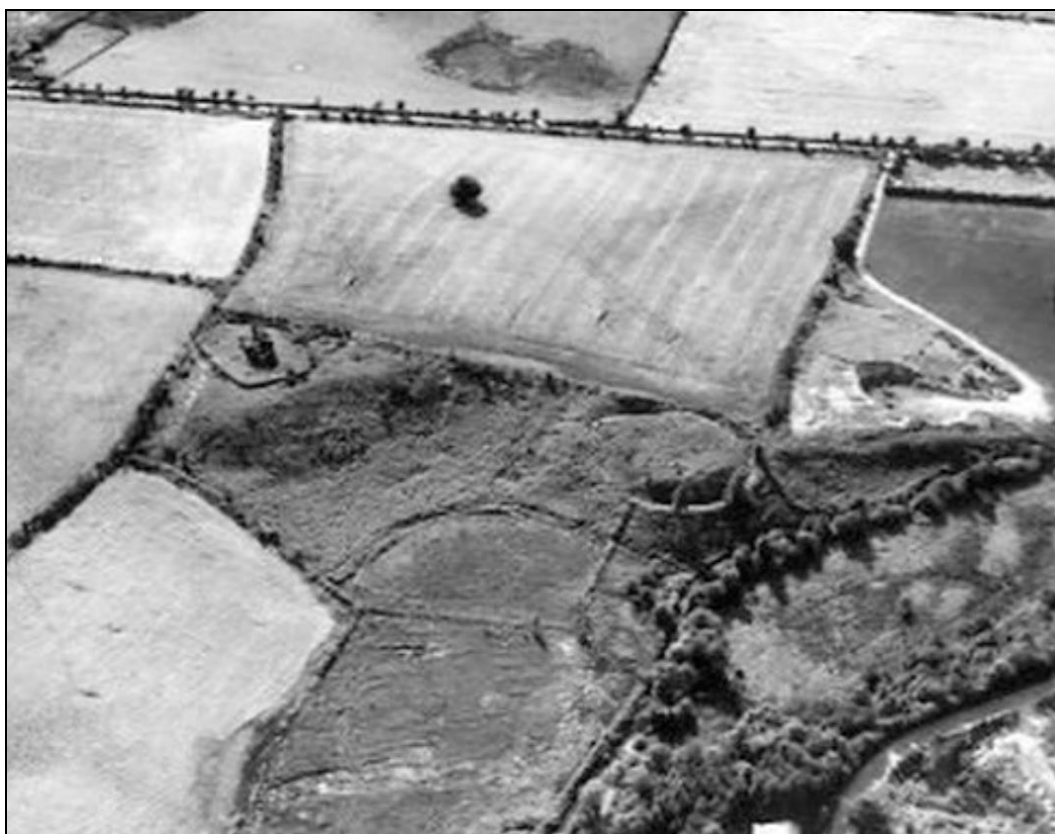
Plate 22: Kilpipe Church, graveyard and motte Cambridge Collection of Aerial Photographs (CUCAP, BDQ72).

There are a number of SMR sites within 1.5km of the site at Kilpipe Church (Plate 20, Figure 6). The earliest of which is a ring-ditch (WI039-017005) which is prehistoric in date (Plates 21 and 22). There are two enclosures in proximity to the ring ditch which may date from any era (WI039-017006, WI039-017001) (Plates 21 and 22). In terms of medieval archaeology there is a castle marked at Kilpipe, a castle (WI039-013002) and a rectangular enclosure (WI039-013001-) marked on the first edition OS 6-inch map.

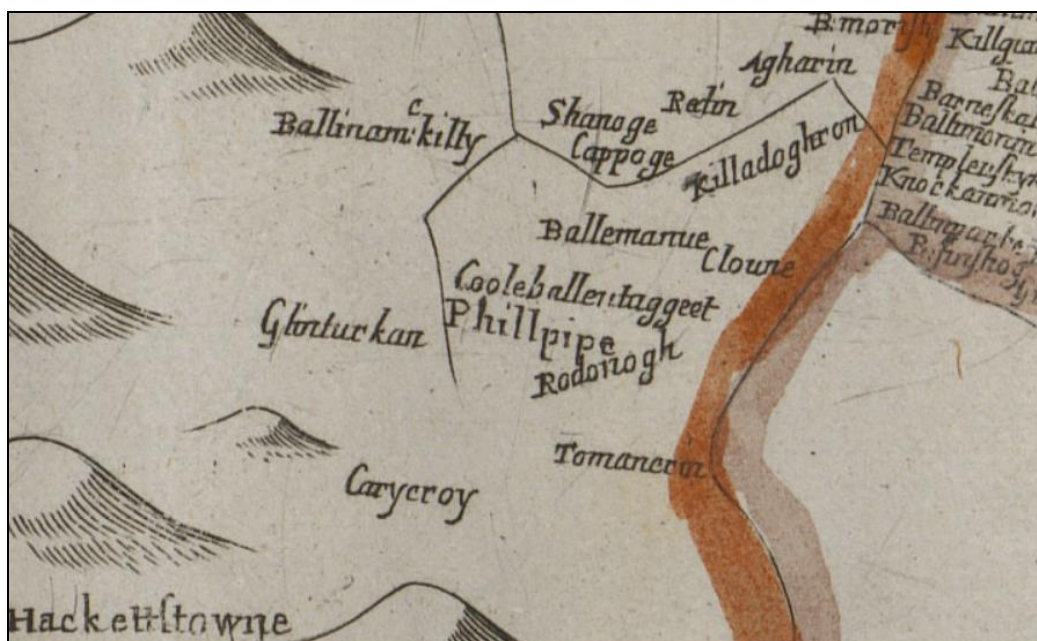
Figure 7: Down Survey Map Barony of Ballinacor, Co. Wicklow.

Kilpipe is labelled as 'Phillpipe' on the Down Survey barony map of Ballinacor (Figure 7).

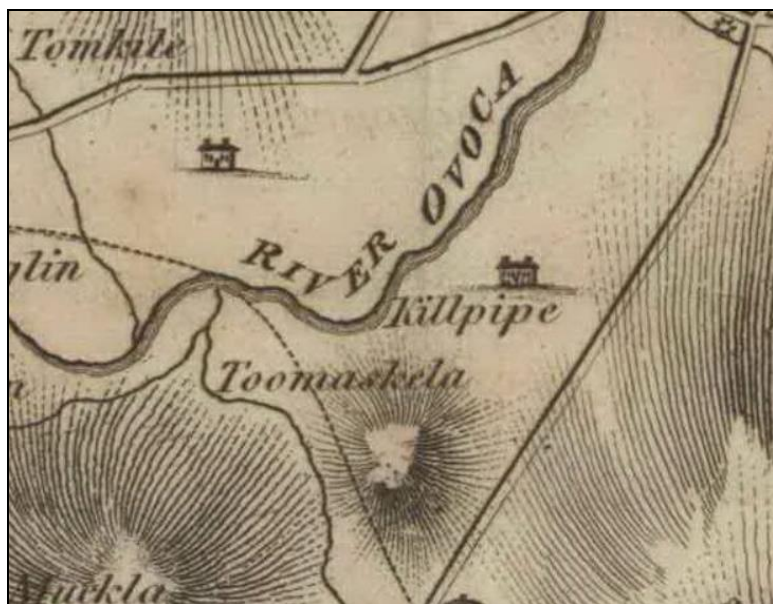
Figure 9: 'Map of the Mountainous and Uncultivated parts of the Counties of Dublin and Wicklow'.

Kilpipe is labelled as 'Killpipe' on this map from 1813, however Griffith omits any depiction of the motte or church but perhaps this is because the intention of the map was to chart uncultivated lands (Figure 9).

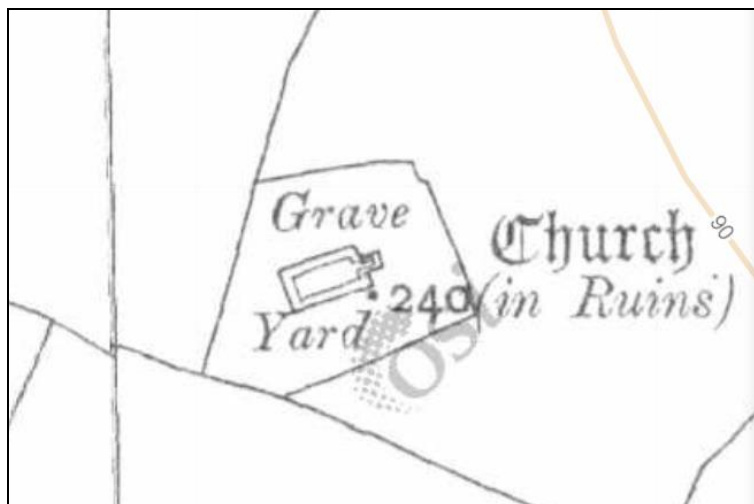
Figure 12: 1908-9 Ordnance Survey of Ireland (third edition).<sup>6</sup>

At the time of the third edition OS map the Church is labelled as 'in ruins'. The apsidal chamber is depicted adjoining the church to the east and is rectangular in plan.

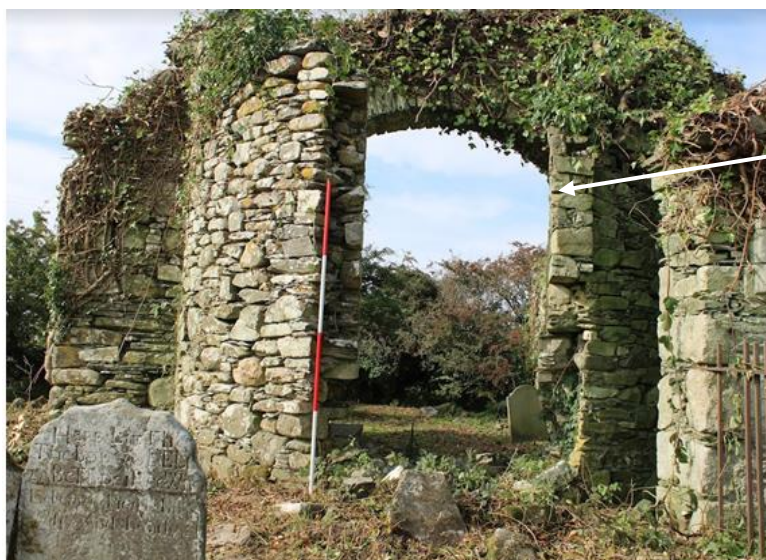
Plate 26: Trace of flat stone wall which framed the apsidal chamber as illustrated in plate 23 above.

The above illustration is a view of the ruins of Kilpipe Church, Tinahely, Co. Wicklow. It is undated but is a copy by William Frazer after an original drawing by Gabriel Beranger after Stephen Reilly. The full record details in the NLI notes that Beranger, Gabriel was alive ca. 1729-1817 and artist Frazer, William, d. 1905, artist. What is noticeable is that the church is in ruins presumably at the time of Beranger's drawing. There is no roof on the church and there are only three open windows depicted. It is possible that the middle one was blocked up by the time of this illustration and it was simply not noted by the artist, there is a tree at the location of this blocked window. The entire window of the apsidal chamber has collapsed however at the time of the drawing it appears that the window opening was framed by a flat wall. It is interesting to note that traces of this design are visible today as highlighted by the white arrows in plates 23 and 24.

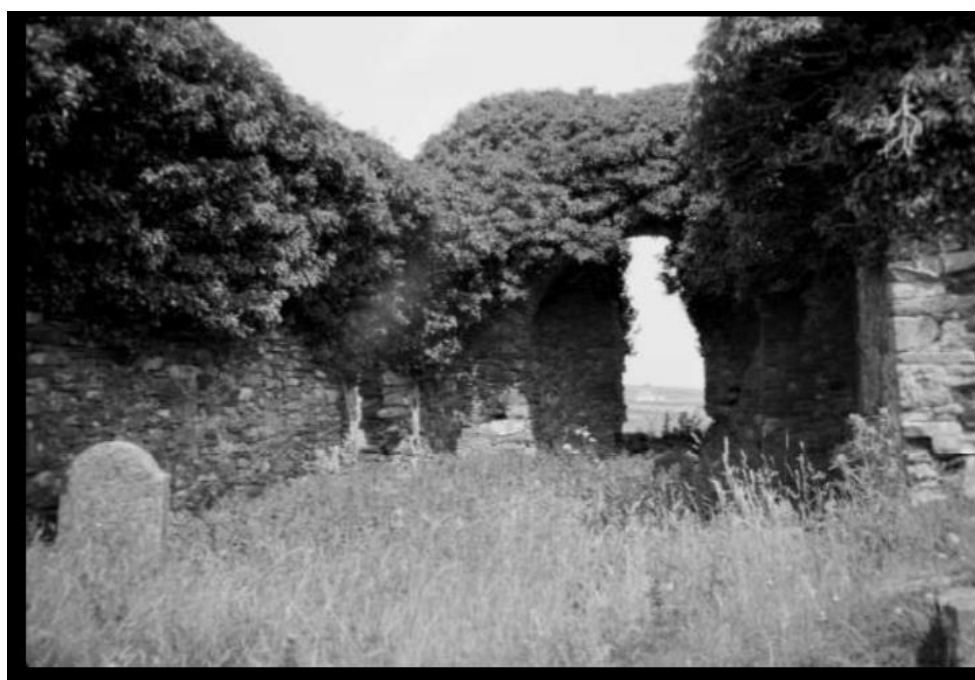
Plate 27: Kilpipe ruins 1943.<sup>8</sup>

A photograph was taken by the Irish Tourist Association photographer in 1943 which depicts clearly how overgrown the church was, the chance arch is covered in vegetation, however the round headed window which has since collapsed is visible in the apsidal chamber.

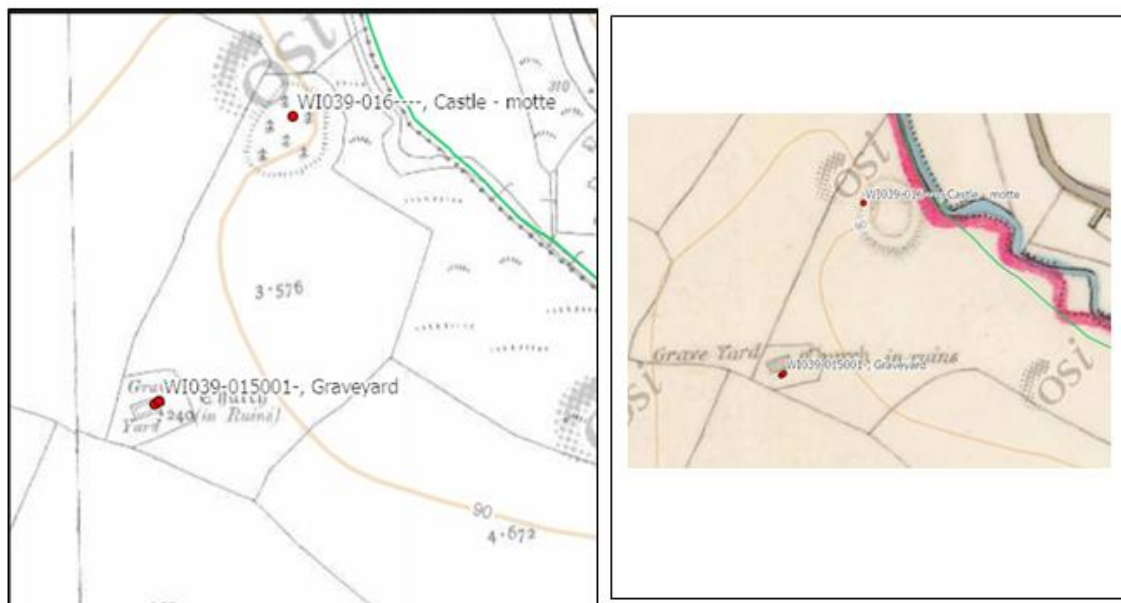
Figure 13: Third and First Edition OS mapping ([www.archaeology.ie](http://www.archaeology.ie)).

At the time of the first edition map the area between the church and the motte is one open field (Figure 13). At the time of the third edition map the field has been divided and there is a boundary marked around the perimeter of the motte which turns southeast and runs southwest to the south of the church. This boundary is visible on the CUCAP image below and is no longer visible today. A curving boundary or pathway not depicted on the first or third edition map is visible on the CUCAP aerial image and on geohive mapping which has been interpreted as a bailey by Arbuthnot as discussed by Dwyer in Section 2 of this report.

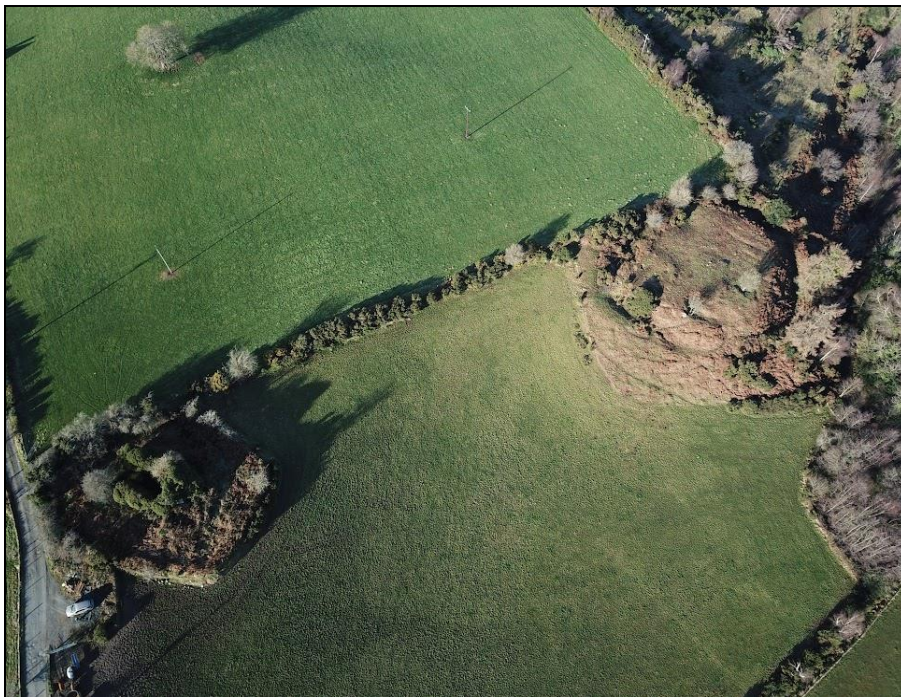
Plate 31: Site 2023, note that the bank which was visible on plates 26-28 are no longer extant.

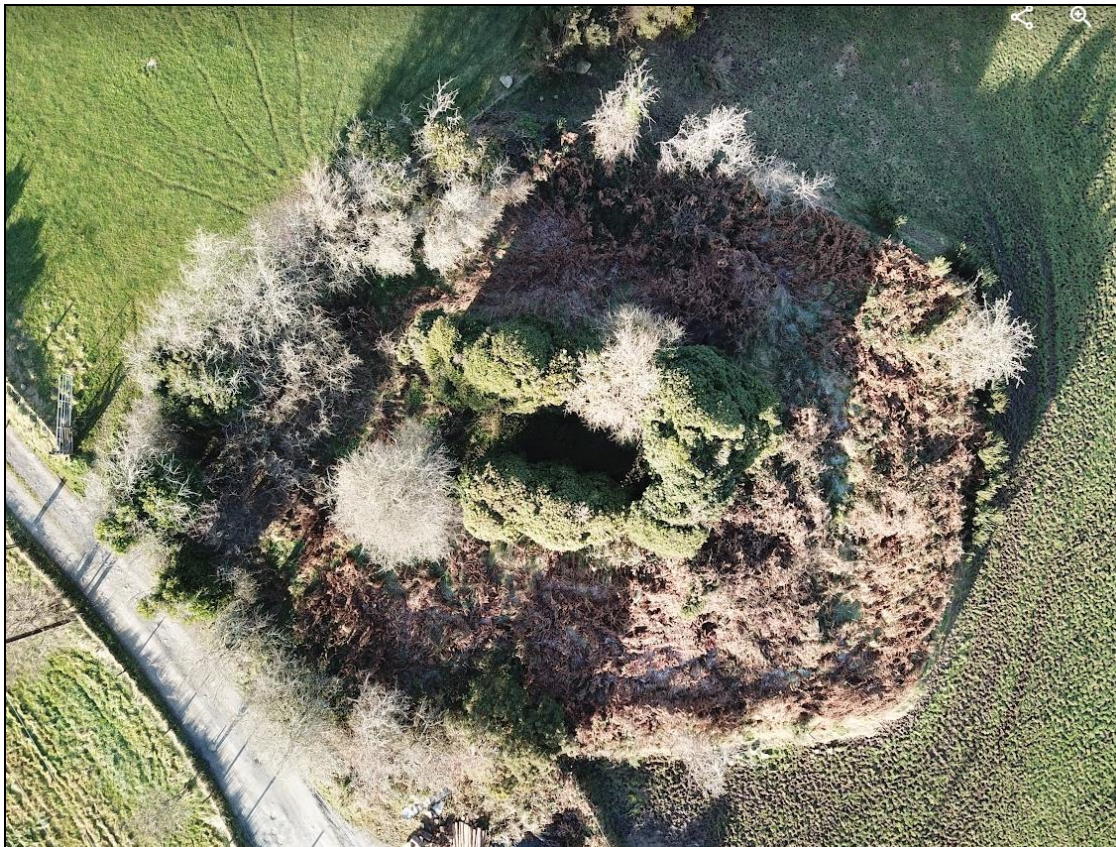
Plate 32: Kilpipe Church before vegetation removal in 2022 (photo Ivor Kenny).

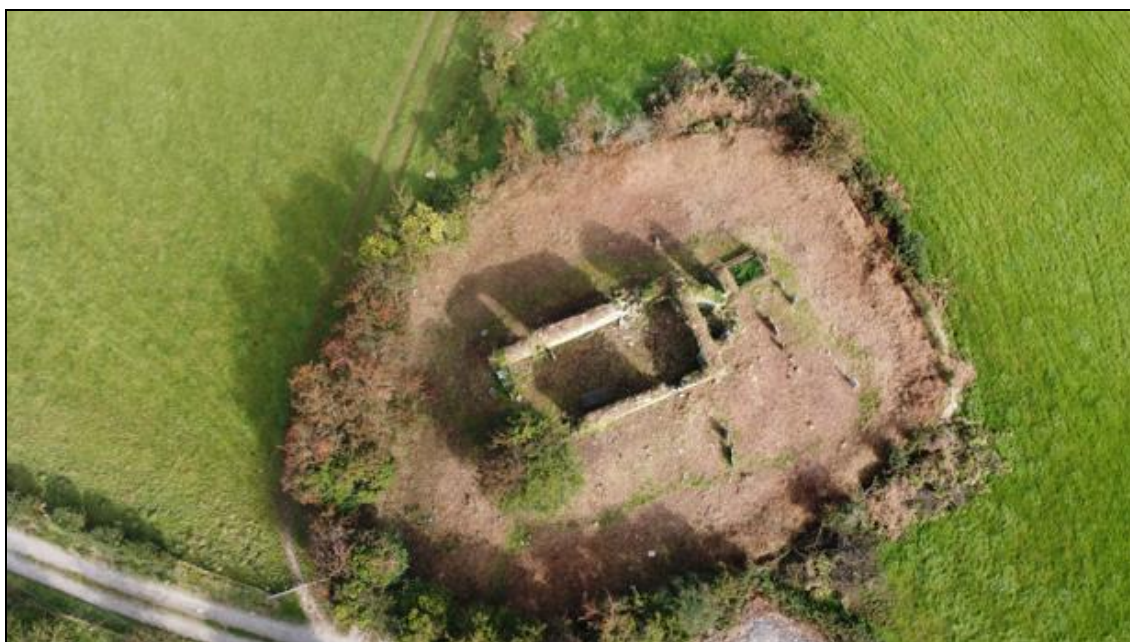
Plate 33: Kilpipe Church after vegetation removal October 2023 (photo Yvonne Whitty).

The extant remains of Kilpipe Church comprise three walls, the north, south and east, which comprise an apsidal chamber and chancel arch. The ruins of the church are in a perilous condition because of climate change which is accelerating the growth of vegetation on the monument (Plate 32). The roof of the apsidal chamber and its window has collapsed and the windows in the north and south walls have also collapsed. A detailed condition survey is attached as Appendix 1 to this report.
