# Roost Disturbance Derogation Application Supporting Document

This report has been prepared on behalf of Radu Giurgiu by Oran Ecology Ltd following a bat survey in the townland of Carrigeen, Co. Roscommon.

The objective of the proposed works is to renovate and extend an existing cottage building

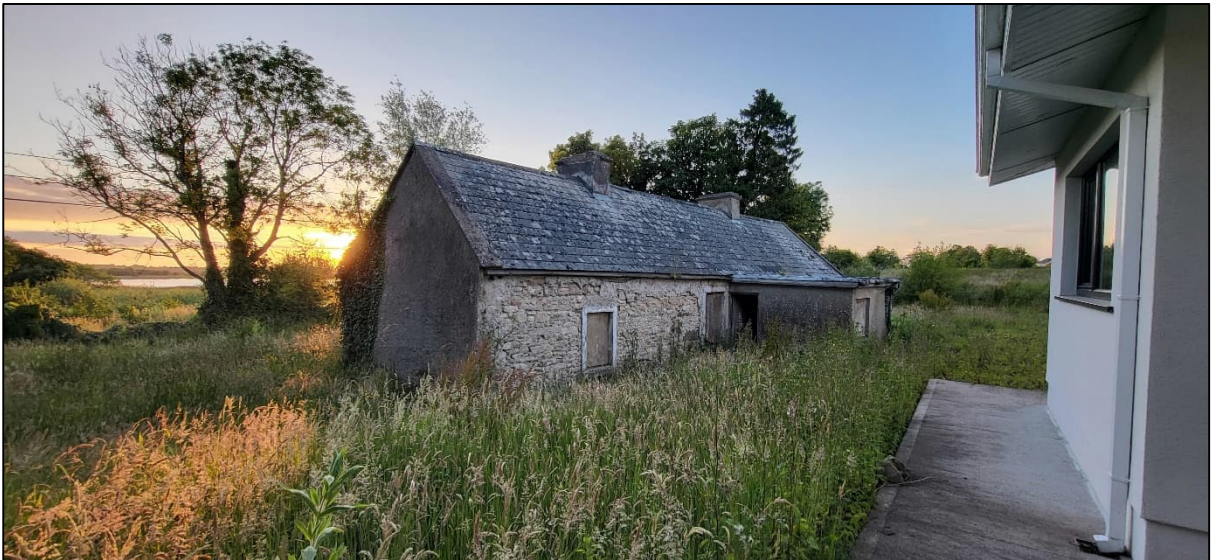
*Plate 1 View from the south-east of the cottage*

The cottage consisted of a single storey building and a small flat roof extension on its eastern side with neither structure containing cavity walls (Plate 1 and Plate 2). All windows were boarded up with plywood and most were well sealed apart from a window to the front of the house which had a gap at the bottom end of the plywood and a window at the rear of the house which had a gap at the top end of the plywood. The door to the rear of the building was left open and the front door was boarded up with plywood and well-sealed. Potential access points were identified during the exterior inspection under fascia boards and soffit, under ridge tiles and around flashing. There was a small gap in the wall where the front porch meets the main building wall but there were no signs of bat droppings at this location in contrast to the 2023 survey with the area heavily covered in cobwebs. Bat droppings were not visible at any location around the exterior of the building. There were patches of ivy on parts of the cottage but no bats were detected within the vegetation.

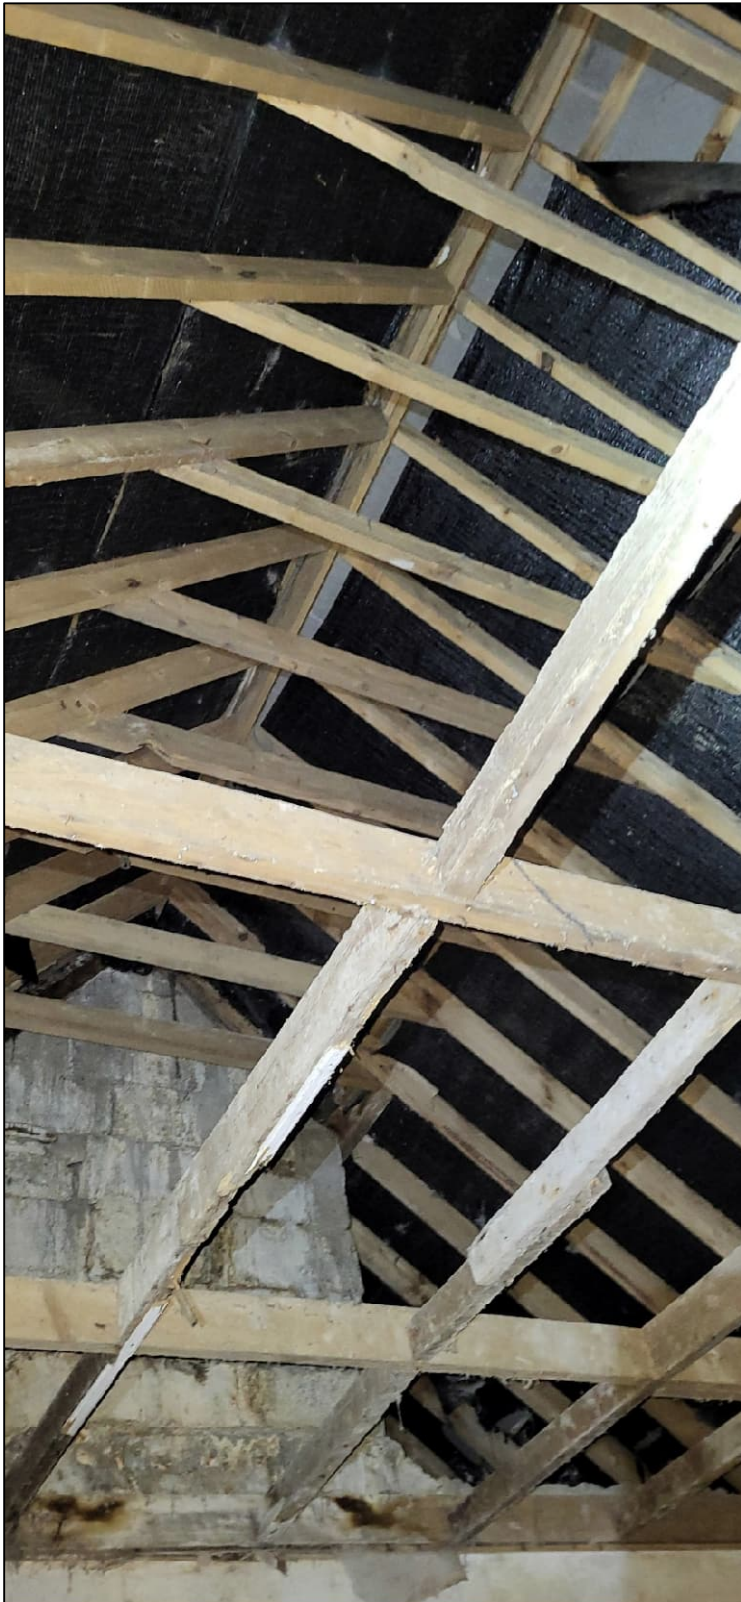
*Plate 3 Open attic space and view of the inside of the roof*

building or the extension and it was possible to see the entire underside of the roof which was lined with felt, with holes identified at a couple of locations (Plate 3). Bat droppings were observed in the northern and southern room of the main house and in the extension but the southern room had the most frequent signs of droppings (Plate 4). The southern room also contained abundant remains of moth wings on the mantel above an old fireplace which can be indicative of brown long-eared bat (Plate 5). A small number of insect remains were also observed in the extension. No bats were visible on the rafters or under the felt in the open attic space. An active swallow's nest was present within the central room of the house.

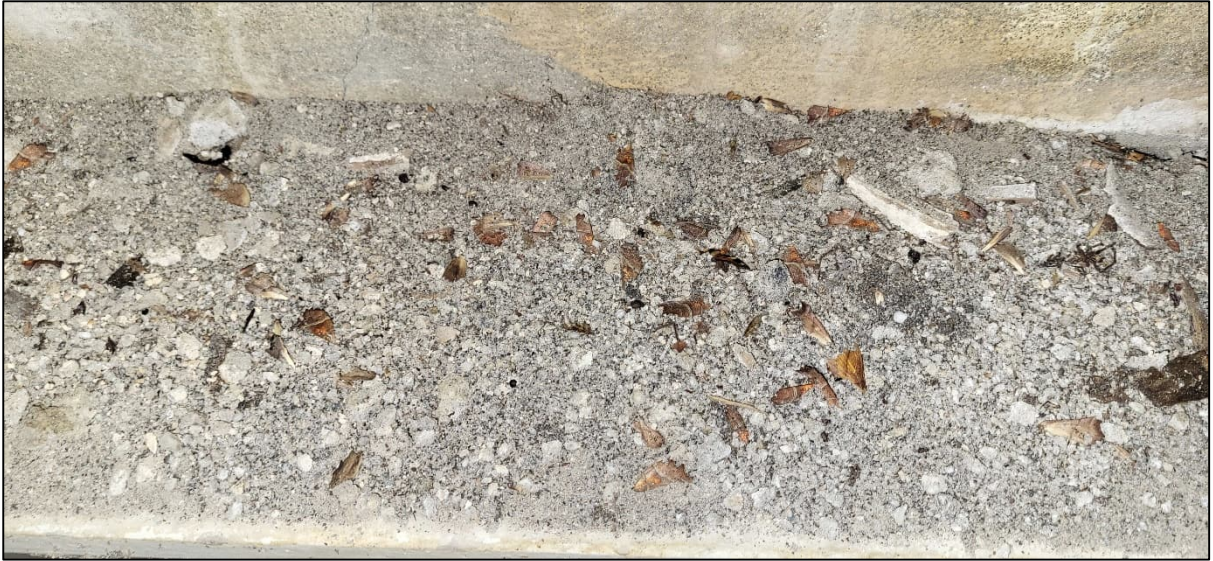
*Plate 5 Feeding remains on mantle over fireplace in the southern room*
