# **Bat Derogation Licence Application 2026 – Supplementary Report**

## **Scoil Mhuire Mount Sackville**

prepared for the National Parks and Wildlife Services

on behalf of The Department of Education

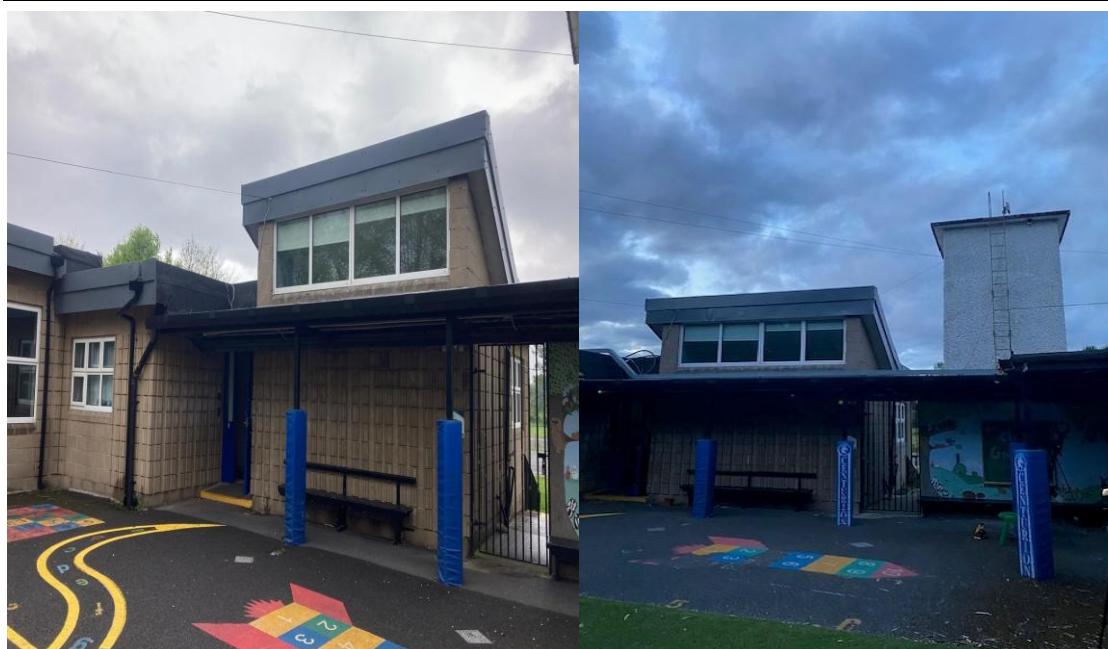
***Plates 1&2 – Modular Building with Flat Roof Where Bat Roost is Located (left) and Disused Water Tower in relation to modular building (Right)***

- 3 The bat roost is, and has been, confined to a modular building of the school comprising of the staff canteen, a bathroom, a storage room for the hot lunch carts, a hallway, and several office rooms (see Plate 1). Bats have been found throughout the building interior, presumed to enter the interior through ingress points between the flat roof of the modular building and the exterior cavity wall, and flying via the connecting hallways to other parts of the school.

- 10 Following collaboration with the Department and the Architects, a preferred concept was designed for the dedicated bat loft for which a disused water tower directly adjacent to the roost was chosen (see Plate 2). The water tower building provided an ideal opportunity to purposefully design an alternative roosting location that eliminates the chance of recurrence of contamination and ingress of the school building and provide optimum conditions for the roosting bats.

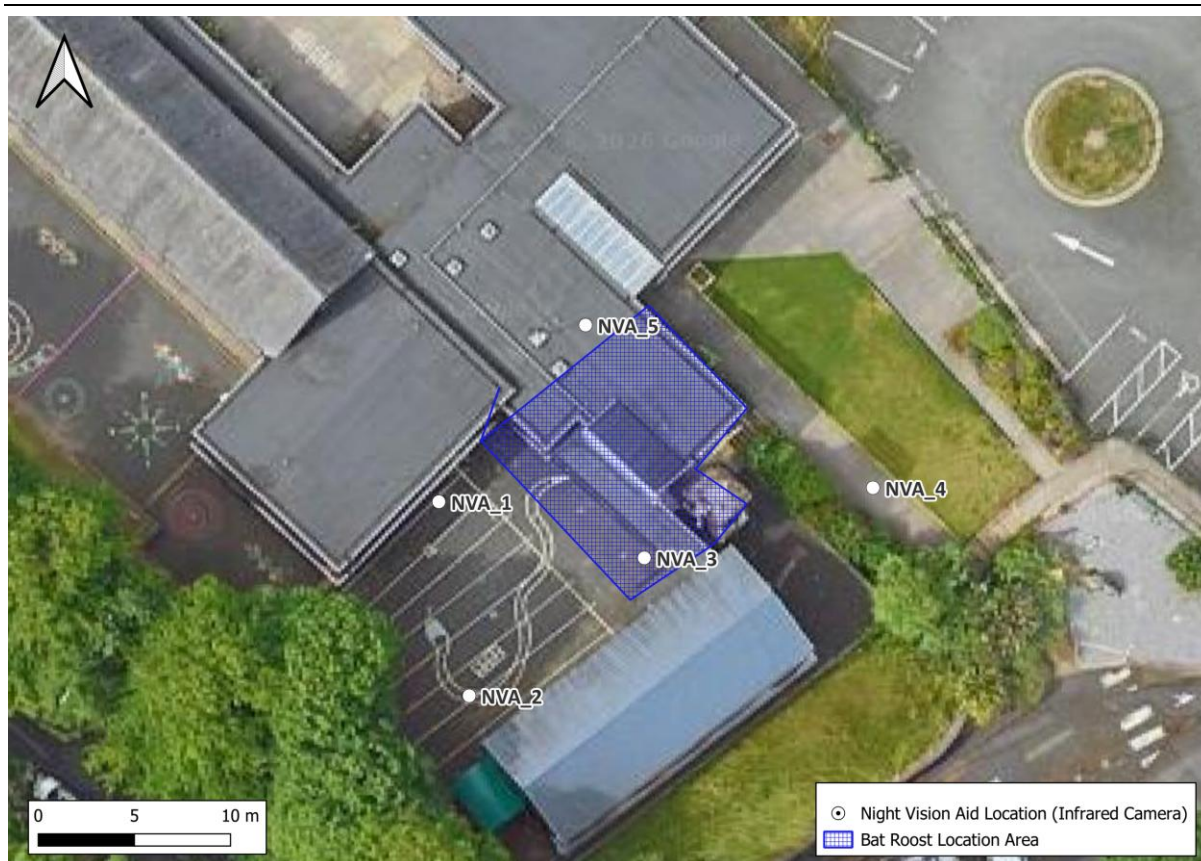
**Figure 3 Night Vision Aid IR camera (NVAs) locations during emergence survey**

- 47 The IR cameras were set up with three (camera 1, camera 2, and Camera 3) capturing the southwestern and southeastern sides of the building and camera 4 and camera 5 capturing the northern and eastern side of the building. camera 5 was placed in such a way that it captured the side on view of the flat roof overhang while camera 4 was positioned face on to the wall, capturing any bats that may emerge from the eastern wall as well. (See Figure 3)

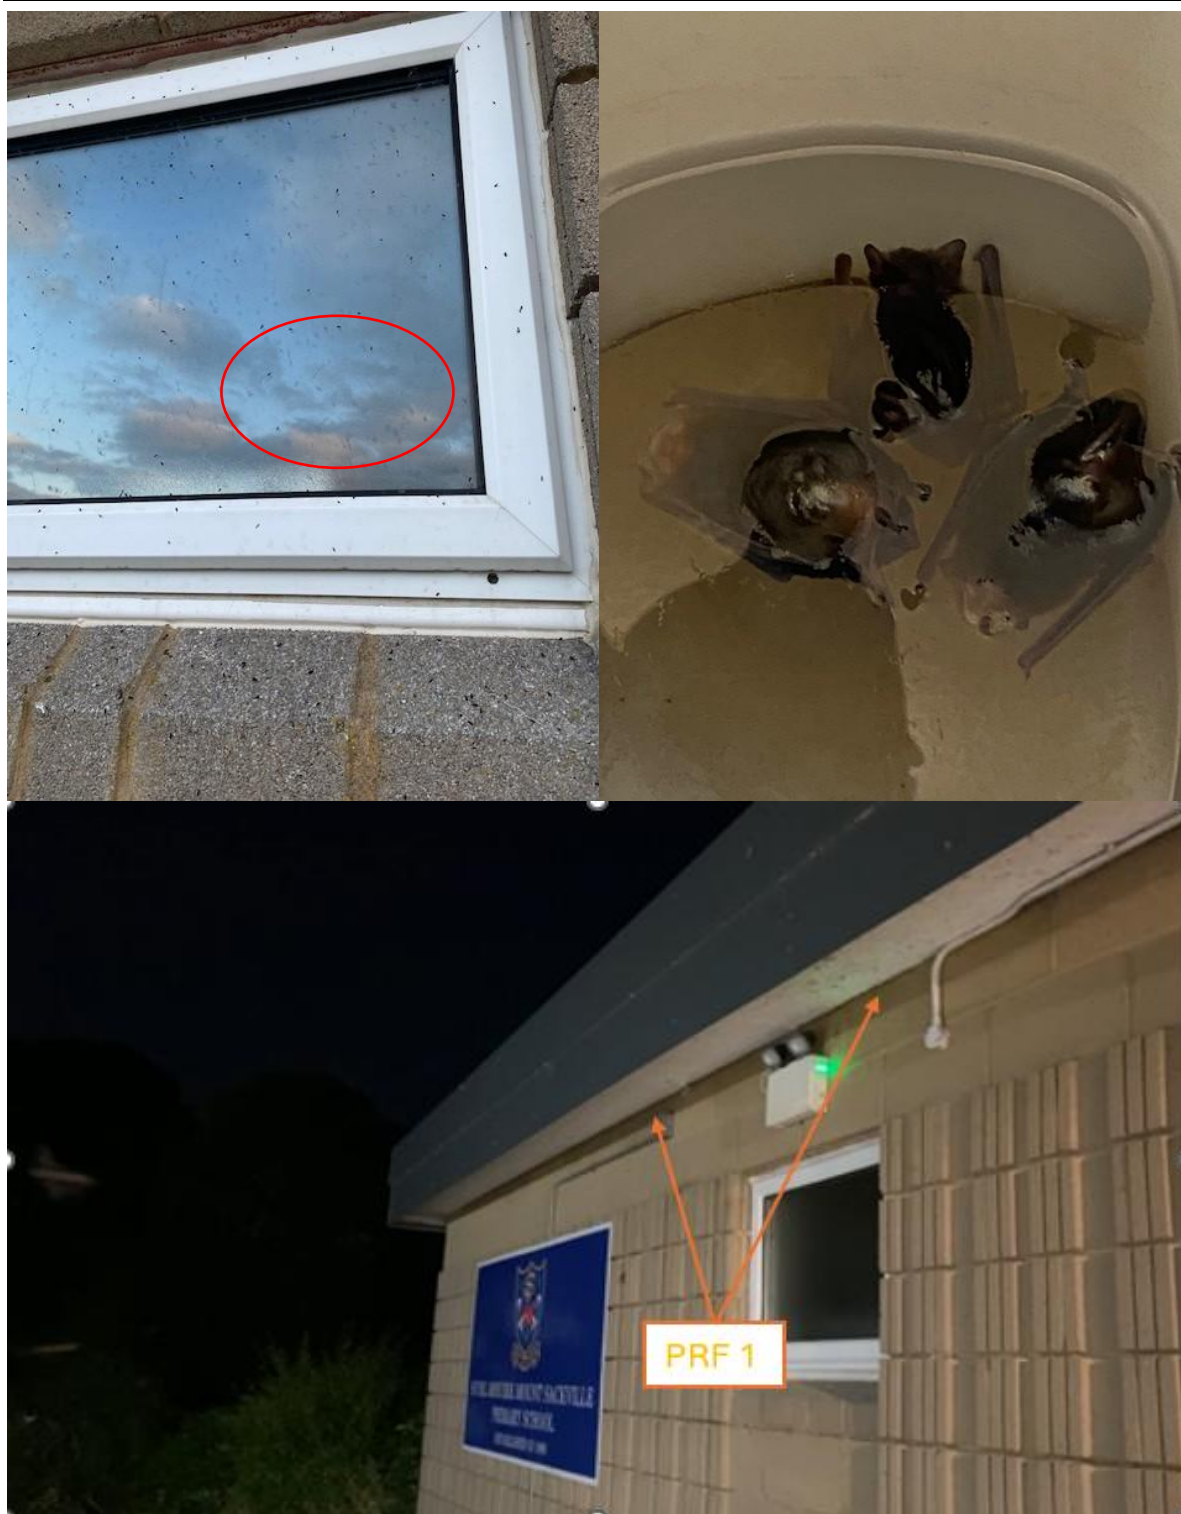
***Plates 3&4&5 – Bat evidence in the form of droppings flecked onto window below roost entry point on northern side of building (top left) dead bats found in the bathroom on the northern side of the flat roof building (top right). Bat entry point (PRF1) above windows as shown between cavity block wall and flat roof (bottom)***

- 56 The external inspection recorded copious amounts of bat droppings flecked on the walls and windows underneath the entry areas (SEE PLATE 3). A number of entry/exit points were noted, and those areas recorded in previous surveys (DNV, 2025) were confirmed and noted. (SEE PLATE 4). Additional entry points noted were small cracks between the exterior cavity wall and the flat roof which overlays it.

- 
- 58 The internal inspection noted dead bat specimens on the floor of an office room, the floor of the bathroom, and three dead bats in one of the toilets (PLATE 5) The interior of the canteen room was inspected, and a strong odour of bat urine was noted pervading the room. Bat droppings were noted on desks and furniture in the principal's office.
- 59 Ingress points inside the building include gaps between the exterior cavity walls and the flat. It is obvious from the evidence that the bats are gaining access in multiple areas and different rooms within the occupied building. it was noted that in other sections of the building, water damage in the roof caused damage, creating holes and cracks in the plaster ceiling.

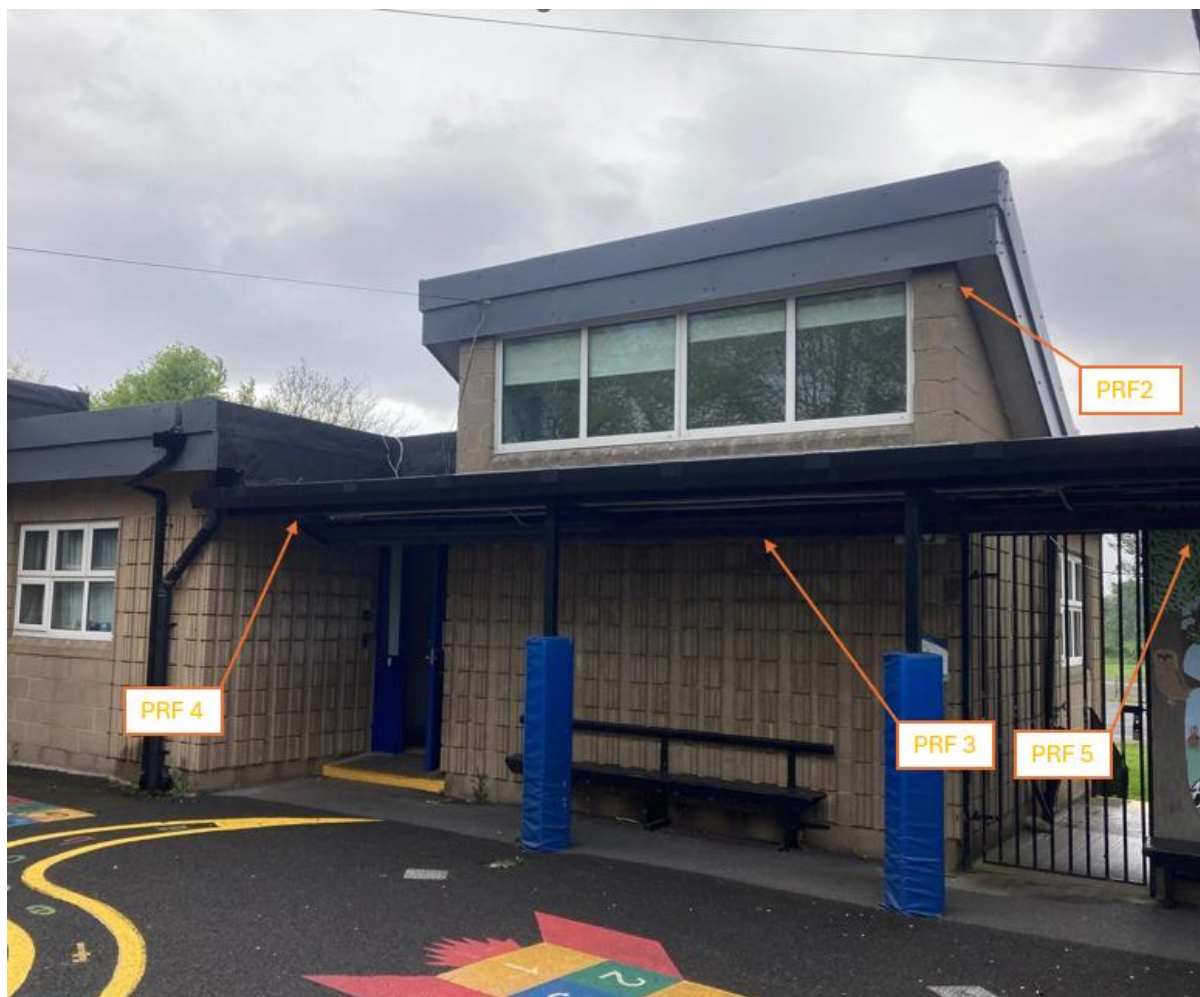
**Plates 6. Previously identified (and confirmed in 2026) Entry and Exit points**

- 57 PRFs were noted and marked as follows:
  - PRF 1 – gaps between the exterior cavity wall on the northeast face and the flat roof
  - PRF 2 - gaps between the exterior cavity wall and the pitched section of the flat roof along the eastern wall. Includes the description of PRF B from DNV report.

- PRF 3 – confirmation of PRF identified previously (noted as PRF A in DNV report) - This feature is found beneath the veranda on the southwestern facing wall of the school canteen. The entrance to this PRF occurs between the steel purlin of the veranda and the cavity block wall of the school canteen.

- PRF 4 - confirmation of PRF identified previously (noted as PRF C in DNV report) - This feature includes a number of gaps beneath the veranda also, where service works have caused damage to the envelope of the building.

- PRF 5 - confirmation of PRF identified previously (noted as PRF D in DNV report) This PRF occurs between the roof of the veranda and the wall of the school canteen. There appears to be a large hollow within this area of the wall.

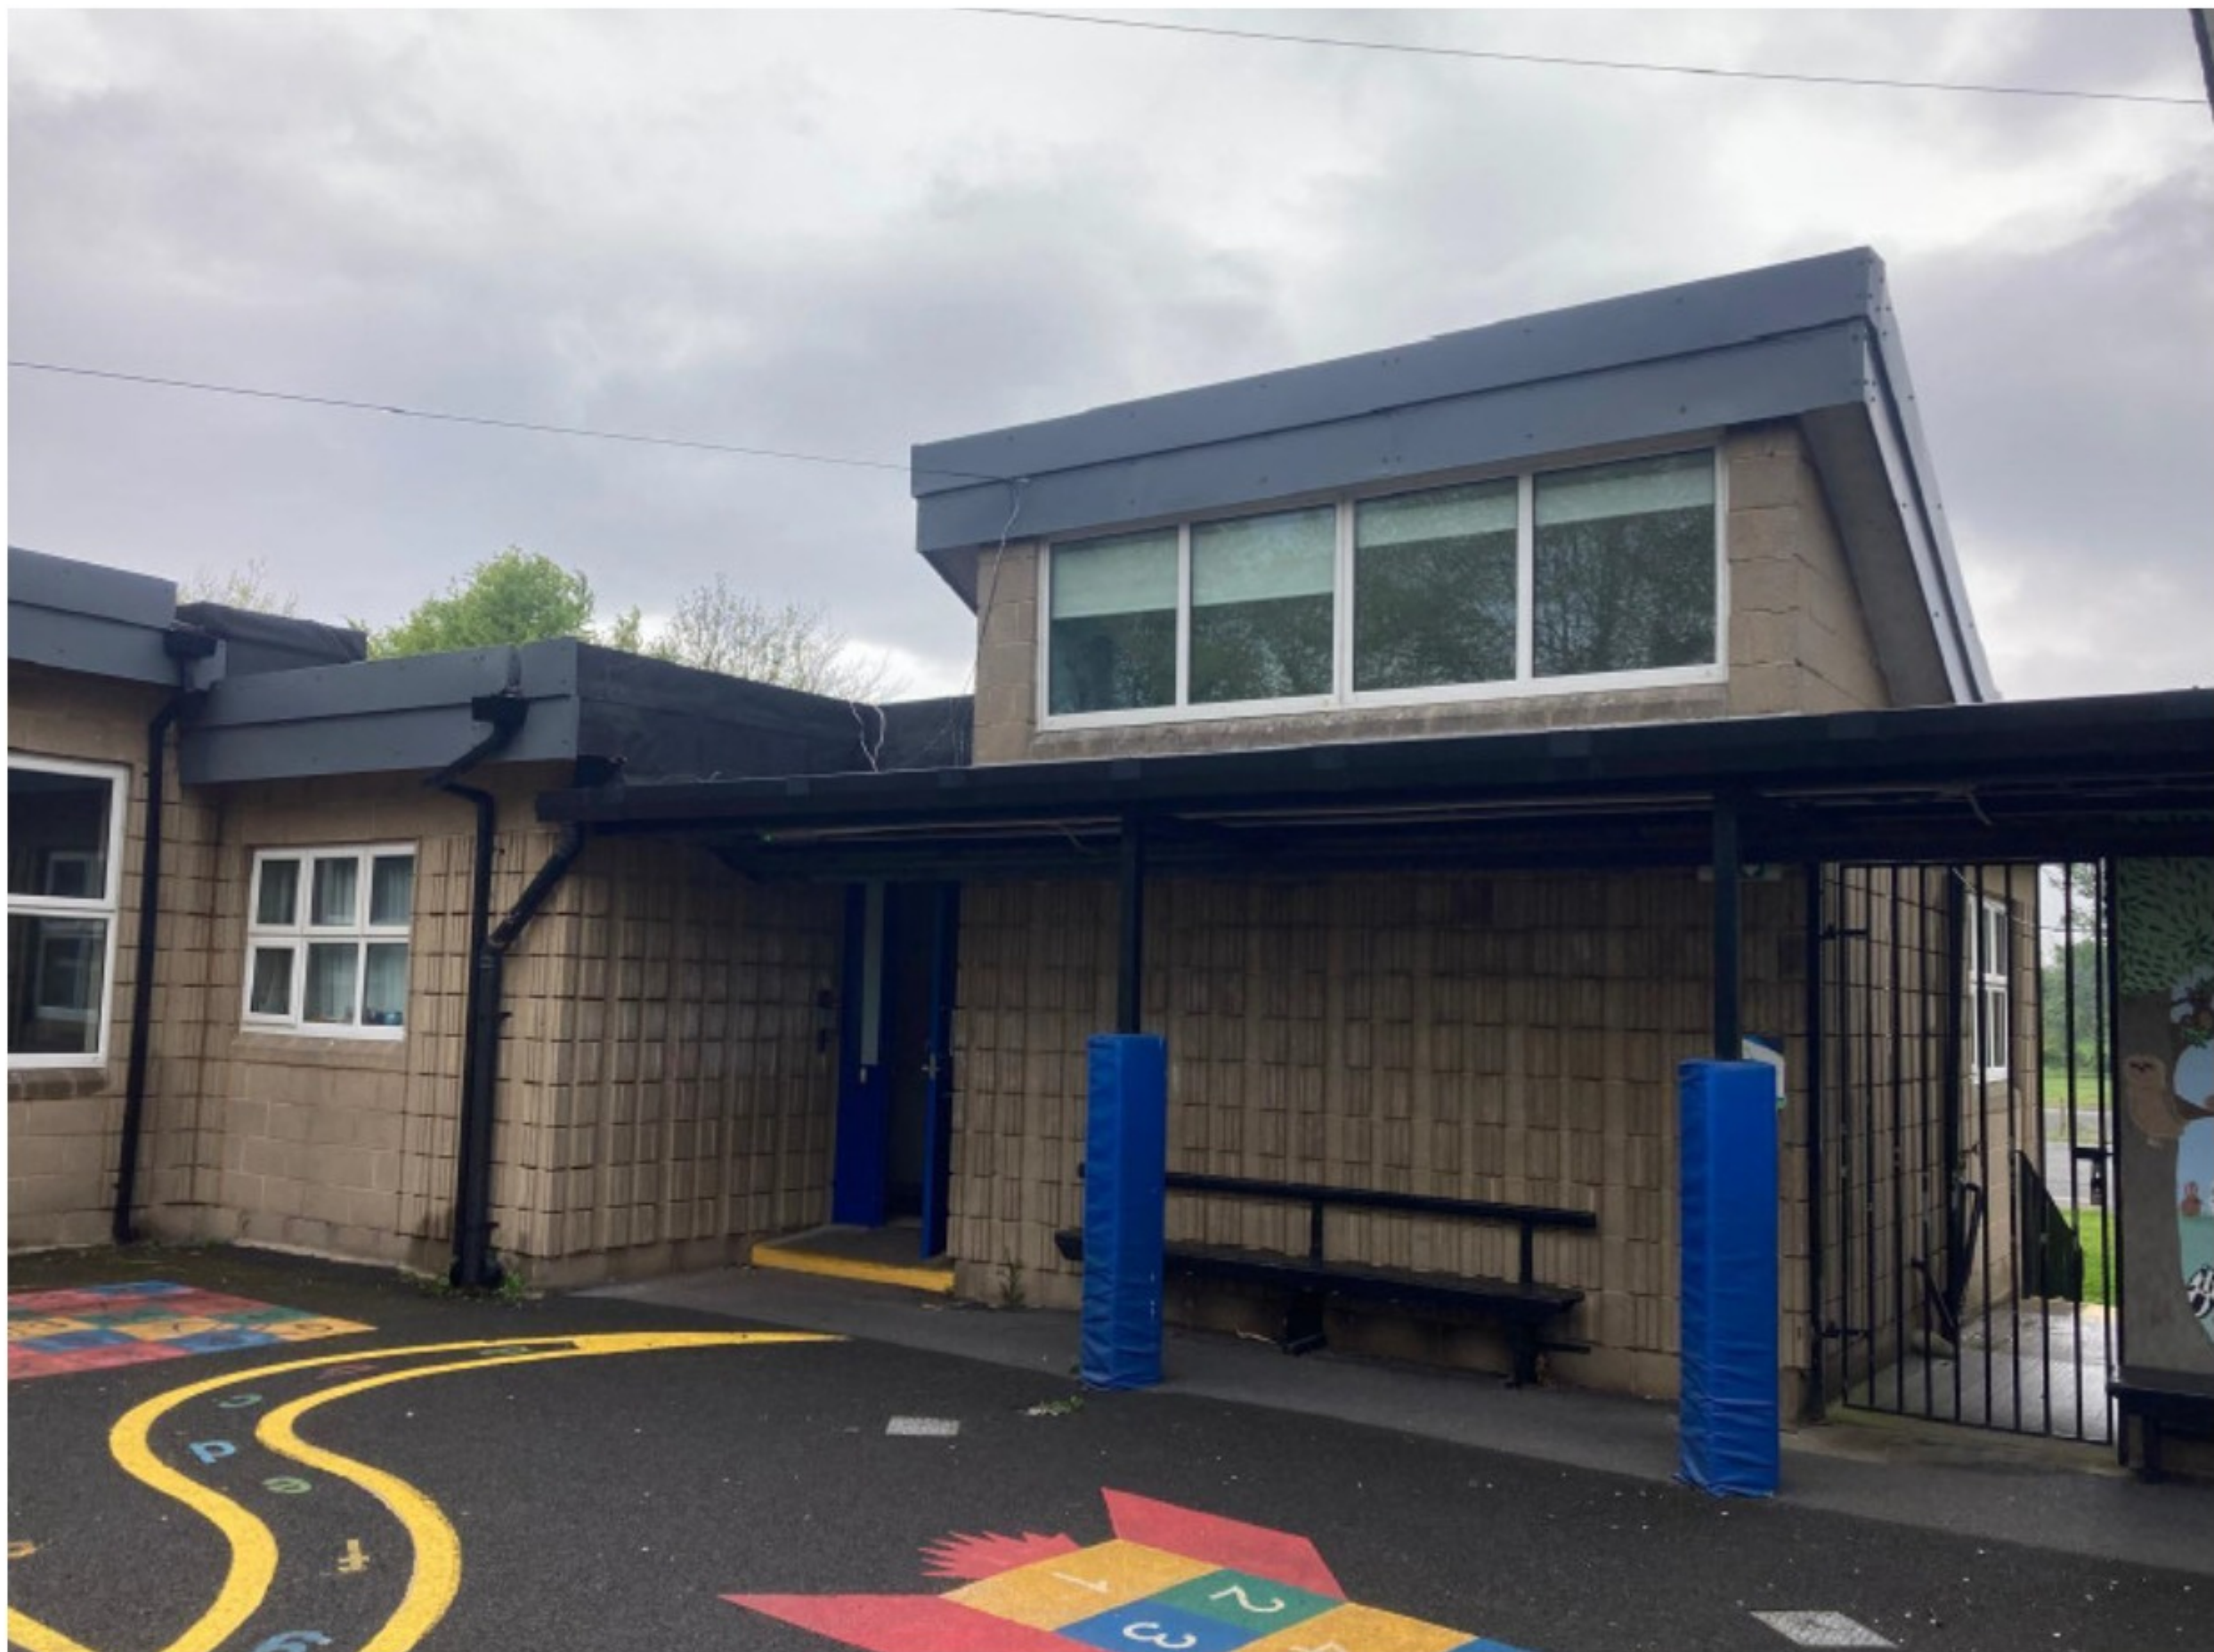
Area of existing school building where bats observed to enter/ exit the roost

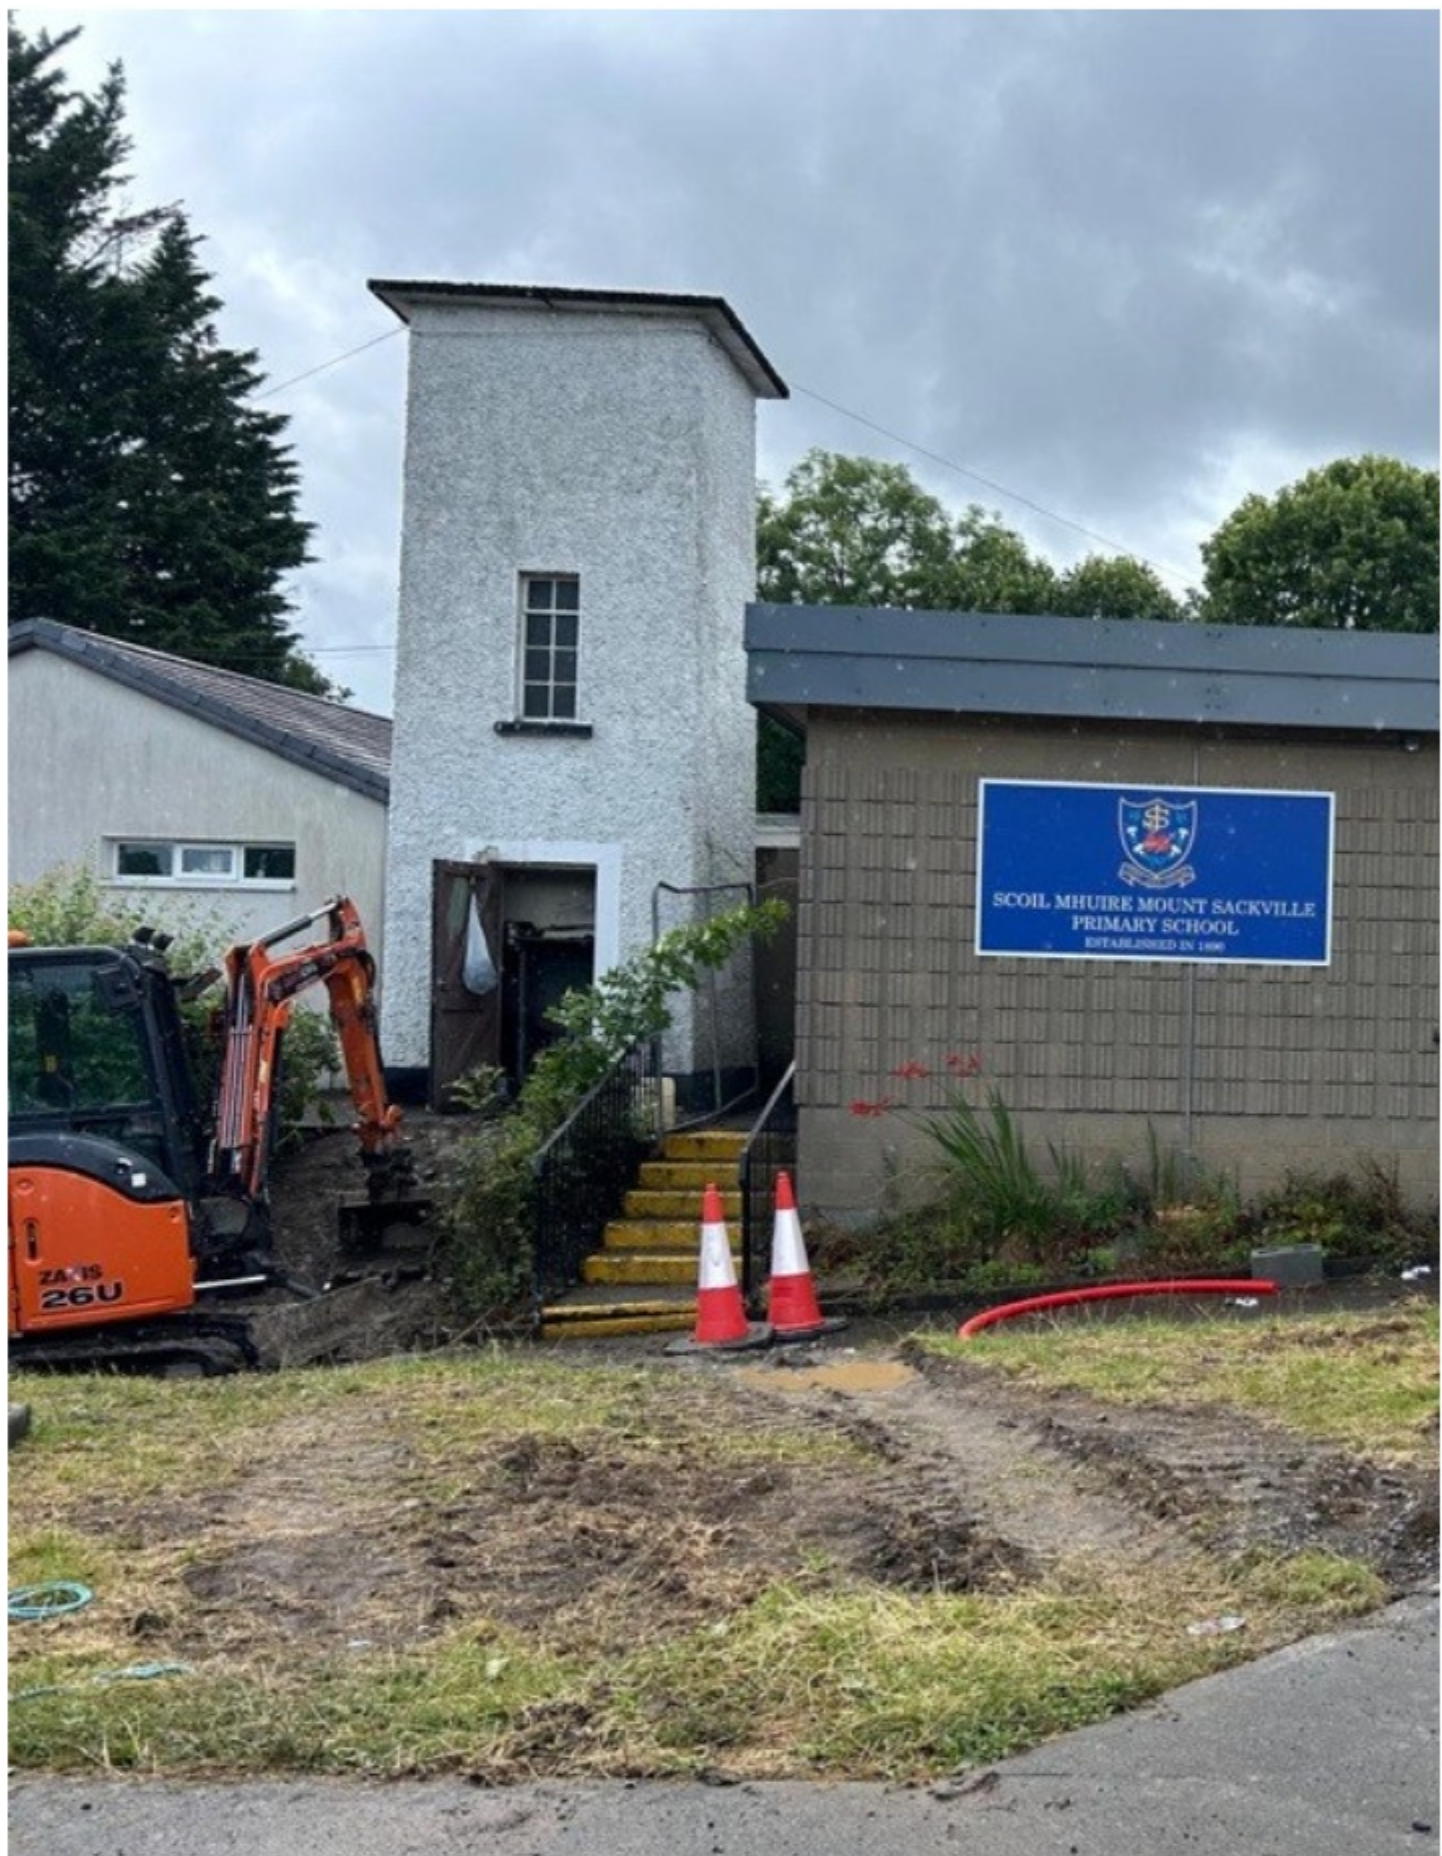
Disused Water Tower adjacent to the existing roost location within the existing school building

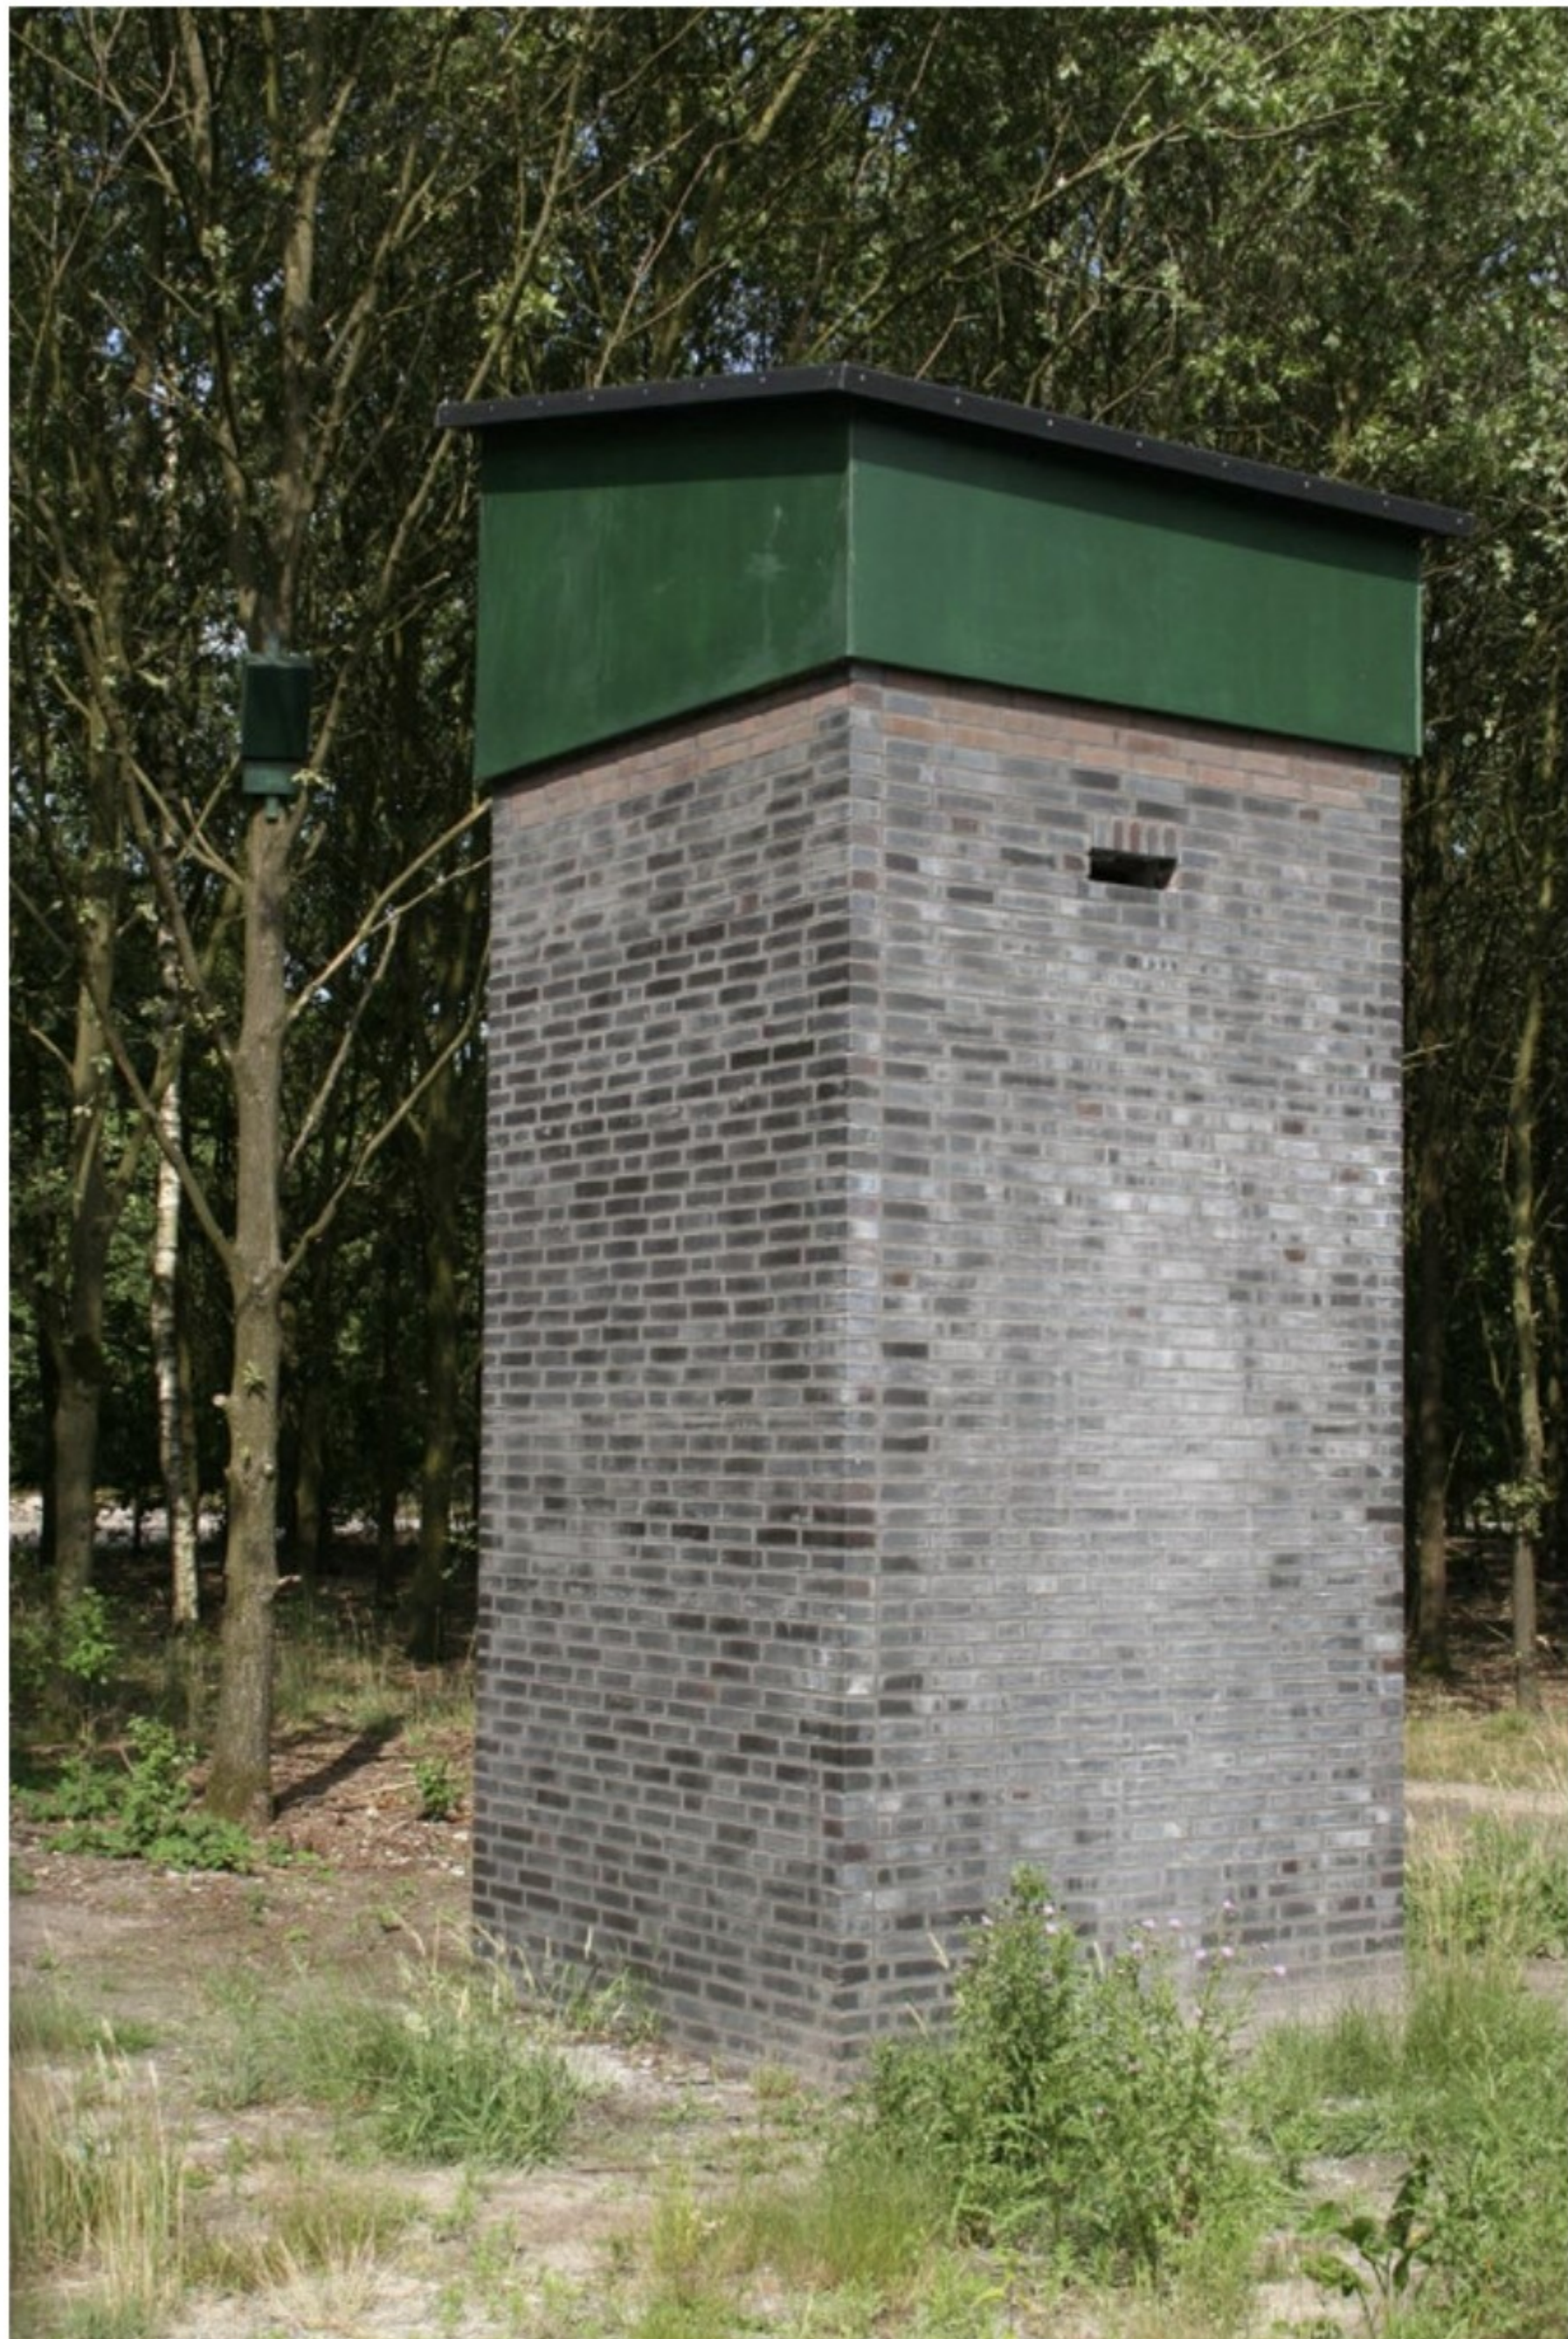
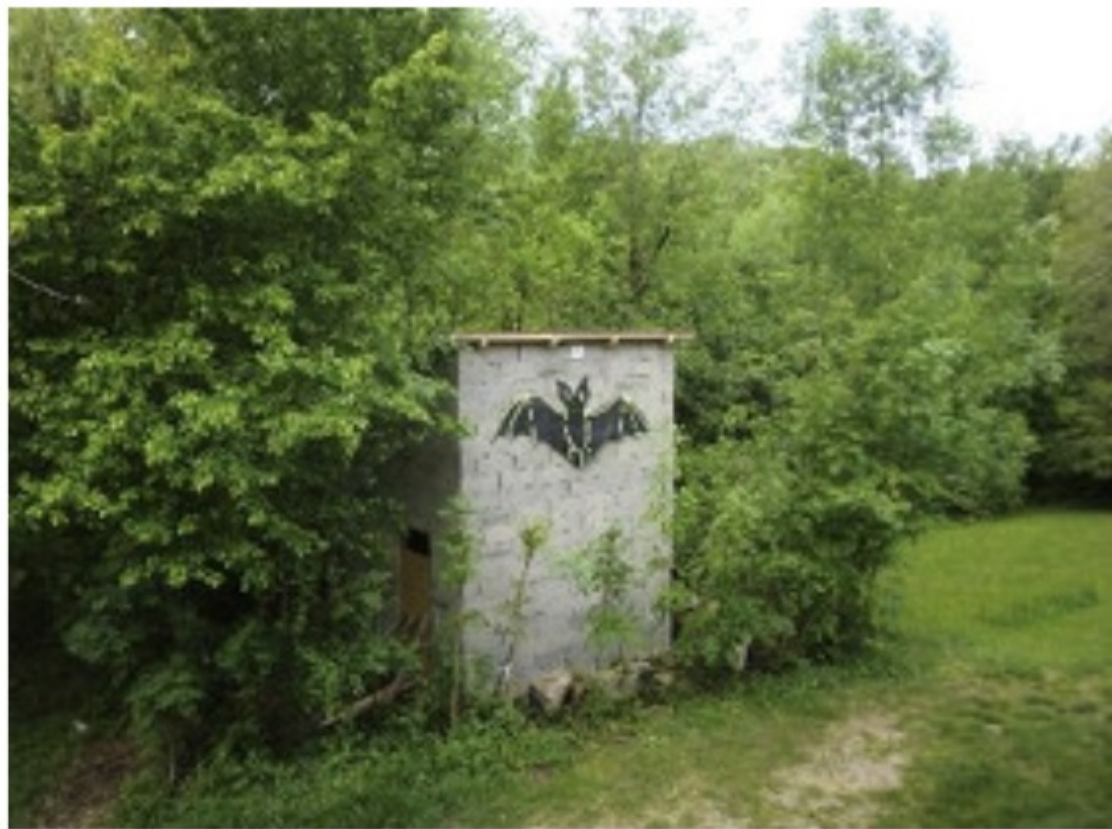
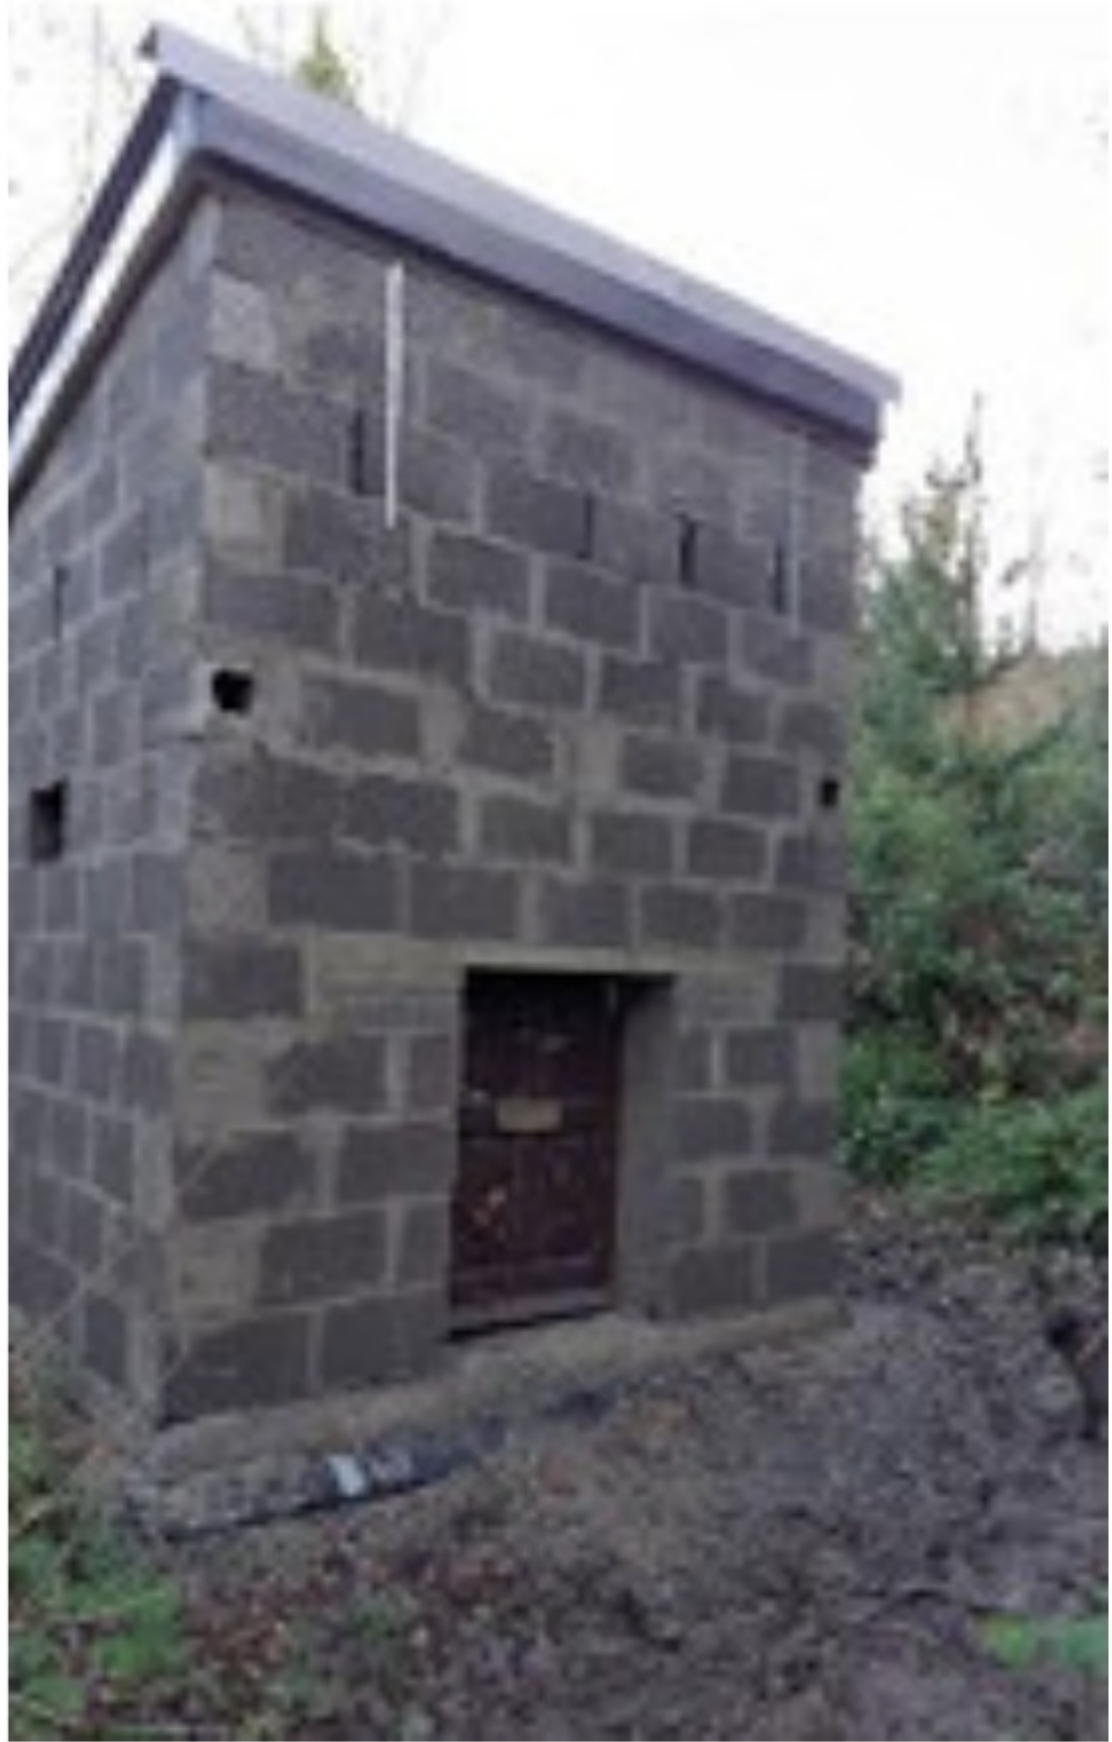
**Purpose Built Bat Towers**  
Netherlands (left), France (top) & Ireland (bottom)

These buildings are designed to be used by a range of species but particularly *Plecotus*, *Myotis* and ***Pipistrellus*** species.  
The bat species present in the school building is **Soprano Pipistrelle**.
