**SUPPORTING INFORMATION**  
**Derogation Licence Application (Regulation 54)**

**ESB Networks Depot, Tiernaboul, Killarney, Co. Kerry**  
**Applicant: ESB Networks**  
**Ecologist: Katy Steele**

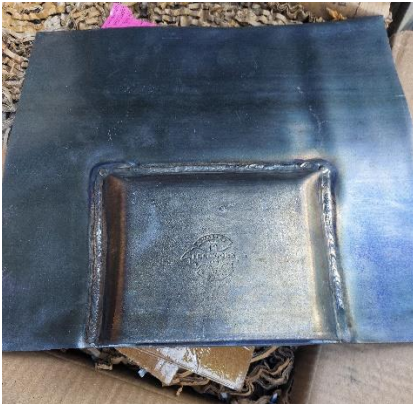
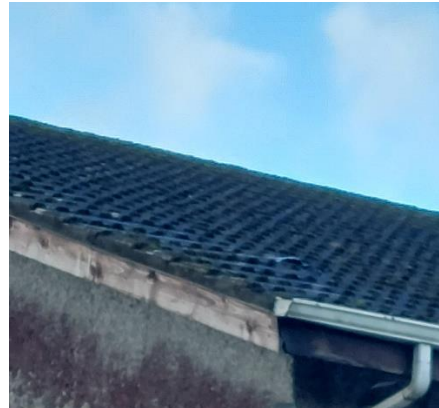
### Plate 1. Installed bat access tile (23 October 2025).

Installed under ecological supervision to provide a long-term, secure access point for bats using the attic roost. The tile is now the principal confirmed entry route.

- Two soffit gaps used for entry prior to soffit deterioration.
- A **bat access tile**, installed October 2025, is now the primary confirmed access.

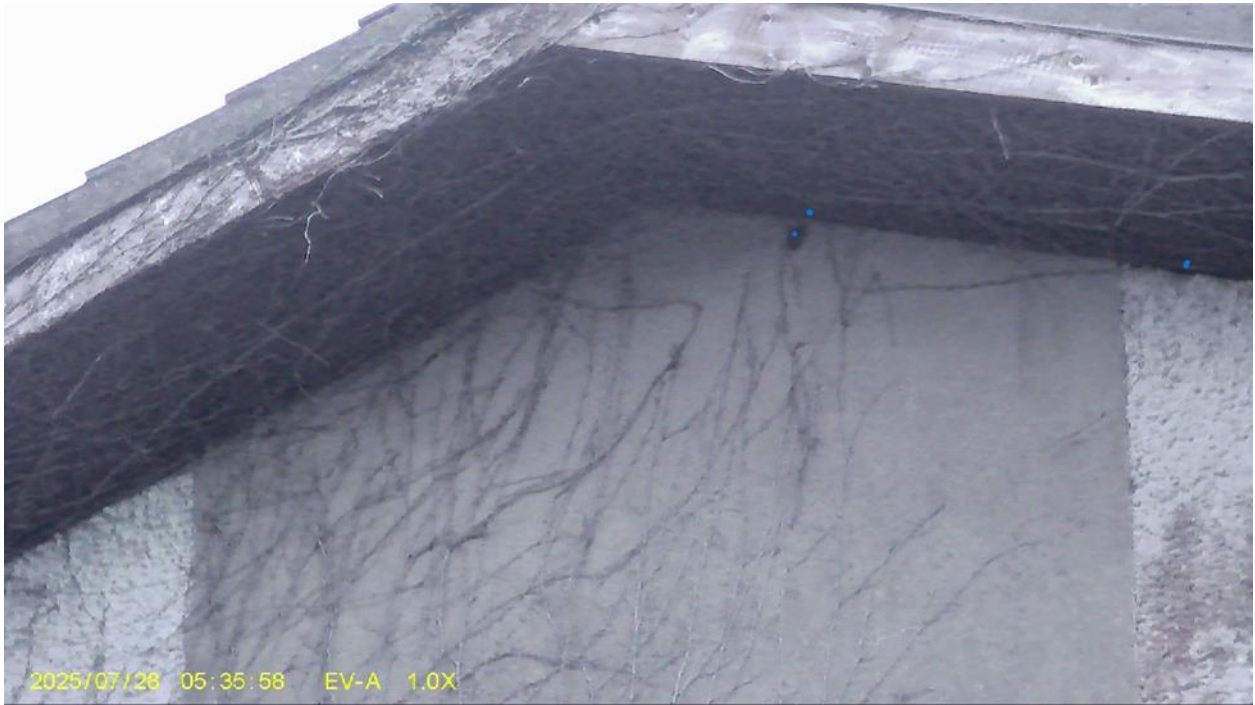
**Plate 4. Existing soffit access point used by bats**

Photograph/screenshot illustrating one of the soffit gaps being used by a soprano pipistrelle bat to access the attic roof. Blue dots note bat and entrances

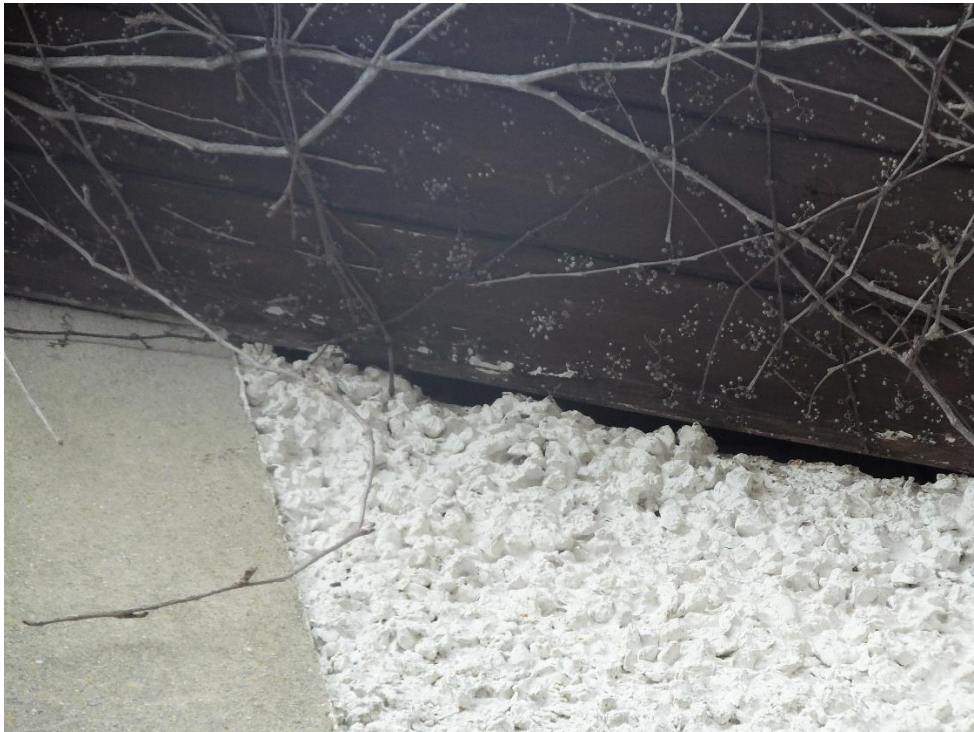
**Plate 5. Soffit gap to be retained during supervised replacement works.**

Image showing the exact location of the soffit bat access feature that will be deliberately maintained during PVC soffit installation.

*Gap used by soprano pipistrelle; this access will be retained during soffit replacement.*

- Existing damaged timber soffits to be replaced with PVC.
- Bat access points will be **maintained or recreated exactly**, using measurements and observations from October 2025 supervision.
- No foams, sealants, or expanding products may be used.

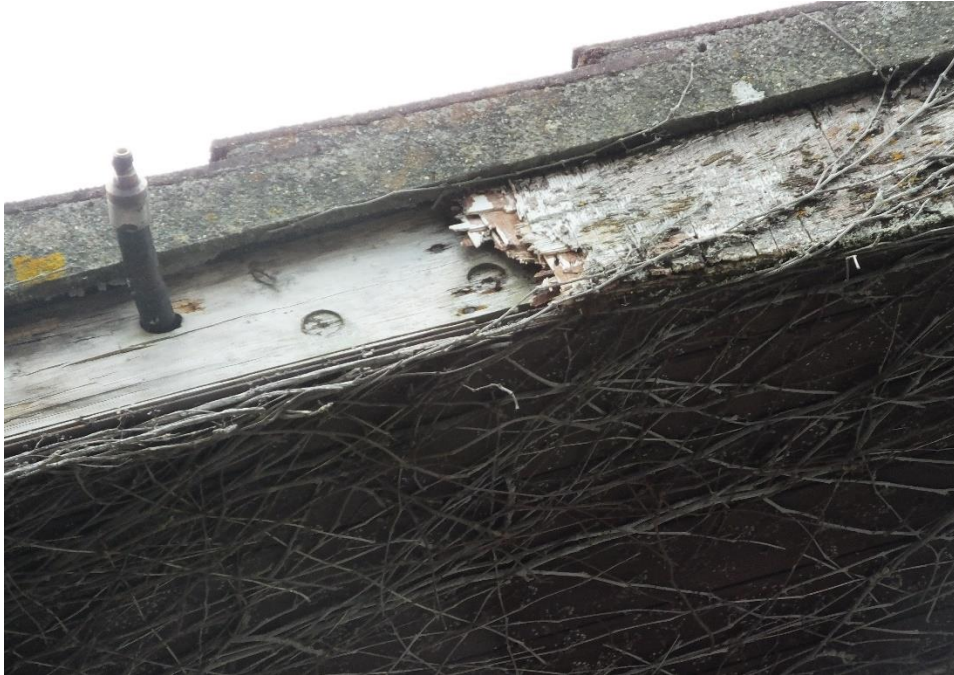
*Current dilapidated condition of fascia, during surveys no bats were observed using these boards.*

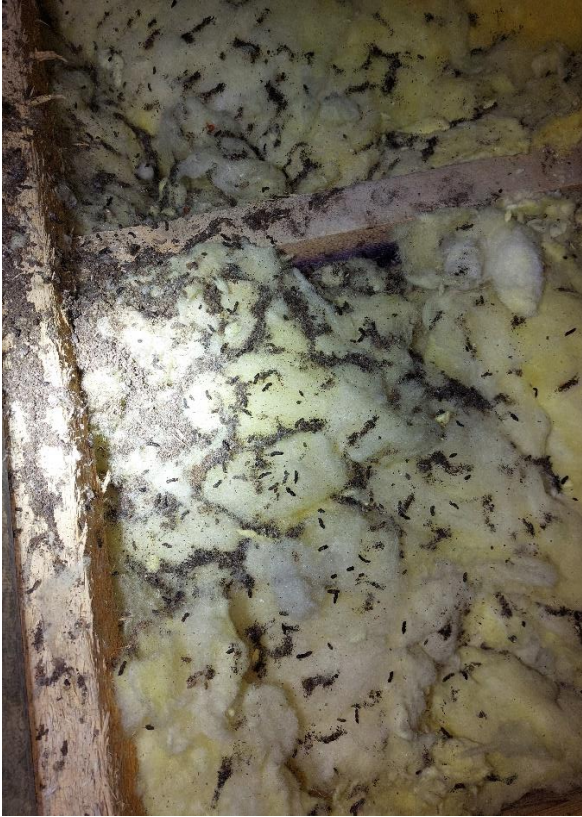
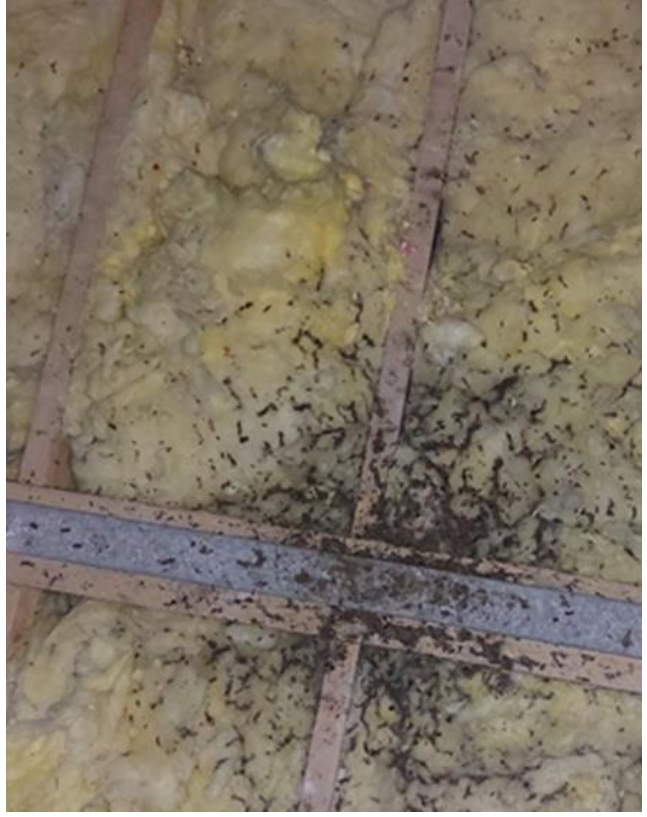
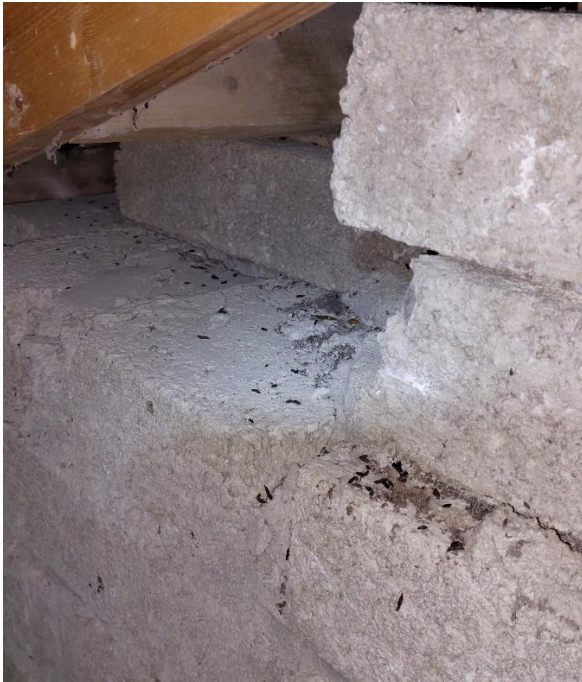
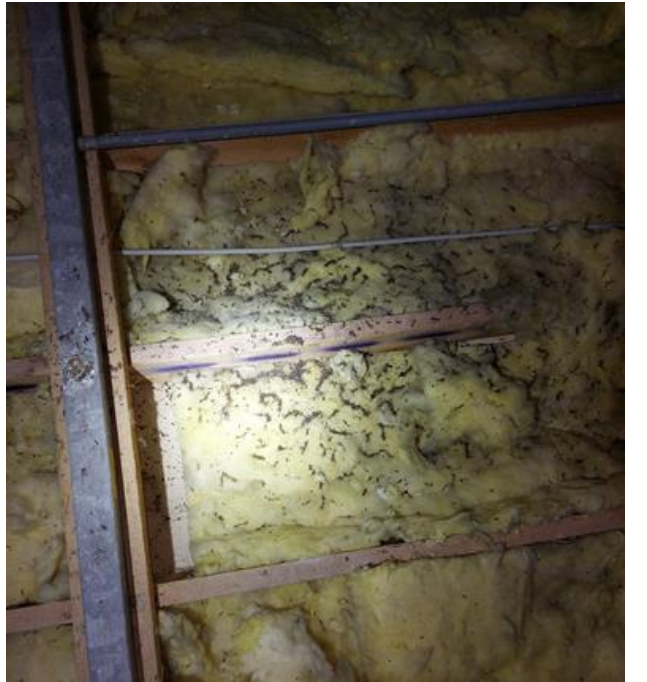
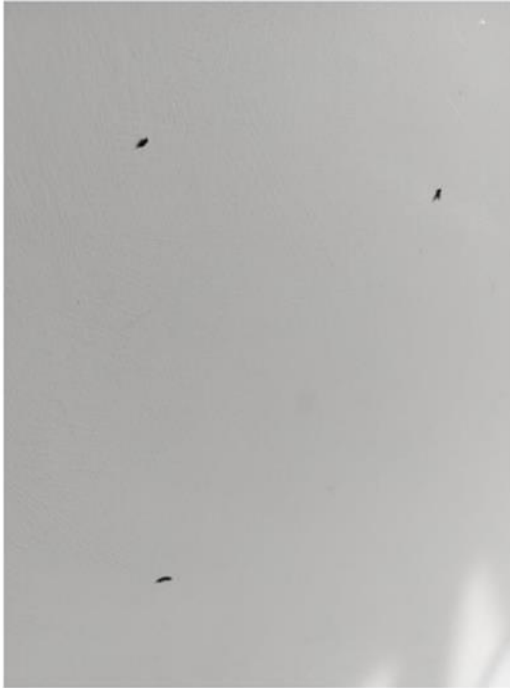
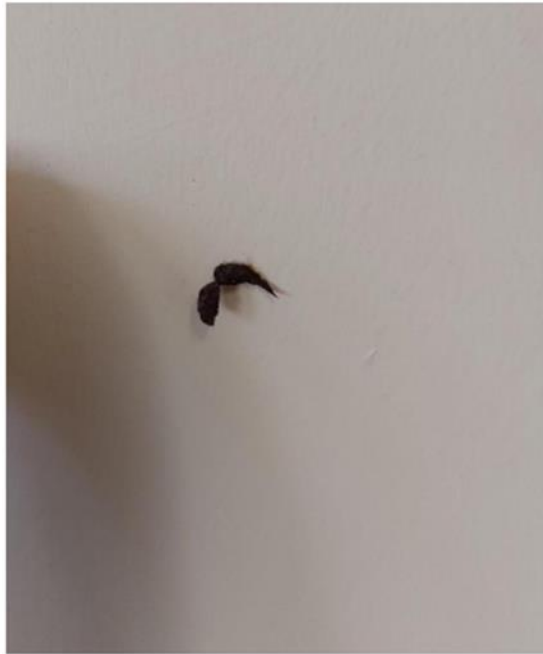
**Plate 6. Internal evidence of bat roost use in southern attic and droppings in Office 7.**

Droppings and structural features recorded during July 2025 surveys confirming multi-species day roost activity.

*Droppings scattered on the walls inside office 7*

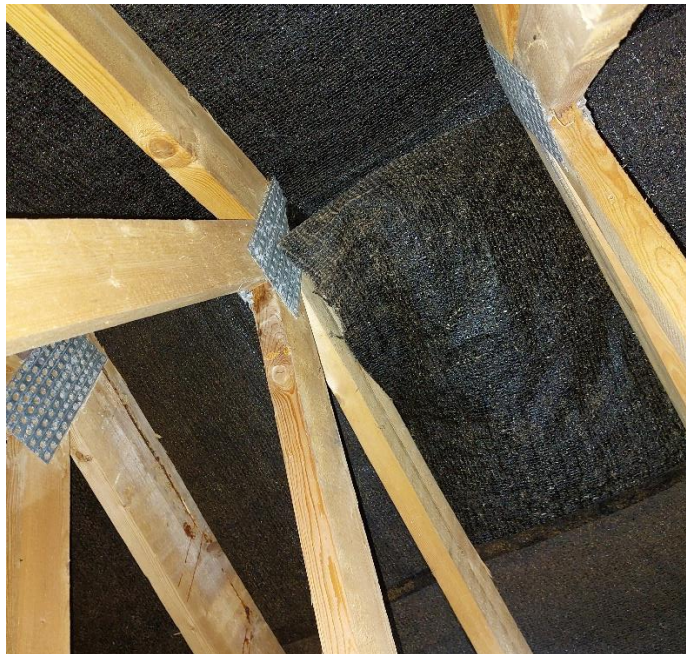
*One of the attic roosts, in loose felt (above droppings) in proposed retention area*

- The attic's felt underlay (roof-felt) beneath the timber sheathing provides narrow loose-filled voids identified as part of the roost habitat.
- The exterior southern elevation of the building.
- Internal office spaces affected by roof and soffit issues.
