Bat Survey Report

Adrigole Housing Project, Co. Cork.

December 2025

Project: Proposed Residential Redevelopment of Adrigole Garda Station, Co. Cork.

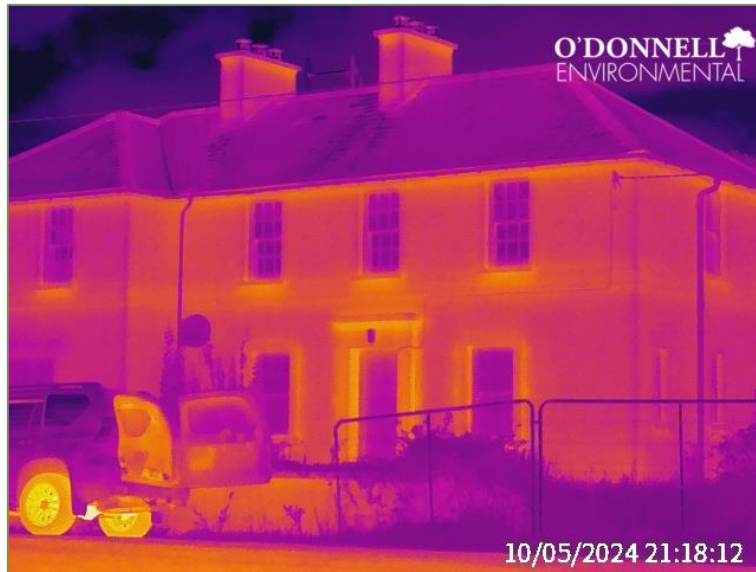
Plate 2.1 Viewshed of thermal camera covering the front/northeastern aspect of the former Garda Station.

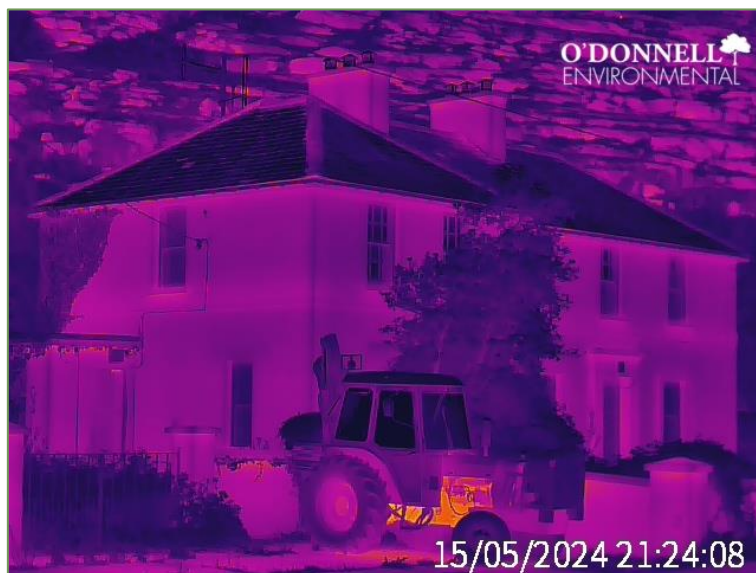
Plate 2.2 Viewshed of thermal camera covering the front/southwestern aspect of the former Garda Station.

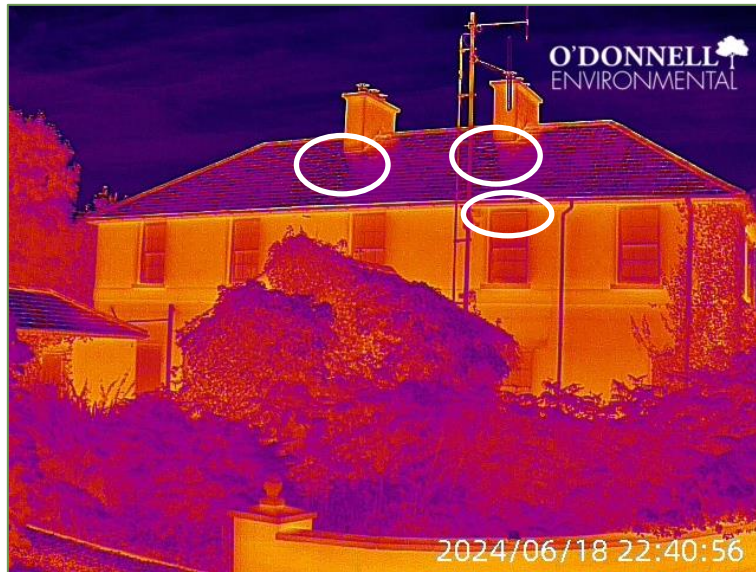
Plate 2.3 Viewshed of thermal camera covering the rear aspect of the former Garda Station. Identified potential access/egress points are highlighted in white circles.

Both emergence surveys and review of thermal imagery did not reveal any evidence of roosting by additional bat species within the former Garda Station. No evidence of re-entry by bats were noted. The main access/egress points are considered to be the loose slate within the western attic roof, the open sash window on the rear upper floor, and the extractor out-pipe associated with the ground floor kitchen (see **Plate 2.3-2.4**).

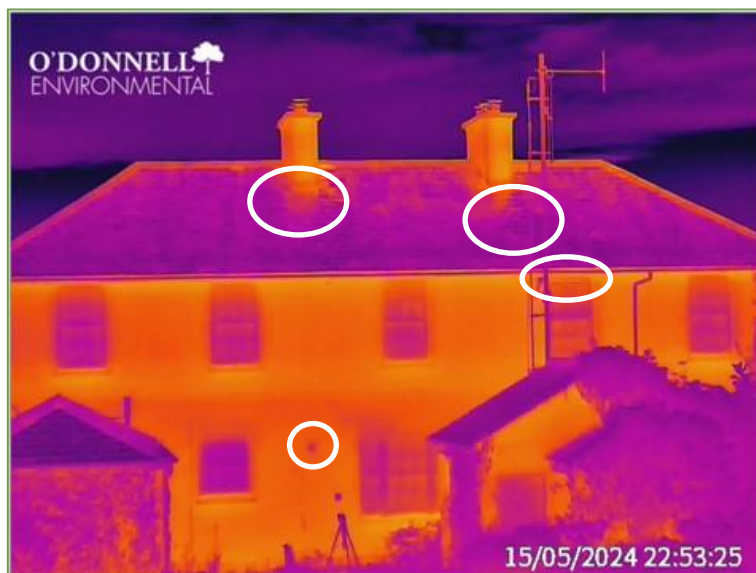
Plate 2.4 Alternative viewshed of thermal camera covering the rear aspect of the former Garda Station. Identified potential access/egress points are highlighted in white circles.

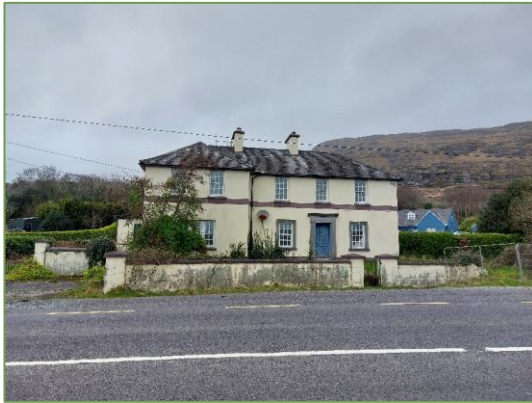
The former Garda Station is a two-storey blockwork structure with natural slate roof underlain by bitumen undertile felt. The site is located directly adjacent to the R572 and surrounded on the remaining sides by private residential gardens containing exotic species. This structure is largely intact and has not been occupied in recent years. However, multiple slipped and loose slates were observed, with water ingress noted at these locations. This is considered likely to contribute to the degradation of the structure into the future.

Plate 3.2.1 View overlooking the front aspect of the former Garda Station.

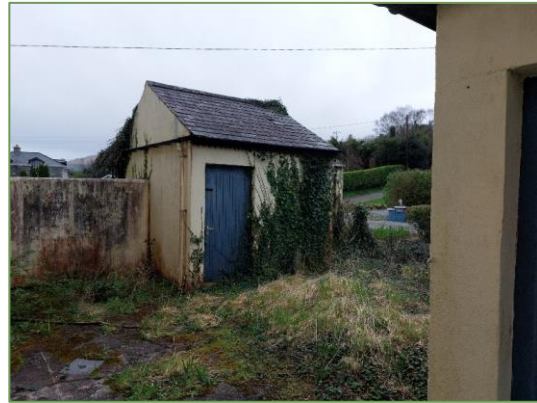
Plate 3.2.2 View overlooking the associated outhouse at the rear of the former Garda Station.

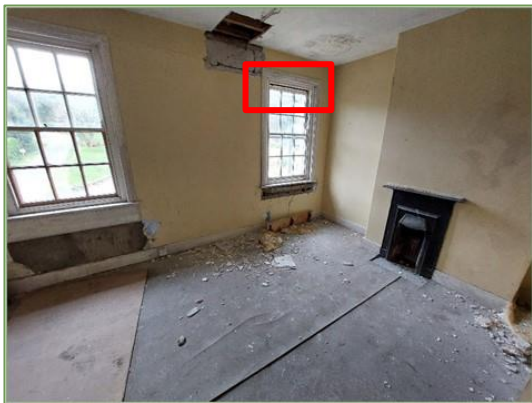
All windows and their seals remain intact with the exception of an open sash window on the upper floor at the rear of the structure (see **Plate 3.2.3**). The entirety of the blockwork presented no gaps or crevices, with a single void present at the ground floor at the rear of the structure in the form of kitchen extraction fan out-pipe (see **Plate 3.2.4**). The roof appeared largely intact alongside the associated fascia-soffit. Portions of the roof appeared recently repaired with modern artificial slate. Loose slates on the rear/northern aspect of the roof provides gaps at multiple points directly into the interior attic space of the former garda station. No evidence of roosting bats in the form of droppings, staining etc. were evident from the exterior of the structure.

Plate 3.2.3 View of the upper floor room with open sash window (red box).

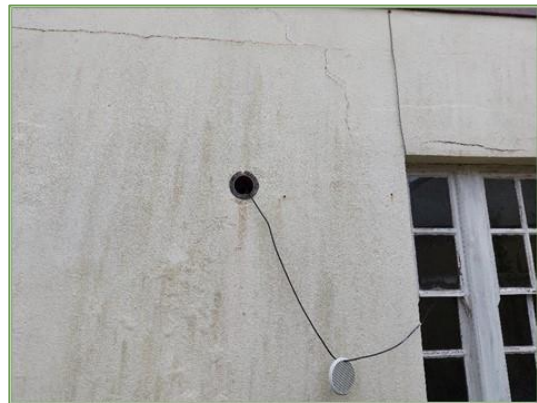
Plate 3.2.4 View of extraction fan out-pipe associated with the ground floor kitchen.

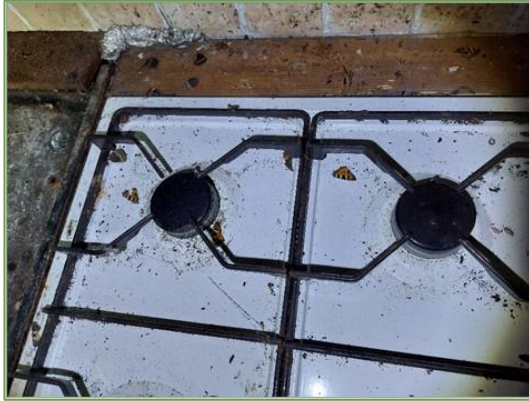
Interior assessment revealed the structure to be divided into two separate discrete spaces by a party wall and were accessed by two separate doorways. All interior spaces were connected via a gap above the attic party wall and are easily accessible by bats. Feeding remains and minor accumulations of droppings were present throughout the entirety of the ground and upper floor of the structure (see **Plate 3.2.5**) and likely represent night-roosting and feeding perches utilised by roosting bats within the structure.

Plate 3.2.5 Example of feeding remains identified throughout the entirety of the former Garda Station.

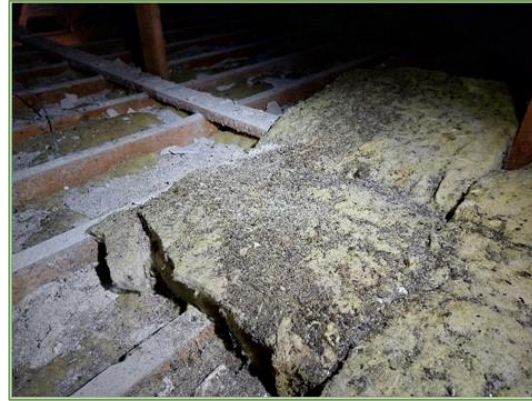
Plate 3.2.6 Large accumulation of droppings located underneath the main roosting location, of which some were fresh and DNA analysed.

Open hatches in the upper floor provided clear access to the attic space which was divided into two discrete sections by a party wall. Large accumulation of droppings, some relatively fresh, were present within the western attic section and appeared to be the main roosting location of bats present within the structure (see **Plate 3.2.6**). DNA analysis carried out by Surescreen Scientific on behalf of O'Donnell Environmental were identified as Brown Long-eared Bat (see **Appendix B**).

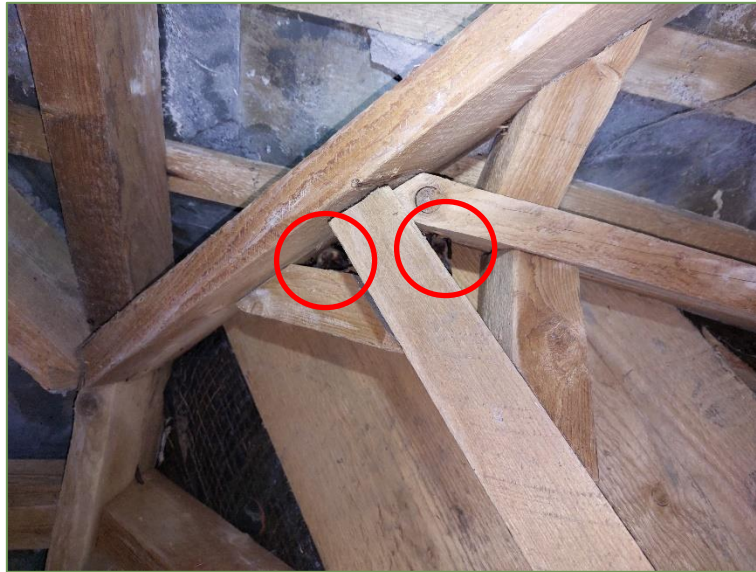
No roosting bats were evident on the initial visit on 21st March 2024. Repeat interior inspections carried out concurrently with the emergence survey on 18th June 2024 revealed two Brown Long-eared Bats present within the western attic section, located above the aforementioned accumulation of droppings within the apex timber-frame joinery (see **Plate 3.2.7**). A single individual was handled (under licence) and confirmed to be male (see **Plate 3.2.8**).

Plate 3.2.7 Two Brown Long-eared Bats (red circles) located within the joinery apex of the western attic section of the former Garda Station

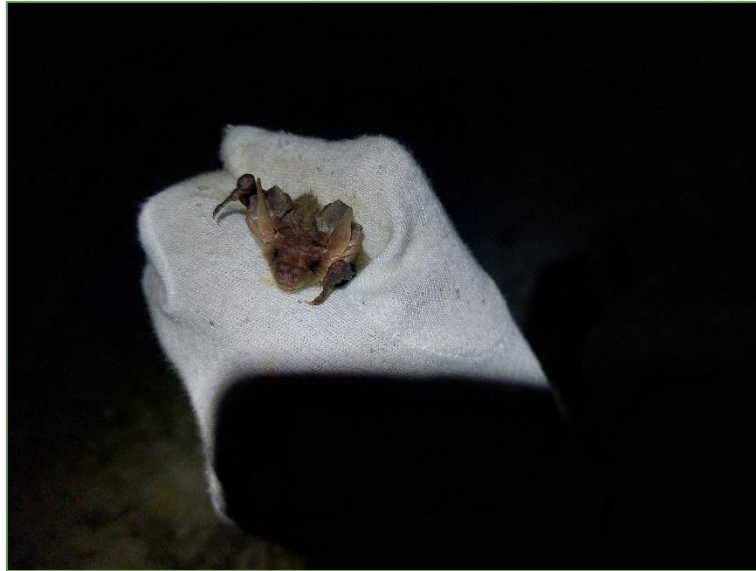
emergence recorded on 15th May 2024. Two Brown Long-eared Bats were identified roosting within the apex timber-frame joinery in two discrete locations on 18th June 2024 (see **Plate 3.2.7**). A single individual was handled under licence by Colm Breslin and confirmed to be male (see **Plate 3.2.8**).

Plate 3.2.8 Brown Long-eared Bat handled and visually confirmed to be male within the former Adrigole Garda Station attic

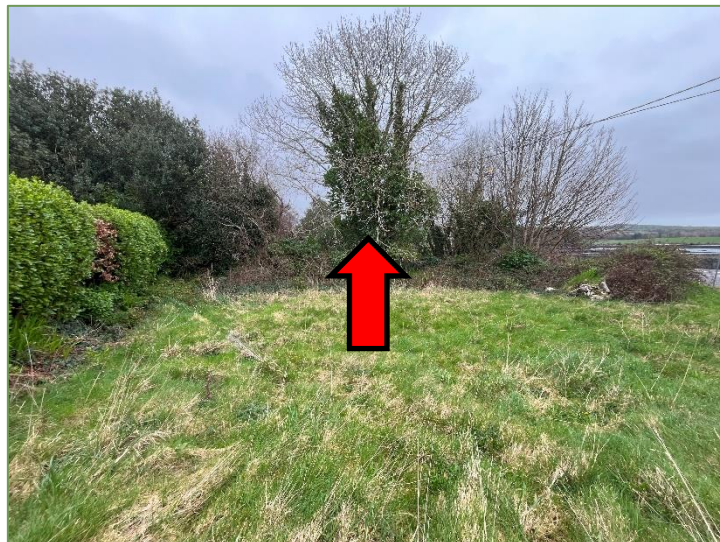
Plate 5.1. View of riparian vegetation bordering the western stream and lone-standing tree (red arrow) which will be retained in its entirety.

Under the current proposal, an existing shrub on the front aspect of the former Garda Station, alongside an area of overgrown vegetation in the northeastern corner of the site will be removed (Crocon Engineers Ltd., 2024). The existing riparian vegetation bordering the eastern stream, including the lone-standing tree (see **Plate 5.1**) but excluding the bramble scrub, will be retained in its entirety in order to maintain the landscape connectivity and provide bats roosting within the former Garda Station and the locality with waypoints and corridors through which they commute to and from roosts/foraging areas. Additionally, this vegetation provides a screening effect for disturbance from artificial street-lighting along the adjacent R572.

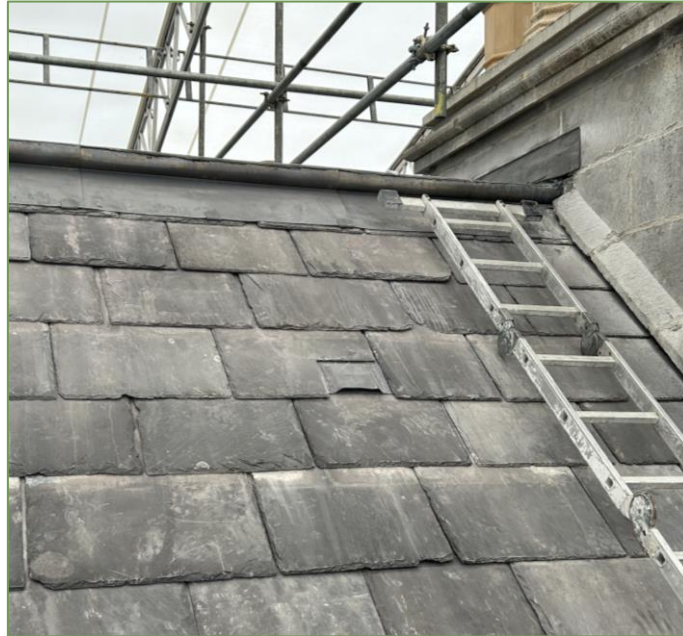
Plate 5.2 - Example of a lead bat access tile.

Permanent access to the current roosting location (western attic section) will be provided via the provision of two dedicated bat-access tiles (see **Plate 5.3**) on the northern aspect of the roof with final locations to be determined in consultation with the bat-licensed Ecologist. At least one of these tiles will be on the northern aspect which currently contains the most viable access/egress points and also is shielded from the artificial street-lighting on the southern aspect.

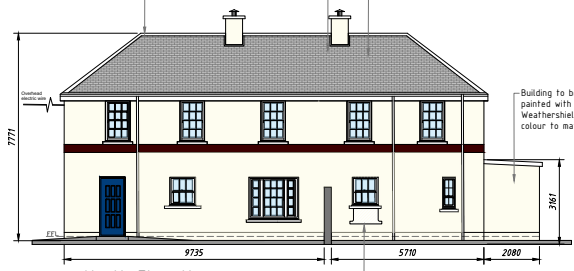
North Elevation
SCALE 1:100

Fire proofing between properties to underside of slate - Refer to drawing no. 05510 for eaves firestopping detail

Fibre cement roof slating on counter battens with vapour permeable underlay, all affixed to manufacturers specifications
