# Derogation Licence Application – Supporting Information

Proposed Medical Centre

Airlie House, Adamstown Blvd., Lucan, Co. Dublin

December 2025

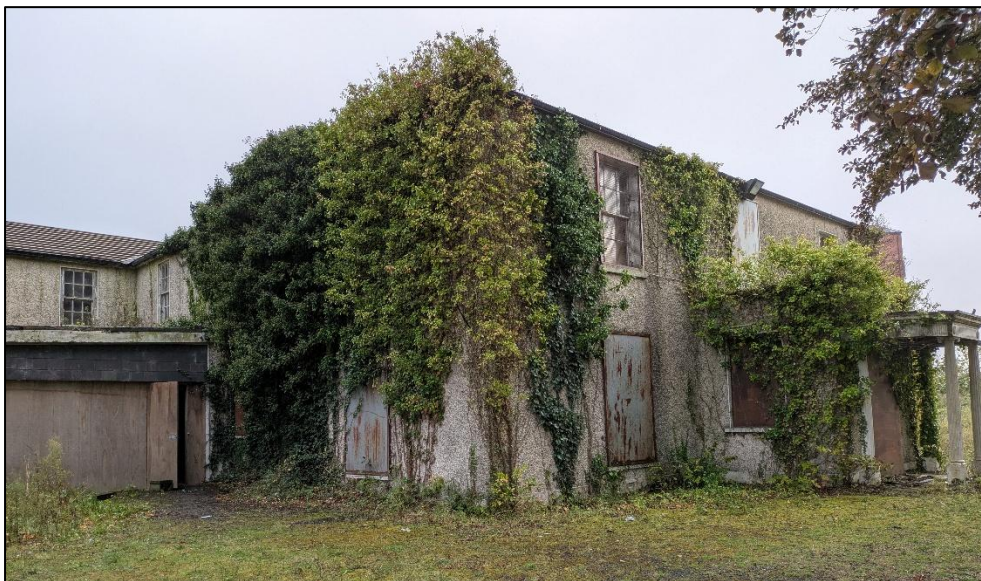
**Plate 1-1.** Airlie House within the proposed development site.

The proposed development site is situated within Adamstown and comprises Airlie House and associated extensions and immediate lands. The site is bound on all sides by recent development, comprising to the housing developments to the north, east and south (St. Helen's and Airlie View) and the Adamstown Boulevard to the west.

The proposed development broadly comprises the renovation of Airlie House into a medical centre including the demolition of the existing extensions and garage, and construction of a new extension to the south.

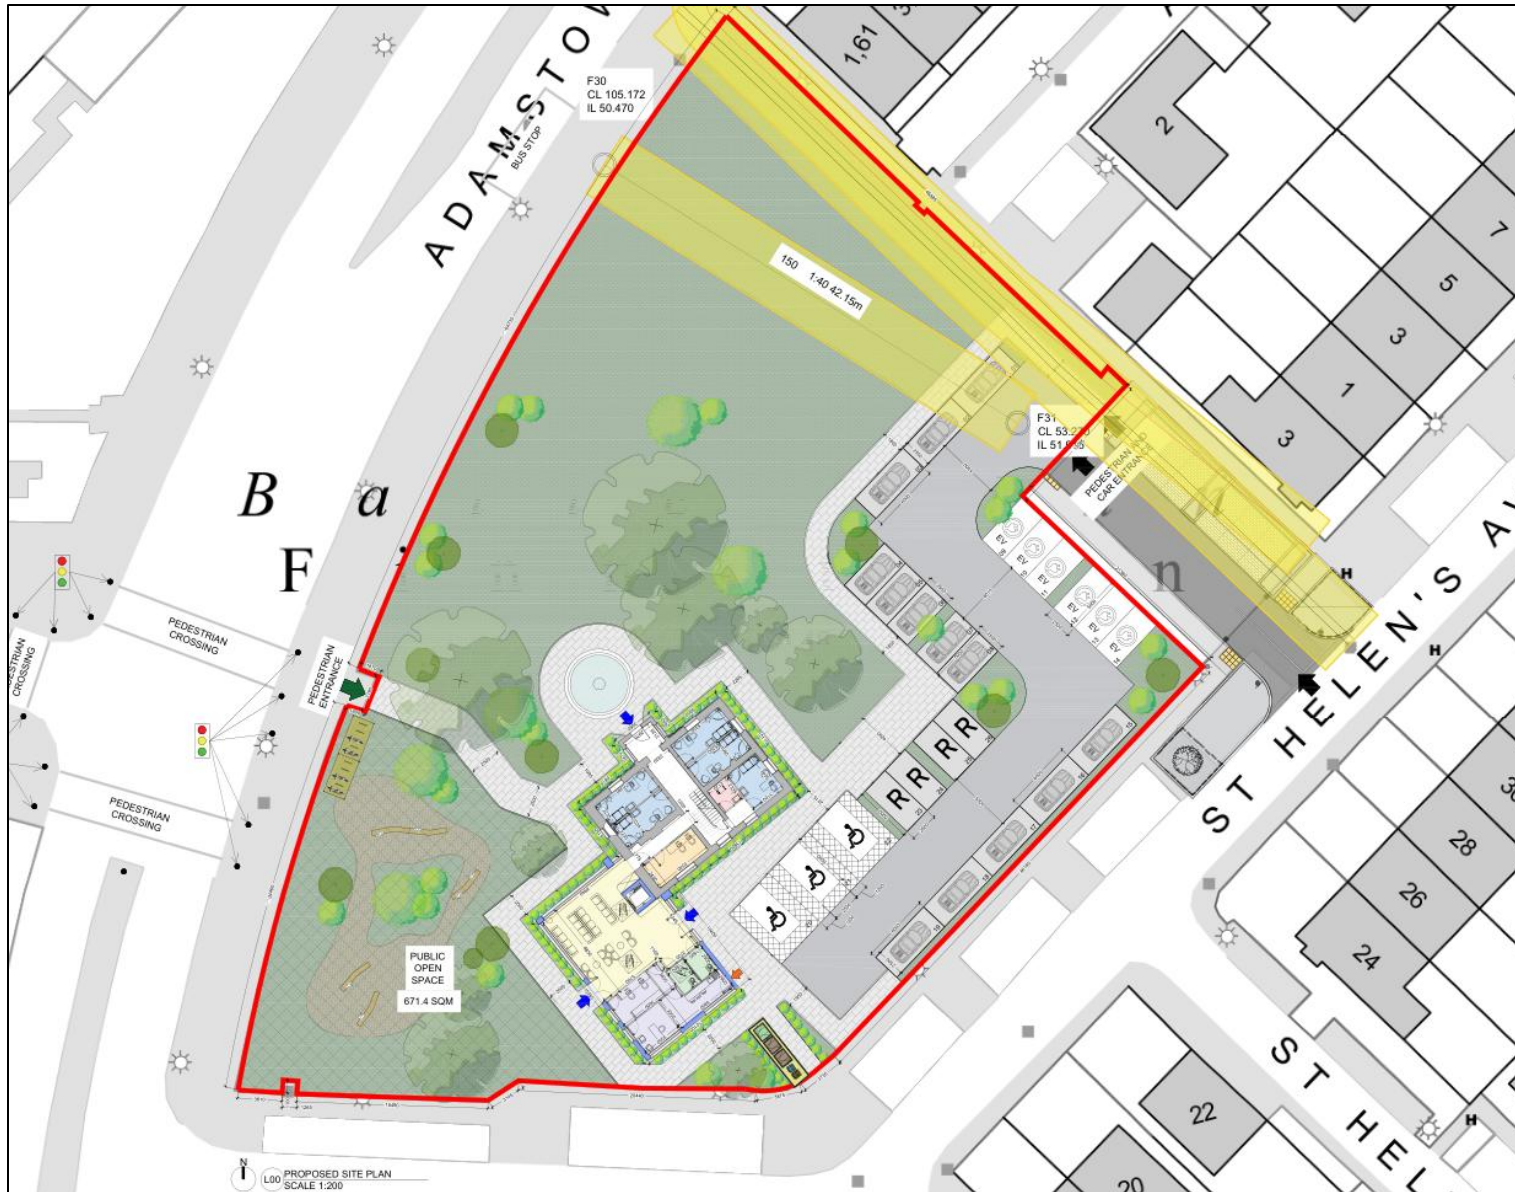
Site development works and landscaping works include the provision of public open space, boundary treatment, 26 car parking spaces with a set-down area in front of the new extension, Secured Vehicular access to the development is via the road network proposed under Planning Reg. Ref. SDZ24A/0022W.

Along with all other site works proposed on c. 0.2 hectares of the Airlie House lands.

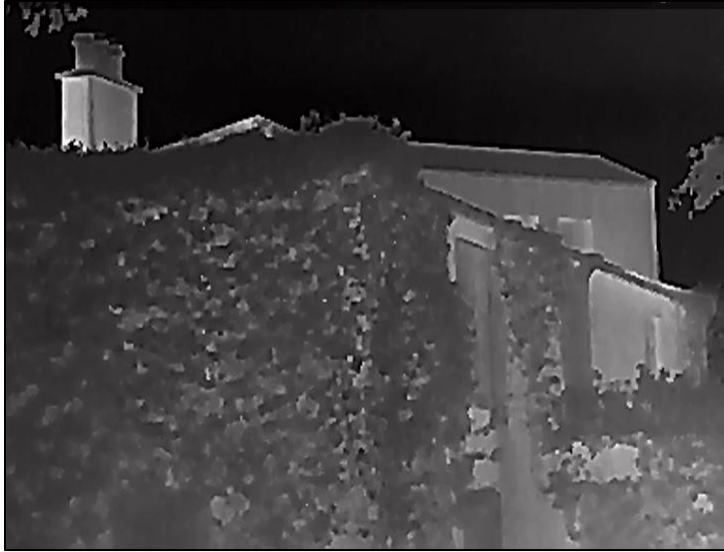
A high-sensitivity thermal imaging camera was also utilised as a survey aid, as per Fawcett Williams (2021). Thermal imaging significantly improves the detectability of bats emerging/re-entering roost sites, as the camera is not restricted by the available visible light. Footage was then reviewed following the survey to ensure no potential emergence was missed during the survey.

**Plate 3-1.** Example of thermal imaging camera footage captured during emergence survey.

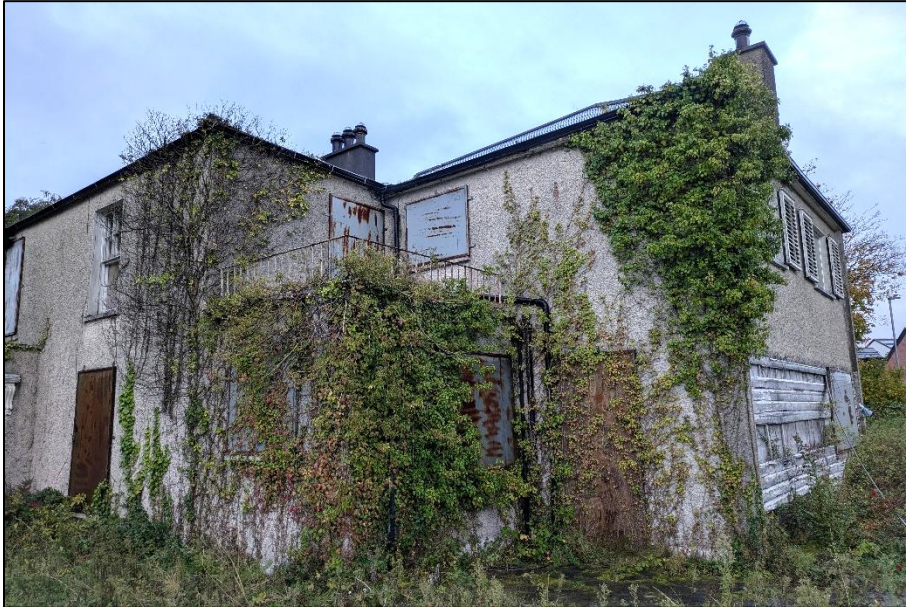
Airlie House comprises a 19<sup>th</sup> century detached three-bay two-storey building. The building is in a poor state of repair with evidence of anti-social behaviour and fire damage. The building has a number of extensions of varying ages. To the south-west of the main house there is a 20<sup>th</sup>-century two-storey extension. To the north-east there is an older two-storey extension and attached flat-roofed garage. The majority of the windows of the building have been boarded up, either via wood sheeting on the inside, or via steel sheets bolted to the exterior. Windows on the main house are predominantly timber frame, with uPVC windows on the extensions.

**Plate 3-2.** South-west extension to main house.

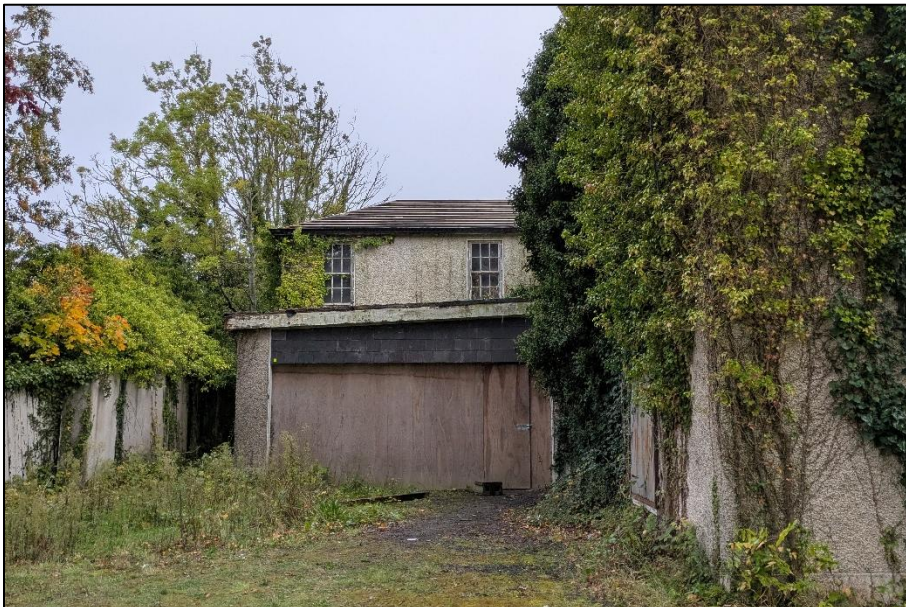
The roof is of the north-east extension and sections of the main house are currently in an unfinished state following what appears to be recent re-roofing works. This roof is largely without slates, and comprises battens on roofing membrane. As such, there has been water ingress into the building and many of the upper floors and internal ceilings are collapsing.

**Plate 3-3.** North-east extension to main house and attached flat-roofed garage (B).

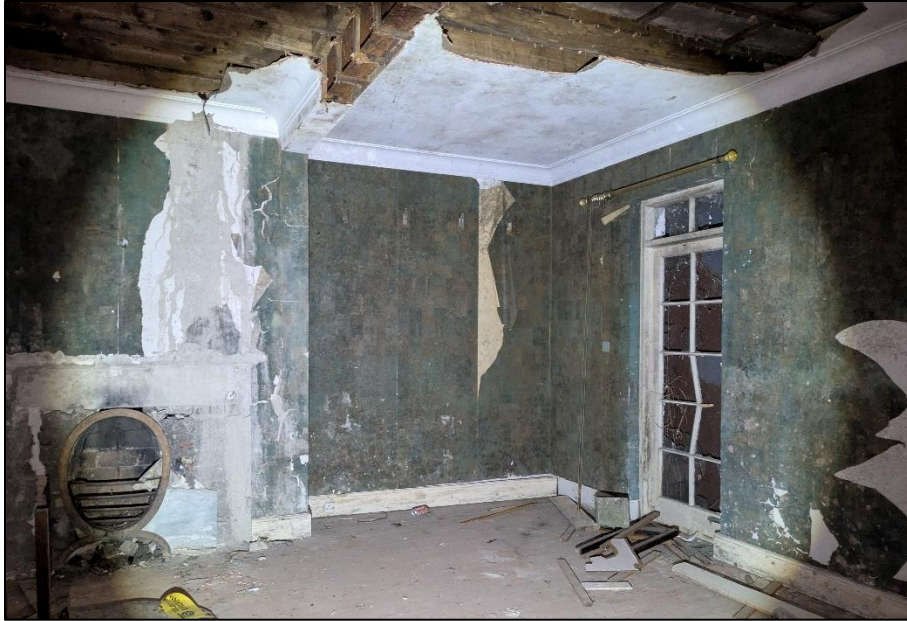
No bat droppings or other evidence of presence was recorded during the roost inspection survey. Note: the first floor was inaccessible in places due to collapsing floors and stairs.

Plate 3-4. Interior of main house.

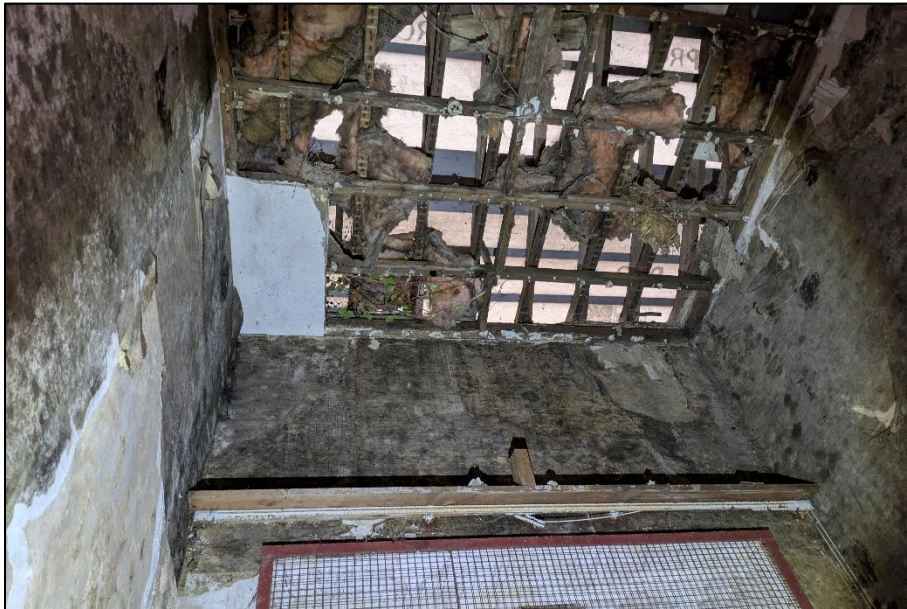
Plate 3-5. Interior roof space showing roofing membrane and water ingress.

- The re-roofing works of the main house should ideally be carried out during autumn or spring. During these times bats will typically be capable of feeding on most evenings and may be torpid during the day, but will not have begun giving birth. Any potential remedial timber treatment required should be carried out during period 31<sup>st</sup> October to 31<sup>st</sup> March, as the chemicals involved in these treatments can be harmful to bats. Replacement roofing felt should be 1F Bitumen felt or similar 'bat friendly' membrane, as this material does not contain polypropylene filaments that can trap bats.

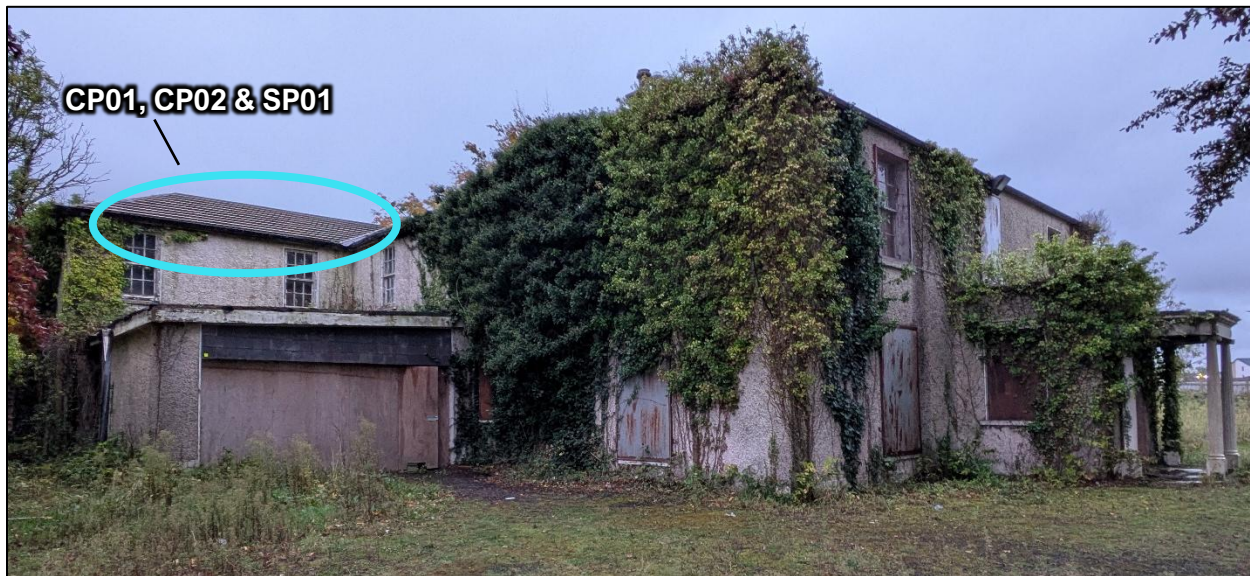
The first observation comprised a distant Leisler's bat record at 19-minutes post-sunset. At 25-minutes post-sunset a single common pipistrelle was recorded coming from the direction of the north-east extension. Adopting a precautionary approach, this bat is assumed to have emerged from this area of the building (ref: CP01). At 26-minutes post-sunset a single soprano pipistrelle was observed similarly coming from roof level of north-east extension, and is similarly assumed to have emerged from this area of the building (ref: SP01). This bat was then observed foraging in the immediate vicinity of the building, including above the garage extension, before leaving the site to the north-west,

At 28-minutes post-sunset two common pipistrelle were recorded coming up over the north-east extension, before foraging in wide circles in general vicinity of the building (CP02). Again, it cannot be ruled out that one or both of these bats emerged from the subject building. A single common pipistrelle remained foraging in within the site from approximately 29-minutes post-sunset to 43-minutes post-sunset. The remaining observations comprised a single soprano pipistrelle briefly recorded foraging at 52-minutes post-sunset, and a common pipistrelle foraging within the site at 59-minutes post-sunset.

Plate 3-6. Estimated emergence area from subject building.

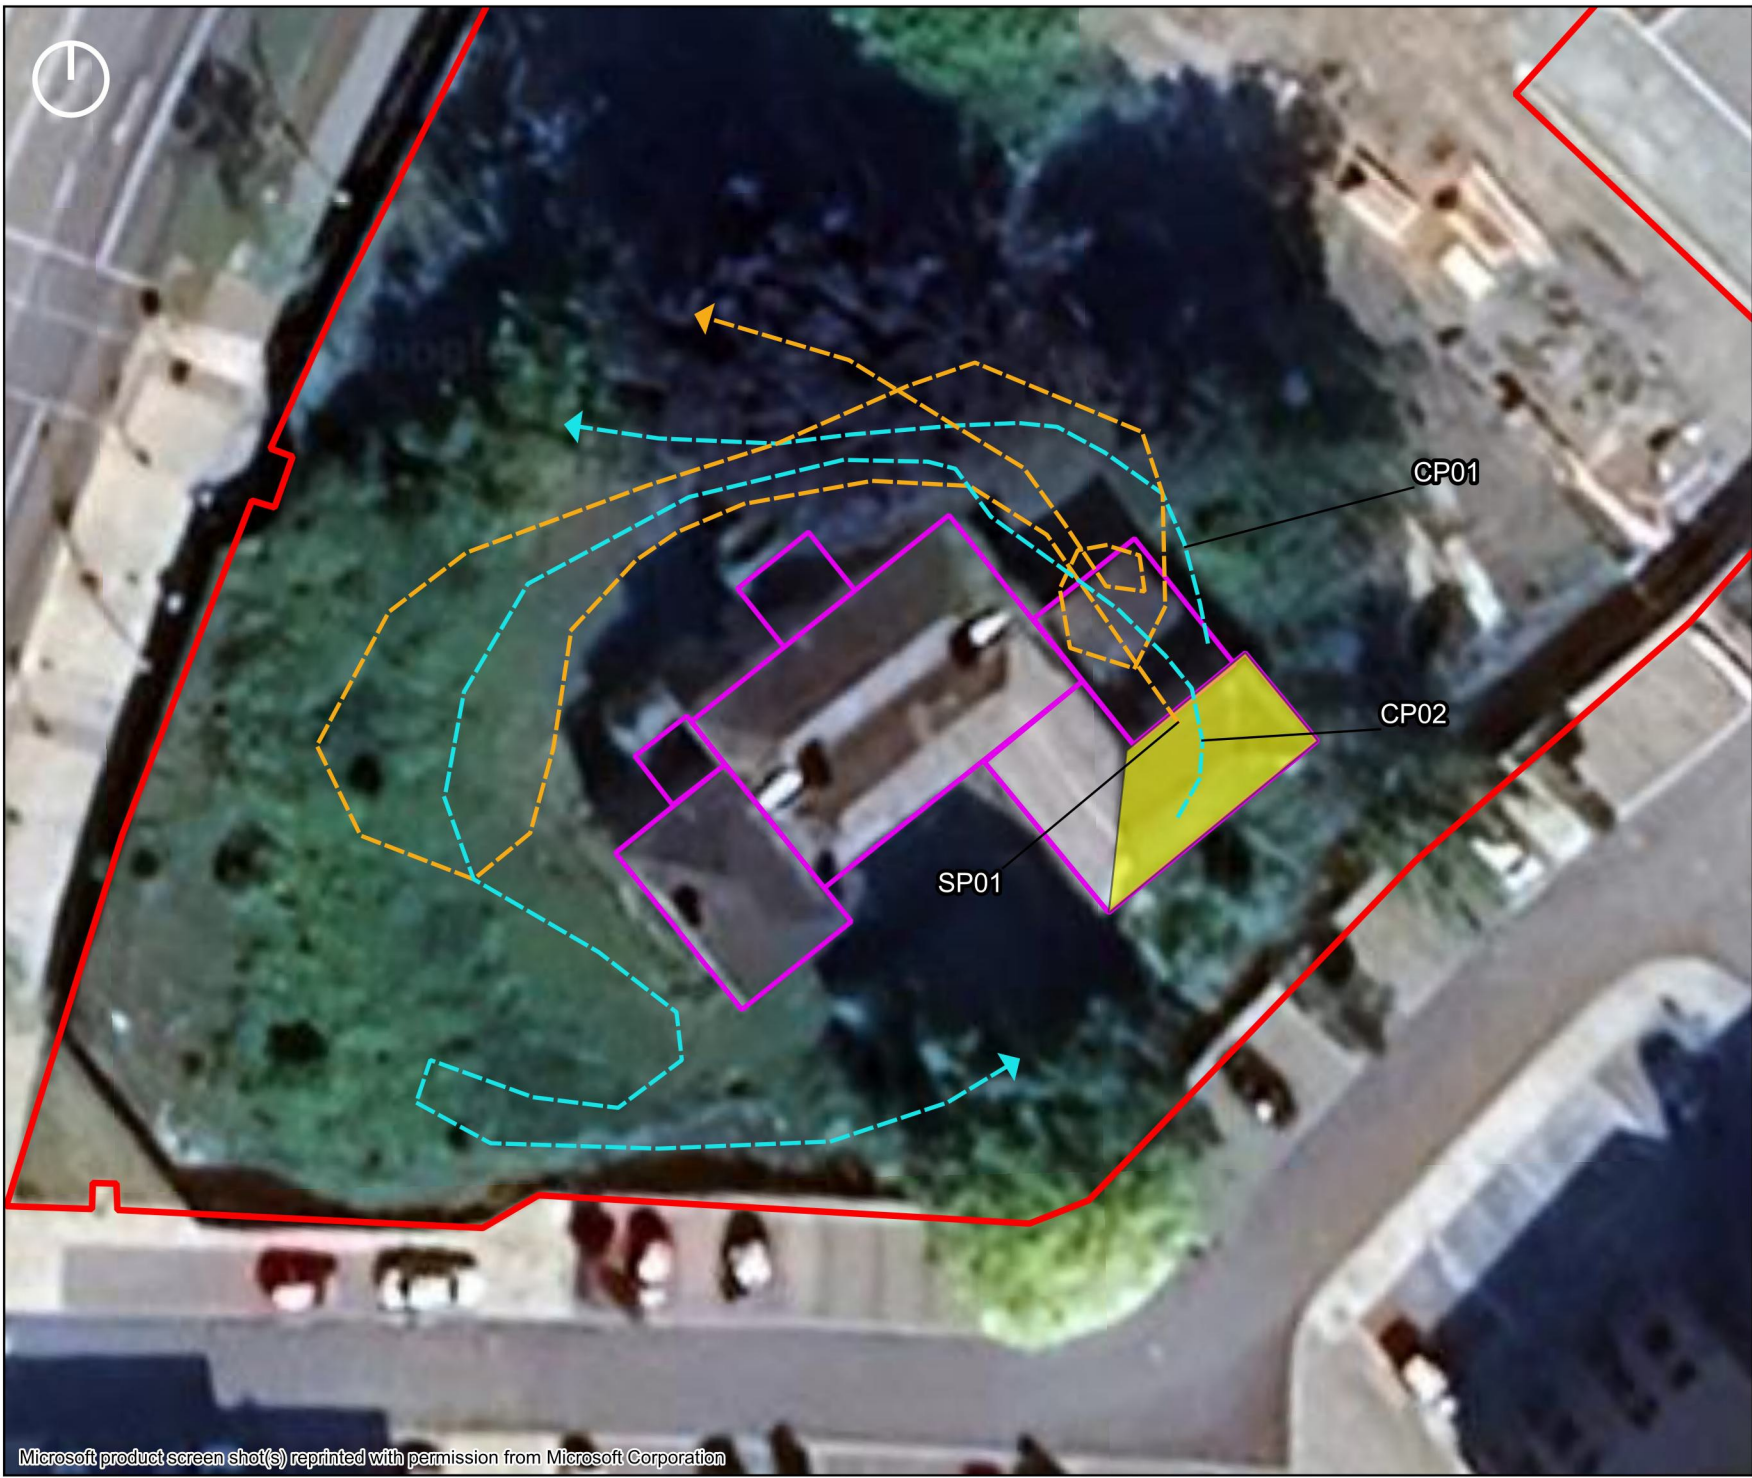
Title  
**Figure 3-1. Notable observations recorded during emergence surveys.**

**Total bats recorded emerging:** likely 2-3no common pipistrelle and likely 1no. soprano pipistrelle.

The emergence survey, carried out in early October 2025, recorded likely 2-3no common pipistrelle and likely 1no. soprano pipistrelle emerging from the north-east extension of Airlie House. Owing to the seasonality and small number of bats observed, these are considered to be **transitional roosts** for common pipistrelle and soprano pipistrelle.

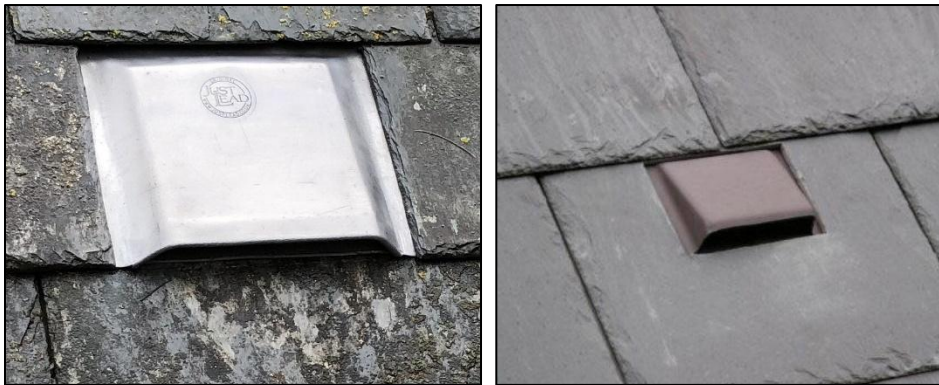
The attic space of the main house has the potential to support roosting bats post-development with appropriate design considerations. As such, in order to facilitate future entry and exit pathways for bats from this attic space post-works, it is proposed to install 6no. bat access tiles / vents<sup>d</sup>, comprising 3no. on each of the two interior facing aspects of the hipped roof. As outlined above, roofing felt in this attic space should be

**Plate 4-1.** Example bat access tiles / vents (*‘Just Lead’*, *‘Beddoes’*).
