# 34-41 Catherine Street Bat Report

November 2025

Prepared for:  
EKO Integrated Services

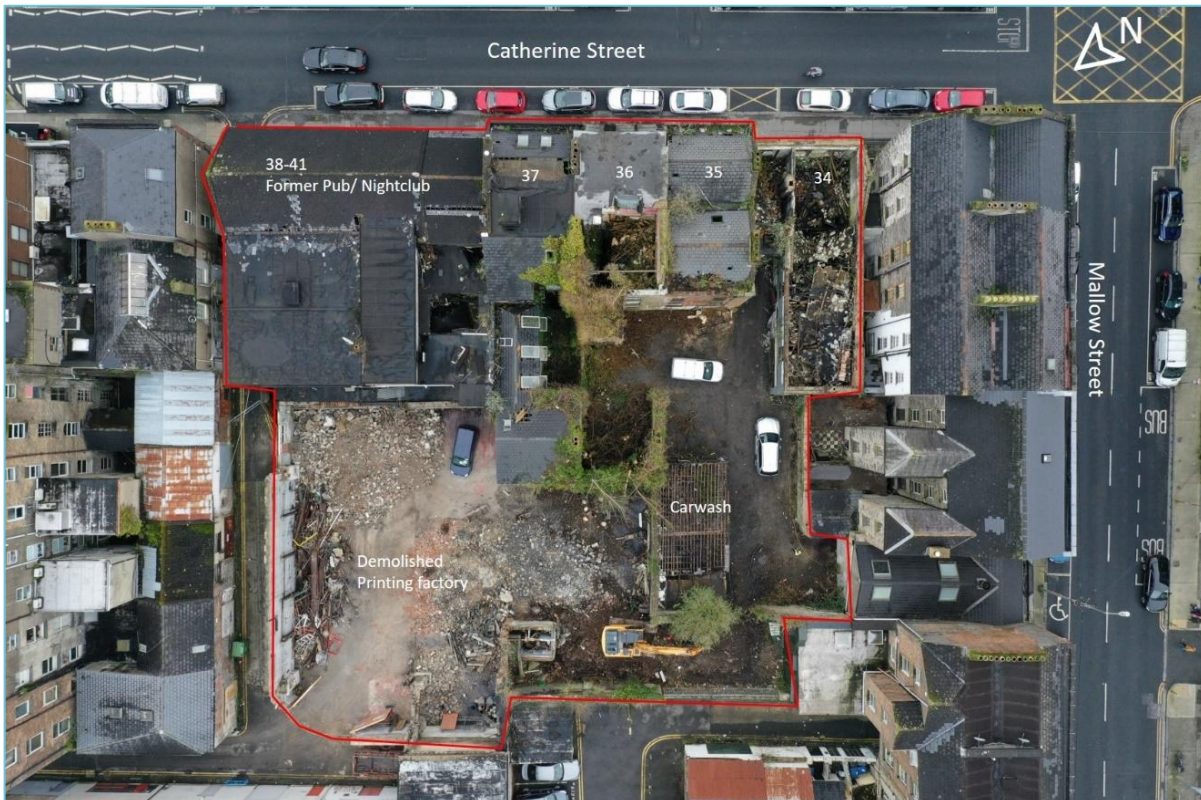
Figure 1-3: Aerial view of the site January 2020.

A Preliminary Bat Roost assessment was undertaken by JBA at 34-41 Catherine Street, in January 2020. The assessment included a desktop review of existing bat records and aerial imagery, as well as an external ground-level inspection of the buildings and vegetation on site (Figure 1-3). Due to the unsafe condition of several structures, internal inspections were not possible, which limited the ability of confirm the presence or absence of bats.

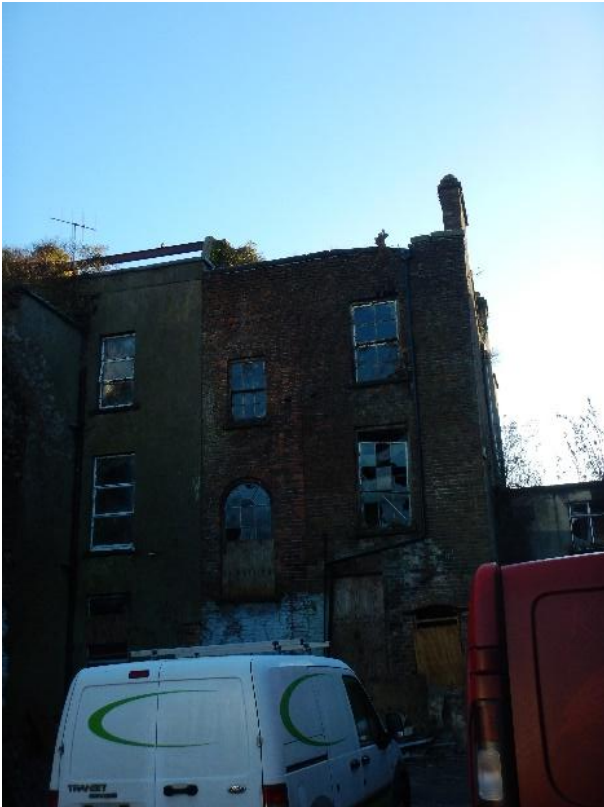
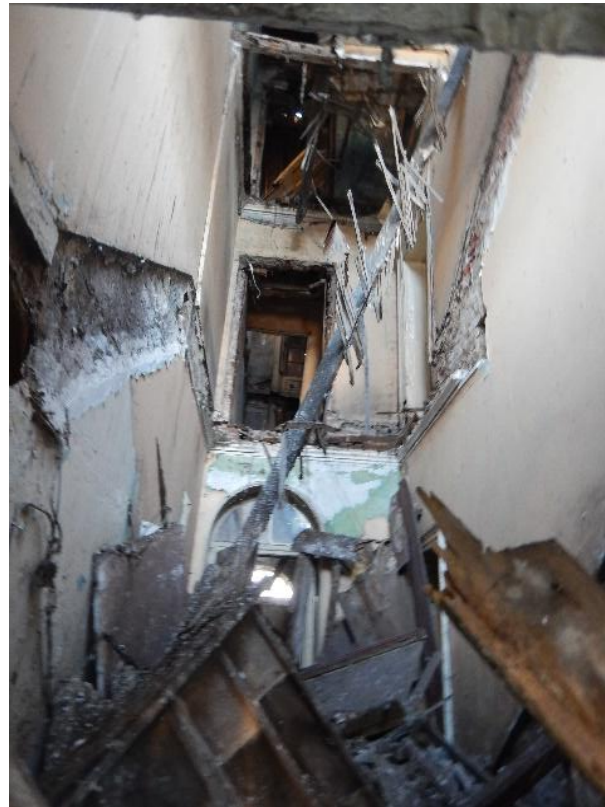
Figure 1-4: Images from the 2020 bat survey of No. 35 and 36.

The survey found that most of the buildings on site had negligible to low potential for bat roosting. No. 34 was deemed unsuitable due to a fire in 2018 that caused the roof and interior to collapse. Buildings No. 35 and 36 were also in poor condition, with collapsed roof and floors, offering limited roosting potential (Figure 1-4).

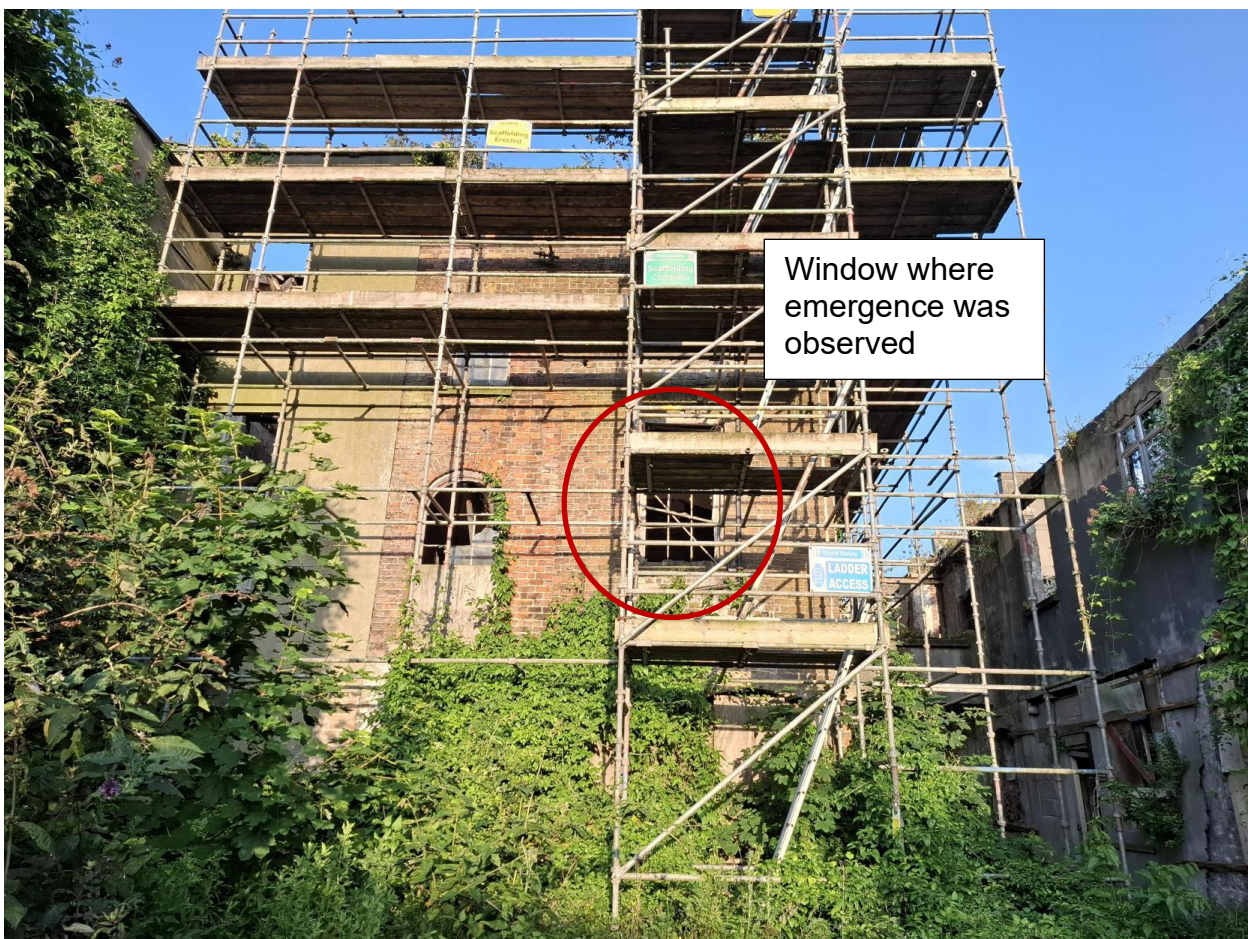
Figure 4-2: No. 35 Catherine Street view from inside the site.

Both surveys confirmed the presence of a small number of Common pipistrelles using the site, particularly No. 35 Catherine Street where the bats have been observed emerging from the second-storey window. The consistency in emergence location and timing across both surveys reinforces the assessment that the structure is likely used as a satellite roost, with the building providing suitable access points and microhabitat conditions for crevice-dwelling species. No other bat species were recorded during these surveys.
