Re: Application for derogation licence at Ardgroom Inward, Beara, Co. Cork

DixonBrosnan have completed an application for a derogation licence at Ardgroom Inward, Beara, Co. Cork on behalf our clients Erika and Volker Herrmann. Detailed bat surveys were completed at the site in 2022 and 2024. Repeat bat surveys were completed in 2025 to assess the current usage of the site by bats. The results of the 2025 survey as summarised in this letter.

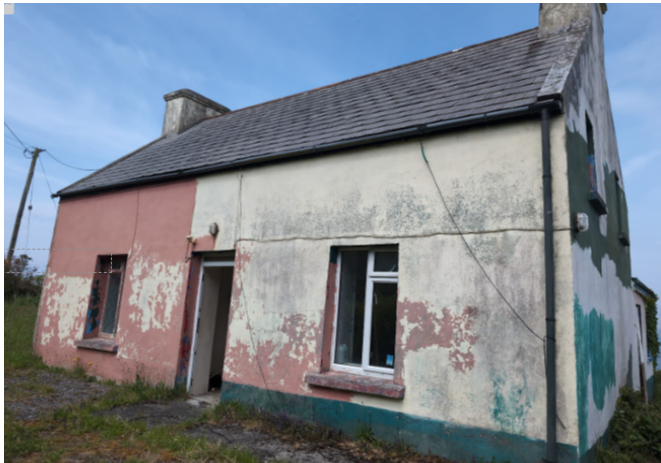
Plate 1. Exterior of Building 1.

Building 1 is a two-storey old farmhouse with slate roof and concrete walls located to the west of Building 2. Lesser Horseshoe droppings were recorded in small storage rooms which are accessed from the upstairs landing. One Lesser Horseshoe Bat was recorded roosting at this location during the daytime survey on the 11<sup>th</sup> of May 2024. Staining on the walls and droppings in the western upstairs bedroom indicate usage by pipistrelle bats. A static detector (Elekon Batlogger) was left *in situ* from the 11<sup>th</sup> to the 13<sup>th</sup> of May 2024. It recorded sporadic signals for Lesser Horseshoe bat throughout the survey period. The results indicate that this farm house continues to be used as a night-time roost by

this species. The presence of one Lesser Horseshoe bat during the day, on one of the survey days, suggests temporary usage as a day roost. The presence of droppings and staining indicates that this building continues to be used as a pipistrelle roost.

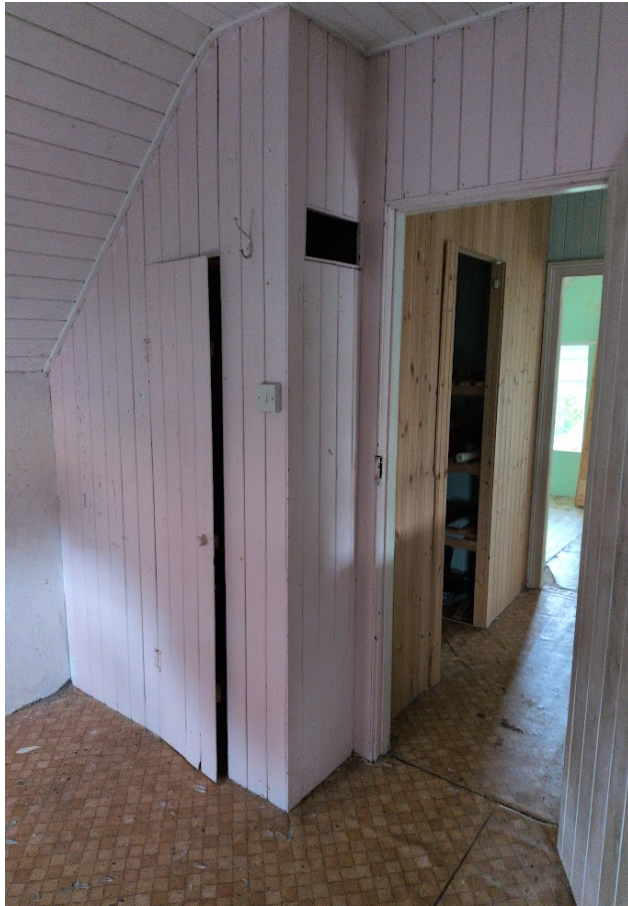
A survey of the building on the 22<sup>nd</sup> of August 2025 recorded one Lesser Horseshoe in an upstairs hot press where a single bat was also recorded during the day in 2024. An Elekon Batlogger (B18) was left upstairs in situ from August 22<sup>nd</sup> to August 23<sup>rd</sup> 2025. Only limited bat activity was recorded between 22.41 on August 22<sup>nd</sup> and 3.05 on August 23<sup>rd</sup> with one faint signal for Lesser Horseshoe Bat at (1.24 on August 23<sup>rd</sup>) and some brief and sporadic signals for Pipistrelle. It is noted that pipistrelle probably emerge from the outside of the building and would not necessarily be picked up on an internal detector. The minimal signals for Lesser horseshoe suggest that outside of its use as a daytime roost for one bat, usage at night was limited in extent.

Plate 2 Hot press and cupboard used by Lesser Horseshoe bat.

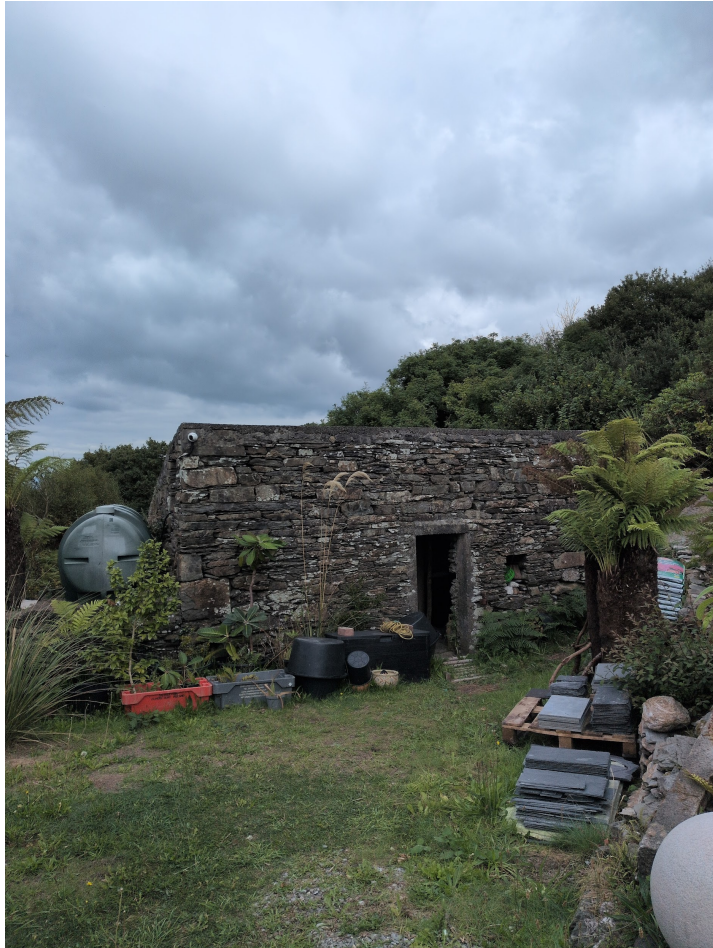
Plate 3. Exterior of Building 3.

Building 3 is an old stone shed with a slate roof and natural stone walls. While this building is located within the proposed development site, there are no works proposed to this building. The windows and doorway of this building are open. It is proposed that this building will be used as specifically as roosting habitat for bats. Details on the works to be completed in relation to this structure are detailed in the derogation application (**Appendix 1**). An initial daytime assessment of this building did not record any roosting bats. An Elekon Batlogger (Bl6) was left in situ from August 22<sup>nd</sup> to August 23<sup>rd</sup> 2025.

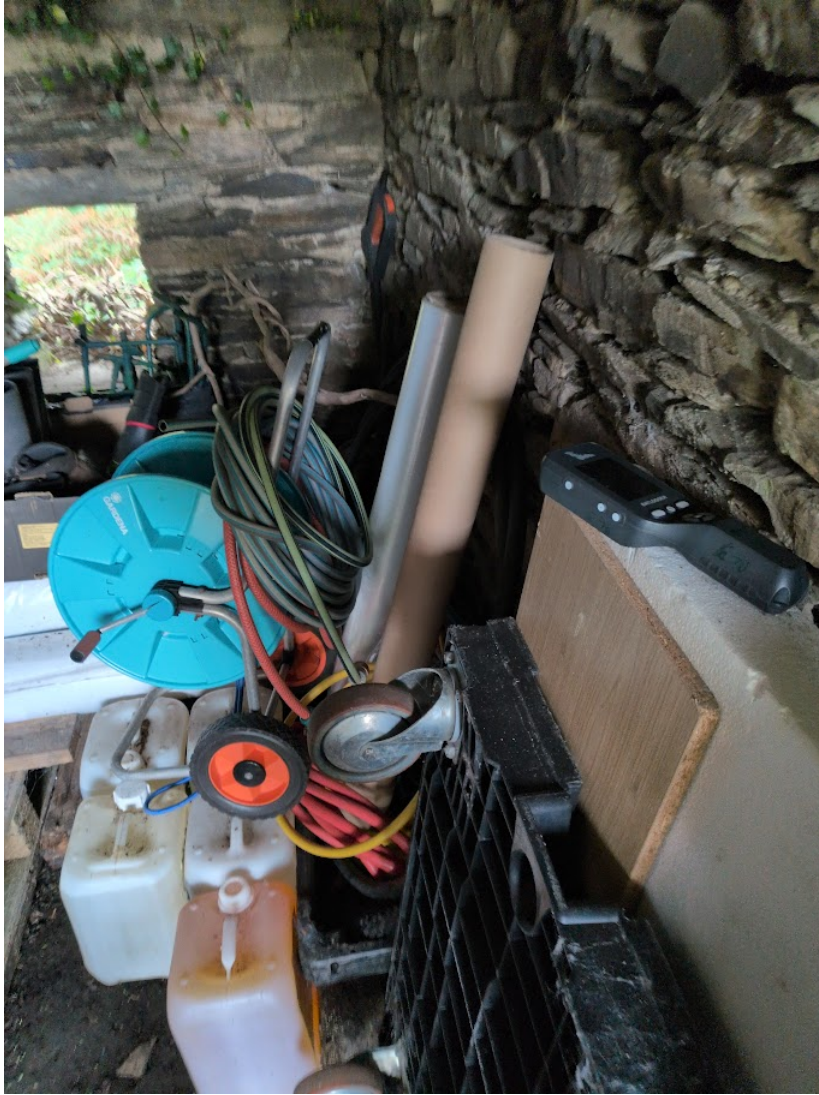
Plate 4. Interior of Building 3

A review of the data from the Elekon bat logger (BL6) indicates that bat activity was recorded from 21.09 on August 22<sup>nd</sup> to 1.09 on August 23<sup>rd</sup>. Pipistrelle activity was limited in extent with one signal recorded at 21.09 on August 22<sup>nd</sup> and 16 signals were also recorded from 23.23 to 23.27 on August 22<sup>nd</sup> 2025. This is probably indicative sporadic foraging around the building or sporadic usage of the building at night. Three brief signals for a myotis bat were recorded at 23.16, 23.35 and 23.40 which is probably indicative of occasional nighttime usage of the structure.

The most common species recorded was Lesser Horseshoe bat which was recorded throughout the survey period. The first signal was recorded at 21.09 on August 22<sup>nd</sup> and the last signal was recorded at 1.02 on the 23<sup>rd</sup> of August 2025. In the intervening period approximately 650 signals were recorded for Lesser Horseshoe bat which indicates continued usage as a night roost.

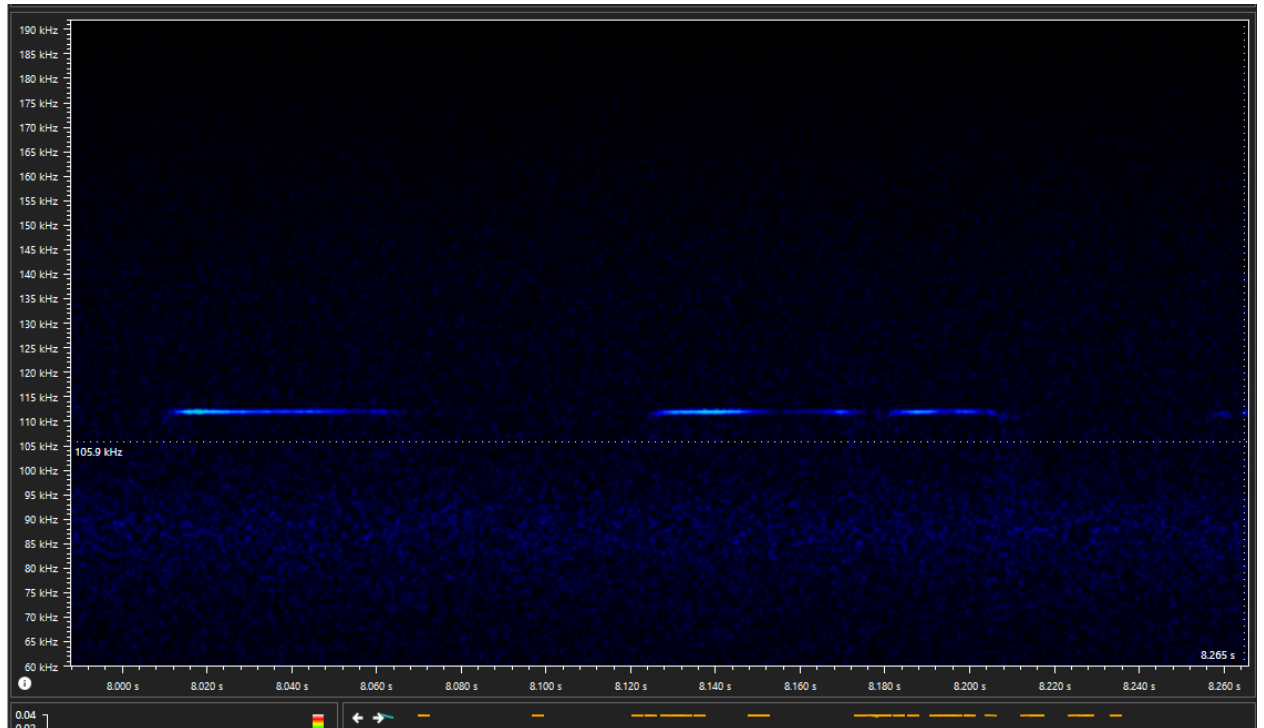
Figure 1. Sonogram Lesser Horseshoe bat

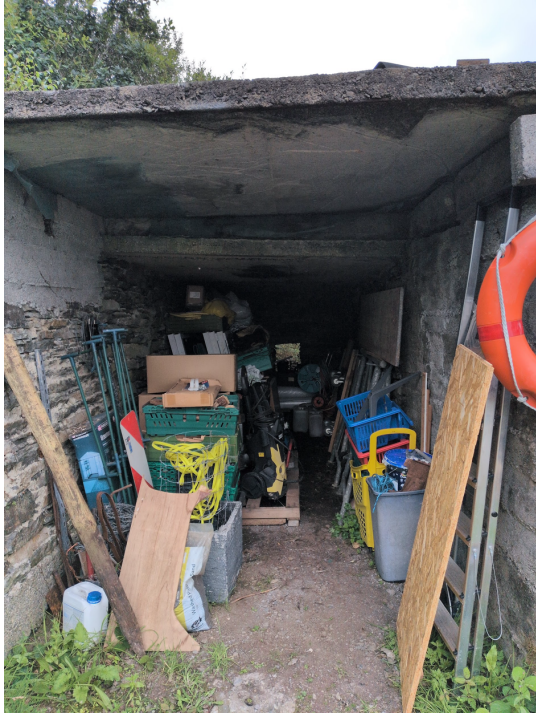
Plate 5. Interior of building 4 in 2025

Building 4 has a corrugated iron roof and natural stone walls. A review of the data from the Elekon bat logger (BL3) indicates that bat activity was recorded from 20.54 on August 22<sup>nd</sup> 2025 to 6.10 on August 23<sup>rd</sup>. Two brief signals were recorded early in the survey period at 20.54 which were indicative of a myotis bat, however the signals were indistinct and identification uncertain. A brief signal for a myotis bat was also recorded at 2.06 on August 23<sup>rd</sup>. A brief signal for a pipistrelle bat was recorded at 21.32 and 15 additional signals for a mixture of common and soprano pipistrelle were recorded during the survey period. There was extensive Lesser Horseshoe activity throughout the survey period from 21.49 on August 22 to 4.49 on August 23<sup>rd</sup>. Approximately 1400 signals were recorded which is indicative of continuous activity. It is noted that the front of this building is open and some of the signals may relate to bats foraging in proximity to the building, however it is considered probable that this building is used as a night roost.
