Bat Survey and Assessment

Killaha East

Report prepared for Liz Keeman and Aidan Crowley

6th February 2026

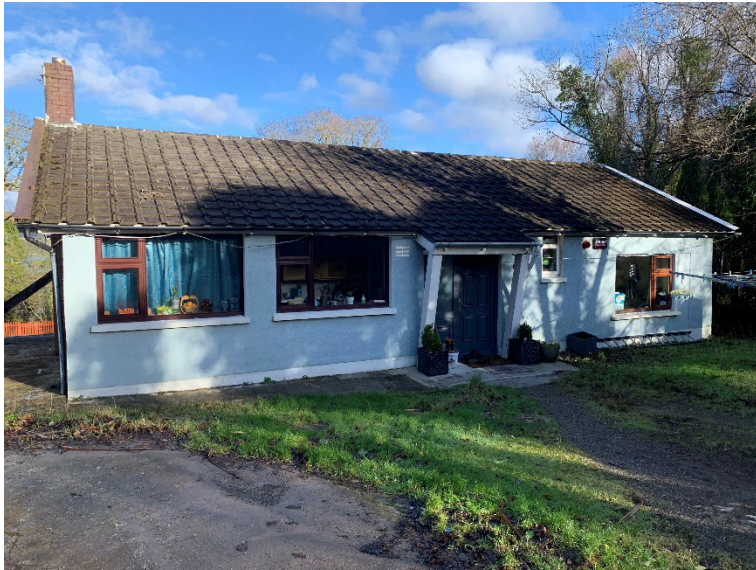
Plate 3-1: Dwelling at Killaha East

Single- storey dwelling with rendered walls and a tile roof with a single chimney on the western gable and wooden soffits to the gable ends (Plate 3-1).

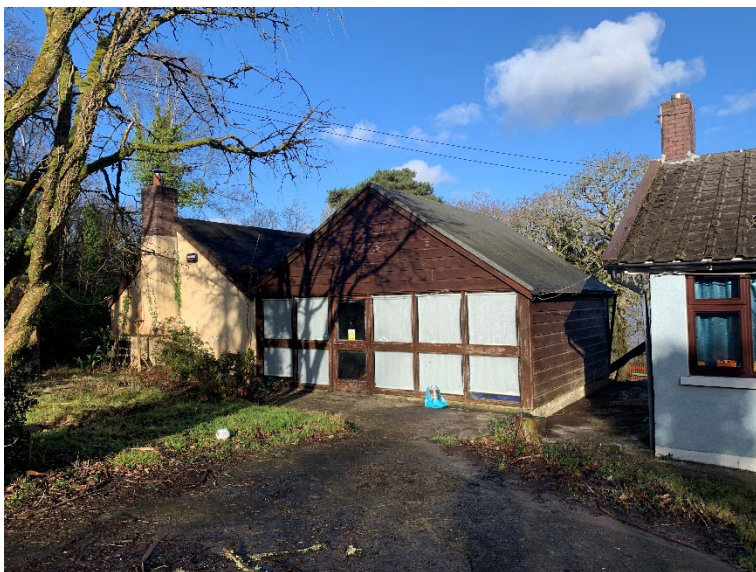
Plate 3-2: Old restaurant at Killaha East

The old restaurant is a single storey building with a double A-frame roof covered with roof felt. The walls of the easternmost room are constructed of timber and the westernmost room is constructed of block with rendered walls (Plate 3-2).

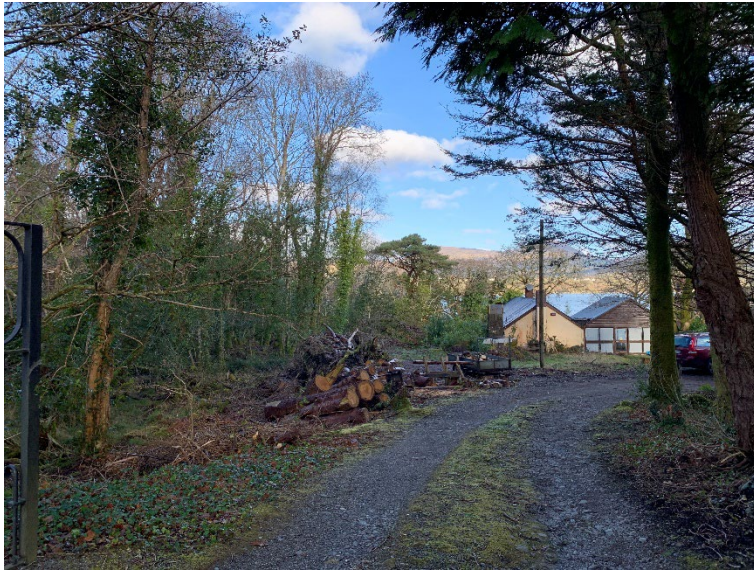
Plate 3-3: View of the buildings and mature trees from the site entrance

The grounds around the dwelling and old restaurant comprise a lawn with mature trees including Oak, Beech, Scot's Pine, Birch, Cypress and Beech with Holly and Hazel (Plate 3-3).

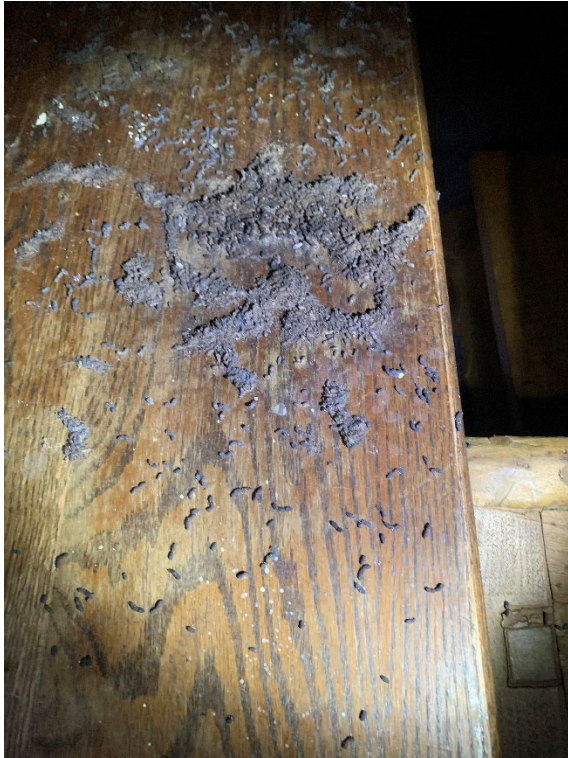
Plate 3-4: Droppings present in the old bar of the restaurant

A small pile of old droppings was present in the old bar of the restaurant; most had disintegrated but some were consistent in appearance with lesser horseshoe bat droppings (Plate 3-5). The window to the old bar is open and one of the ceiling boards is broken, which would allow access to the roof space.

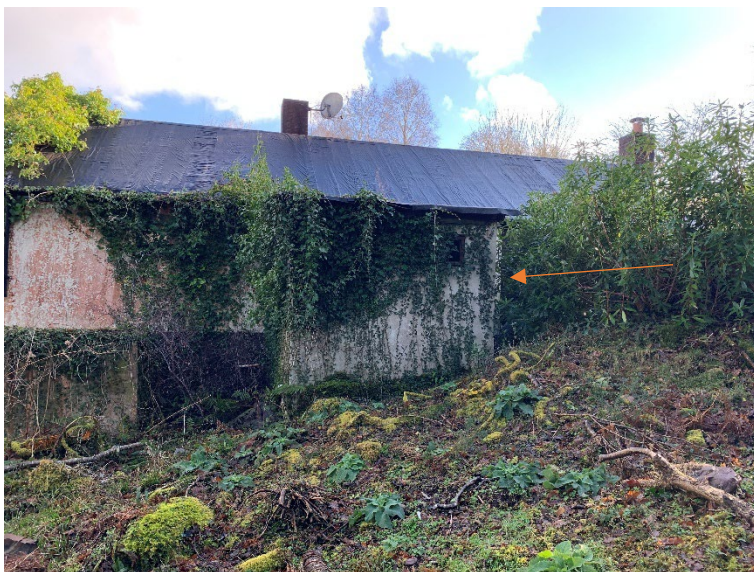
Plate 6-1: Existing outhouse to be converted into a compensatory roost

- An existing outhouse adjacent to the old restaurant (but not attached to the restaurant) shall be re-purposed to provide a compensatory roost. As such, the compensatory roost will be located as close to the existing roost as possible.

- The existing building measures 2.3m x 1.4m internal floor space, with an internal height of 2.3m from floor to the top of the wall.
- The building is constructed of block.
- Existing windows shall be boarded up leaving a gap at the top of one window to provide an opening measuring 20cm high as an entrance for the bats.
- The existing flat roof will be replaced with an A-frame roof with natural slate and 1F bituminous felt on timber joists. There will be a loft space with an open trap door measuring 50cm x 50cm to allow bats to fly up into the roof space. The roof will be at a pitch of 35° and will provide an internal height from floor to roof apex of 3.4m.
- The existing door on the southern gable end shall be kept locked.
