Otter (*Lutra lutra*) derogation licence
application for the Ardcahan Bridge, River
Bandon, Co. Cork

Prepared by Triturus Environmental Ltd. on behalf
of Cork County Council
February 2026

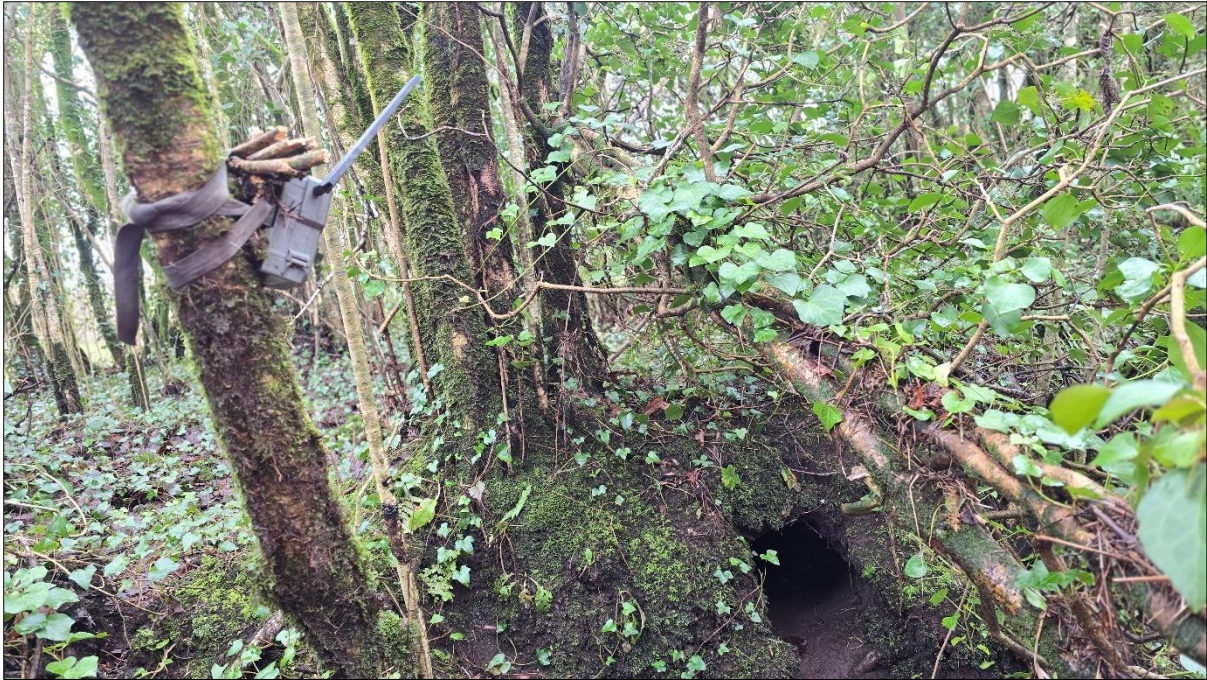
Plate 3.1 Holt H1, entrance on east bank of River Bandon with well-worn slide to river

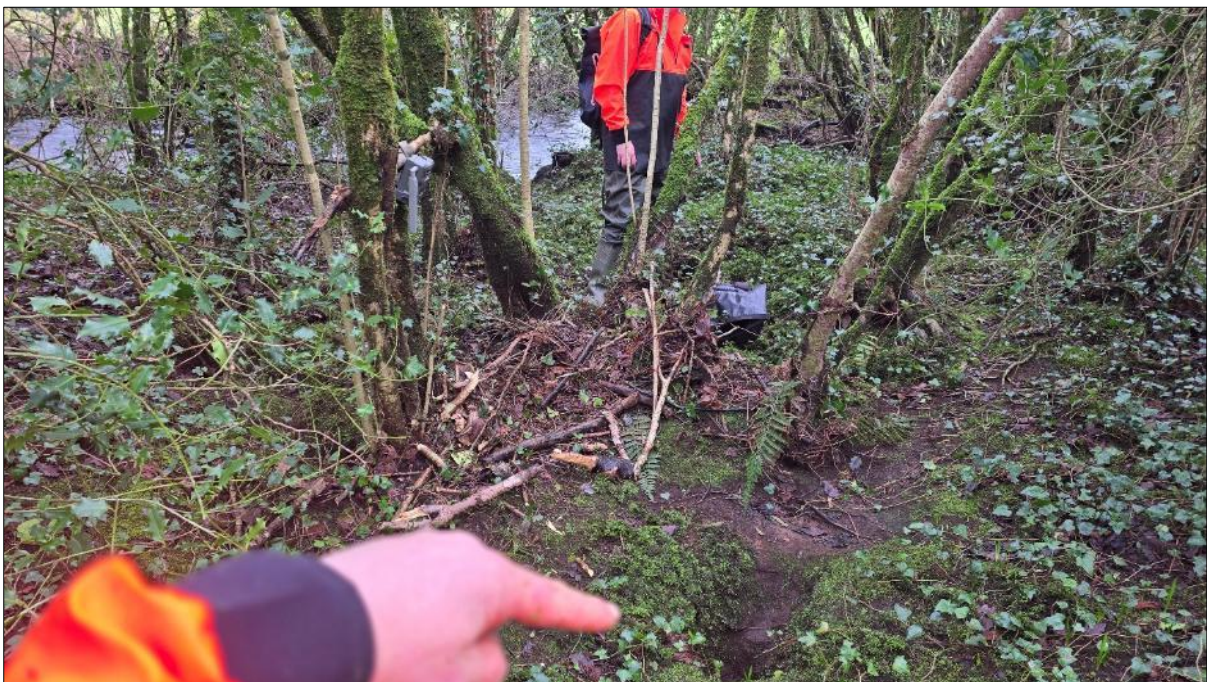
Plate 3.2 Secondary entrance of holt no. H1 (4 in total) with trail camera on well-worn trail and latrine area

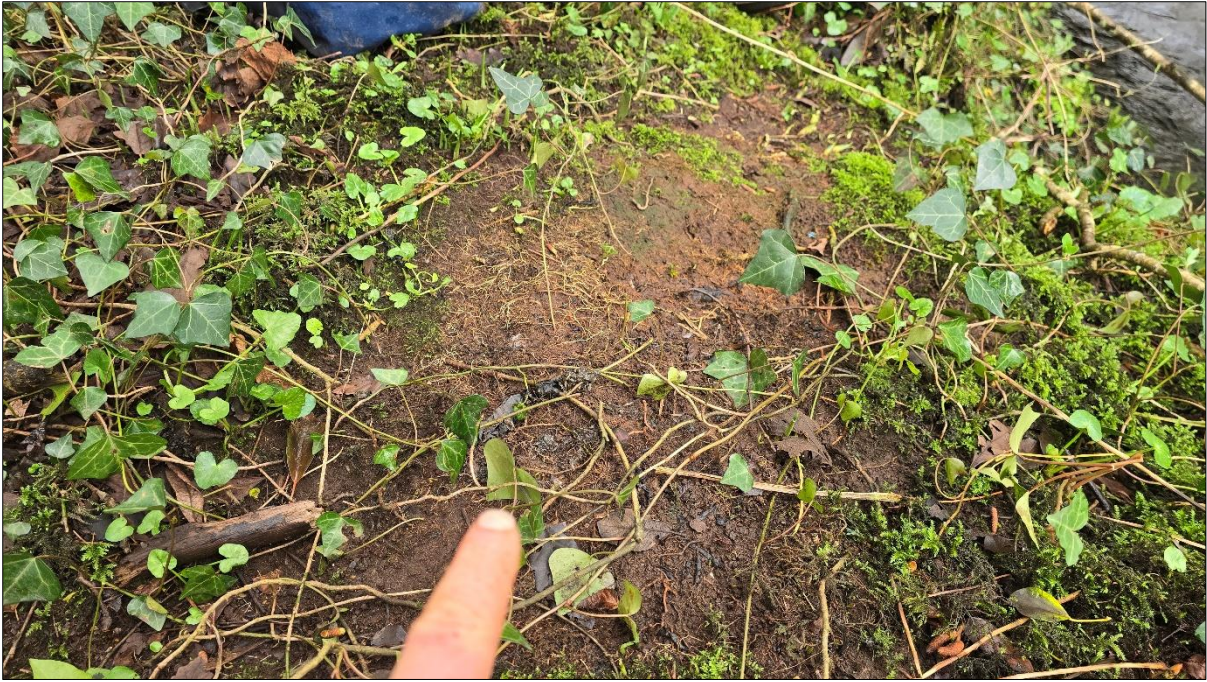
Plate 3.3 Very regular latrine site with fresh spraint on mud and 'scorched' mosses near holt no. H1

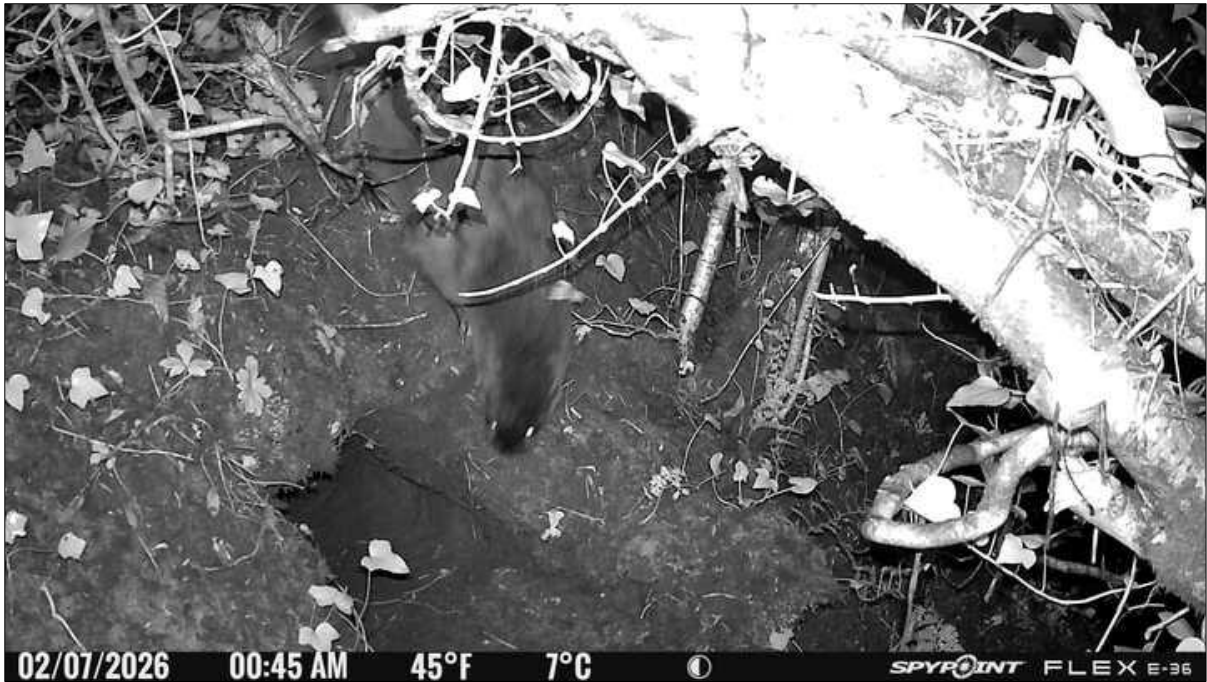
Plate 3.7 Otter entering holt H1 on the 7th February 2026, exhibiting characteristic nocturnal behaviour
