**Ecological Report to Inform an Application for Derogation
Licence
Under the European Communities (Birds and Natural
Habitats) Regulations 2011–2021 pertaining to Otter
(*Lutra lutra*)**

Requested For:	Kerry County Council
Prepared By:	Southern Scientific Services Ltd
Our Reference:	SSS-SKG-141

Report Prepared By	Monica Kane
Report Reviewed By	Tim McCarthy Colette Murray
Issue Date:	20/04/2026
Comment:	Final Report
Revision:	01

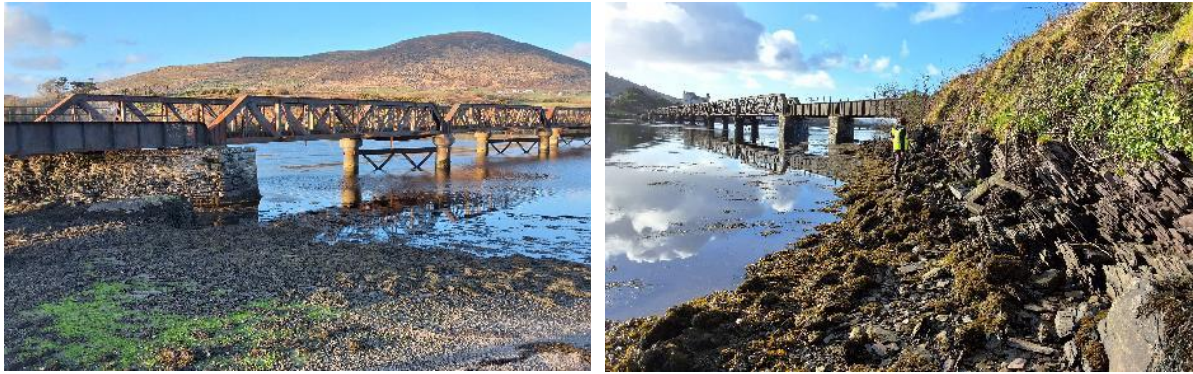
Figure 2. View of the Cahersiveen Railway Bridge from the southern shore at Cahersiveen town park (L) and from the northern shore (R)

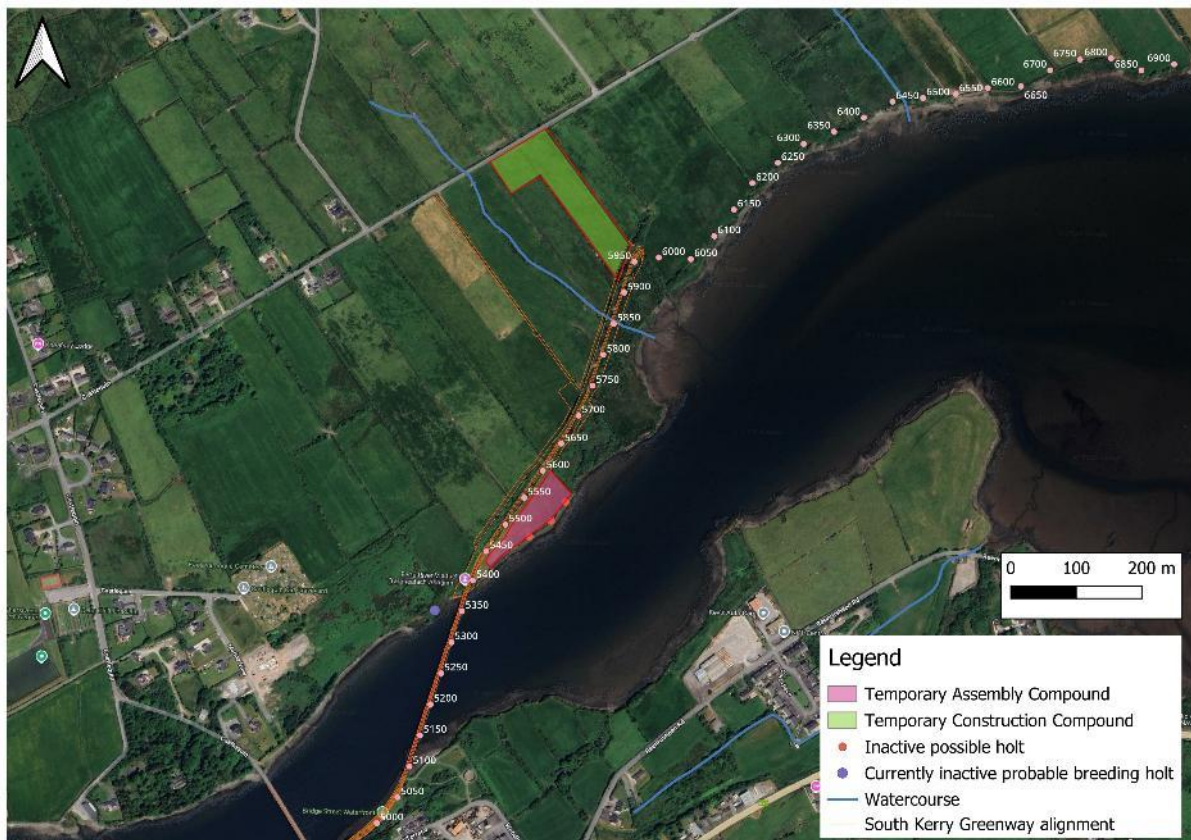
The works to be covered by a derogation comprise the construction of a greenway on the old railway line along the northern shore of Valentia estuary across the Cahersiveen Railway Bridge and into Cahersiveen town park on the southern side. The greenway works were permitted following the submission of a planning application (Planning ref. ABP-302450-18). Two proposed temporary construction compounds adjacent to the project will also be required to facilitate the works. One confirmed, and three potential, Otter holts have been recorded during pre-construction surveys in the vicinity of the old railway bridge. All holts are currently inactive. While the Otter holts lie outside of the planning and construction boundaries, potential indirect disturbance to Otter during construction may occur arising from noise emissions and the physical presence of machinery and workers, and for that reason a derogation licence is being sought to temporarily block up the holts, all of which are currently inactive. An artificial holt will be provided as mitigation.

Figure 3. Greenway route, site compounds and Otter holt locations

Initially, the works will involve the construction of two temporary site compounds located adjacent to the greenway route. Refer to Figure 3. The larger main compound, the temporary construction compound, will be situated in agricultural land located between the greenway and the local road to the north and will be used for construction of the greenway. A smaller compound and laydown area, the temporary assembly compound, situated in an agricultural field next to the old Cahersiveen Railway Bridge will be used for the bridge repair works and the assembly and installation of pre-fabricated truss sections. Compound preparation will involve the clearance of agricultural grassland vegetation and topsoil followed by the laying of hardcore material (crushed stone) over the soil, and erecting boundary hoarding/fencing. Welfare cabins, tool stores, waste storage, compressors, generators, etc, will be provided in compounds. Site access to the bridge will be through the temporary construction compound via the local road and along the greenway. Excavated soil and a portion of grassland vegetation will be retained on site to form vegetated earthen bunds; the soil will be used for site reinstatement back to agricultural grassland once construction is complete.

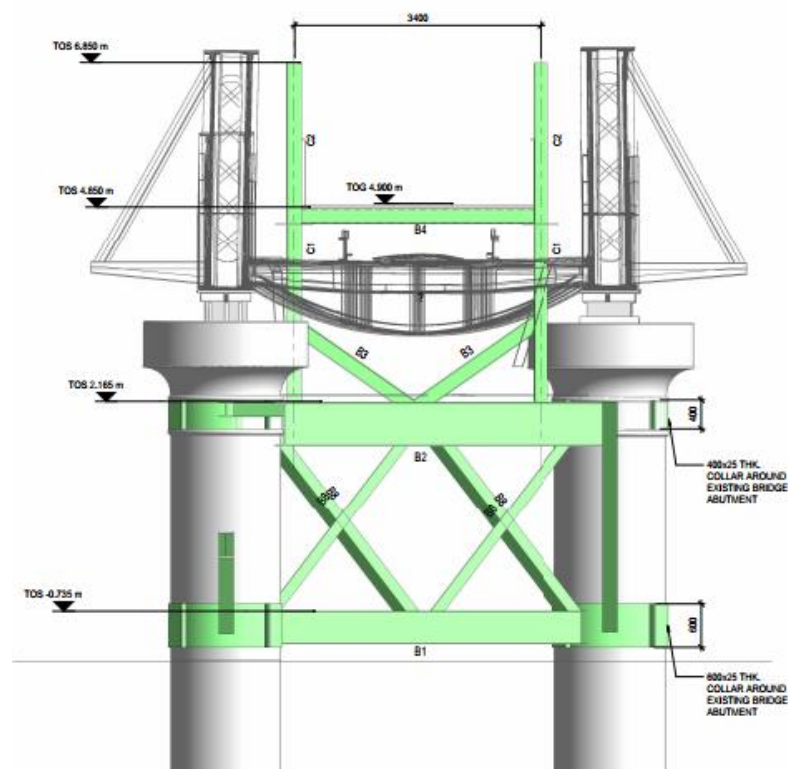
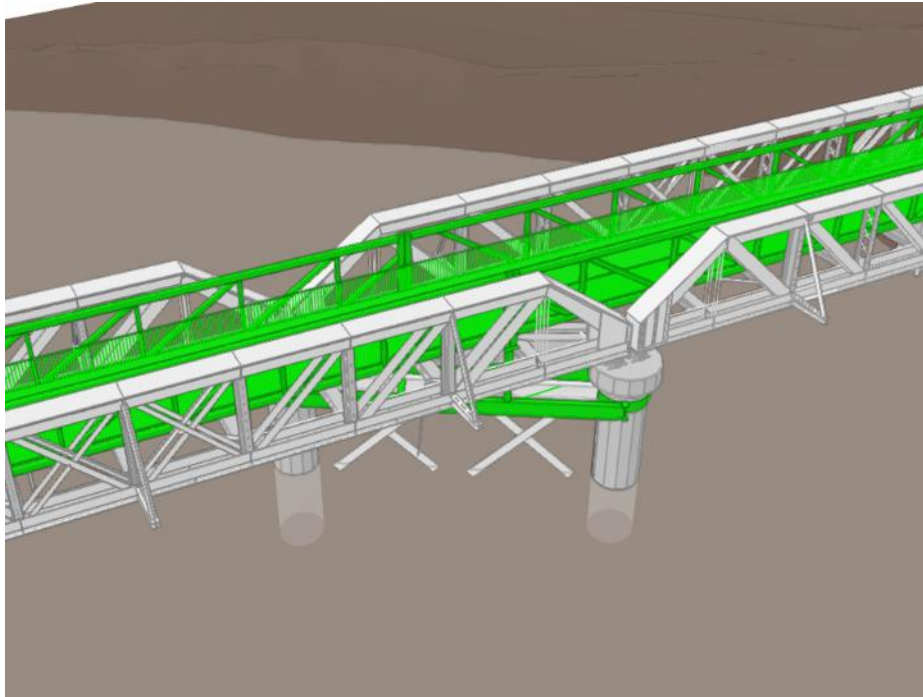
Figure 4. New Truss Typical Section & 3D Model View

Once the remedial work is complete, a new support structure independent of the existing superstructure will be installed at each pair of piers. This support structure replaces the existing cross bracing between sets of piers and is connected at existing fixing points. See typical section and preliminary 3D model view below.

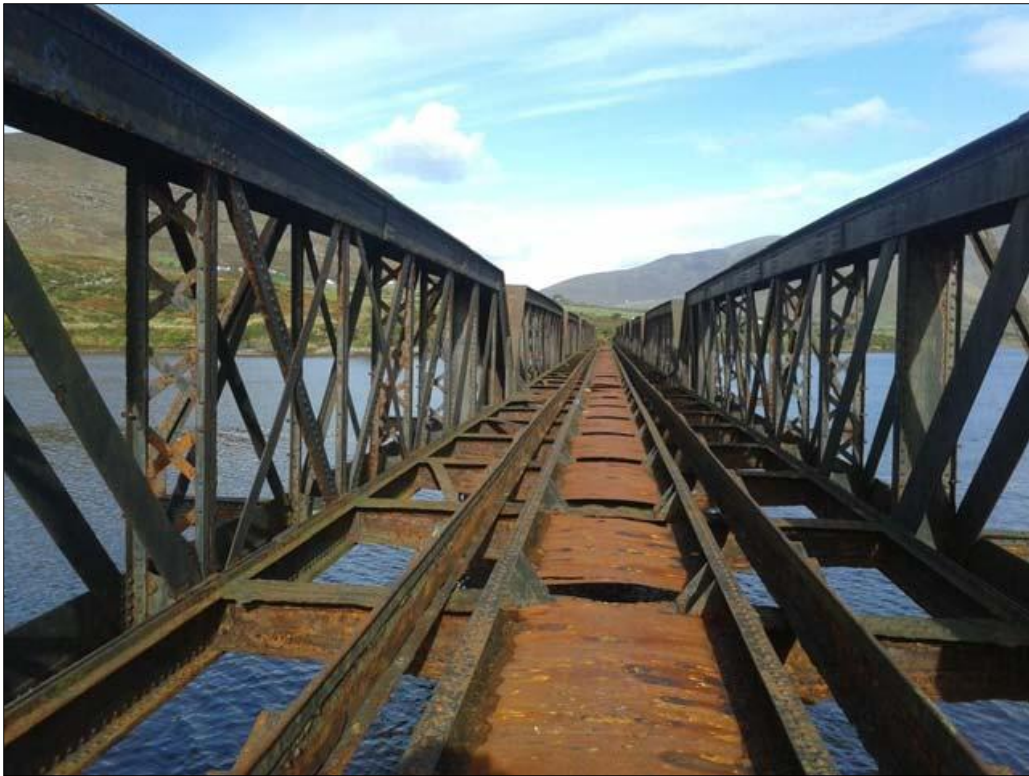
Once the new supports are in place, articulated trucks will deliver the 15m steel truss sections (straight pieces of metal set into a series of triangles in a single plain). Two 15m sections are paired and joined on a dedicated assembly bed aligned with the bridge geometry. The bed is a level, engineered platform with space for MEWPs (mobile elevating work platform), survey equipment, and bolting teams. Pneumatic torque tools and impact wrenches are used for bolted splices, supported by compressors located nearby. Localised welding may occur, requiring hot work controls and fume management. Once assembled, the 30m segment will be lifted into position onto rollers using a large mobile crane and jacked (pushed) onto the existing railway bridge. The crane slews the segment onto temporary bearings or rollers at the jacking front. The jacking front is the operational hub where the assembled truss is connected and pushed forward onto the bridge.

Figure 5. Pre-fabricated steel truss sections will be installed within the existing railway bridge structure

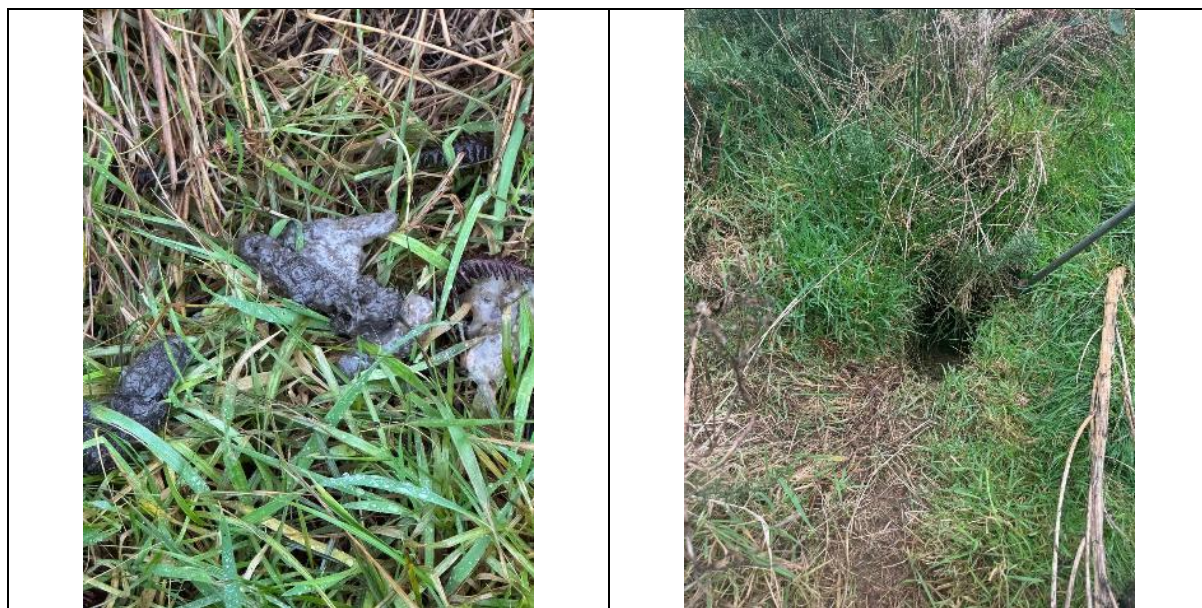
A previously unrecorded underground active Otter holt was found close to the shore during pre-construction surveys in the vicinity of the Cahersiveen Railway Bridge in late 2024. The new holt lies approximately 5m from the coastline in grassland and scrubby habitat and 30m from the bridge and lies outside of the footprint of the SKG project. A camera trap placed near the holt captured an Otter regularly emerging from the holt and gathering up bedding before re-entering the holt in December 2024. Two Otter were captured leaving the holt indicating the possibility that the holt was used for breeding. The holt entrance and path to the shore were well worn (see Figure 6). Refer to 'Currently inactive probably breeding holt' point location in Figure 7, below.

Figure 6. Otter spraint in vicinity of holt (L) and Otter holt entrance (R) photographed in December 2024

A second visit a year later in December 2025 showed the entrance and path to the underground holt was well vegetated appearing to be inactive though a jelly discharge was recorded nearby. A camera trap was installed in January 2026 with a second placed in the area in March 2026, and though an Otter was captured passing the holt on one occasion, the holt has been inactive since. These cameras are checked weekly with the most recent check on 15th April 2026.

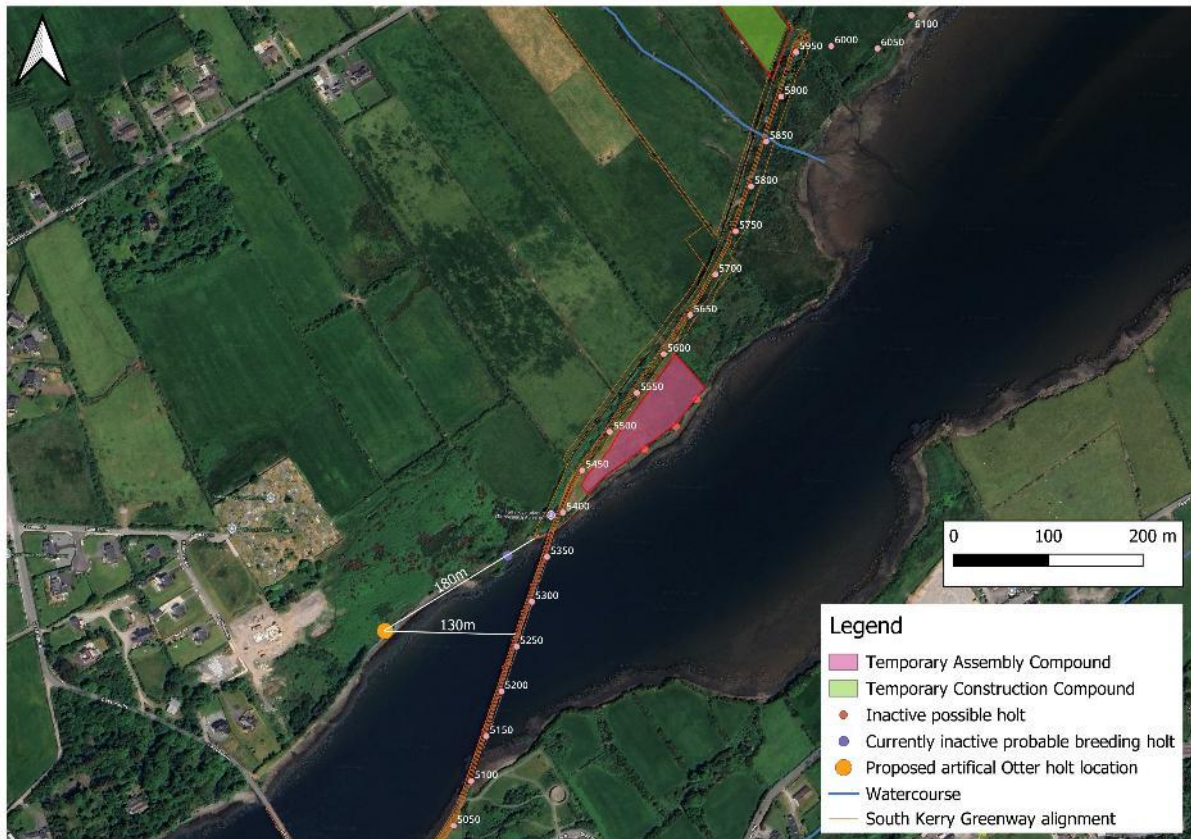
The artificial Otter holt will be located approximately 150m further southwest of the probable breeding holt in similar habitat, rank grassland with Gorse scrub. It is located 130m west of the bridge works area, 180m southwest of the northern bridge abutment works area, and 100m northeast of a coastal public walkway on the north shore (see Figure 8). Like the holt it is temporarily replacing, it will be located close to the coastline in a field that does not appear to have been used for agriculture for several decades. The field is large extending from the coast up to a graveyard to the north, and a new house to the northwest-west. The field is not open or easily accessible to the public, nor used for agriculture so provides a secure location. It supports areas of bracken, Willow and gorse scrub and rank grassland.

Figure 8. Location of artificial Otter holt

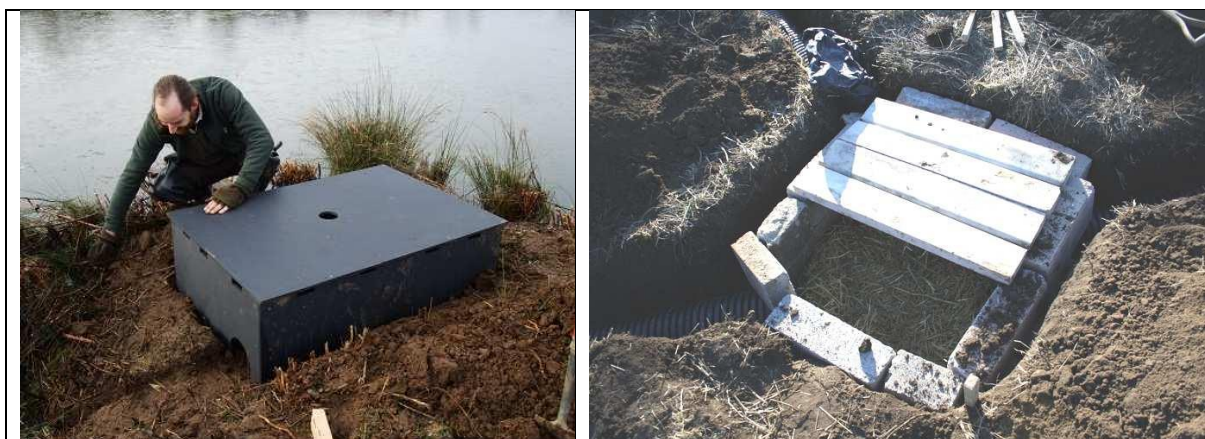
The underground holt will either be made *in situ* by hand or will consist of a pre fabricated recycled plastic holt. The holt will be dug into the ground by hand ground and its roof covered over with soil to a depth of 15cm. The soil will be turfed or seeded. The recycled plastic holt may be partially buried, depending on design. For a constructed holt, breeze blocks or unmortared bricks and paving stones will be used for the walls and roof of the chamber. A recycled plastic holt will come flat packed and will be assembled on site. No machinery will be used; all transport of materials and work will be done by hand.

Figure 9. Recycled plastic chamber (L). Constructed chamber with breeze blocks (R). Source: Skinner et al., 2014.

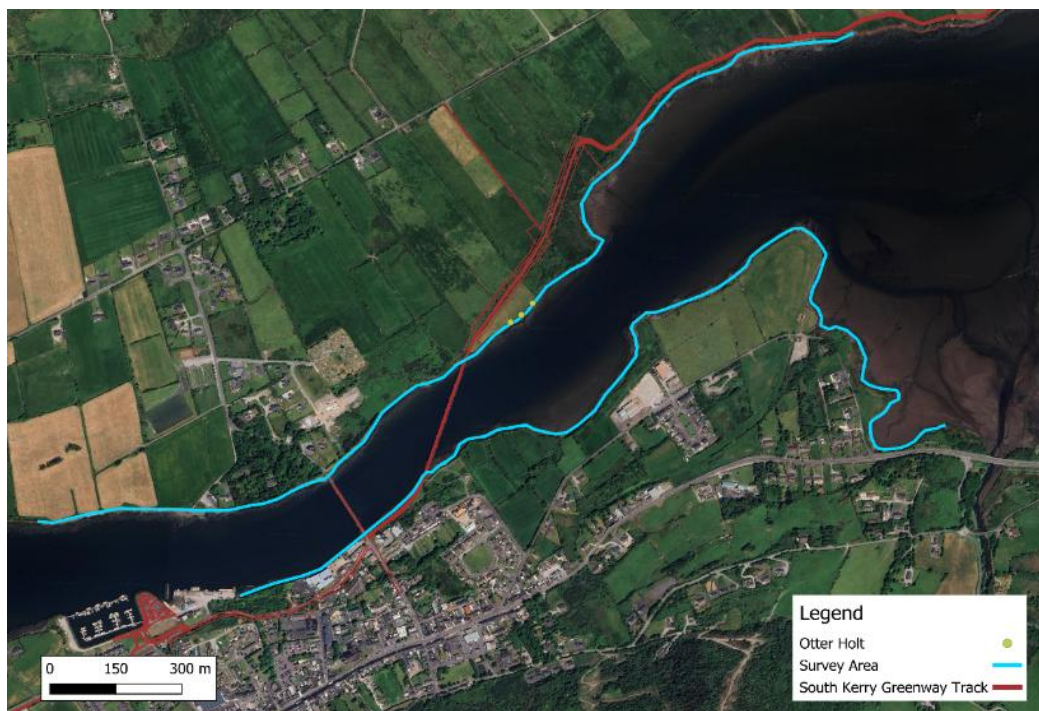
Figure 1. Scope of survey area (blue) along north and south coast of Valentia River estuary

On February 18th 2026, ecologists with SSSL carried out a walkover survey of the coastline to identify potential Otter holts (see Figure 1). Any observed potential holts or evidence of Otters was recorded and its location mapped. Most of the shoreline was accessible on foot apart from the area around Cahersiveen quays. The survey focus was around identifying possible holts along the upper shoreline and not the terrestrial habitat above or beyond this area, nor was it an exhaustive search for Otter signs (tracks, spraints, prey remains).

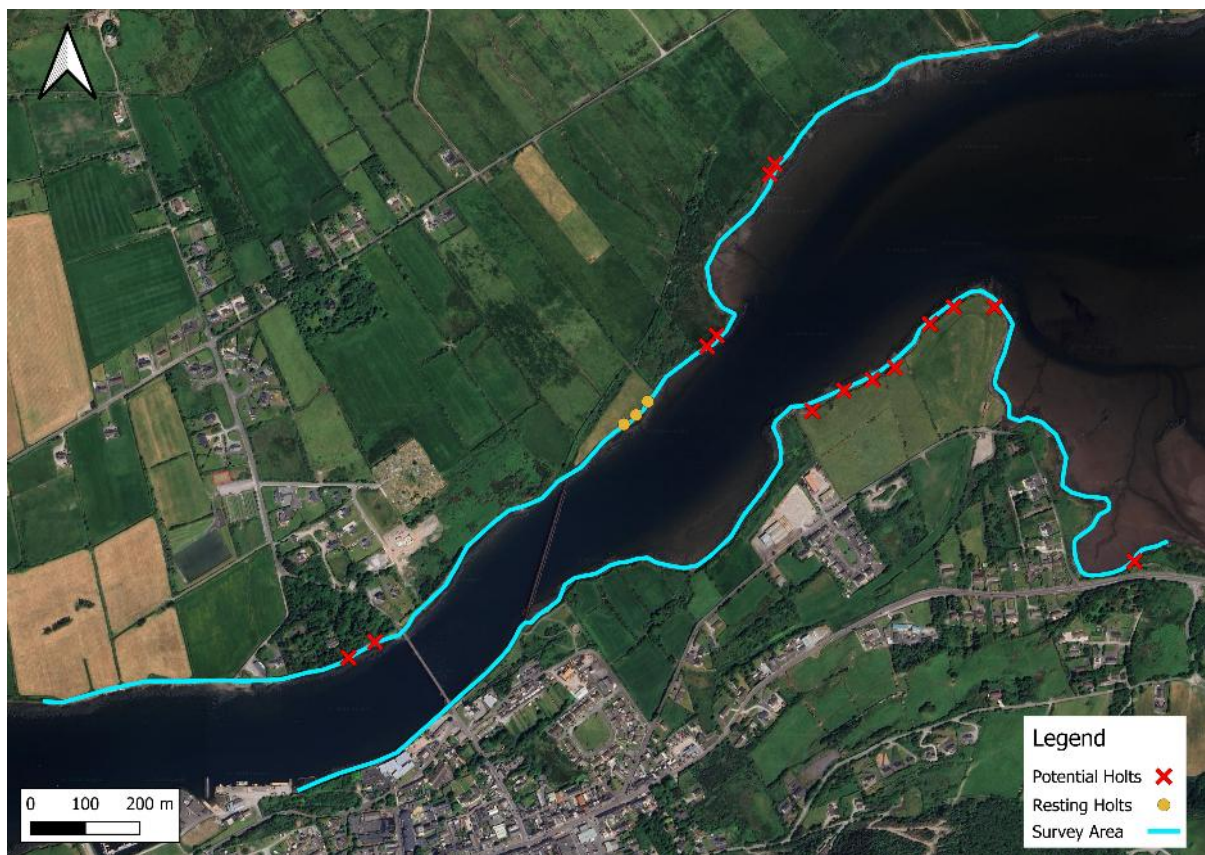
A number of potential holts were identified along the north and south coastline. A total of 8 possible otter holts were identified along the southern coast, while 7 potential holts were identified along the northern coast (see Figure 2 below). Potential holts were identified primarily in areas of soft coast, with a limited number present in areas of rocky shore. Along with potential holts, a number of areas were identified where future holts are likely to occur given coastal erosion. In addition to this, a number of streams leading into the estuary were identified, with mammal tracks present leading up and around the banks of these streams. While detailed survey of these streams was not possible given obstructions such as barbed wire and dense scrub, there is potential for further suitable otter holt habitat present along these streams.

Figure 2. Survey area with previously identified holts (Yellow) and potential holts identified during the survey (Red)
