# Otter Derogation Licence Application Supporting Document

Waterfront, Carcur, Park, Wexford

May 2026

Deborah D'Arcy Ecologist

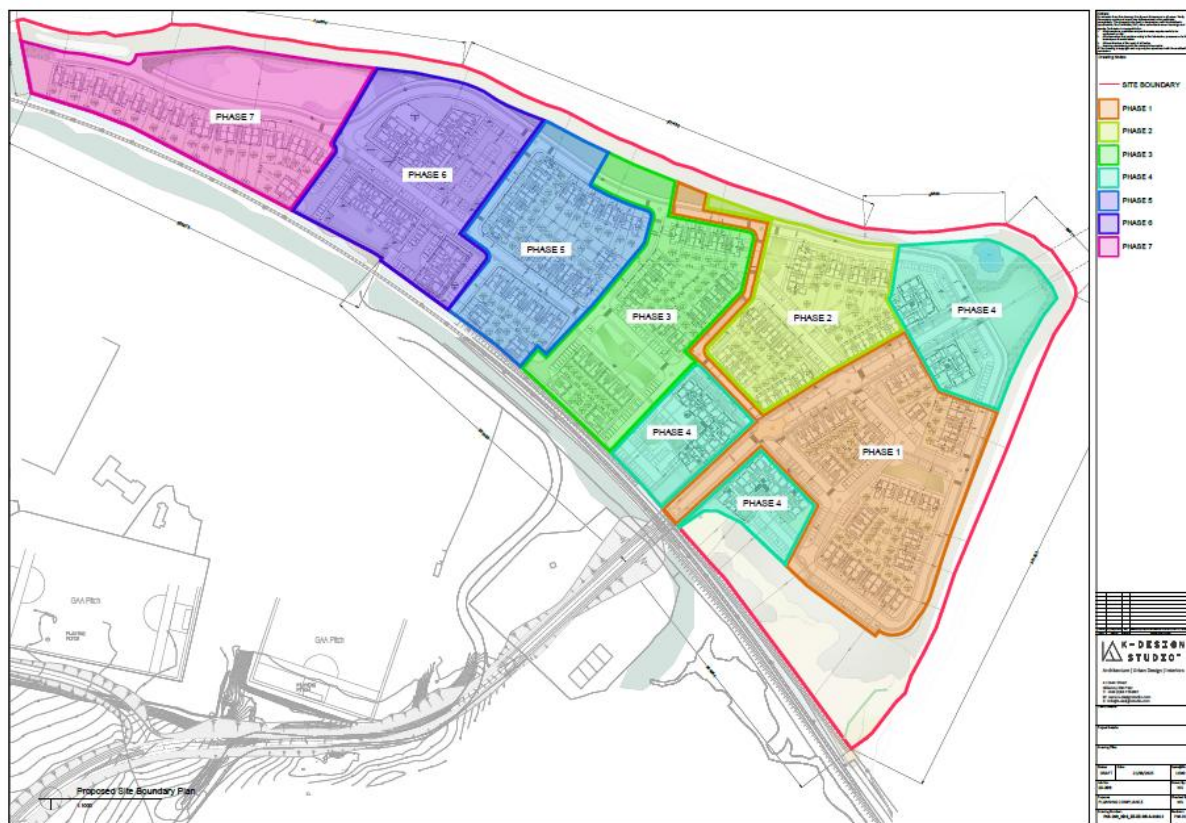
Figure 3-2 Site Layout

**The development for which this derogation is sought pertains only to Phase 1 and Phase 2 of the residential development granted permission in 2020, construction of the associated road access and boundary wall through Phase 4 area and construction of the pond in north east corner. The Phase 1 and Phase 2 and Phase 4 construction areas are shown in Figure 3-2.**

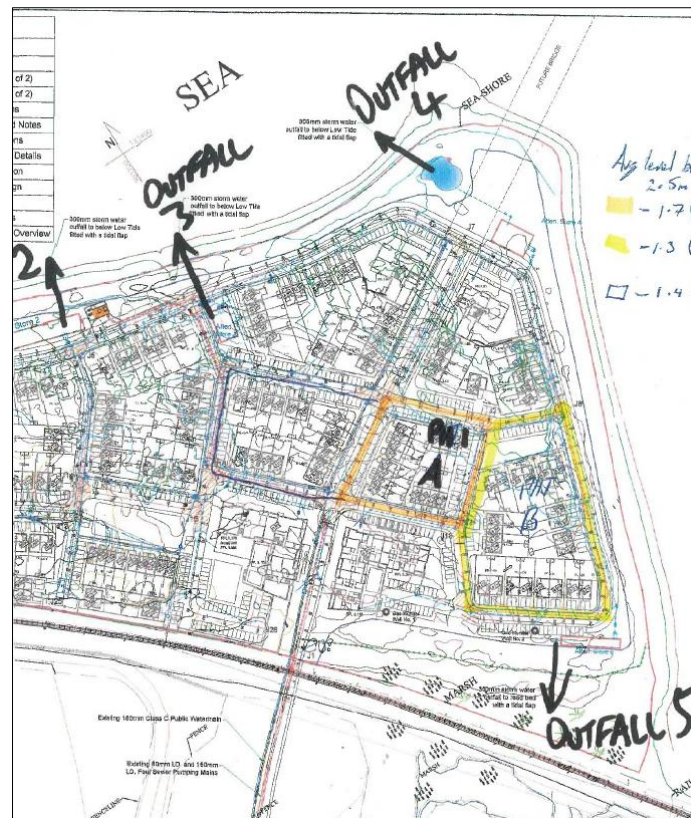
Figure 4-1 Location of Outfalls (William Neville & Sons, November 2025)

- Each attenuation store is preceded by an oil interceptor and a silt trap as indicated on the layout plans. These proposals are set out in Engineering Drawings included in **Appendix A**.

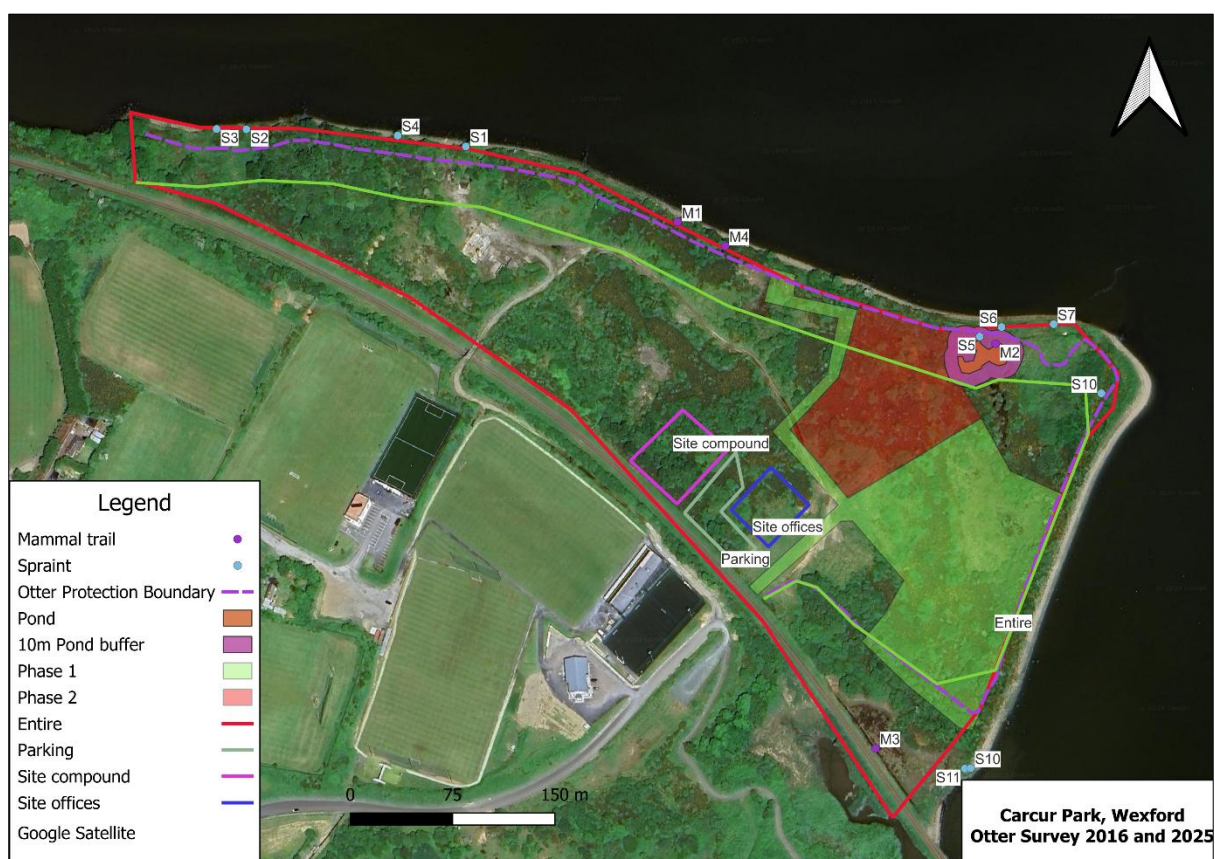
Figure 5-1 Spraint and Mammal trail records in 2025

The main spraint hotspots were located along the shoreline, shown in Figure 5-1, at:

- i. the northwest near the intermittently active holt,
- ii. the northeast near the pond,
- iii. the northeastern point of the site,
- iv. The southeast near the reedbed.
