TII, RSI Review, Unresolved Design Issues

ROUTE: N71

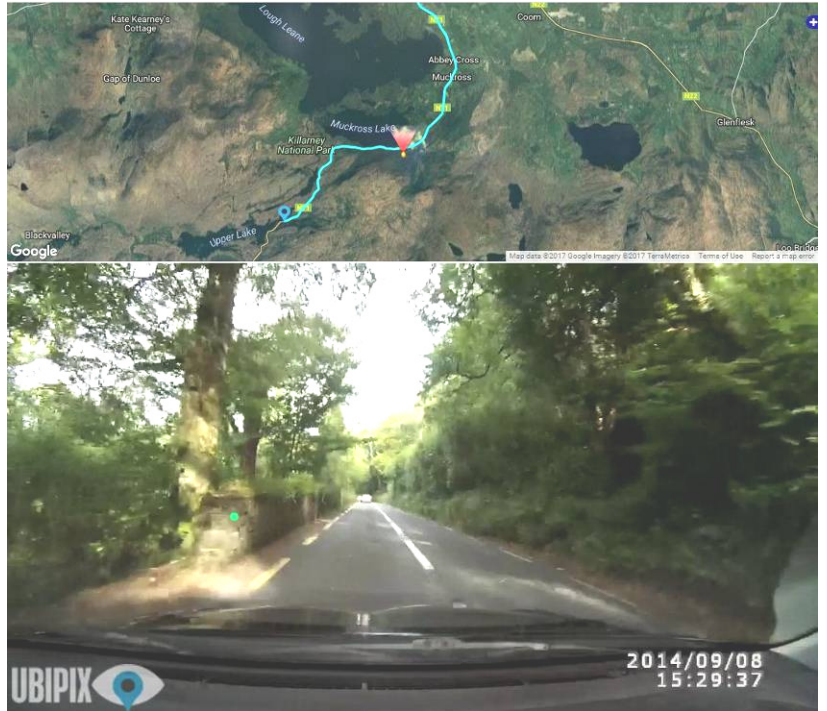
Ubipix Tag ID: 1082

Problem Category: Roadside_hazard

Risk of collision with inconspicuous boundary wall.

Severity: M

Likelihood: U

Risk Rating: L

Broad Solution: Signage

Reflective paint / signage should be applied / erected to the parapet wall, so that it is visible to oncoming traffic.

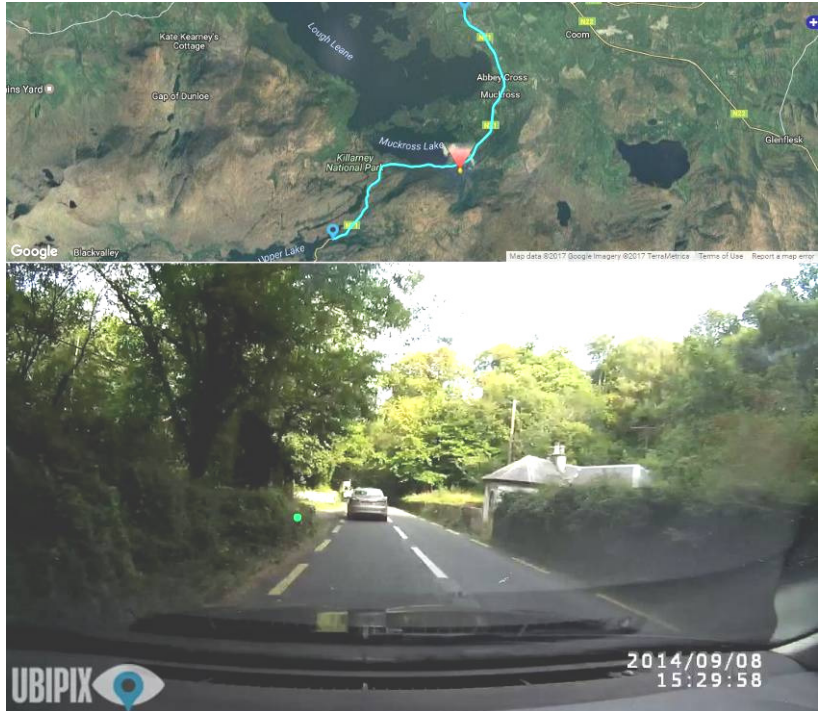
Ubipix Tag ID: 600

Problem Category: Roadside_hazard

Risk of collision with inconspicuous roadside wall. Particular risk at night.

Severity: S

Likelihood: U

Risk Rating: M

Broad Solution: Signage

Reflective chevrons should be applied to the wall.
