Torc-Dinis proposed cyclepath (Planning ref. 321908-25)

Art. 54 derogation licence application

Report on alternatives

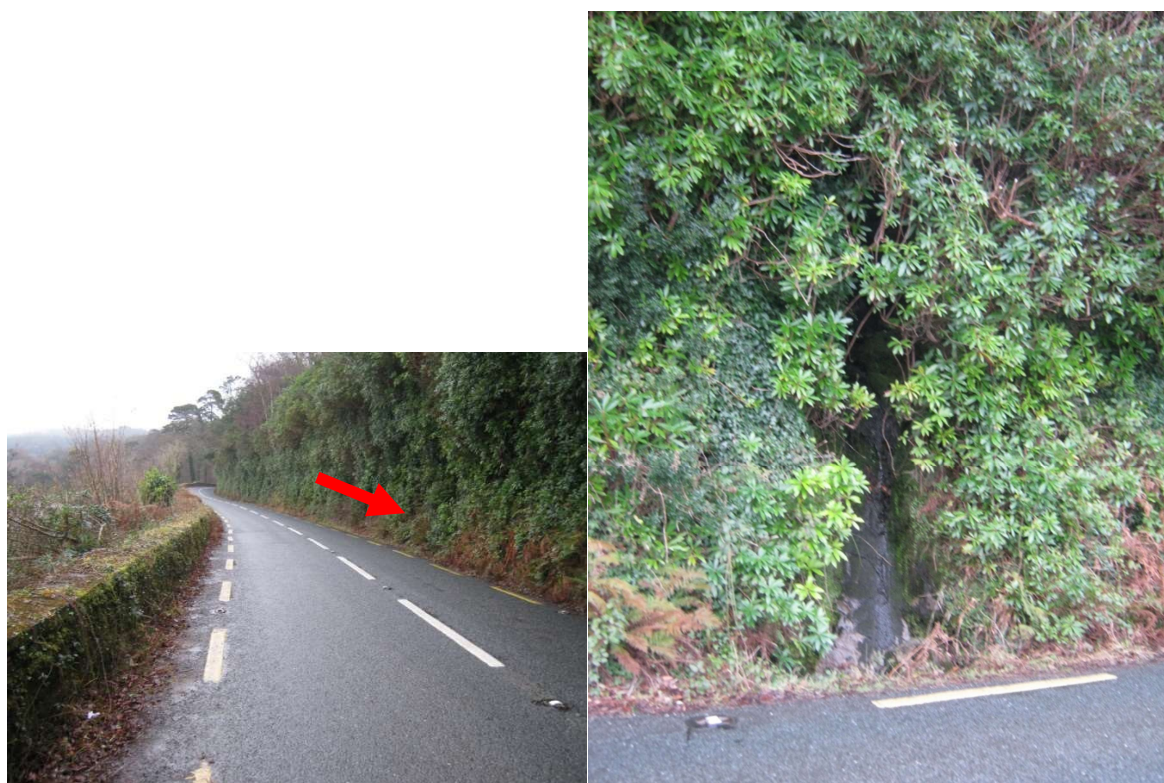
Fig. 4. Location of small waterfall (red arrow) relative to on-coming traffic from west (NPWS, 8 iii 23). The rock-face is 2.5-3m high, after which there is a step back of c.1.2m to another rock-slope (hidden by rhododendron).

There were three reasons for not preferring this alternative. The first reason was the presence of Flora Protection Order bryophytes in a small waterfall (Fig. 4) along the upper (southern) side of the road³. The second was the fact that Torc Mountain rose steeply on this side of the road, with up to 5m high areas of rock directly above the road. This would have required significant rock-breaking and probable benching further back into the remnant woodland. This would have been both costly and result in a loss of some characteristic mature oak woodland trees (sessile oak, holly, birch, yew).

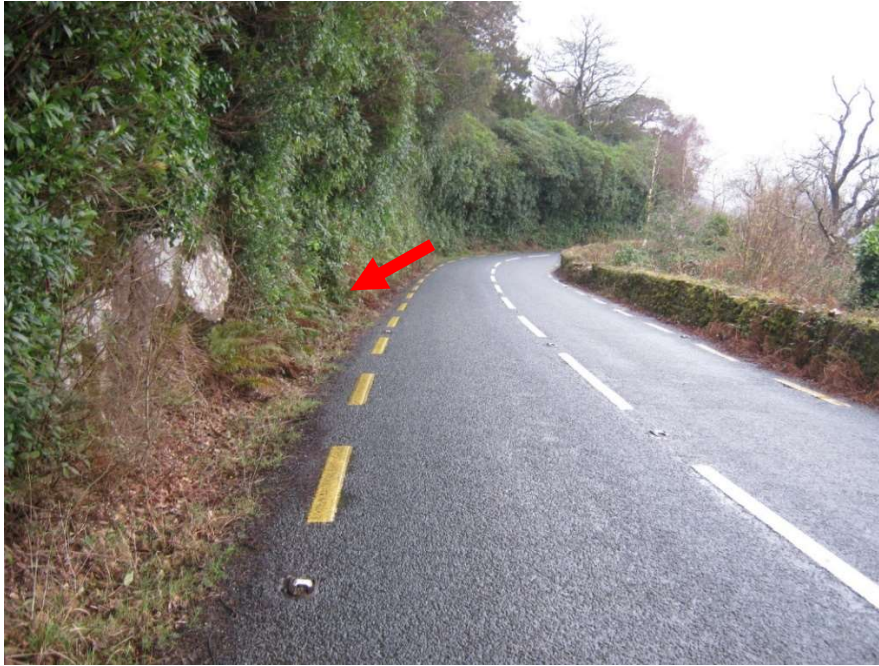
Fig. 5. Location of small waterfall (red arrow) and bend towards east (NPWS, 8 iii 23).

This alternative would use the proposed raised boardwalk along the first (eastern) section of road, avoiding the small waterfall of bryological conservation importance, but at, and after, the bend after this (see Fig. 5) the road would be widened on the Torc mountain side. However, even though the rock slope is lower here than it the avoided section, a considerable amount of rock removal probably requiring benching up into the wooded slope would be required. For this reason, this alternative was rejected.
