Cistern House Extension and Walled Garden

Ward River Regional Park, Brackenstown, Swords, Co. Dublin

Bat Survey

25th September 2025

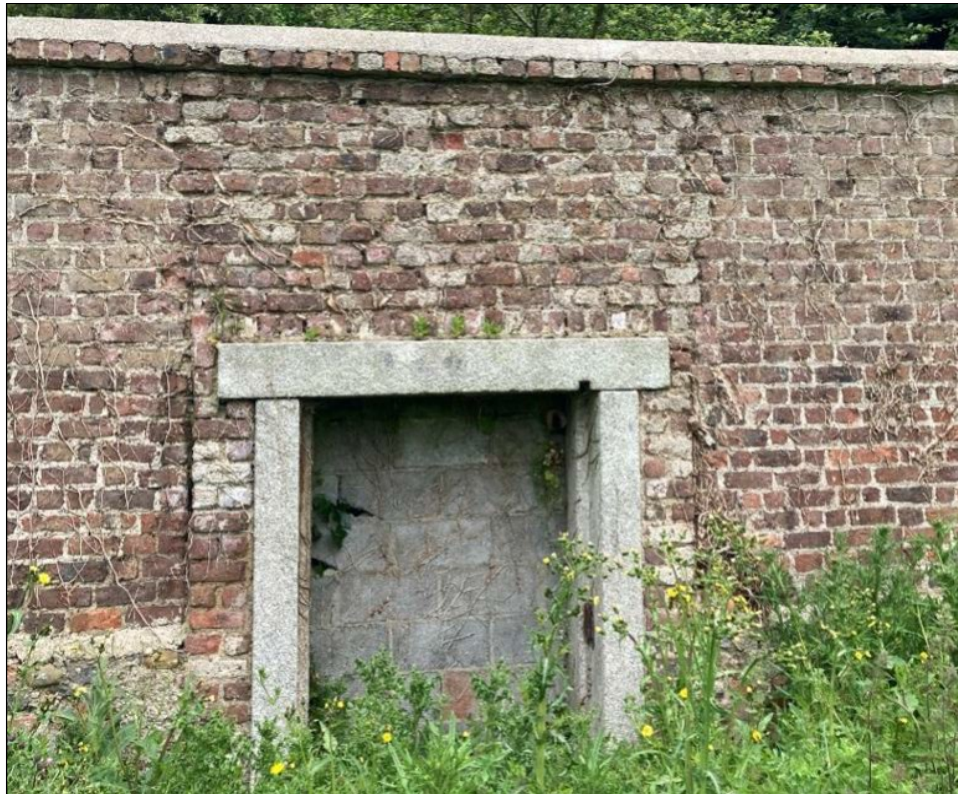
Plate 1. Vertical joint lines at midpoint of Eastern wall.

The walls present as structurally stable overall with localised evidence of cracking, weathering and decay due to extensive ivy/vine covering and vegetation growth.

- Filling and injection of cracks in walls using a lime-based mortar
- Replacement of the top course and coping of the entire perimeter of the walled garden walls
- Repointing of brick work using a lime-based mortar
- Removal of isolated instances of brick damage/decay and replacement with undamaged bricks

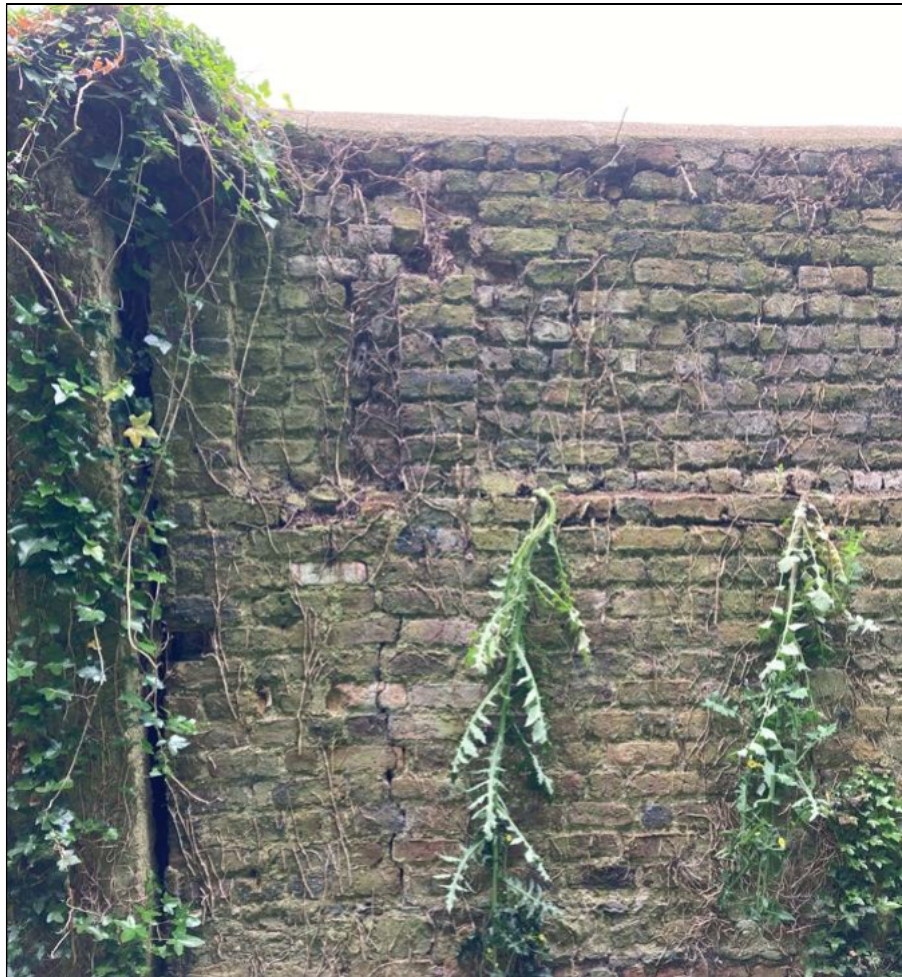
Plate 4. Crack in south-east corner.

The Southern Walled Garden measures approximately 34.25m x 86.55m, with a natural ground (garden) area of approximately 2917.37m². The walls present as structurally adequate, apart from the Eastern wall and South-Eastern corner. The Western boundary has been rebuilt with more modern concrete blocks and steel fencing. The Southern wall is missing varying numbers of top masonry courses. There is localised evidence of cracking, weathering and decay due to extensive ivy/vine covering and vegetation growth. The walls are constructed as random rubble, laid to course at instances and extended and infilled with brick constructed in English Garden Wall bond.

- Rebuilding of the southern block wall as English wall bonded brick
- Potential for rebuilding of the entire Southern boundary wall

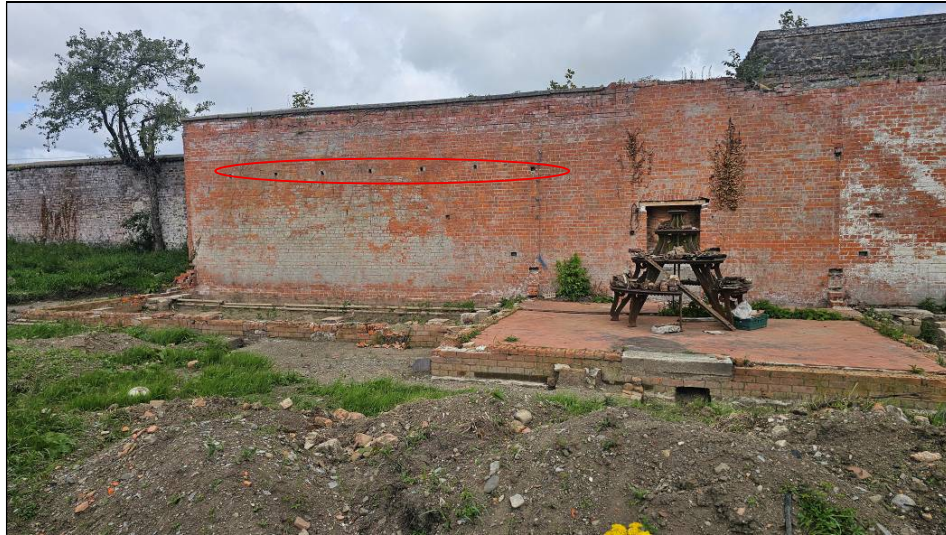
Plate 11. Potential roosting locations in the Walled Garden walls to be retained.

No bats were recorded roosting within the Northern and Southern Garden Boundary Walls, however a number of suitable crevices and holes were identified, which could be retained without compromising the structural integrity or fabric of the wall. The wall offers good hibernation potential for roosting bats and may also be used during the summer months by small numbers of bats.

A number of features in the boundary walls of the walled garden have been identified as having roosting potential for bats. These are primarily located on the northern wall of the northern walled garden. Where possible these will be retained or rebuilt under the supervision of a suitably qualified ecologist.

These areas will be inspected by a suitably qualified bat specialist and features identified as having roosting potential for bats will be marked up for retention.

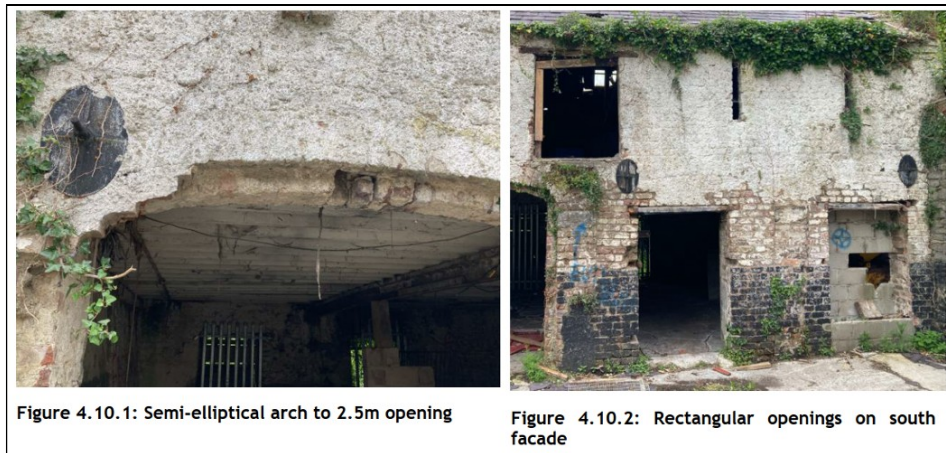
Figure 24. The southern side of the Cistern House Extension.

Figure 4.10.1: Semi-elliptical arch to 2.5m opening

Figure 4.10.2: Rectangular openings on south facade

- Rebuilding of the semi-elliptical arch to the 2.5m wide opening
- Timber lintels over windows are to be replaced like-for-like
- Removal and replacement of steel beam after adequate propping of the existing timber floor joists
- Replacement of existing floor joists and floorboards
- The parrass plates and tie rods should be preserved and protected during any maintenance or restoration works. They should be checked and tightened on completion of works
- Once safe access is possible the timber rafters will be more closely inspected and the stone slates and ridge caps will be removed to replace the battens and any identified damaged rafters.

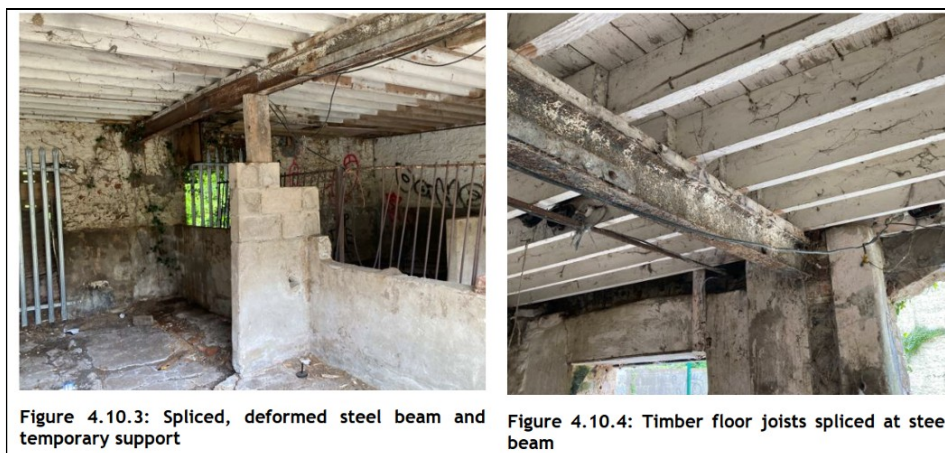
Figure 25. Lower floor of the Cistern House Extension.

The ground floor of the Cistern House Extension was accessed on the 5th August 2025 and the surfaces searched for evidence of roosting bats in the form of droppings, etc. The upper part of the building was viewed from below but could not be safely inspected.
