Reference: 1931-GRAS-XX-XX-RP-A-000002

Bat Derogation License Report

Gartan Lodge is a late 19th century house situated in Carrowtrasna Lower, near to Letterkenny, Co. Donegal.

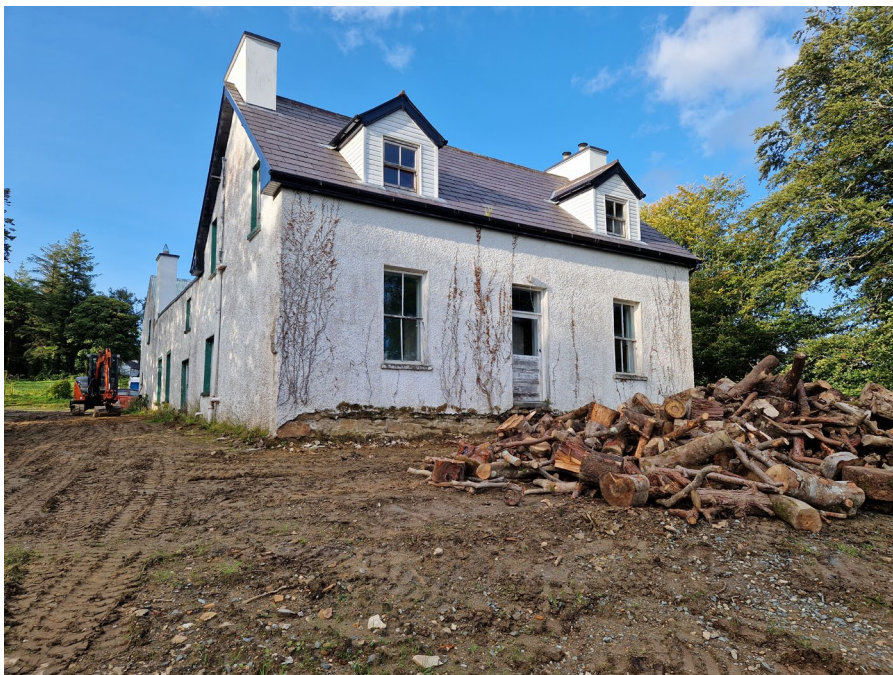
House – View from South

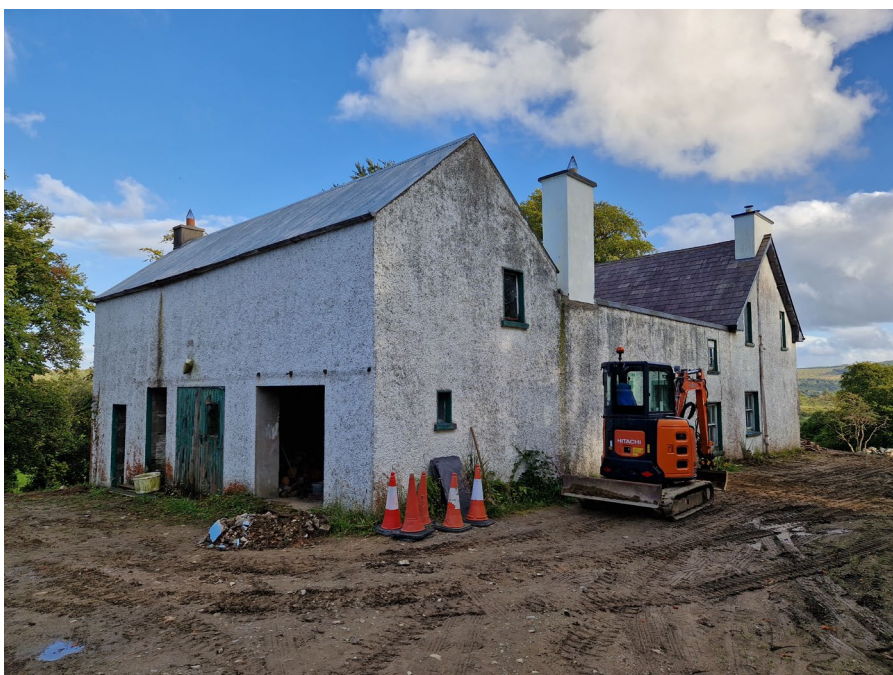
Storage building/North Wing – View from North

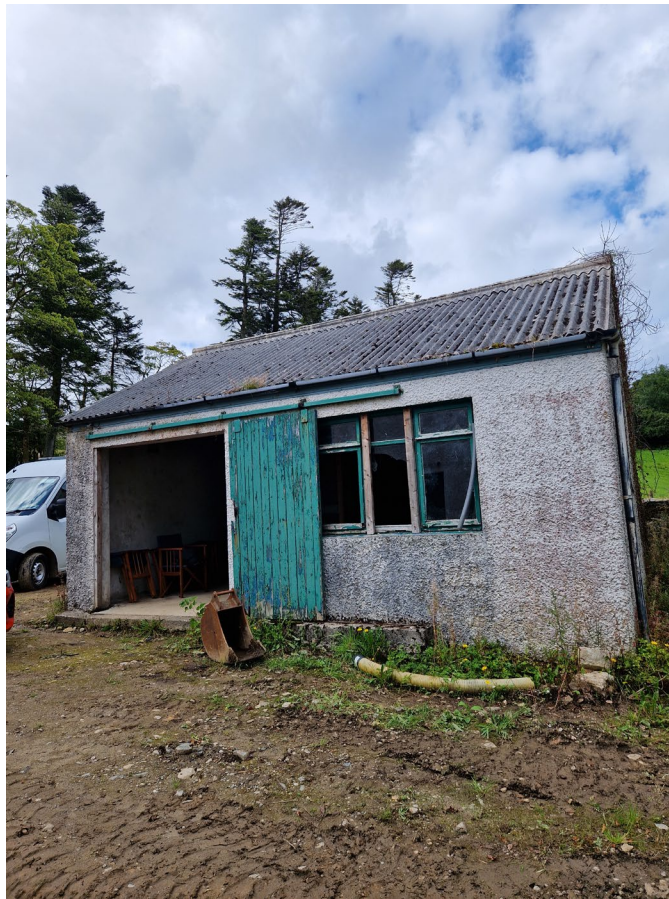
Shed

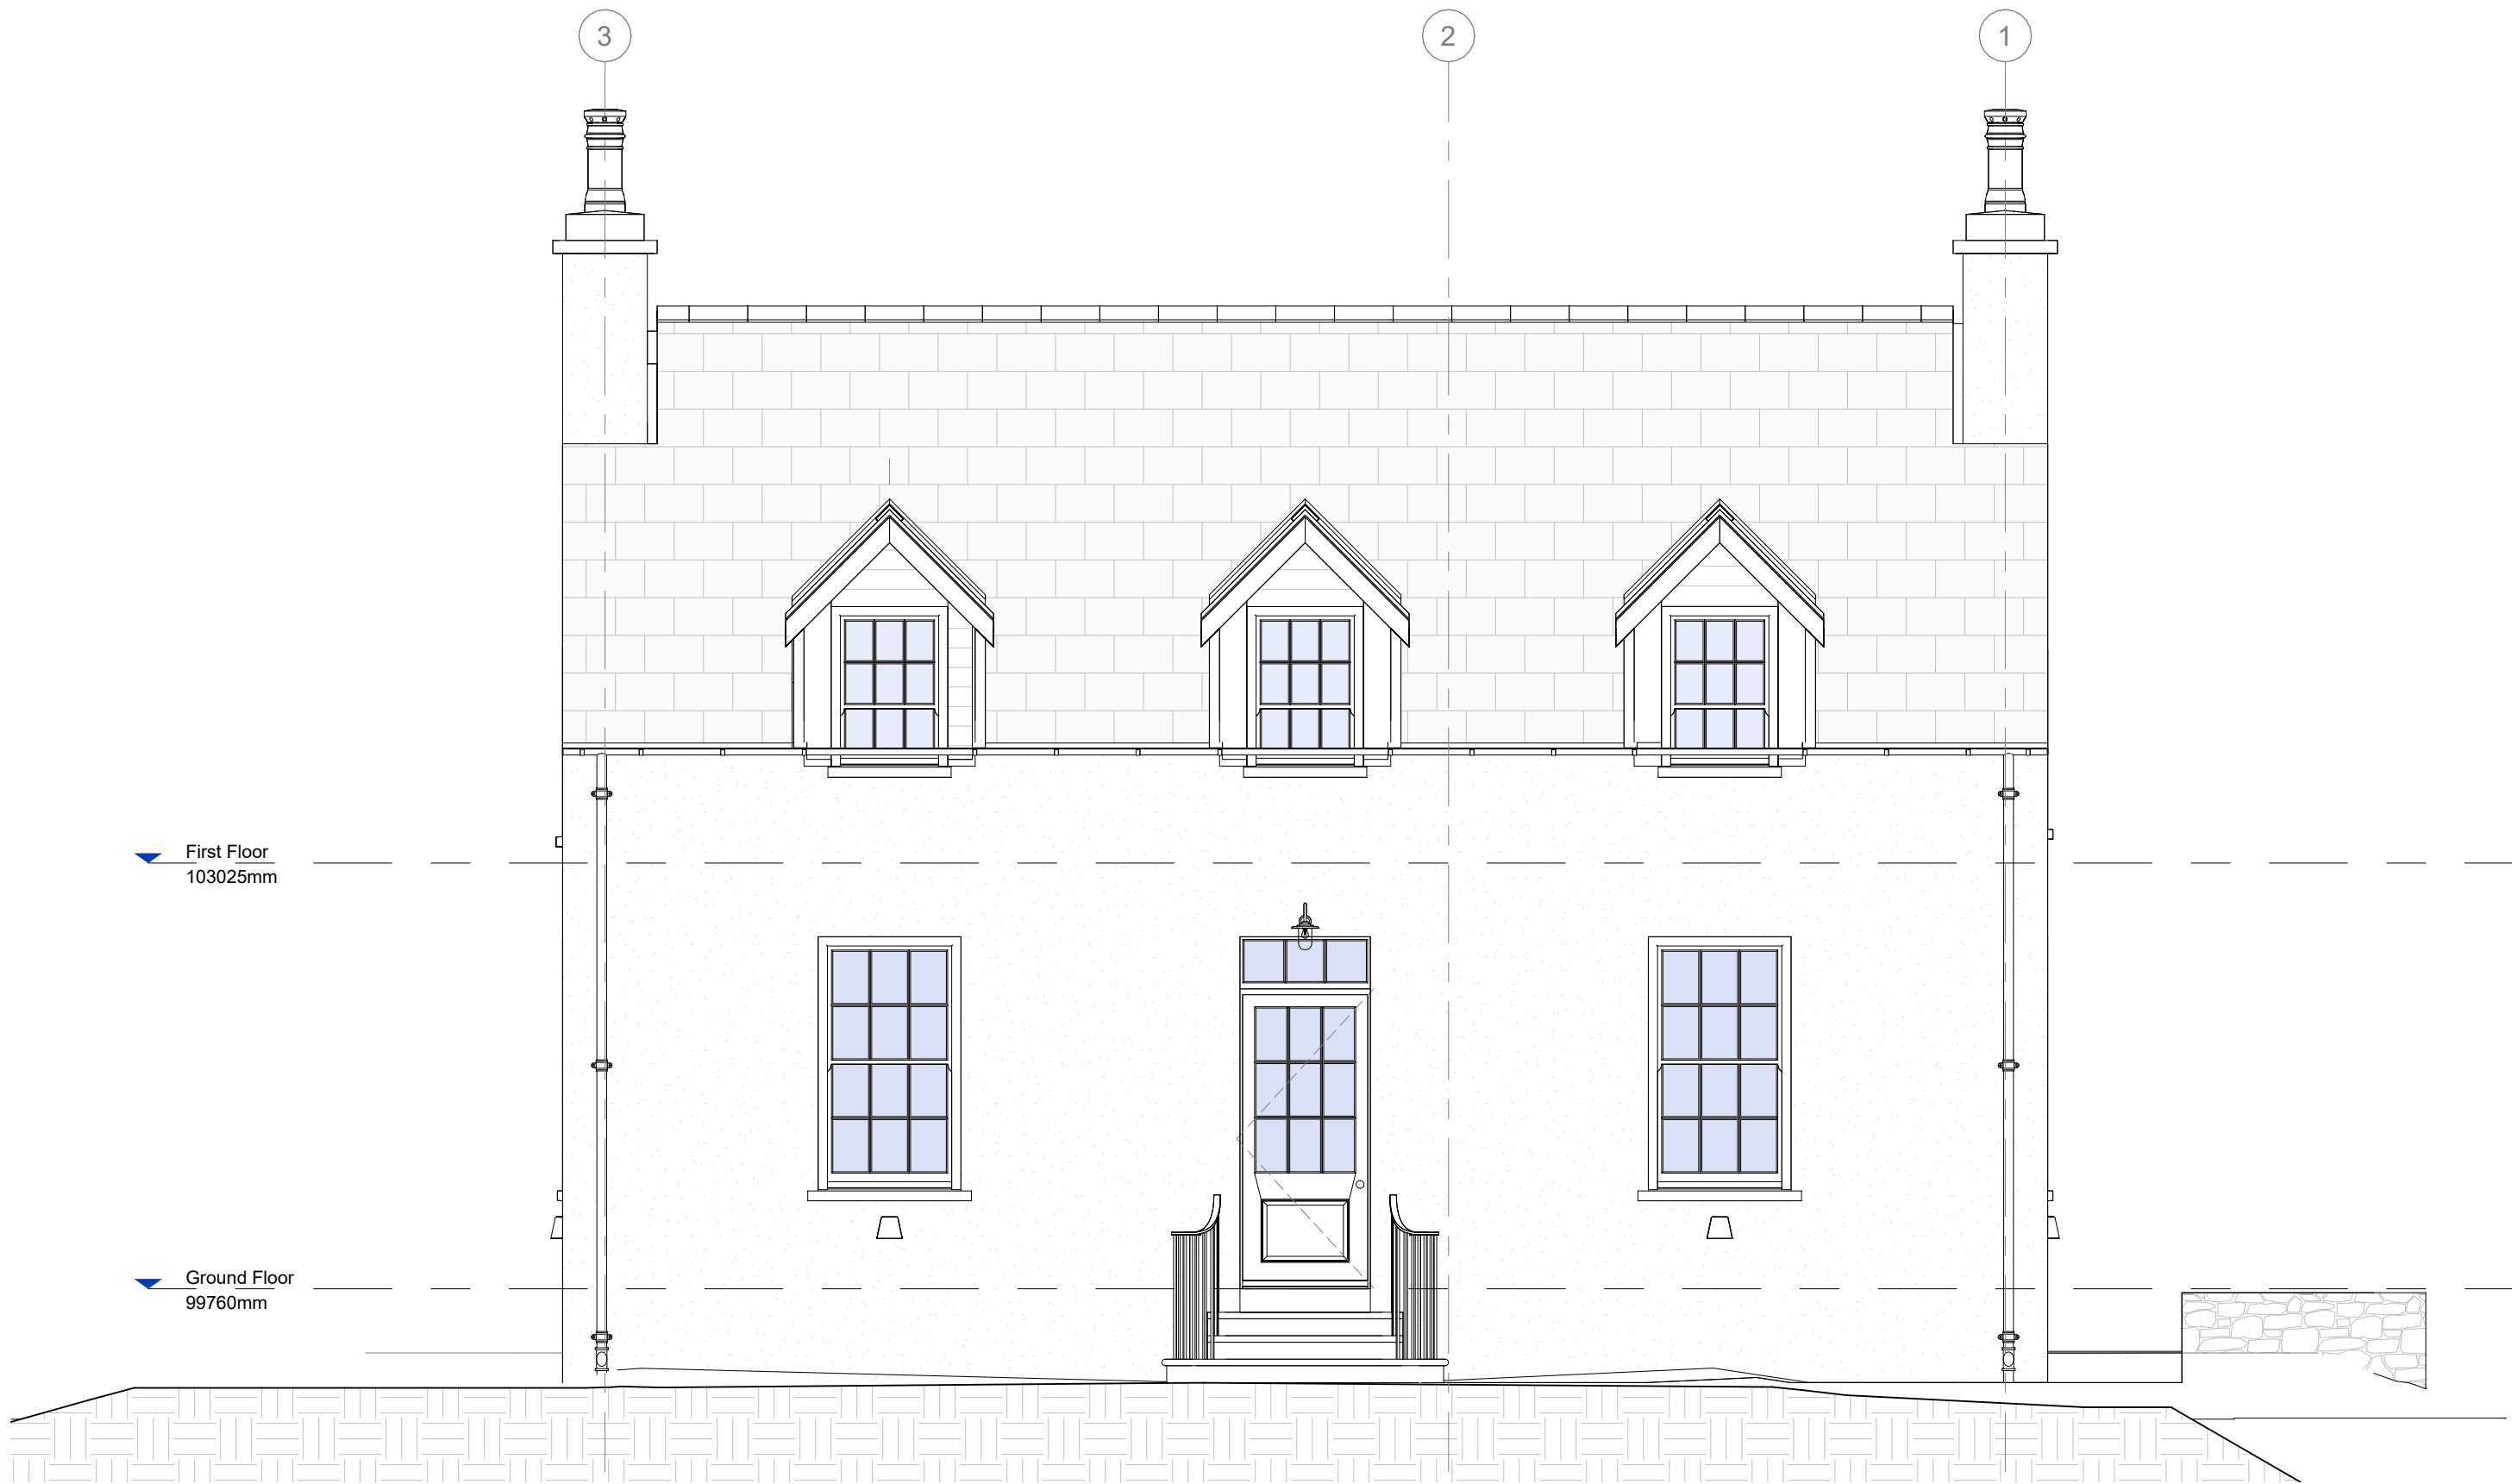
South Elevation
1 : 50

Project	Gartan Lodge		
Address	Letterkenny Co. Donegal, Ireland		
Client	Tom Slaney		
Date	17/01/25		
Drawing Status	Sketch		
Drawing Title	Elevations - South & West - Proposed		
Drawing No.	1931-GRAS- ZZ-XX -DR-A-026104	Revision	P1
Scale / Format	1: 50 / A1	Drawn by	DA
		Checked by	DL

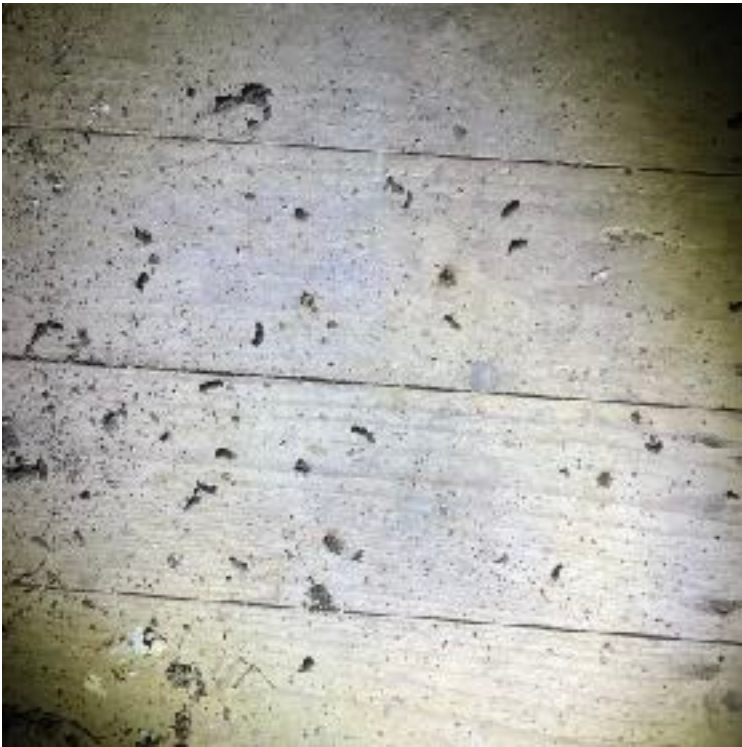
Bat droppings were detected on the floor of the upstairs store area, small tortoiseshell butterfly wings were also detected at the same site. However, no bats were detected using this space during the dusk emergence survey. The indications of bat use point towards recent use by bats as some of the droppings were fresh as were the butterfly wings.

Figure 1. Bat droppings found in store room upstairs space.

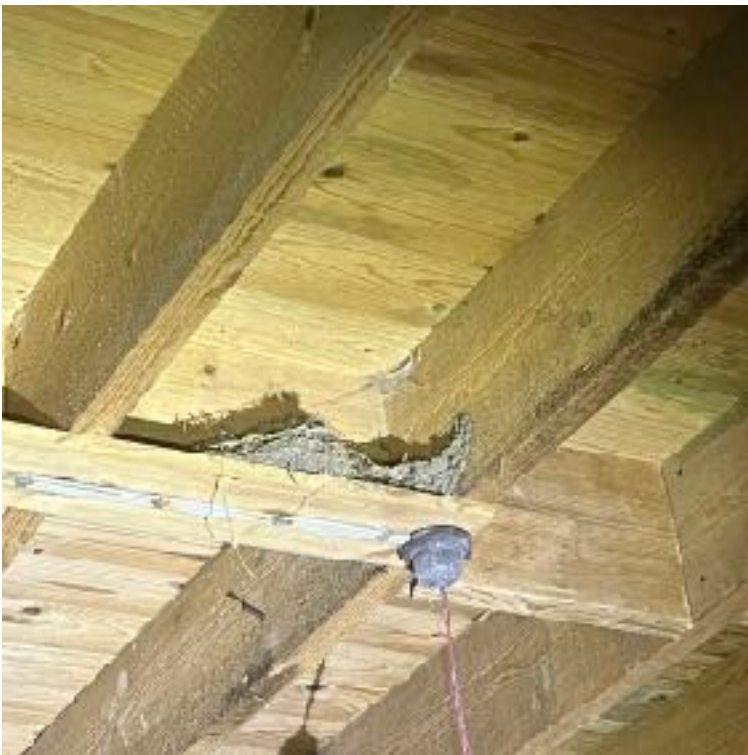
Figure 2: Swallows nest in east shed.

As an active swallows' nest was found in the storage building, six bird boxes (three open fronted and three small holed) will be installed on the North side of trees around the property. These have been identified on the site plan attached.

- Bird boxes, both open fronted and small holed are recommended for the north side of the building and on some of the trees when works are completed.
- Access should be kept in the north facing sheds via half doors or retaining existing openings for birds.

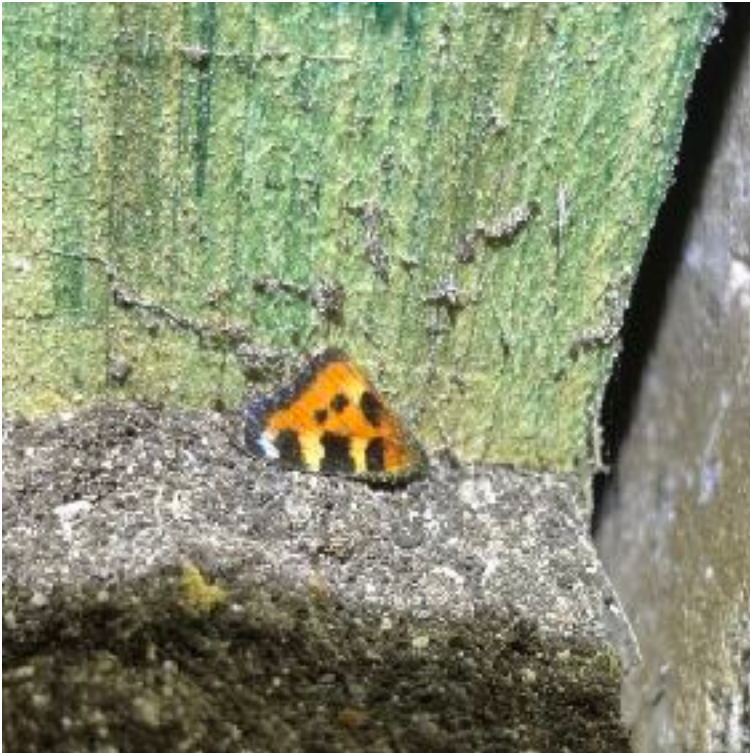
Small tortoiseshell wings were found in the master bedroom indicating bat foraging. Cobwebs were absent in all rooms upstairs where flight paths may exist. No droppings were recorded in the upstairs rooms.

Figure 3: Small tortoiseshell butterfly wing found multiple times.

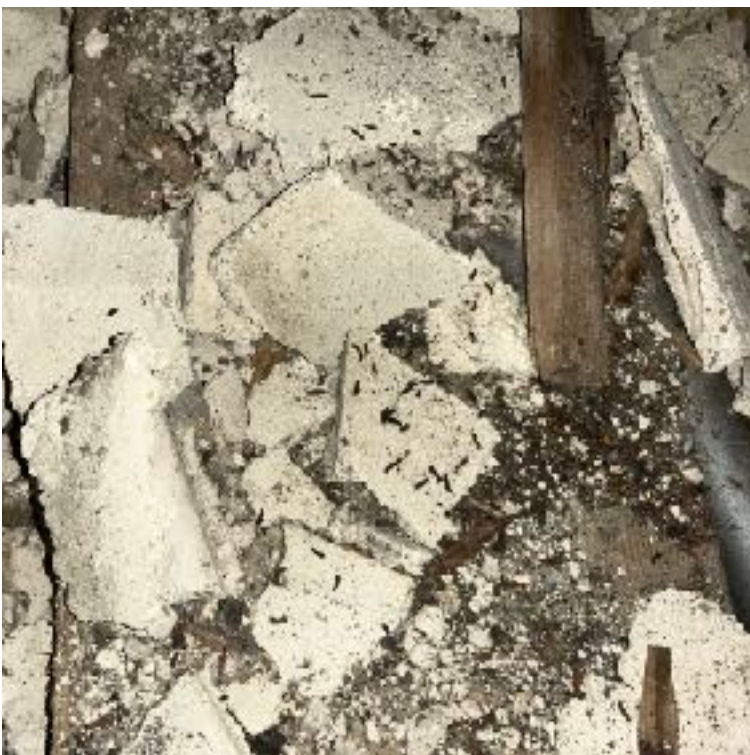
Large numbers of droppings were found in two main clusters in the attic space of the main house. These were at the south end and the central space (see figure 4). An absence of cobwebs along with the droppings, some of which were fresh, pointed towards a bat roost in the attic space.

Figure 4: Large numbers of bat droppings in attic space of main house. Each long black sliver is an individual bat dropping.

Within the House, a 1-2m long timber lined roosting box with internal rough finish that is connected to the existing access point (as per the ecologist's report) will be installed. This will act as a temporary replacement for the roost, which will be replaced with a permanent measure next winter, as per the advice of the ecologist.

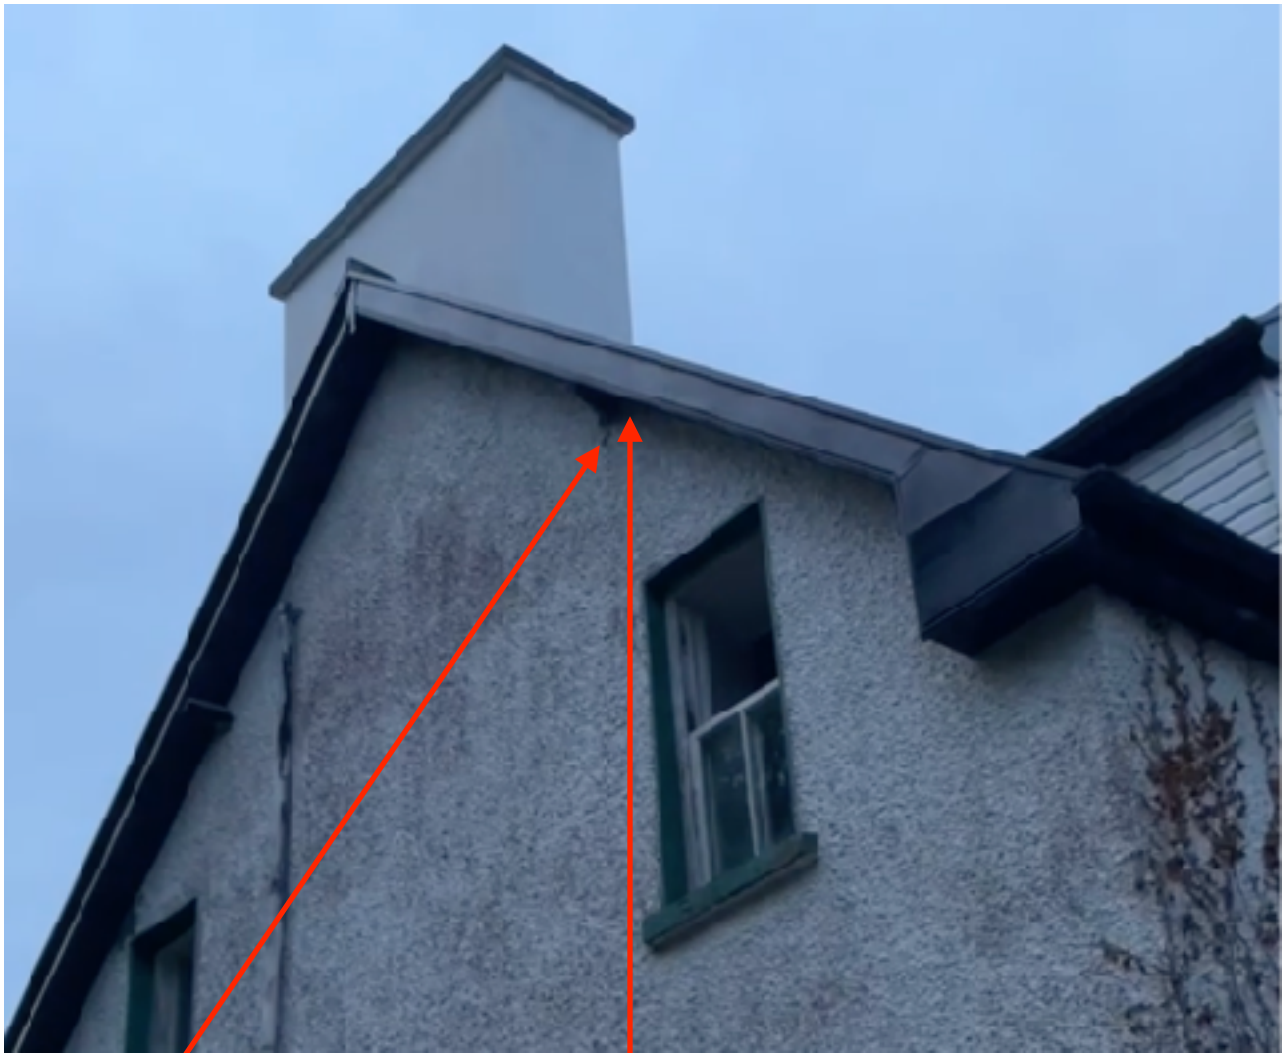
Figure 5: Screen-grab of video of soprano pipistrelle emerging from the more frequently used exit point located on the west gable side of the south end of the main house.

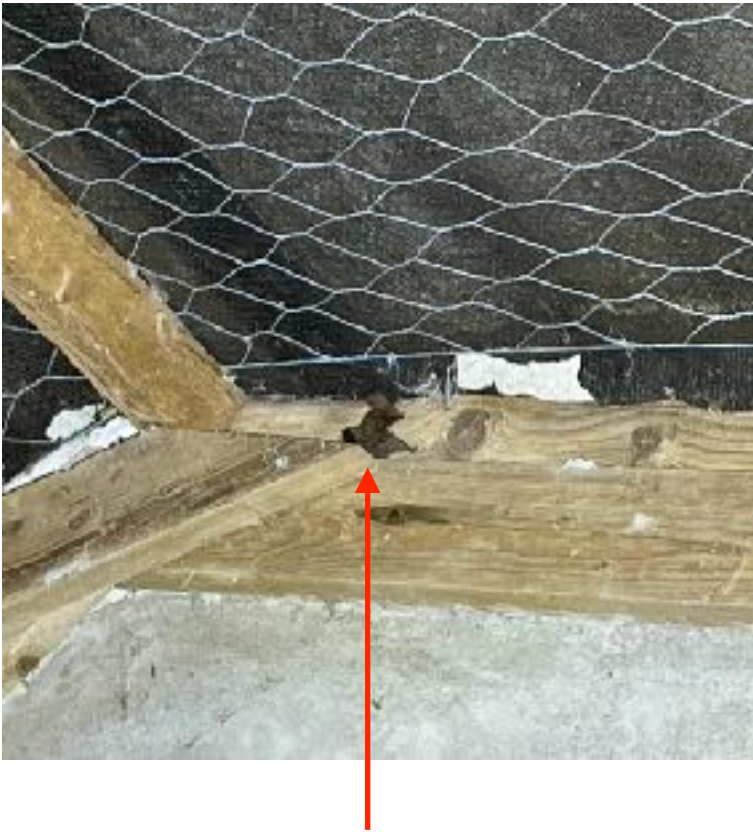
Figure 6: Brown long eared bat emerging from its roost under the roof lining in the outdoor shed.

- Access must be retained for bats in the out-buildings by the use of either half doors, louvers and/or the retention of existing openings. Large entrances are recommended around the doorways for continued future use by brown long-eared bats.

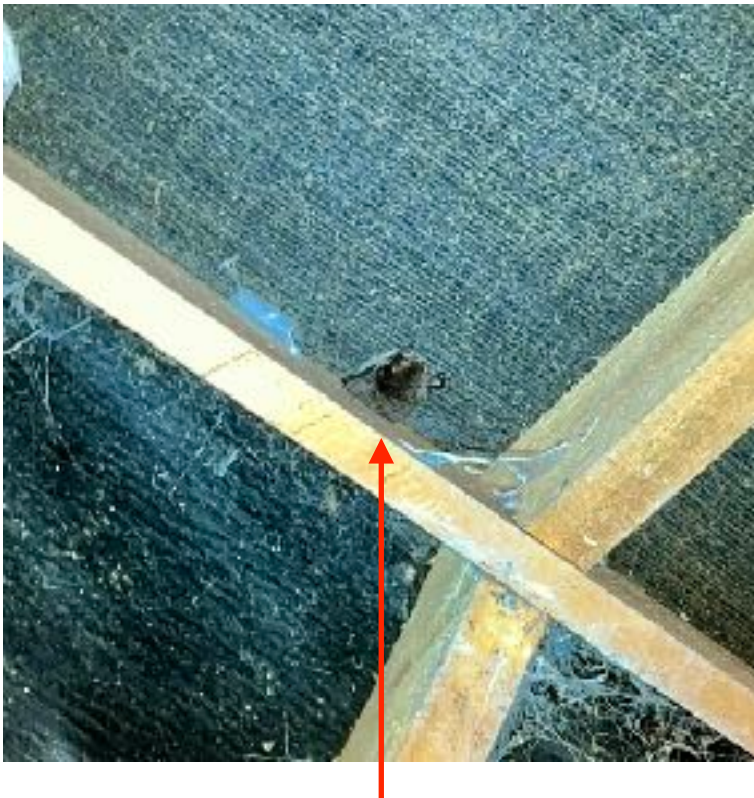
Bat droppings and insect wings were observed at the southern end inside the stable building. No cobwebs in the roof space further indicated bat use. 2 brown long-eared bats were observed using the roof space, one roosting from the roof lining (see figure 8) and one foraging between the rafters.

Figure 8: Brown long-eared bat roosting on roof lining in stable building.

No works are proposed to this building, so the conditions for bats will be the same.
