Baseline Bat Report

Ulster Canal Restoration

Project Title: **Ulster Canal Restoration**

Document Title: **Baseline Bat Report**

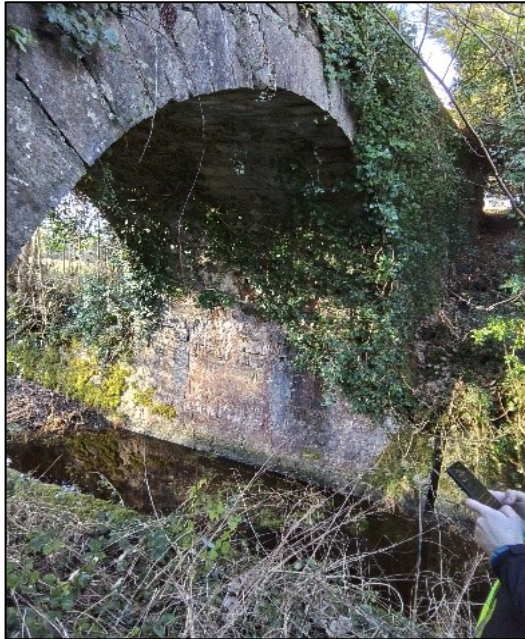
One structure, Kelly's Bridge, was a Stone Masonry Arch bridge (IG Ref: H 45347 21884). The structure is located at the centre of the site. No evidence of roosting bats was found within the structure; however, a number of gaps and cracks suitable for potential crevice dwelling bats was identified within the bridge stonework. It was assigned a *Moderate* roosting potential (Plate 3-1 to 3-6). The bridge was subjected to dusk emergence surveys on the 18th June and the 19th September 2024 and a roost was identified. The adjoining broadleaf woodland present high quality foraging and commuting habitat, and connectivity to the wider area.

Plate 3-1 Arch bridge east side view.

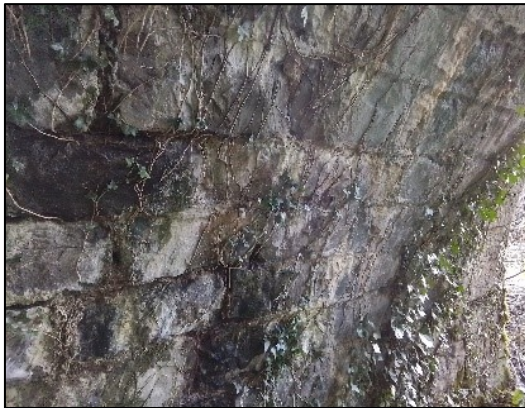
Plate 3-3 Stone blocks are sealed with cement with a small amount of ivy growth, some water leakage through the stonework.

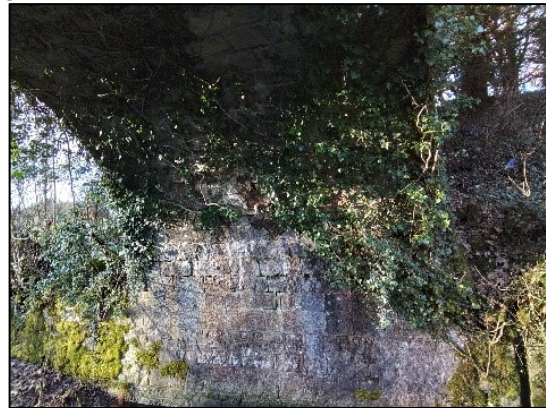
Plate 3-4 Ivy growth on the underside of the bridge.

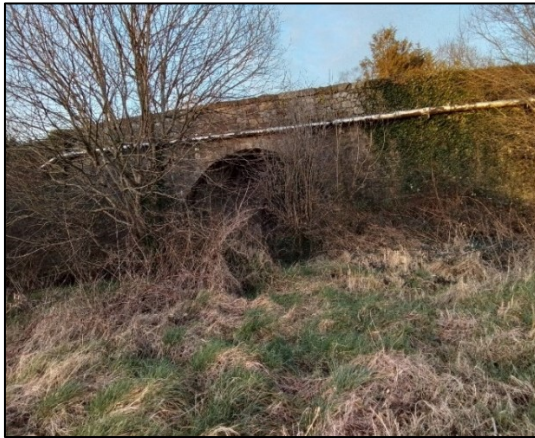
The second Stone Masonry Arch Bridge located toward the northern section of the site (IG Ref: H 45350 21883). The arch of the bridge is plastered with a long crack running through the centre of the arch and is visible on the roadway while on the top of the bridge (**Error! Reference source not found.** & P

late 3-8). Many suitable roosting spaces were identified, cracks, gaps and fissures are visible in the bridge walls and stone wall on the bridge top. It is assigned a *Moderate* roosting potential. The stone wall is partially overgrown. No evidence of bat use such as droppings or grease marks were identified.

Plate 3-7. Bridge 2 Stone masonry bridge with ivy cover and a pipe along one side.

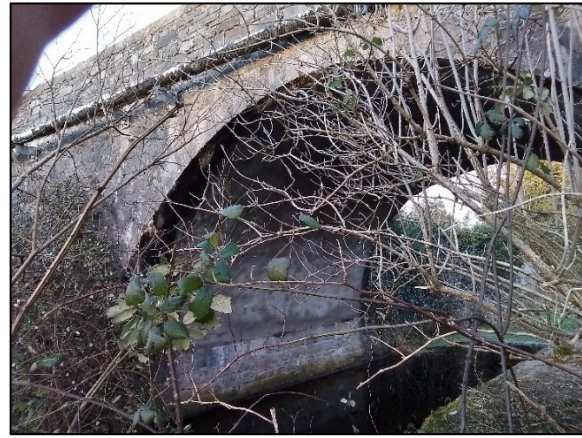
Plate 3-8 Southern aspect showing the plastered underside of the bridge.

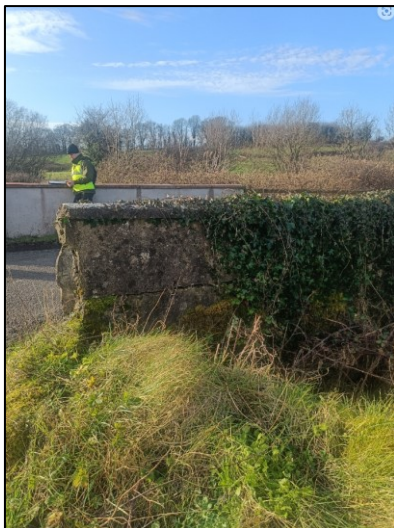
A bridge with internal concrete pipe structure located to the south of the site (IG Ref: H 44718 21466). The exterior inspection of the bridge showed access was limited due to the presence of scrub and briars on both sides. The pipe sits in a dry drain where water has been previously diverted away from the south with to a nearby drainage ditch to the north. The previous canal has been grazed by cattle and remains wet ground, scrub and a treeline grows within the proposed canal north of Bridge 3. There was a small crack found in the external wall. No evidence of roosting was found. There is no suitability for roosting bats present, it was assessed as *Negligible* suitability (Plate 3-9 & Plate 3-10).

Plate 3-9 Bridge 3 Concrete pipe, with ivy cover and lime plaster over solid block bridge walls

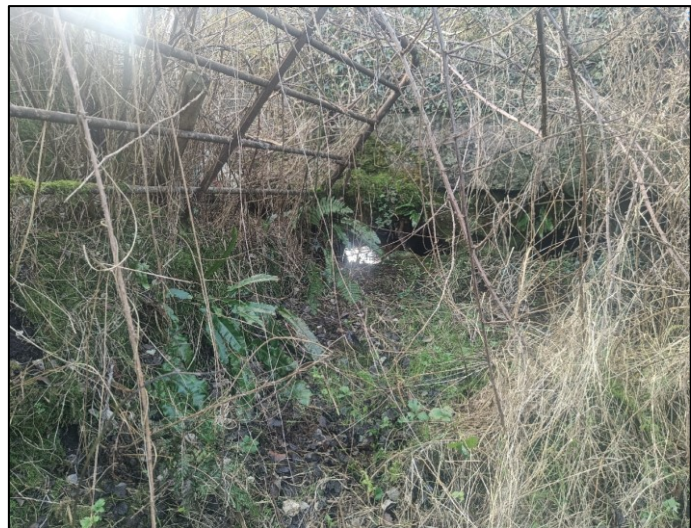
Plate 3-10 Bridge 3 Concrete pipe habitat, briar and scrub growth, the no water contained in the drain base.

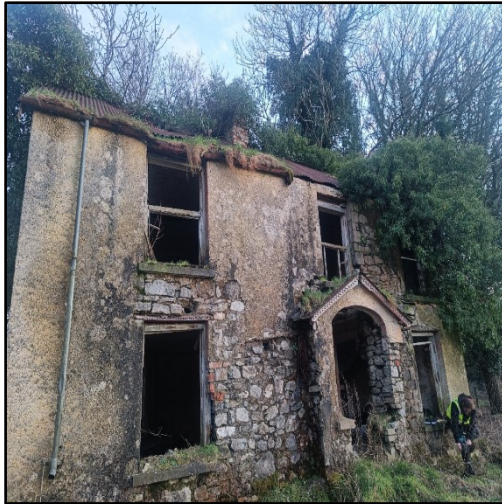
A derelict two-storey stone plastered building (Irish Grid ref: H 46651 22738) was inspected on 30th January and a follow up inspection was undertaken on 9th April 2024 (Plate 3-11 to Plate 3-16). Potential bat access areas include an open doorway and nine open windows with missing windowpanes, as well as vent grates at the back and front of the building which are cracked and broken. The first floor was made of a small entrance hall, two rooms - a kitchen and sitting room area, one with a fireplace and open chimney. The roof is slate with wooden rafters and a separate ceiling area. The roof has extensive damage as a result of a fallen tree, ivy growth and weather erosion.

The entire building is in an advanced state of disrepair, with structural damage, ivy cover and vegetation growth throughout. There is a small wooden staircase leading to upstairs, but was inaccessible due to health and safety concerns..

Plate 3-11. Derelict two-story house with collapsing damaged roof.

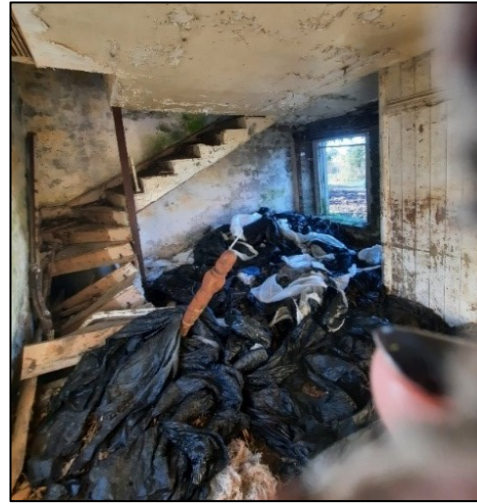
Plate 3-12. Interior view with partially collapsed staircase.

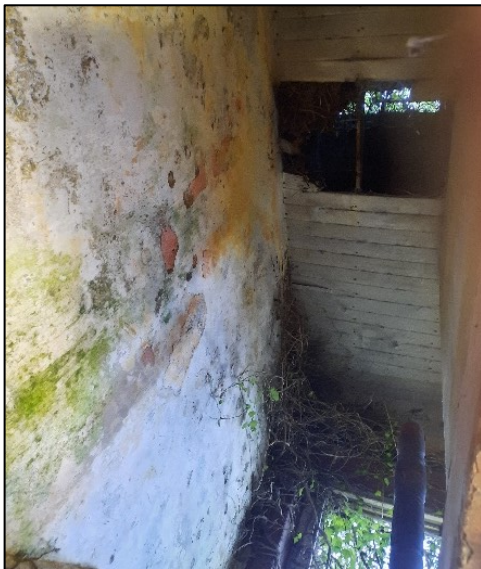
Plate 3-13 View of first floor ceiling with damage visible.

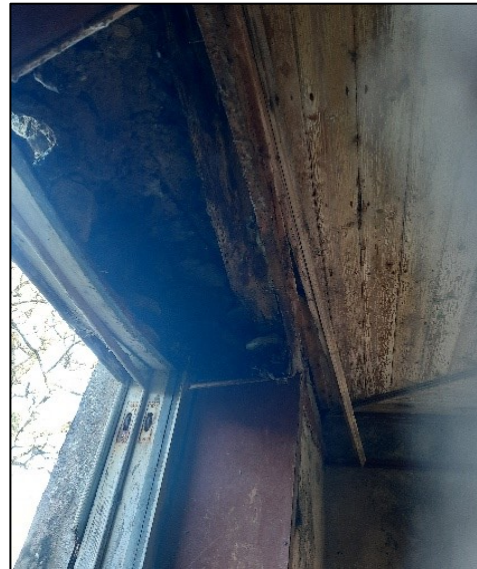
Plate 3-14 Gap between window frame and ceiling.

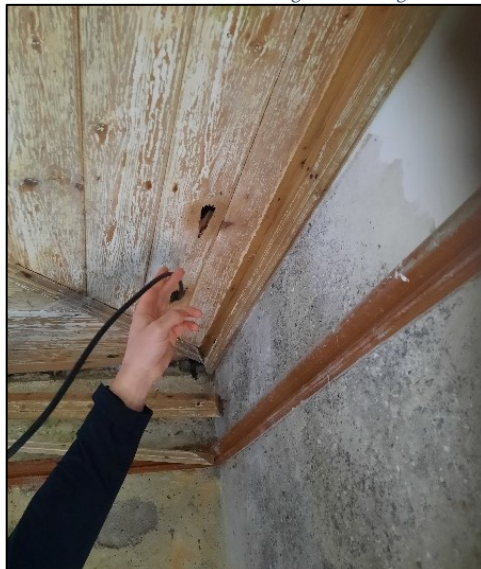
Livestock can also access the building, and rubbish is discarded throughout. The ground floor ceiling consists of wooden panel boards in the sitting room and plastered ceiling in the kitchen. A single chimney breast and stove occurs in the centre of the building. Potential roost features included cavities within the walls and ceiling of the building (Plate 3-15 and 3-16). It was assigned *High* roosting potential.

Plate 3-15 Endoscope use on the small gap in ceiling.

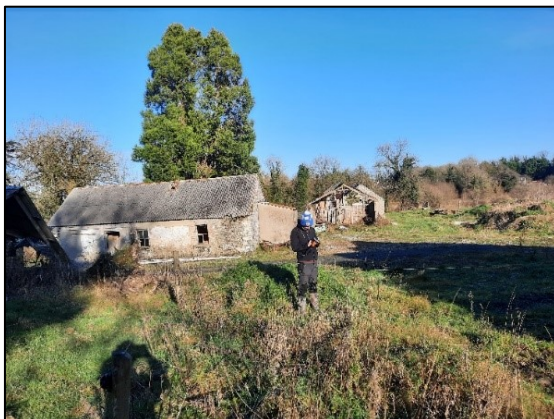
Cottage B1 has more damage as a result of rotten wood, damaged slates and open doorways and windows. Cottage B1 is brighter with open attic space with sections of missing ceiling and gaps in the slates.

Plate 3-21 Northern Cottage B1 with missing windows, open doors and missing and damaged slates.

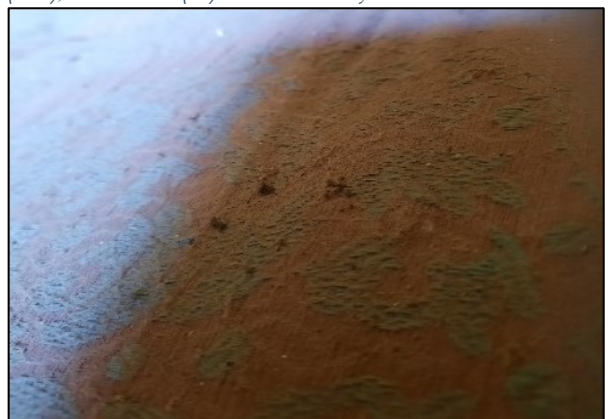
Evidence of potential bat use was found with a small number of droppings in Cottage B2 (Plate 3-22) and the shed north of Cottage B1. Suitable potential access points were identified along the fascia as well as within gaps in the roof slates and via open windows in Cottage B2.

Plate 3-22 Droppings found in shed to the north of cottage B1, droppings were also found in southern cottage.

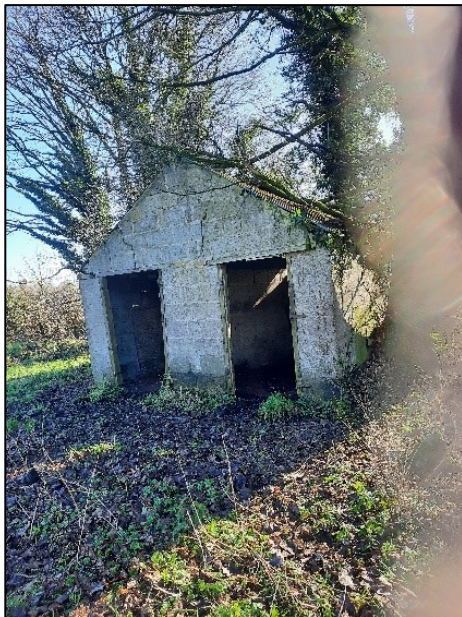
The structure was a single storey concrete block shed with galvanised roof, and wooden rafters with two internal livestock standing/ feeding/handling areas accessible from the exterior (Plates 3-23 and 3-24). There were small cracks and gaps in the block work, with high light presence inside the small structure,

Plate 3-23 Double cow shed with a high level of light within and no doors.

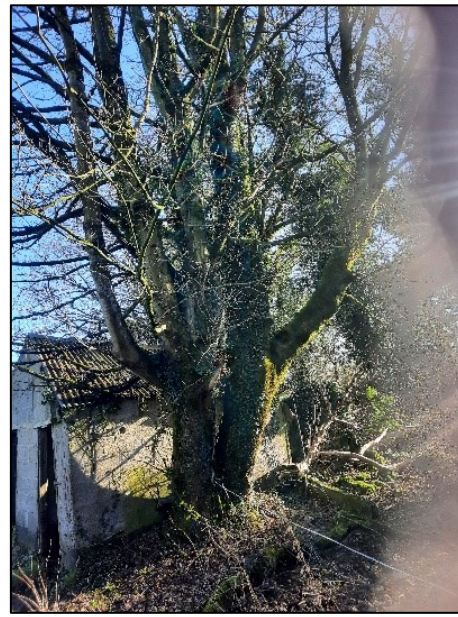
Plate 3-24 Tree to the south of the cow shed with roosting features (PRF-I).

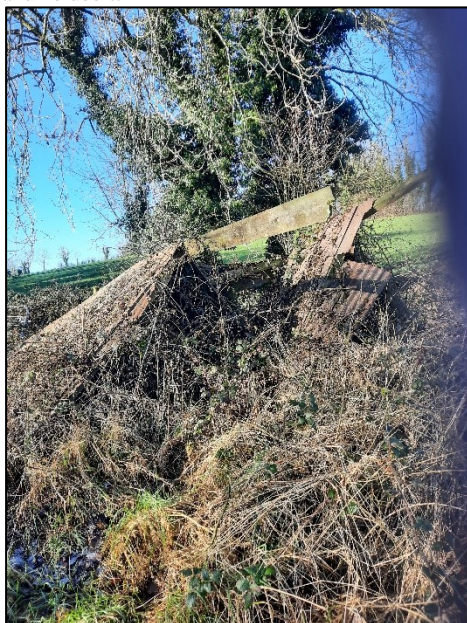
Plate 3-25 Collapsed shed roof with corrugated iron roof and briars covering the structure.

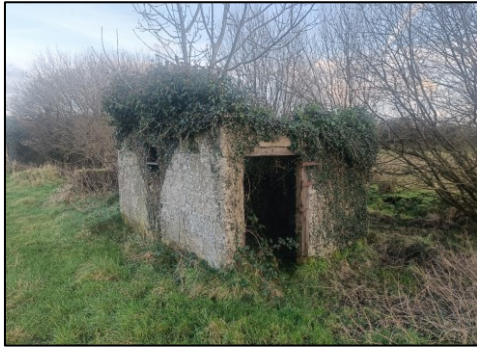
The structures were assessed as having a *Negligible* potential for roosting bats I.e. ‘No obvious habitat features on site likely to be used by bats, however a small element of uncertainty remains as bats can use small and apparently unsuitable features in occasion.’

Plate 3-27 Small shed with *Negligible* suitability for opportunistic roosting, located adjacent to the canal.

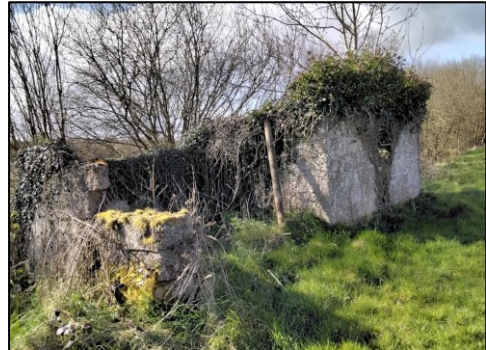
Plate 3-28 Derelict shed with missing roof.

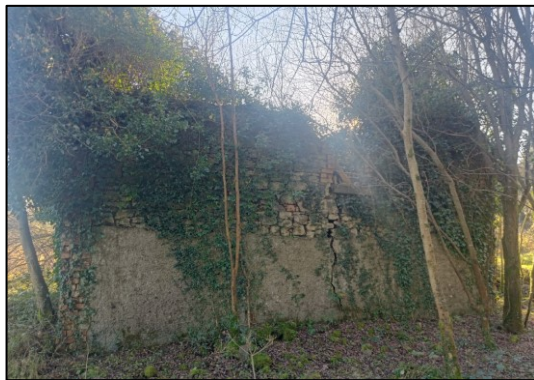
Plate 3-29 Northern Aspect showing brick wall, ivy growth and missing roof.

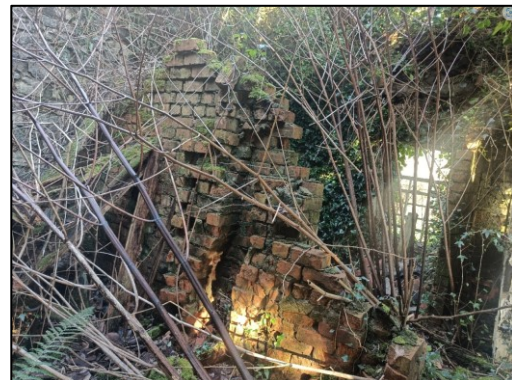
Plate 3-30 Internal view of the structure, with ivy growth and many gaps and cracks.

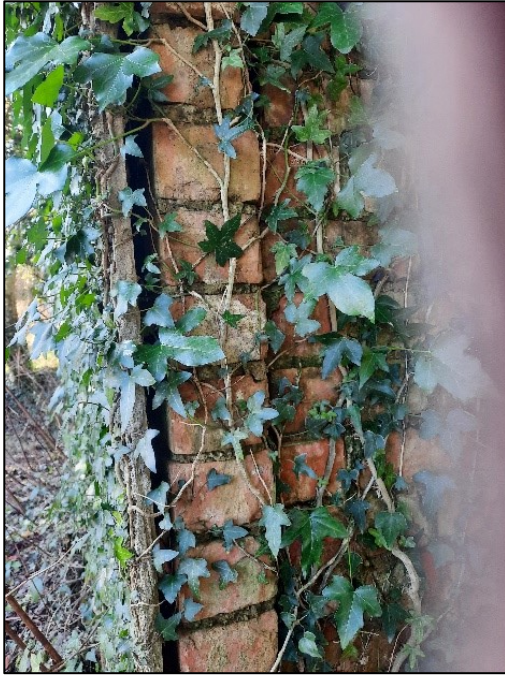
A red brick building ruin was located to the north of the Bridge 3 and adjacent to the small lake, located at (Irish Grid Ref: H 44665 21631). It consists of four high standing red brick walls and a collapsed roof within immature broadleaf woodland (Plate 3-31 3-32). Vegetation, thick ivy and trees grow within the confines of the structure. The gaps between the brick, small gaps and crack on the walls of the structure and around the windows and doorways plaster provide roosting potential (Plate 3-31).

Plate 3-31 Old ruin with red brick and plaster that is separating from the brick leaving a large gap.

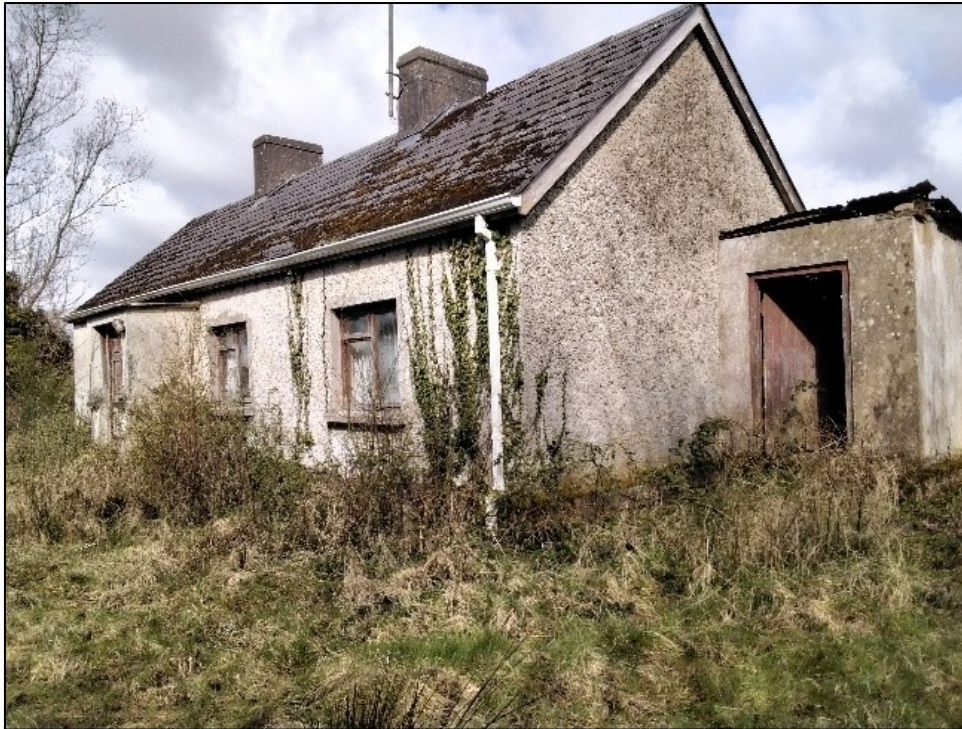
It is possible bats may utilise the building opportunistically or to commute to other areas (i.e. *Low* potential). As such, the structure was assessed as having a *Low* potential for roosting bats.

Plate 3-33 Derelict Bungalow with Low bat roosting suitability.

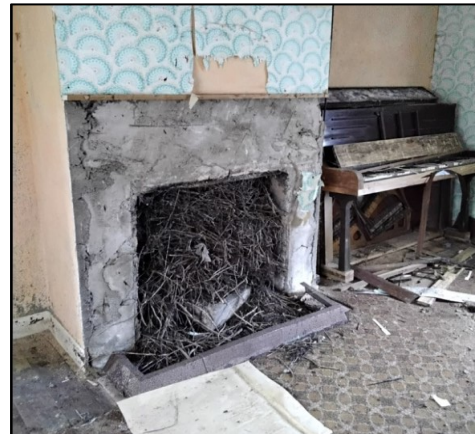
Plate 3-35 Fireplace full of bird nesting material.

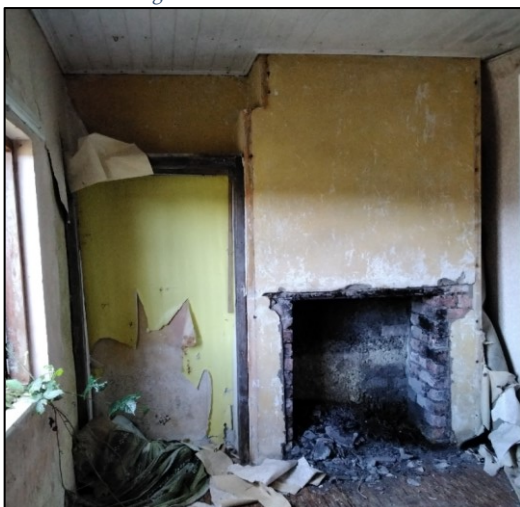
Plate 3-36 Empty fireplace inspected for bat droppings, no evidence of live bats were found.

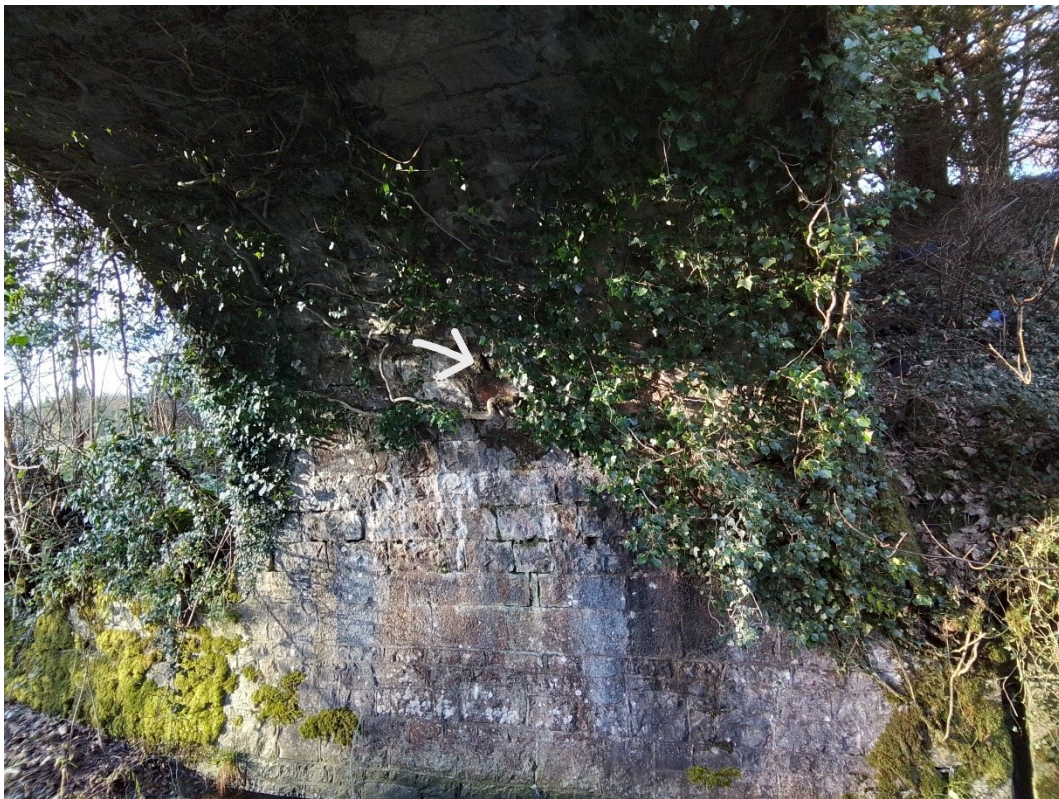
Two emergence surveys were conducted on the 18th June and 19th September 2024 at Bridge 1. Surveyors were located at the east and west aspects of the bridge, with clear views of the exterior wall and beneath the arch. Moderate bat activity was observed throughout the surveys, and four *Myotis* spp. individuals were observed emerging from underneath the bridge arch during the first survey. Two *Myotis* spp. bats were observed emerging from the same location during the second survey.

Plate 3-43 Emergence location at Bridge 1
