# Bat Survey Report & Derogation Licence Application

Moneygorm Residential  
Renovation,  
Co. Waterford,  
P51VCH9.

December 2024

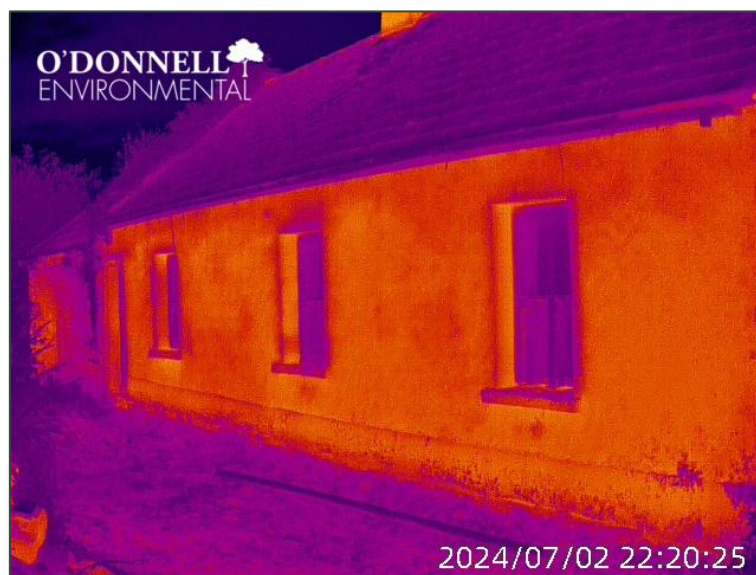
**Plate 2.1** Viewshed of thermal camera covering the front/southern aspect of the former residence.

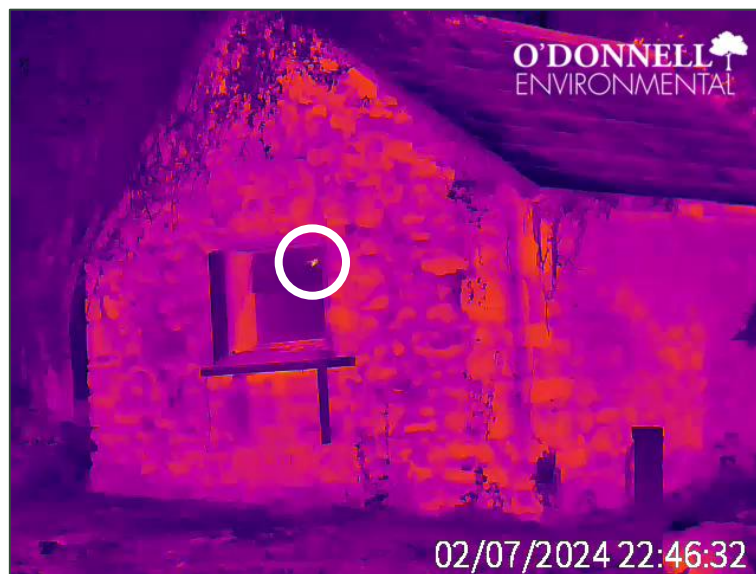
**Plate 2.3** Viewshed of thermal camera covering the western aspect of the former residence, with Common Pipistrelle emerging from above the window lintel (white circle).

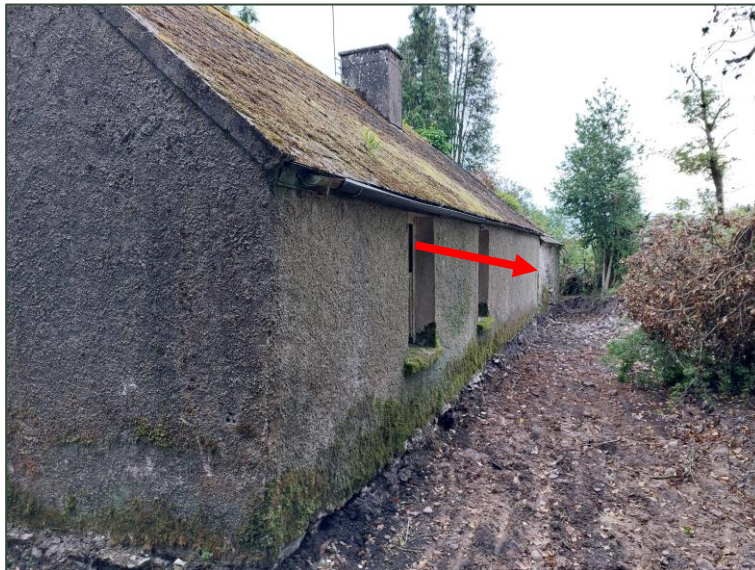
**Plate 3.2.2** View of rear/northern aspect of the former residence, with main egress point for the Brown Long-eared Bat maternity colony in the form of an open window (red arrow).

Brown Long-eared Bats exited only through the rear open window (see **Plate 2.2** and **Plate 3.2.2**) which was sheltered by mature hedgerow habitat. Post-emergence activity of this species appeared mostly to the north of the house, with individuals quickly commuting offsite along boundary hedgerows. Review of thermal imagery and echolocation data revealed approximately 21 Brown Long-eared Bats exiting the former residence. A single Common Pipistrelle was recorded emerging from above the western gable lintel (see **Plate 2.3**) and commuting in a westerly direction. Approximately 75 minutes after sunset, Brown Long-eared Bat were recorded re-entering through the same window.

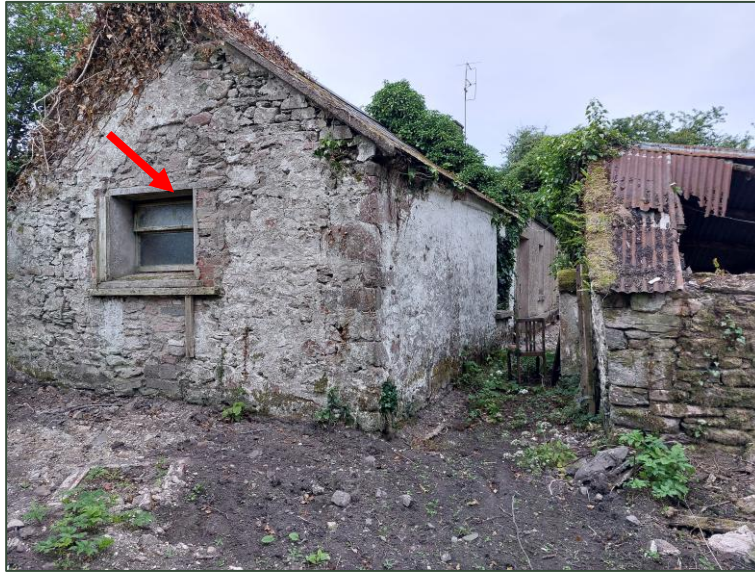
**Plate 3.2.3** View of the western aspect of the former residence, with Common Pipistrelle roosting space identified above window lintel (red arrow).

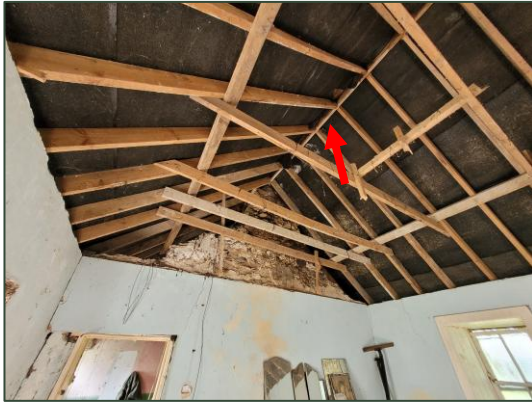
Interior assessment of the derelict cottage revealed a maternity colony of Brown Long-eared Bat beginning to form on 8<sup>th</sup> March 2024 on the eastern gable apex underneath the bitumen felt (see **Plate 3.2.4**) with approximately 10 individuals present.

**Plate 3.2.4** Interior view of parlour with original Brown Long-eared Bat roosting location highlighted (red arrow).

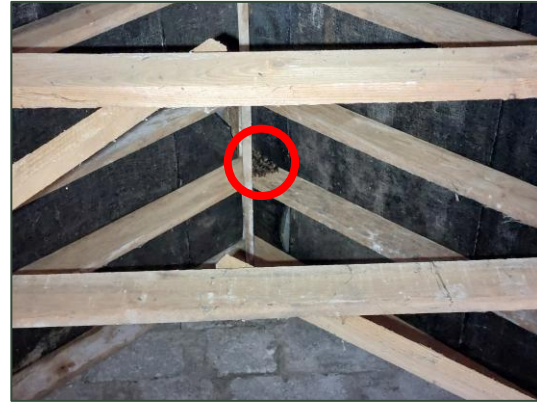
**Plate 3.2.5** Brown Long-eared Bat maternity colony location identified on 8<sup>th</sup> March 2024 having moved to bedroom apex at the eastern gable.

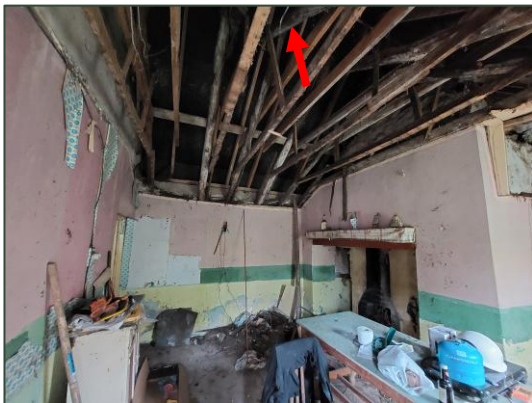
The interior of the structure comprises a series of internally connected rooms between the original cottage and stonework extension. A suspended ceiling formerly present housed a concealed attic space which is now exposed (see **Appendix B** for complete internal layout). Bat droppings and occasional feeding remains were observed throughout the interior spaces. The original cottage appears to have been reroofed in recent decades, with the current roof overlaying a set of older timber structures as evident within the former kitchen (see **Plate 3.2.6**).

**Plate 3.2.6** Interior view of old kitchen, with roosting space on 1<sup>st</sup> November 2024 at apex (red arrow). Note the current roof overlaying the previous, older roofing timbers.

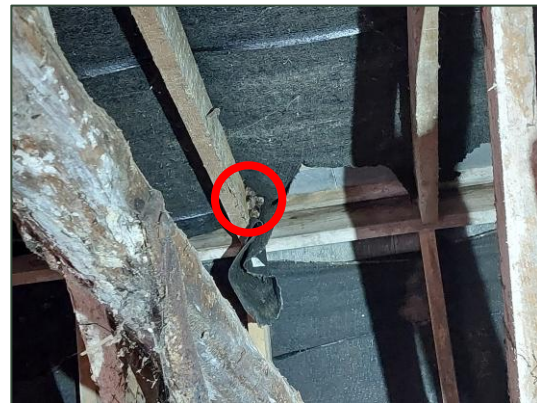
A small number of Brown Long-eared Bat were identified (approximately 6) within the folds of bitumen felt above the former kitchen on 1<sup>st</sup> November 2024. The weather was noted to be unseasonably warm at the time of this survey. The cottage may be used to some extent for hibernation due to the variety of microclimates available to bat species.

**Plate 3.2.7** Brown Long-eared Bat roosting space identified on 1<sup>st</sup> November 2024 in old kitchen apex.

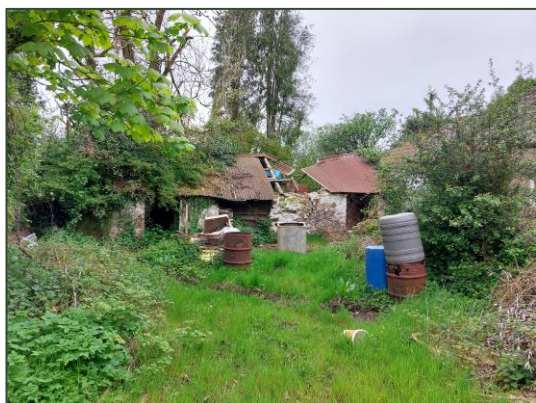
A series of outbuildings are associated with the former residence and are largely in advanced states of dereliction (See **Plate 3.2.8**). These structures consist of corrugated metal roofing and timber supports atop stonework walls, of which a portion of the roof is missing and was damaged by treefall during summer 2024. The interior is largely exposed to the elements, with considerable light, water and wind ingress. Additional small stonework ruins adjoin these outbuildings but are largely rubble and present no suitability for roosting bats. No evidence of roosting bats was identified within the outbuildings and stonework ruins, although the likelihood of periodic night roosting cannot be entirely excluded.

**Plate 3.2.8** Outbuildings located immediately south of the former residence.

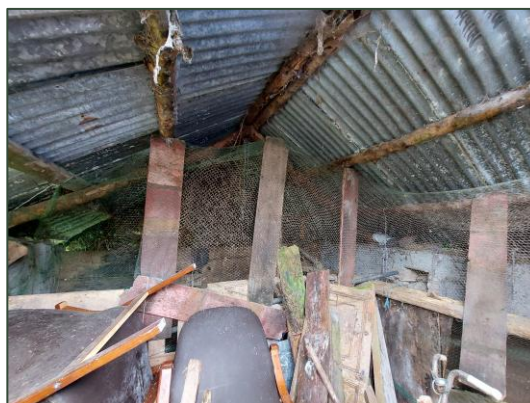
**Plate 3.2.9** Interior view of the outbuildings associated with the former residence.

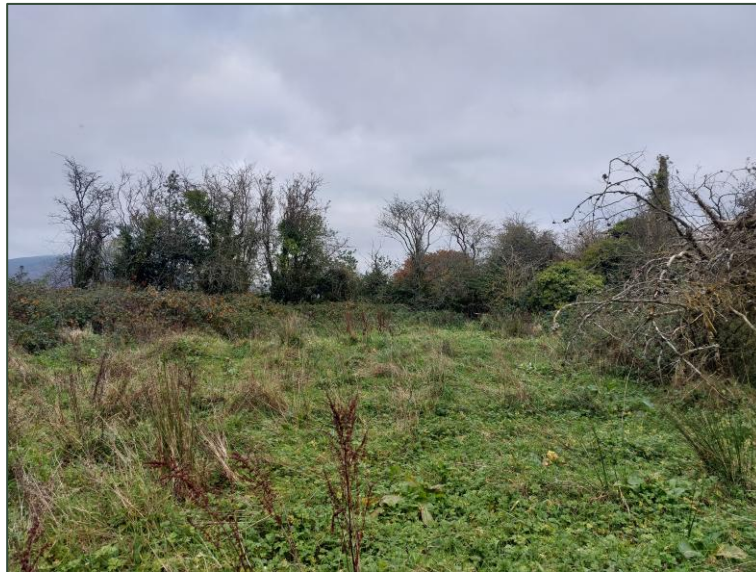
The proposed location (see **Figure 1; Appendix A; Plate 5.1**) has been chosen with cognisance to the operational phase off the proposed development and landscape variables outlined by Entwistle et al. (1997). Consideration was also given to habitat connectivity to the existing roosting space within the derelict cottage. The alternative maternity roost location has been sited within an undisturbed location of the site and is surrounded on three aspects with vegetation in the form of hedgerows and standing deadwood. A suitable buffer in the form of hedgerow exists between the proposed location and the derelict cottage such that the likelihood of noise and light impacts arising from construction works and operational phase are considered negligible. Mature hedgerows bordering the site provide clear connectivity between the existing roosting location and the proposed alternative location. The location will be south-facing and sited at a suitable distance from hedgerows to reduce scrub encroachment. Scrub will be cleared each winter in a 2-metre radius surrounding the bespoke roost, and all flyways associated with access/egress points kept open.

**Plate 5.1** - View looking north of the proposed location of bat barn. Note the vegetation buffering the northern, eastern and southern aspects. The derelict cottage/works area is located behind the eastern vegetation buffer.
