# Appendix: Application for Derogation under the European Communities

11.1 Explanation as to why the derogation sought is the only available option for works and no suitable alternative exists as per Regulation 54 of the European Communities (Birds and Natural Habitats) Regulations.

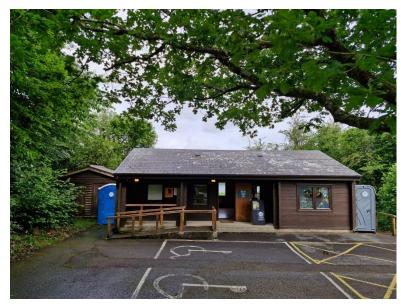
Figure 1: Visitor Centre, derelict toilet, porta-loos and carpark area.

It is important to note that the Visitor Centre adjacent the derelict toilet (See Figure 1) in DWNR is the main maternity or hibernation roost for Common Pipistrelle (*Pipistrellus pipistrellus*) and Soprano Pipistrelle (*Pipistrellus pygmaeus*) in the area, with in excess of 200 bats.

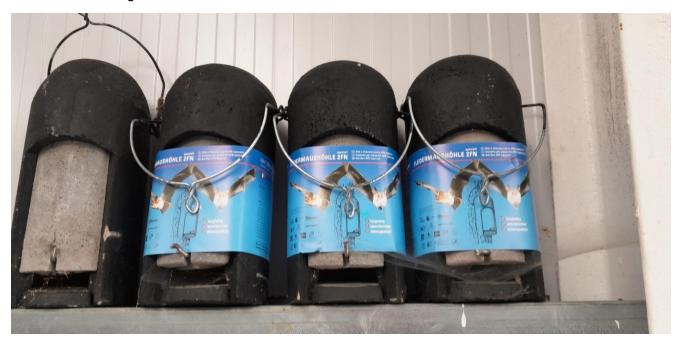
Figure 3: 2FN Bat boxes.

Material: SCHWEGLER Wood-Concrete Nest Box. Hanger: steel, galvanised.

• Outside diameter: 16 cm.

Height: 36 cm.

Weight: approx. 4.9 kg.

This box was developed exclusively for Bats. It is made to the latest findings and has been used successfully in practice for many years. The intermediate floor ensures that it provides the best possible protection against small predators, draughts and bright light.

With two access options: The Bats can land on the tree trunk and climb in from underneath or fly away directly from the wide entrance area at the front. The roost is largely self-cleaning, as the droppings can fall out of the bottom of the cavity. Nonetheless, checking and cleaning are recommended if the Bat Box is used by large numbers of Bats. This type is especially suitable for forests and parks.

The front panel can be removed for inspection and cleaning.

**Prior to any works commencing**, a number of dedicated bat boxes (Figure 3) will be provided as alternative roosting sites for bats.

The structures should be placed near existing foraging areas and commuting routes used by bats, in a dark corner, e.g. northwest.
