Project: **Grange Cottage**

Subject: **Bat Derogation Licence Application Report**

Prepared by: **Dr Emma Boston BSc (Hons) MRSB, CEcol, MCIEEM** Date: **06/06/2025**

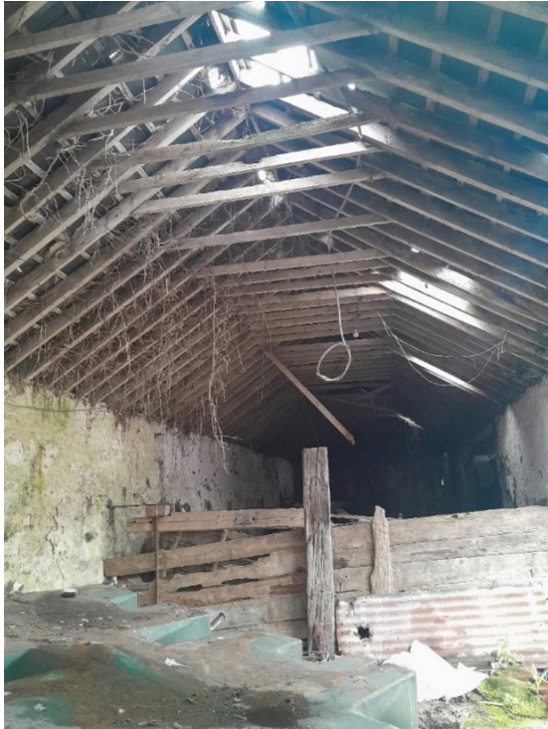
Plate 1. S04 internal view

The PRA of structures within the Site carried out on 07 February 2024 identified two structures, large open farm buildings, as having Low suitability for roosting bats (S04 and S05), given they were derelict, with roofs in poor condition, with sections of missing tiles and open doors. A small number of scattered bat droppings were found within S04, but no feeding remains (e.g., moth wing cases) found within either structure. It was considered possible that bats only entered the structures for foraging, exploiting insects that may shelter in these covered areas, rather than roosting within the buildings themselves. However, there is potential that brown long-eared bats could utilise these as feeding roosts and there are features present (open beams) that may be used by small numbers of roosting bats.

Structure reference	Structure description	Roost type	Access / roost features	Location (ITM coordinates)
S04 (see Plate 1)	A L-shaped open derelict structure with vegetation growing out of the roof in parts. The walls are made of stones and the roof is slated with internal wooden beams.	Low suitability. Potential feeding roost/day roost.	The building has wooden beams as well as tiles and stone walls that may support one or small numbers of bats opportunistically. Bat droppings were observed internally. No feeding remains noted, but buildings are open and is considered suitable for use as a feeding perch by brown long-eared bats.	703213, 732286
S05 (see Plate 2)	An open derelict structure with metal sheet roofing. The walls are made of concrete with some wooden beams.	Low suitability. Potential feeding roost/day roost.	The wooden beams within the building may support one or small numbers of roosting bats opportunistically. No bat evidence, including any feeding remains was observed internally. Building is open and is considered suitable for use as a feeding perch by brown long-eared bats.	703240, 732249

- The licence holder will oversee and advise both contractors and Site operators on mitigation implementation. They will be present during the enabling works, which will include the removal of vegetation around and on the buildings (including sections of roof), and during the removal of the old slates and rafters);
- Specific timing requirements – redevelopment works must take place between September and mid-November inclusive, to pose the lowest risk to roosting bats;
- The provision of a minimum of five bat boxes to compensate for the loss of bat roosting habitat must be mounted on site prior to the enabling works, these will be of types suitable for both soprano pipistrelle and brown long-eared bats;
- Should any bats be found during these works, the licence holder will move the bat to one of the mounted bat boxes.

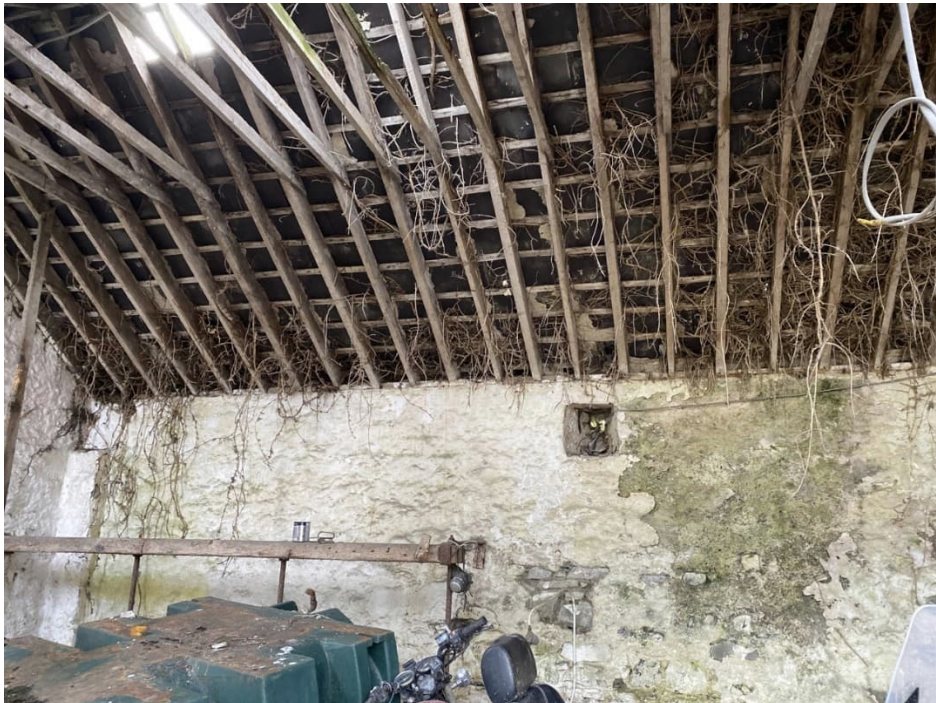
Plate 2. S05 internal view

S05	Day roost	Soprano pipistrelle	Single emergence of soprano pipistrelle from the rafters of structure.	A single soprano pipistrelle bat observed emerging from the rafters of the structure, approximately 36 minutes after sunset. A single bat observed foraging around the building approximately 38 minutes after sunset.
