Derogation License Application Supporting documents

Moore Street Development, Kilrush, Co. Clare

Bat Survey Report

Moore Street Development,
Kilrush, Co. Clare

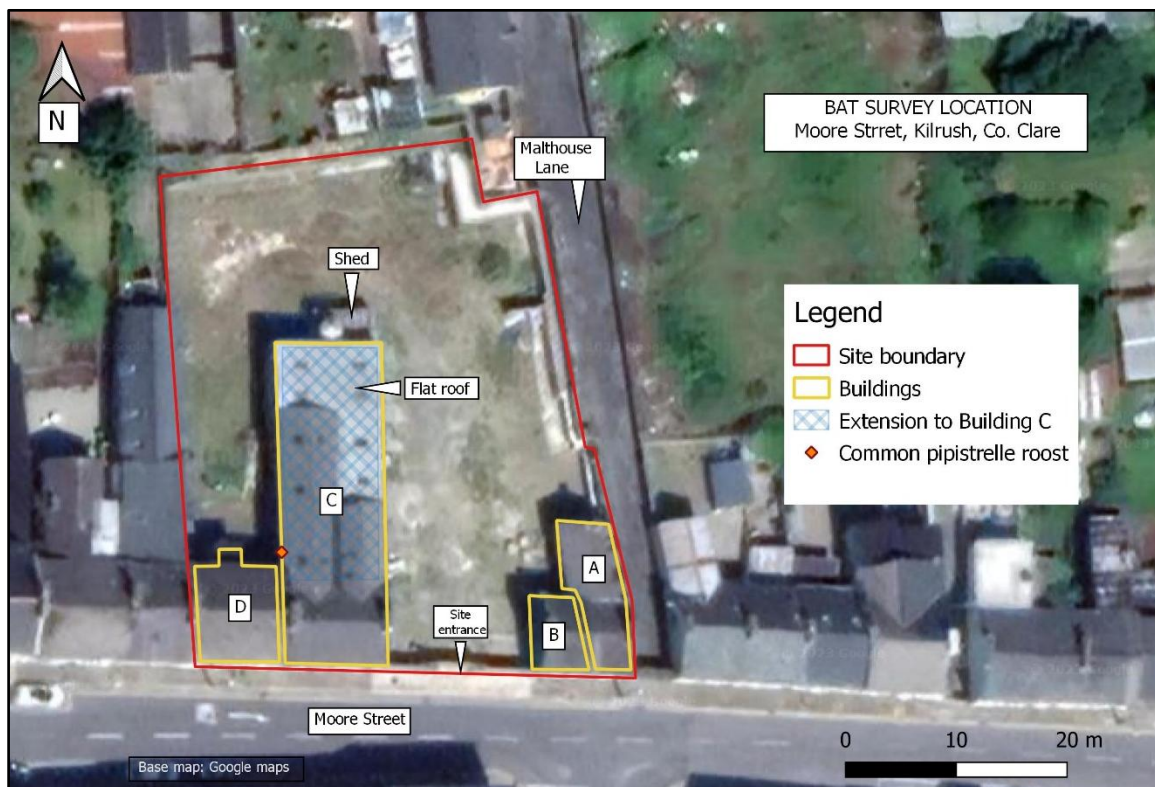
Figure 1. Development site of Moore Street Development and the present building locations

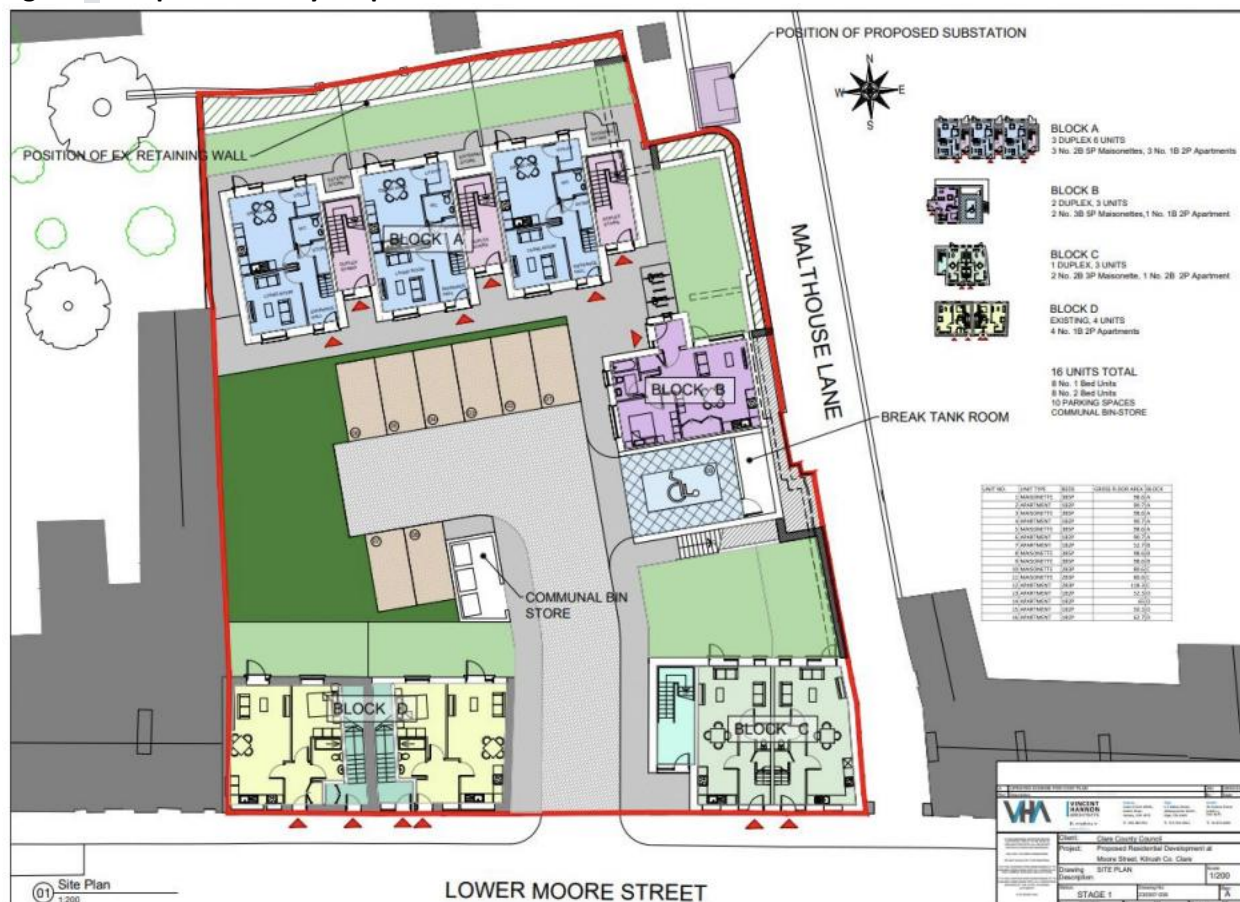
Figure 2: Proposed site layout plan

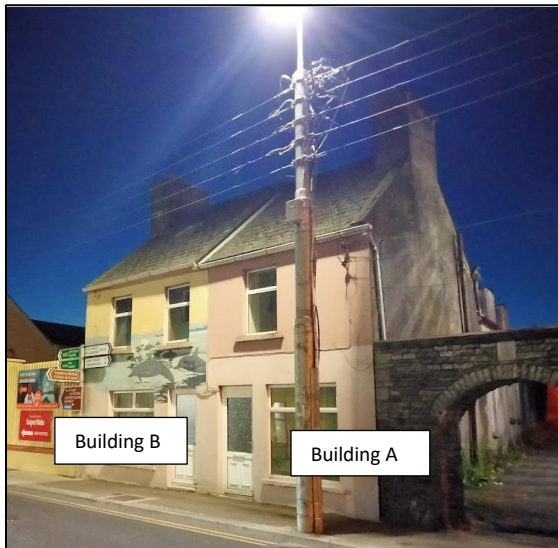
Plate 1. Building A front and side elevations: building suffers from significant light pollution deterring bat activity

The front and east (right hand side) elevations suffer significant light pollution from street lighting, see Plate 1. Many species of bats and other mammals are sensitive to lighting and will avoid areas which are illuminated. Bats are amongst the most sensitive receptors in relation to light pollution originating from development². The strong street lights will cause disturbance to bats of roosting and foraging opportunities. Lighting impacts are considered significant on all building frontages onto Moore Street. A thorough search of the ground floor rooms and 1st floor front room did not reveal any signs of bats

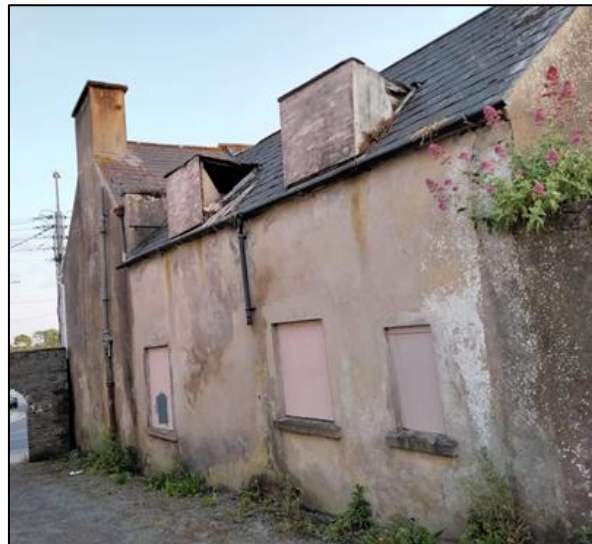
Plate 2. Building A, side elevation with extension (right of photo). Dormers set into roof allow bats easy entry but internal conditions are damp and draughty

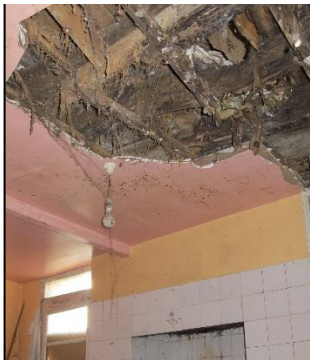
Plate 3. Building A. Ground floor ceiling with rotten timbers and collapsed plaster

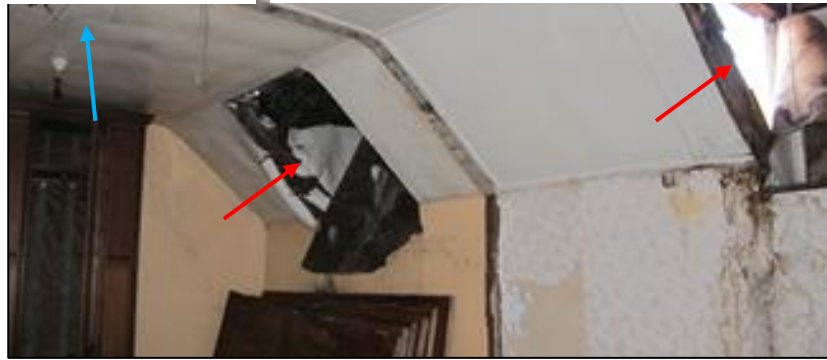
Plate 4. Building A. Internal view of dormers (red arrows). Attic (blue arrow) was not accessible and is limited in height to approx. 1 metre

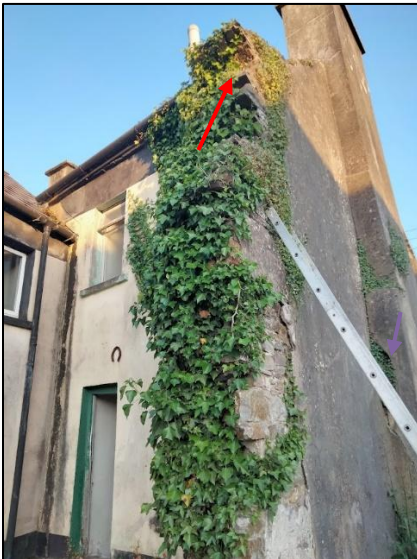
Plate 9. Building B. Rear view of building,
parapet with hole (red arrow) and cracks in
the wall render (yellow arrow)

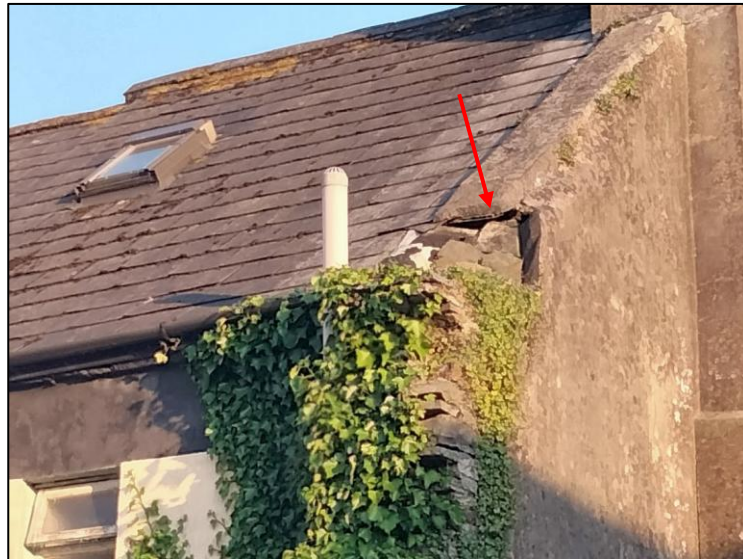
Plate 10. Building B. Rear view of building parapet
with hole (red arrow)

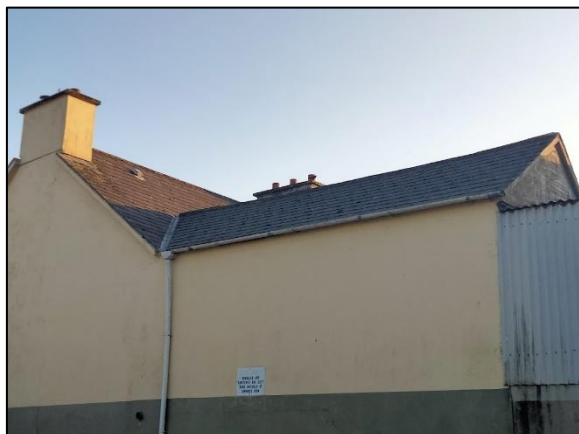
Plate 14. Building C. Gable wall and east facing wall of extension with pitched roof. Bat roost potential is low here

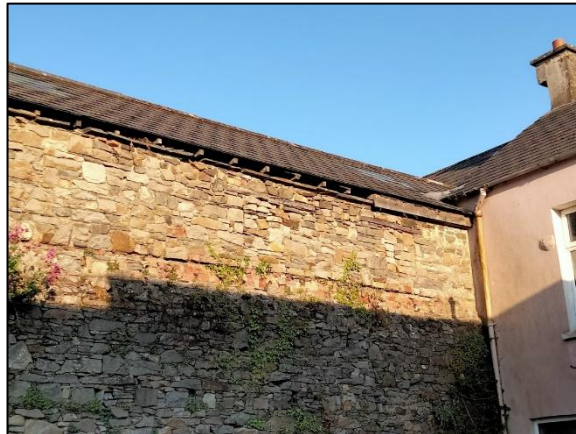
pitched roof of the extension has medium bat roost potential due to open rafters and sheltered dark spaces available.

Plate 15. Building C. East facing wall of extension with pitched roof. Building D on right, note holes in stonework and exposed end rafters. Bat roost potential considered medium

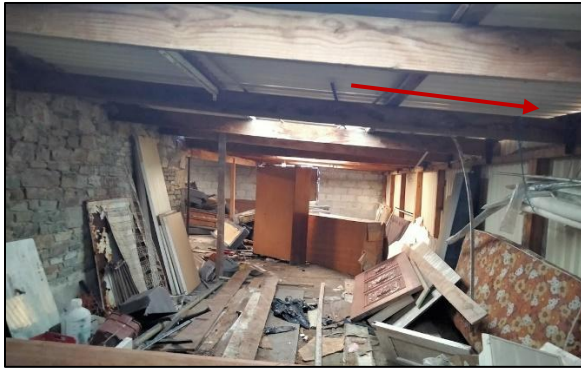
Plate 20. Building C Extension. First floor room in flat roof section, note box profile on roof sheeting (red arrow providing numerous holes. Daytime roosting potential was considered low with skylights flooding room with daylight

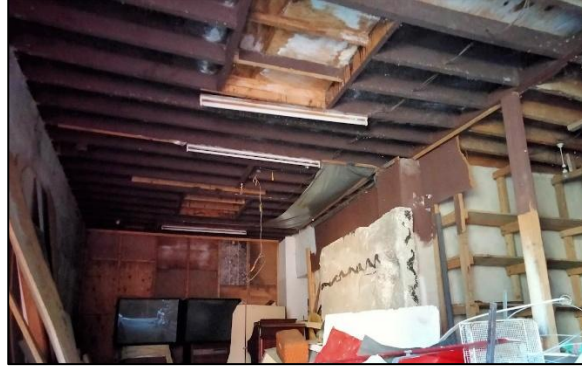
Plate 21. Building C Extension. Ground floor room which is normally in darkness, bats have no access to the ground floor

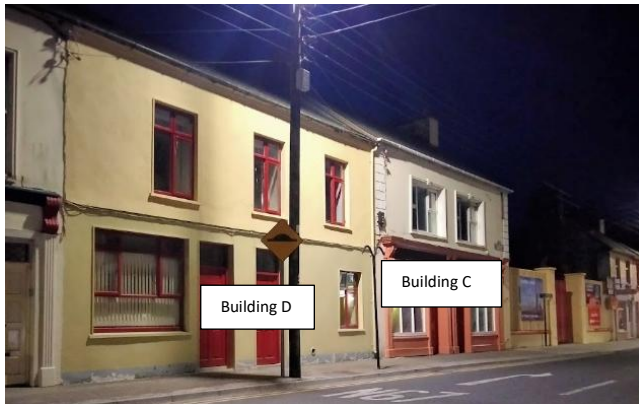
Plate 22. Building D. Front elevation, similar to all the buildings surveyed, the building suffers from significant light pollution deterring bat activity

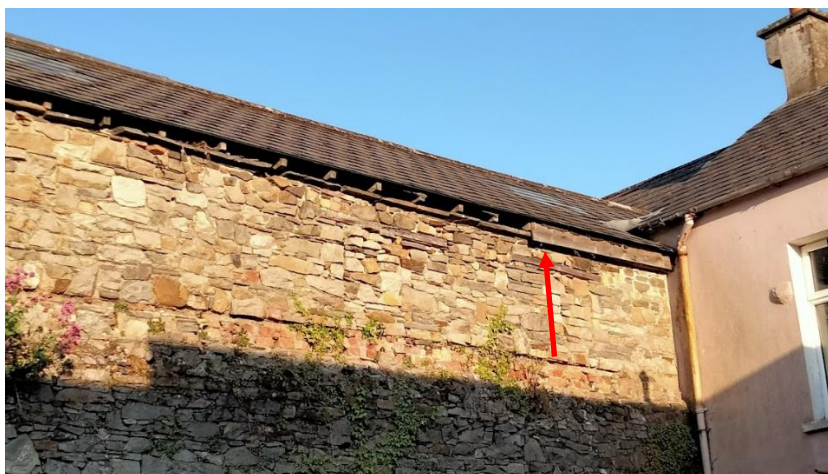
During the first emergence survey on the 3rd June, 2no. common pipistrelle bats were observed emerging from the western side of the extension roof of Building C. Subsequently, common pipistrelles were sporadically visiting the site on the western and northern sections for foraging, with one soprano pipistrelle detected with a faint recording. No bats were observed commuting through this section of the site. During the second emergence survey on the 5th June, the survey concentrated on the eastern part of the site and no bats were observed emerging from any of the buildings. Common pipistrelle bats were observed foraging with bats commuting across the site in an east-west axis. Soprano pipistrelles were not recorded and Leisler's bat calls were frequent but very faint, their calls coming from high over the site. No other bats were seen emerging from any of the buildings under consideration on either of the dusk surveys. No bats were observed entering any of the buildings during the dawn survey. A summary of the results and locations of all bats detected are presented in Table 4. It should be noted that these detections are bat passes and are indicative of levels of activity, rather than an actual count of bats.

Plate 28. Building C. Extension roof with location of common pipistrelle roost (red arrow). Building D on right.

2no. common pipistrelle bats were observed emerging from the extension roof of Building C. This roost can be categorised as a Day Roost (generally March-November). These roosts are used during the day to rest in. Males of most Irish species spend the summer roosting alone or in small groups with other males in such roosts. Bats may regularly use a number of day roosts, switching between them on a daily basis, though conversely they may occupy the same roosting site for several weeks.

Consideration should be given to the inclusion of purpose-built bat roosting opportunities within the proposed buildings on the site. It is recommended that integrated bat boxes are built into the external walls of the proposed buildings to compensate for the loss of potential roosting opportunities in the buildings demolished. An ecologist should be consulted during the design phase of the proposed development with regard to the choice and siting of integrated bat boxes within the building walls. Integrated bat boxes tend to be more permanent and less subject to disturbance than externally sites boxes (Gunnell *et al.*, 2012). One supplier is Schwegler available with various designs at <https://www.schwegler-natur.de/fledermaus/?lang=en>. (. (e.g Schwegler bat tube 1FR; Bat wall system 3FE))
