# Bat Report

**Final**

**August 2025**

JBA Consulting was commissioned to undertake bat surveys at a property in Castlecrine, Co. Clare, in response to a request for further information from Clare County Council regarding a proposed renovation and development project. The site comprises of an existing cottage and associated outbuildings, located within a landscape of improved agricultural grassland and mature hedgerows and treelines.

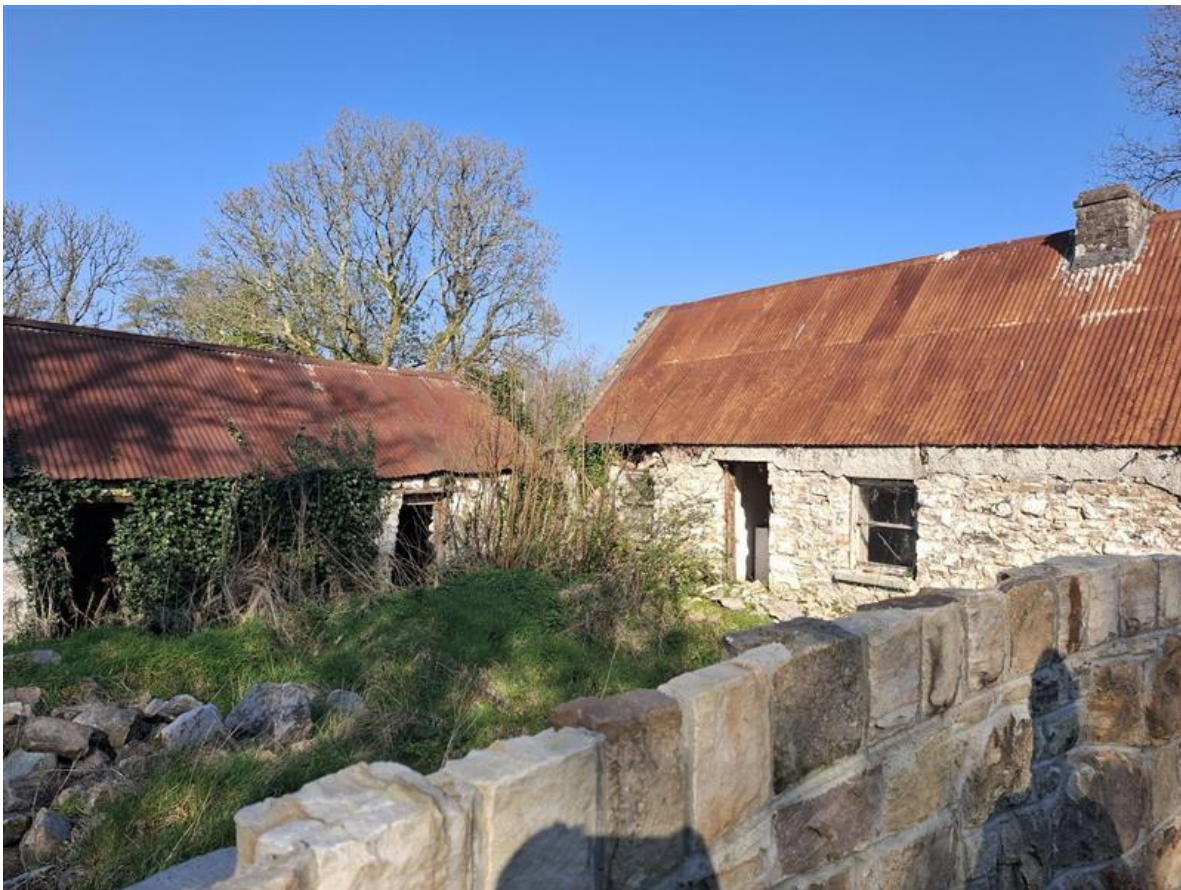
Figure 4-1: Photograph of the structures.

Two structures within the proposed project boundary were inspected for evidence of bats. Internal and external inspections of all structures were conducted, and evidence collected has been compiled below.

No evidence of bat activity or a bat roost was found within either of the buildings.

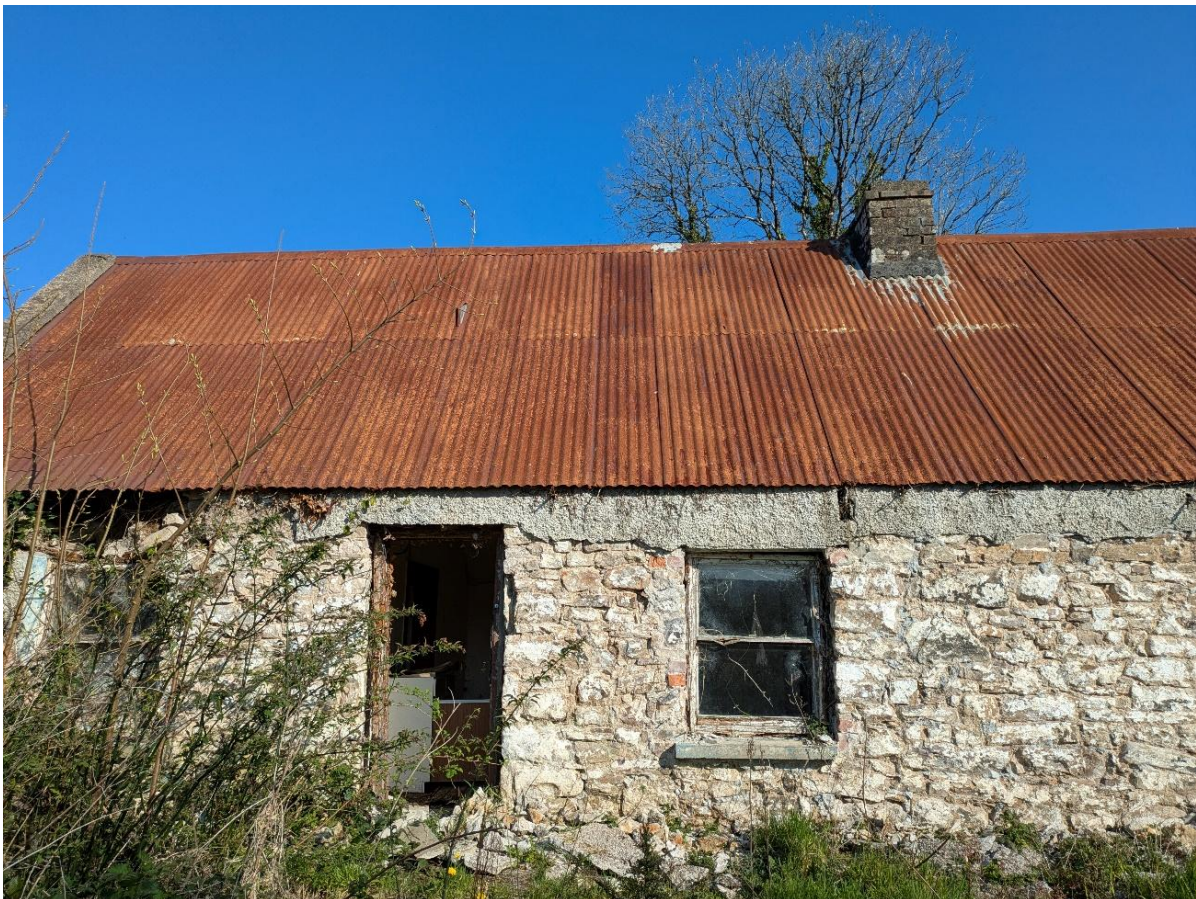
Figure 4-2: Cottage – exterior front view.

From the exterior, the cottage appeared unsuitable for roosting bats due to the galvanised steel roof, which typically offers poor thermal properties and limited

roosting opportunities. However, following an internal inspection, JBA ecologists observed that beneath the steel sheeting was the collapsing structure of an original thatched roof. Although parts of the walls were collapsed, it was evident that the internal roof space was enclosed, dark, and likely to be thermally stable – conditions that are consistent with roosting preferences of bats. The bats are flying into the attics where the beams have collapsed and broken through the ceiling and created holes (see Figure 4-12).

Although no physical signs of bat activity – such as droppings or staining – were observed during the inspection, the presence of a retained thatched roof and numerous access points to the attic space indicated that the cottage provides suitable roosting features for bats.

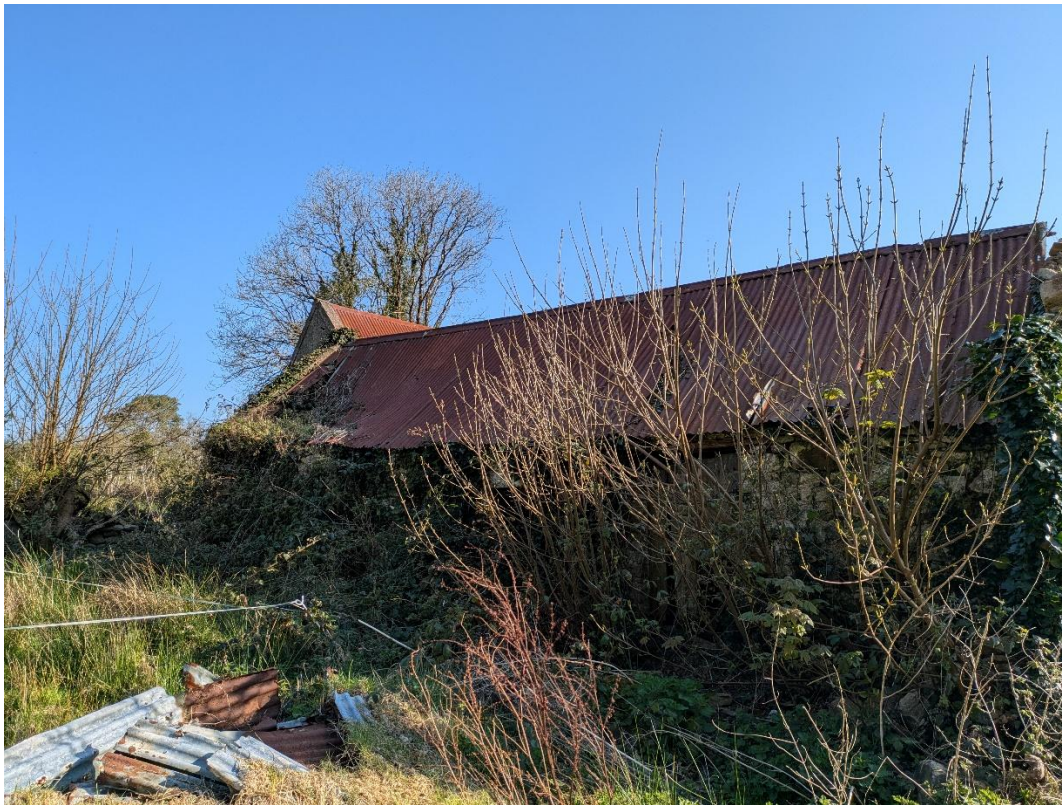
Figure 4-5: Exterior rear of the sheds.

Both sheds were deemed less suitable for bat roosting. Although there were dark crevices in places, damage to the steel roof at the rear of the building means that there is a lot of light entering the spaces. Additionally, the space does not provide much protection from adverse weather conditions and is not as thermally stable as the cottage.

No physical evidence of bat activity or a bat roost was found during the inspection of the sheds.

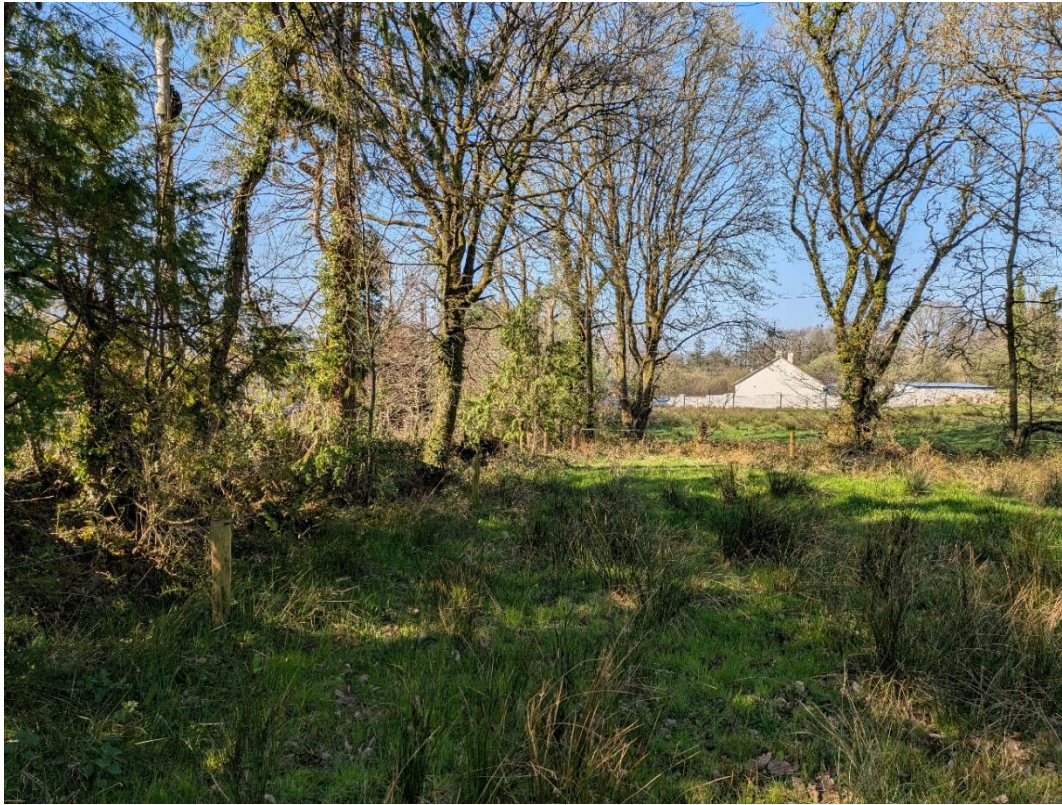
Figure 4-7: Photograph taken of site exterior habitats.

Based on the external habitat of the site, improved agricultural grassland with mature treelines and hedgerows bordering the area, it is likely that bats are foraging and commuting via the site. While commuting and foraging on the site is likely for common bat species, Lesser Horseshoe Bats prefer to forage in woodland or scrub within 2.5km of their roosts. Therefore, it is unlikely that Lesser Horseshoe Bats are utilising the site for anything more than commuting to woodland foraging areas. 400m north and east of the proposed site, there is approximately 100 hectares of woodland that is far more likely to be utilised by this Annex II species.

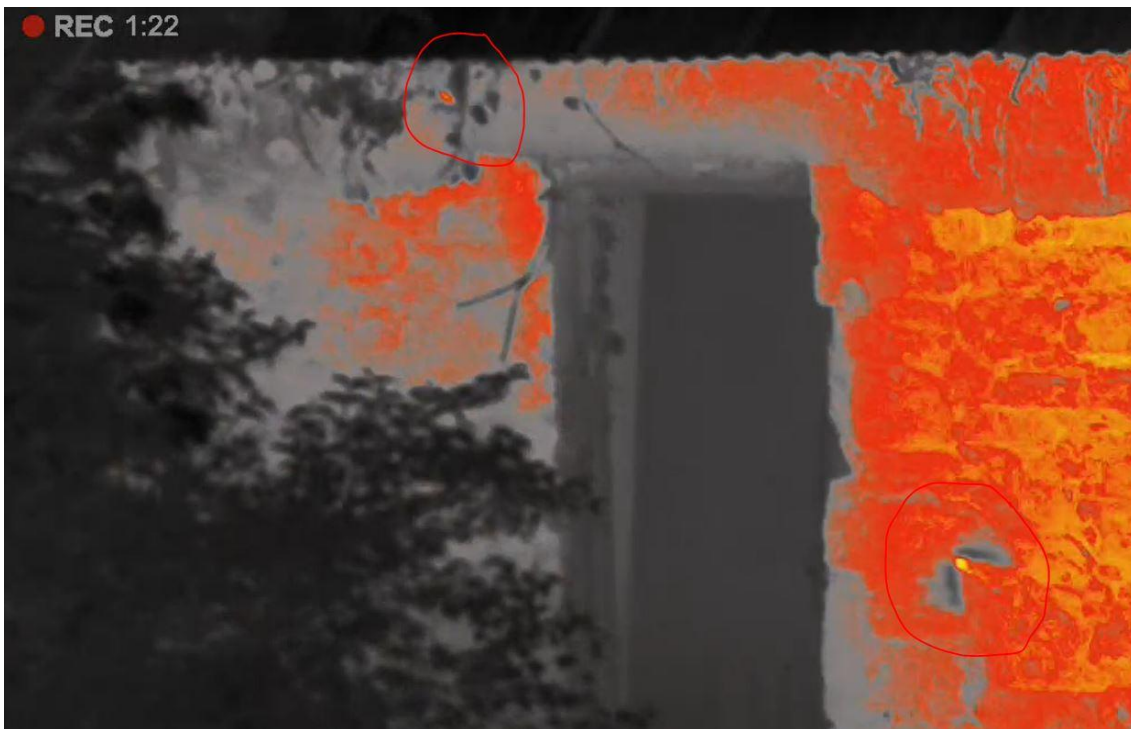
Figure 4-9: Two Lesser Horseshoe Bats flying out of the Cottage structure.

Time	Species	Location	Comments
21:18	Unknown	North boundary	Unknown species bat flew over the mature treeline on the northern site boundary, headed east. Commuting behaviour. Too fast to ID.
21:23	Pipistrelles (Soprano and Common)	Outside eastern boundary	Approx. 2-3 pipistrelles feeding in the agricultural field opposite the site (to the east).
21:26	Soprano Pipistrelles	West boundary	4 Sopranos flying overhead from west to east, along the mature hedgerows.
21:29	Soprano Pipistrelles	West boundary	2 Sopranos overhead, flying west to east.
21:35 – 21:47	Lesser Horseshoe Bats	Cottage and Sheds	Minimum of 3 LHB, likely more. Bats flew in and out of the doors of the cottage and sheds for approx. 12 minutes as the bats tested the light. Thermal imaging video and photo evidence was recorded (Figure 4-9, Figure 4-10, Figure 4-11). LHB flew east, over mature treelines.

The emergence survey conducted confirmed the presence of an active bat roost within the cottage while utilising the adjacent sheds, with a minimum of three Lesser Horseshoe Bats observed emerging and re-entering the buildings during the survey, likely light testing, consistent with pre-emergence behaviour.

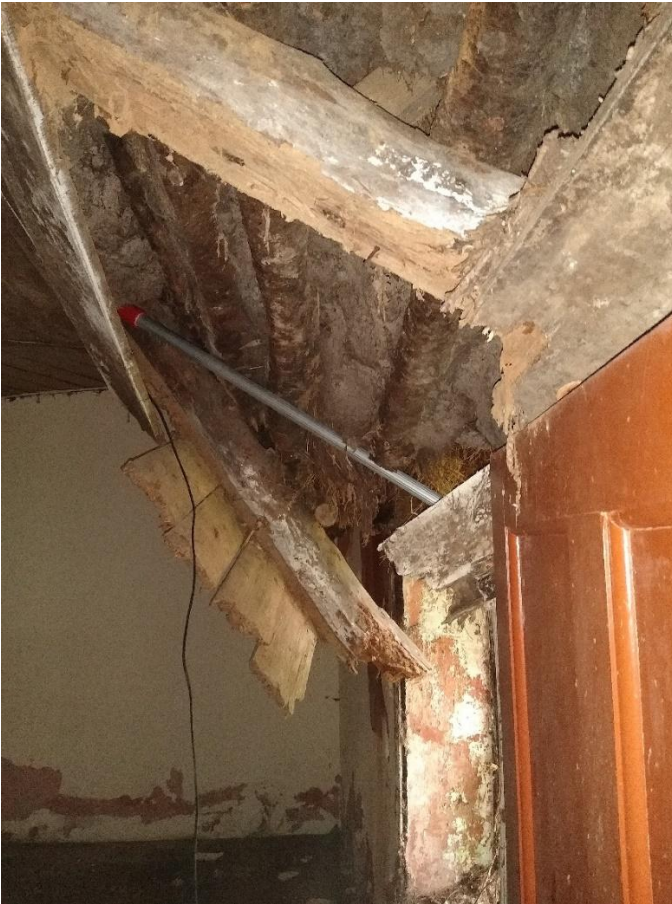
Figure 4-12: Photograph of the microphone in the attic void of the cottage.

Following the first emergence survey which confirmed a small number of Lesser Horseshoe Bats on site, a bat static detector was deployed within the cottage from 26<sup>th</sup> May to 3<sup>rd</sup> June 2025. The detector was strategically positioned with the ultrasonic microphone on an extension lead placed in the attic space, an area identified as having suitable roosting conditions (Figure 4-12).

The detector was programmed to record when triggered from sunrise to sunset each night, capturing echolocation calls during peak bat activity hours. Upon retrieval, the recordings were analysed using specialist bat call analysis software (Anabat Insight). Three bat species were identified in the recordings: Lesser Horseshoe Bat, Common Pipistrelle, and Soprano Pipistrelle. All three species are known to utilise built structures and surrounding vegetation for roosting, commuting, and foraging, particularly in rural environments. Soprano and Common pipistrelle were only recorded on a single night, and only 4 and 2 calls were recorded indicating very limited usage of the structure.
