# BAT DEROGATION LICENCE APPLICATION SUPPLEMENTARY REPORT

Prepared for Michael Guiney for works under the  
Community Monument Fund 2025

Kilgobbin Castle, Stepside, Co Dublin

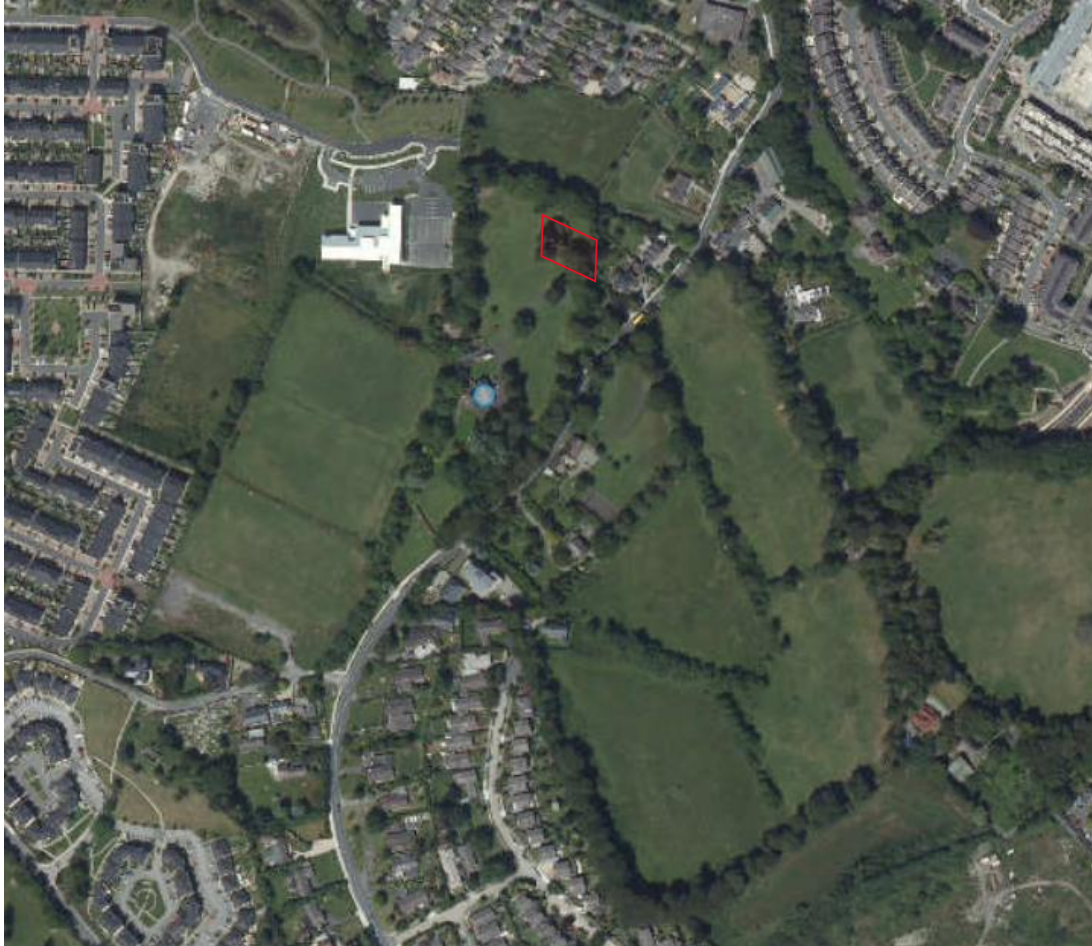
Figure 2-1 Aerial imagery of lands

Kilgobbin Castle is located in private land as part of the garden of Mr Michael Guiney who lives in a house on the same lands. The location is in Stepside, Co Dublin (53.259659682267575, -6.212725289226657). See Figure 2.1 for site location over aerial imagery and map. The site footprint is confined to the castle only and no other works are proposed outside this boundary. The castle is currently fenced with heras fencing due to its poor structural condition.

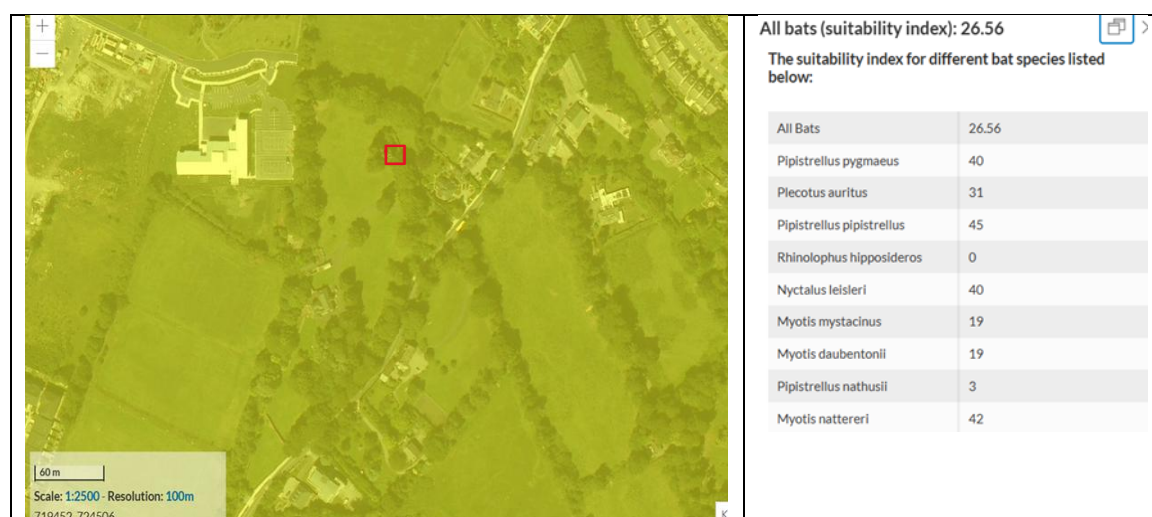
The bat habitat landscape suitability index (BCI) was also consulted and as shown below the overall suitability index across all bat species is 26.56. The maps are a visualisation of the results of the analyses based on a 'habitat suitability' index. The index ranges from 0 to 100 with 0 being least favourable and 100 most favourable for bats. The maps are constructed using spatial units of the OSI National Grid. The index presented is for all species combined, in addition to the individual species' indices as shown below in the table.

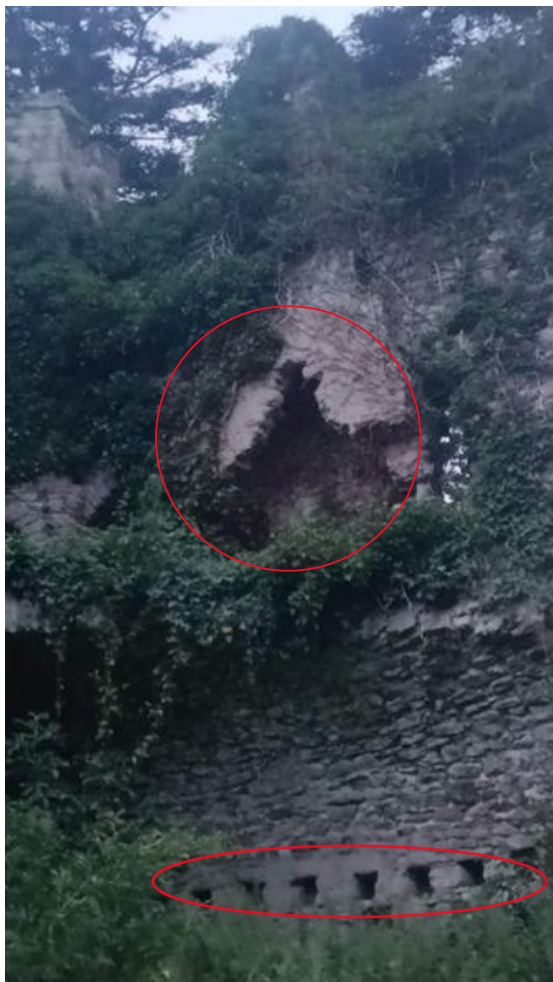
Photo 3-1 potential roost features at Kilgobbin Castle

Kilgobbin Castle is considered to have high roosting potential for bats. The building, although roofless, does offer a many roosting features including gaps, cracks in the stonework and mortar. The castle also has a number of features that could offer sheltered and dark habitat for roosting bats, these include the barrel vault and rectangular holes for former joists as shown below in Photo 3.1. In addition, there is dense vegetation present on much of the surviving walls, including thick ivy that offers roosting potential for bats.

The two trees immediately adjacent to the fencing, whilst covered in ivy are classified as low PRF. This is due to the species type, of douglas fir with little visible cracks or crevices, and whilst dense the ivy stands are less than 5mm thick.

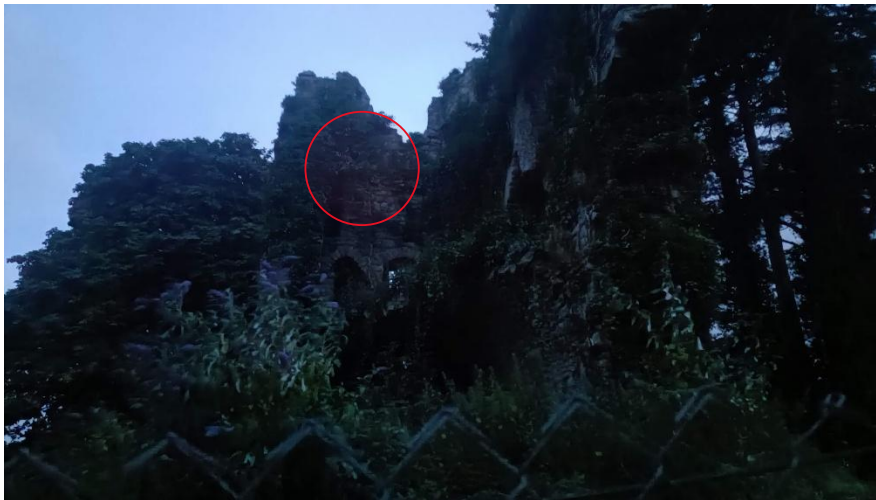
The most common bat recorded by the detectors were Soprano pipistrelle. The earliest bat species recorded was also Soprano pipistrelle at 22:15. A number of bats were observed during the survey, commuting and foraging around the mature treeline adjacent to the castle. Bats (soprano pipistrelle) were also observed commuting north east over a gap in the treeline. An individual Common pipistrelle was observed emerging from this area at 22:40 as indicated by red circle in the photo below. No other bats were recorded or observed emerging from the Castle over this emergent survey.

Photo 3-2 Red circle indicates approximate location of emerging Common pipistrelle at 22:40.

The bat survey results undertaken confirm that Kilgobbin Castle is currently used by bats for roosting purposes. One Common pipistrelle was recorded and observed emerging from the upper level of the north western part of the castle despite the building supporting numerous potential roost features. Based on the above results, the roost is used by at least one common pipistrelle, though numbers may fluctuate over time and conditions given the castle does include several features for potential roosting. Based on the above and application of Bat Mitigation Guidelines (2022) the roost is of low status, comprising at least one bat of common species, see Table below.

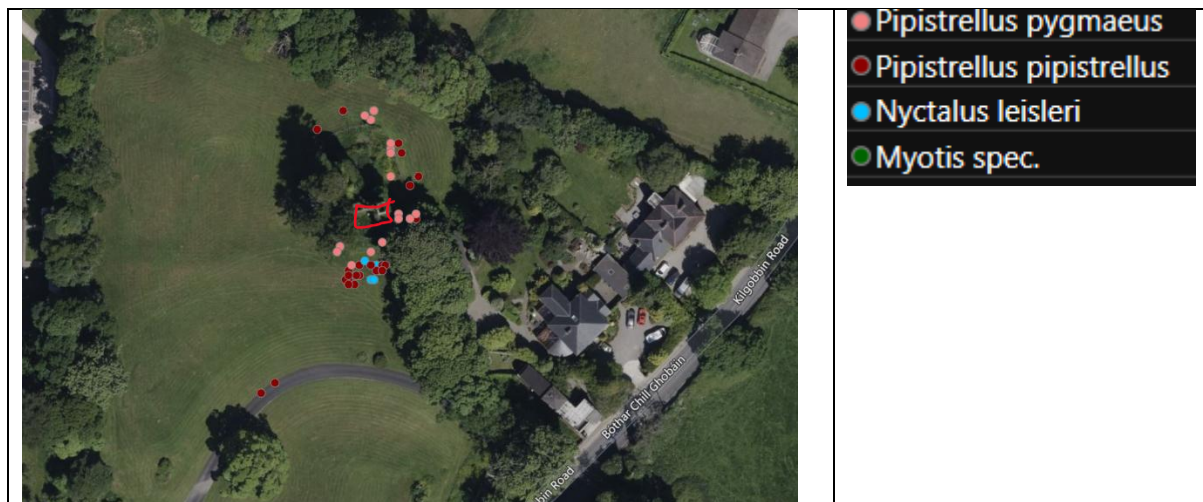
Figure 3-1 Bat species recorded during bat activity survey 4<sup>th</sup> July 2025
