REPORT IN SUPPORT OF AN APPLICATION FOR DEROGATION LICENCE UNDER  
REGULATION 54 & 54A OF THE EUROPEAN COMMUNITIES  
(BIRDS AND NATURAL HABITATS) REGULATIONS 2011, AS AMENDED WITH REGARD  
TO BATS OCCURRING AT KILPATRICK CHURCH

July 2025

Forest, Environmental Research and Services Ltd.

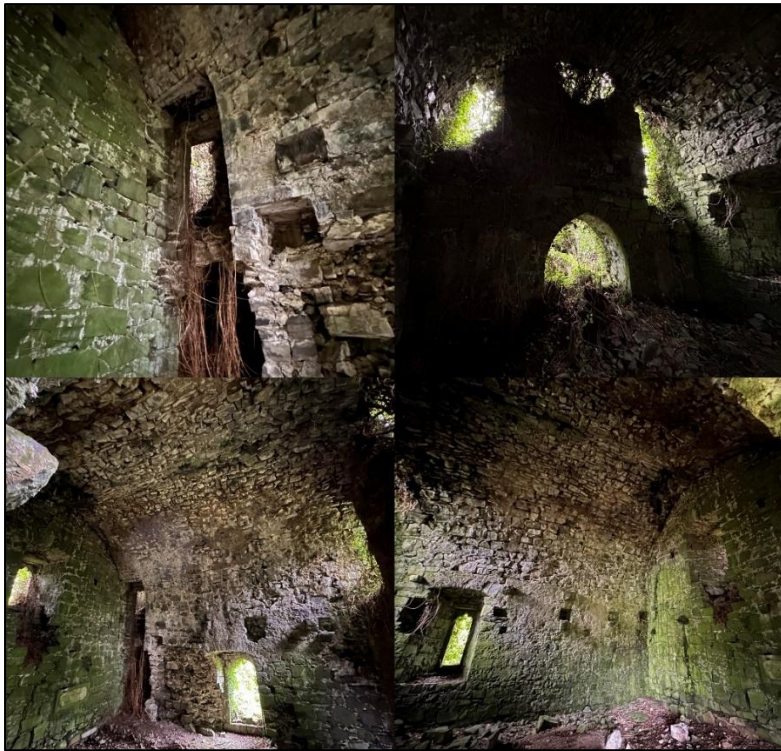
*Figure 5: Interior of structure*

Photographs of habitats inside the structure occurring are illustrated in Figure 5 and Figure 6.

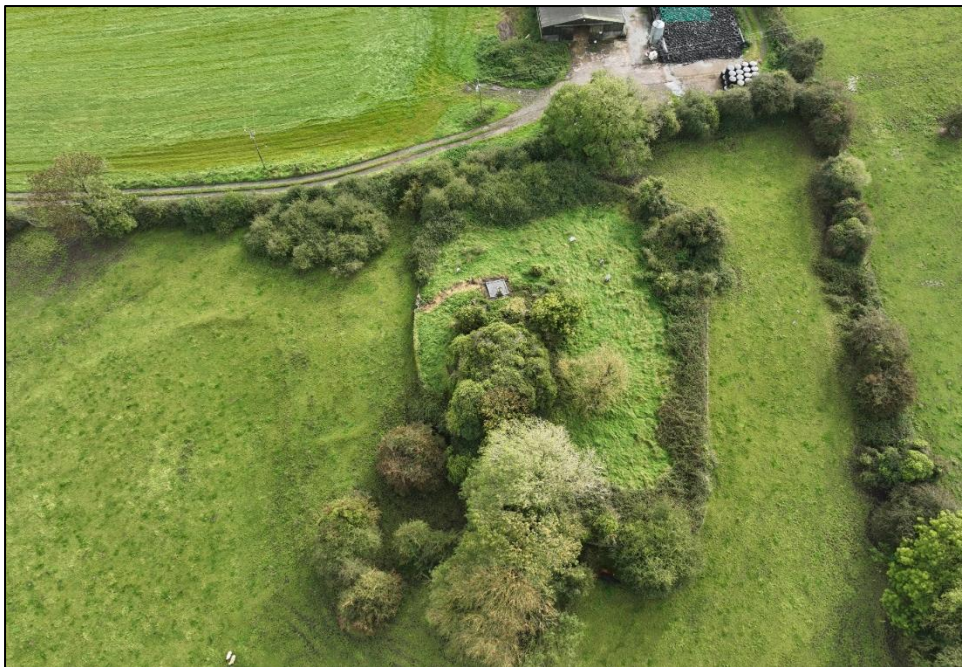
*Figure 6: Aerial overview of exterior of structure*
