# BAT DEROGATION LICENCE APPLICATION – MAAM COURTHOUSE

| Project Reference | 250342 |
| Subject | Maam Courthouse Refurbishment - Derogation License |

Photograph Survey of Maam Courthouse – 6<sup>th</sup> March 2024

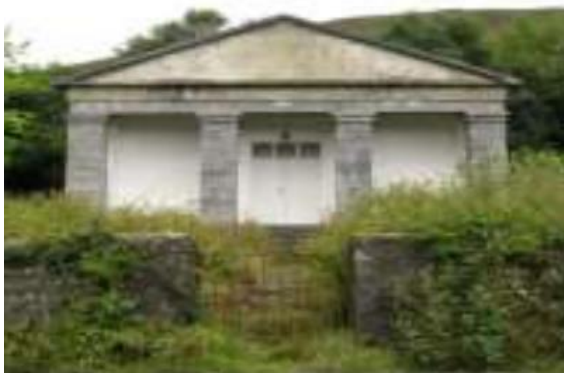
*Plate 1 Archival image of Maam Courthouse from the Galway Record of Protected Structures (RPS No. 554), showing the building prior to significant vegetation encroachment.*

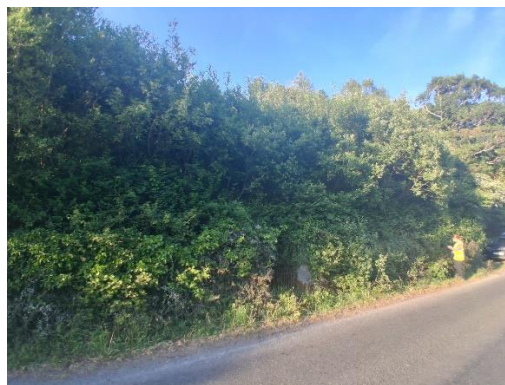
*Plate 2 Current view from the same location, illustrating the extent of vegetation overgrowth around the courthouse.*

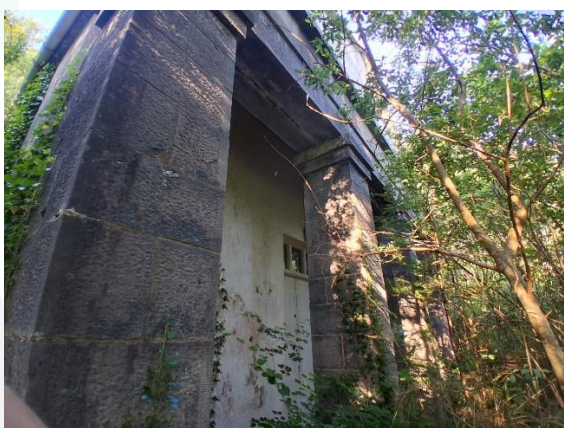
*Plate 3 View of the courthouse, now heavily obscured by overgrown willow vegetation.*

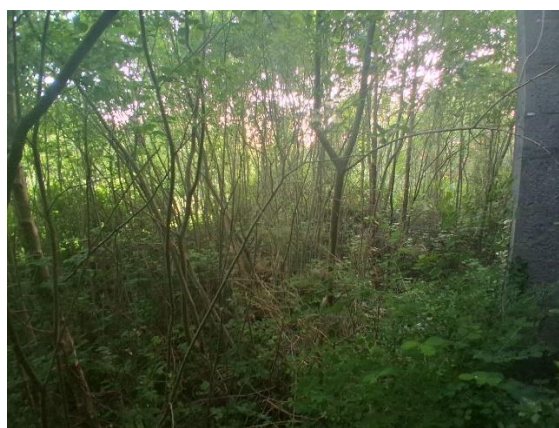
*Plate 4 Surrounding willow-dominated scrub encroaching on the courthouse.*

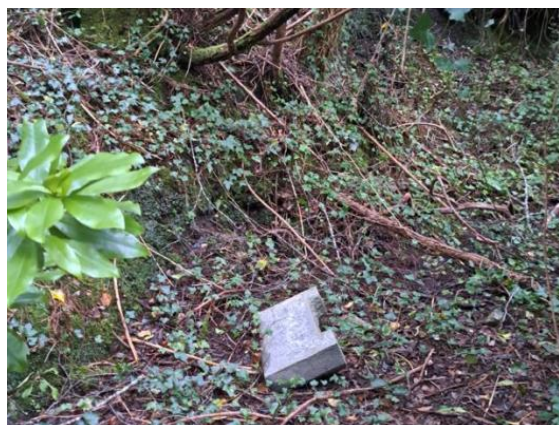
*Plate 6 Fallen chimney capping at rear of courthouse.*

- Chimney repairs will include:
  - Removal and replacement of the existing limestone capping (partially fallen).
  - Installation of new galvanised steel cowls into chimney pots.
- All rainwater gutters and downpipes will be:
  - Cleaned.
  - Steel components sanded, primed, and repainted, along with all associated fittings.

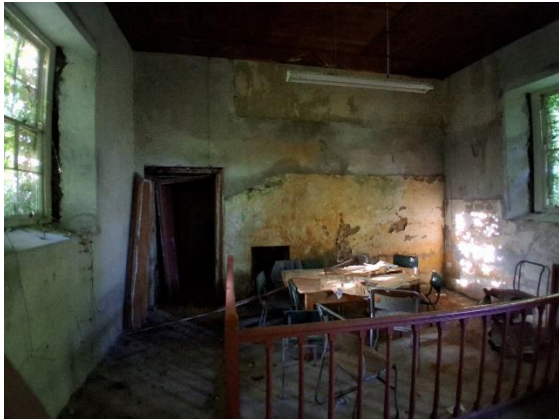
*Plate 7 Interior of the courthouse showing miscellaneous debris to be removed as part of the proposed works.*

- A 6 cubic metre skip will be provided to remove unwanted material from inside the building (Plate 7).

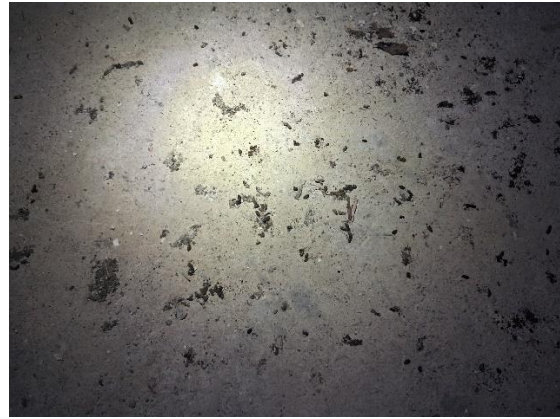
During the internal inspection of the courthouse on 15<sup>th</sup> May 2025, small accumulations of bat droppings were recorded on the ground floor within the main courtroom (Plate 8), indicating use of the building by roosting bats. No live bats or feeding remains were identified internally at the time of inspection, and access to the attic space was limited due to structural constraints (i.e. small cavity). However, visual inspection through a broken ceiling panel (Plate 10) and external observations, including a visible gap in the slate roof (Plate 11), confirmed that multiple potential bat access points are present.

*Plate 8 Small accumulation of bat droppings recorded within the main courtroom*

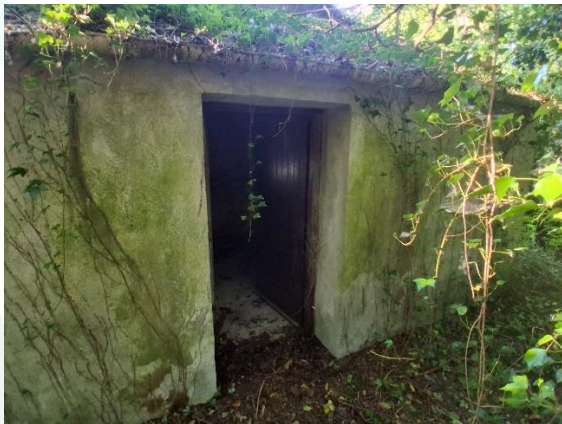
*Plate 9 Open door at rear of structure providing access for bats.*

- › If any timber treatment is required, only bat-safe, pre-treated, and fully dried timber will be used.
- › Access for bats will be retained through the existing open rear doorway and broken ceiling panel, as well as the hole in the roof, ensuring continued availability of the roost throughout the works. Should future sealing of the building be required, an alternative access point will be designed in consultation with the Galway County Council Conservation Officer and its specifications agreed with the NPWS.

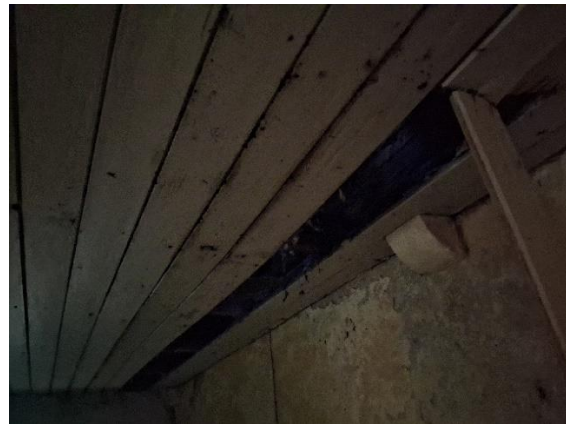
*Plate 10 Broken ceiling panel allowing limited visual access into the attic space, as well as a potential access point for bats.*

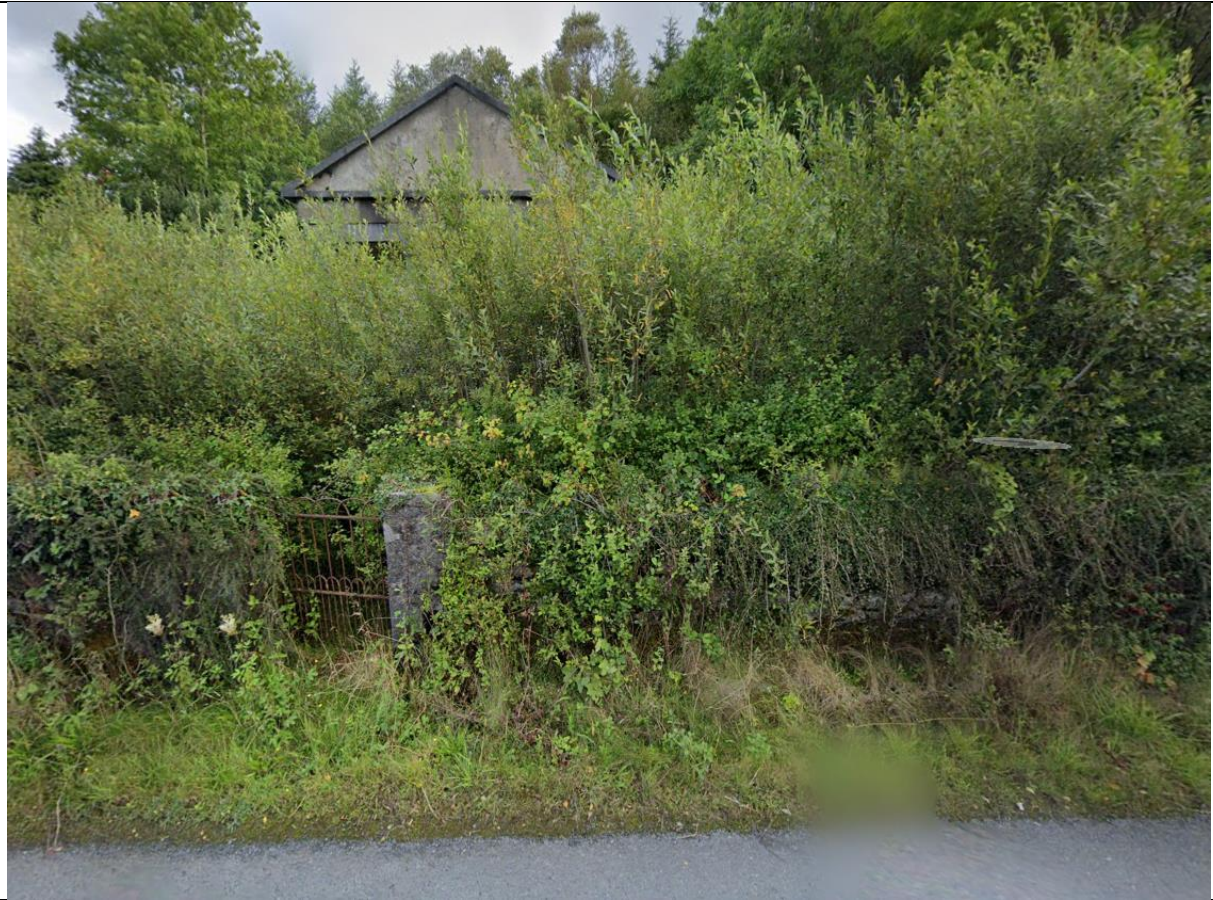
Front Entrance from the N59. This is the only entrance into the property.

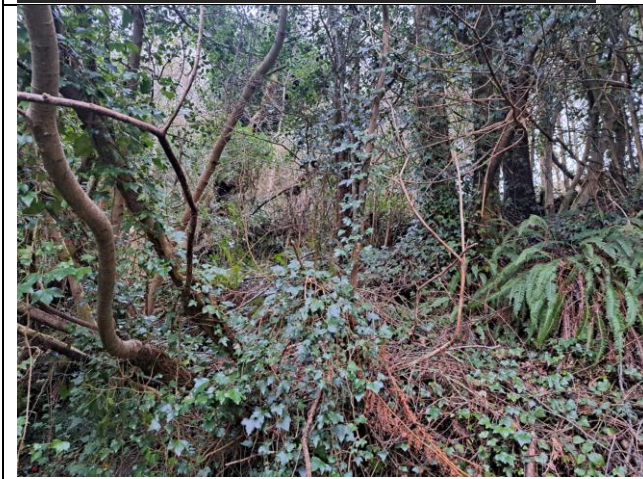
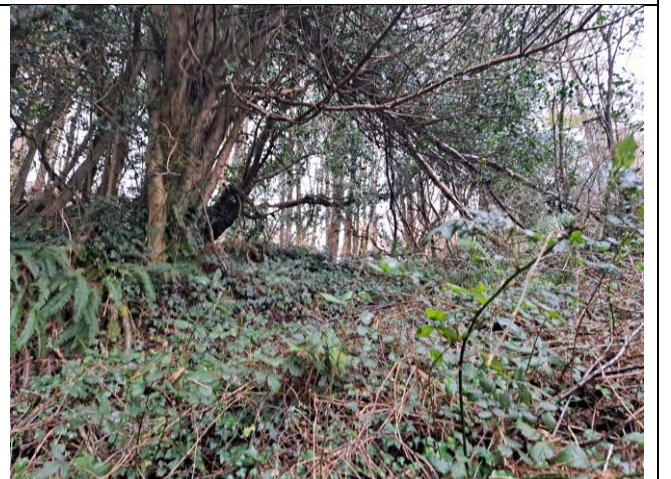
Remove all vegetation from the building.

All trees to be cut and removed off site. Any trees or branches of 125mm dia. Or smaller to be put through a woodchipper and all chippings left on site.

All vegetation removed from the external stone boundary walls.

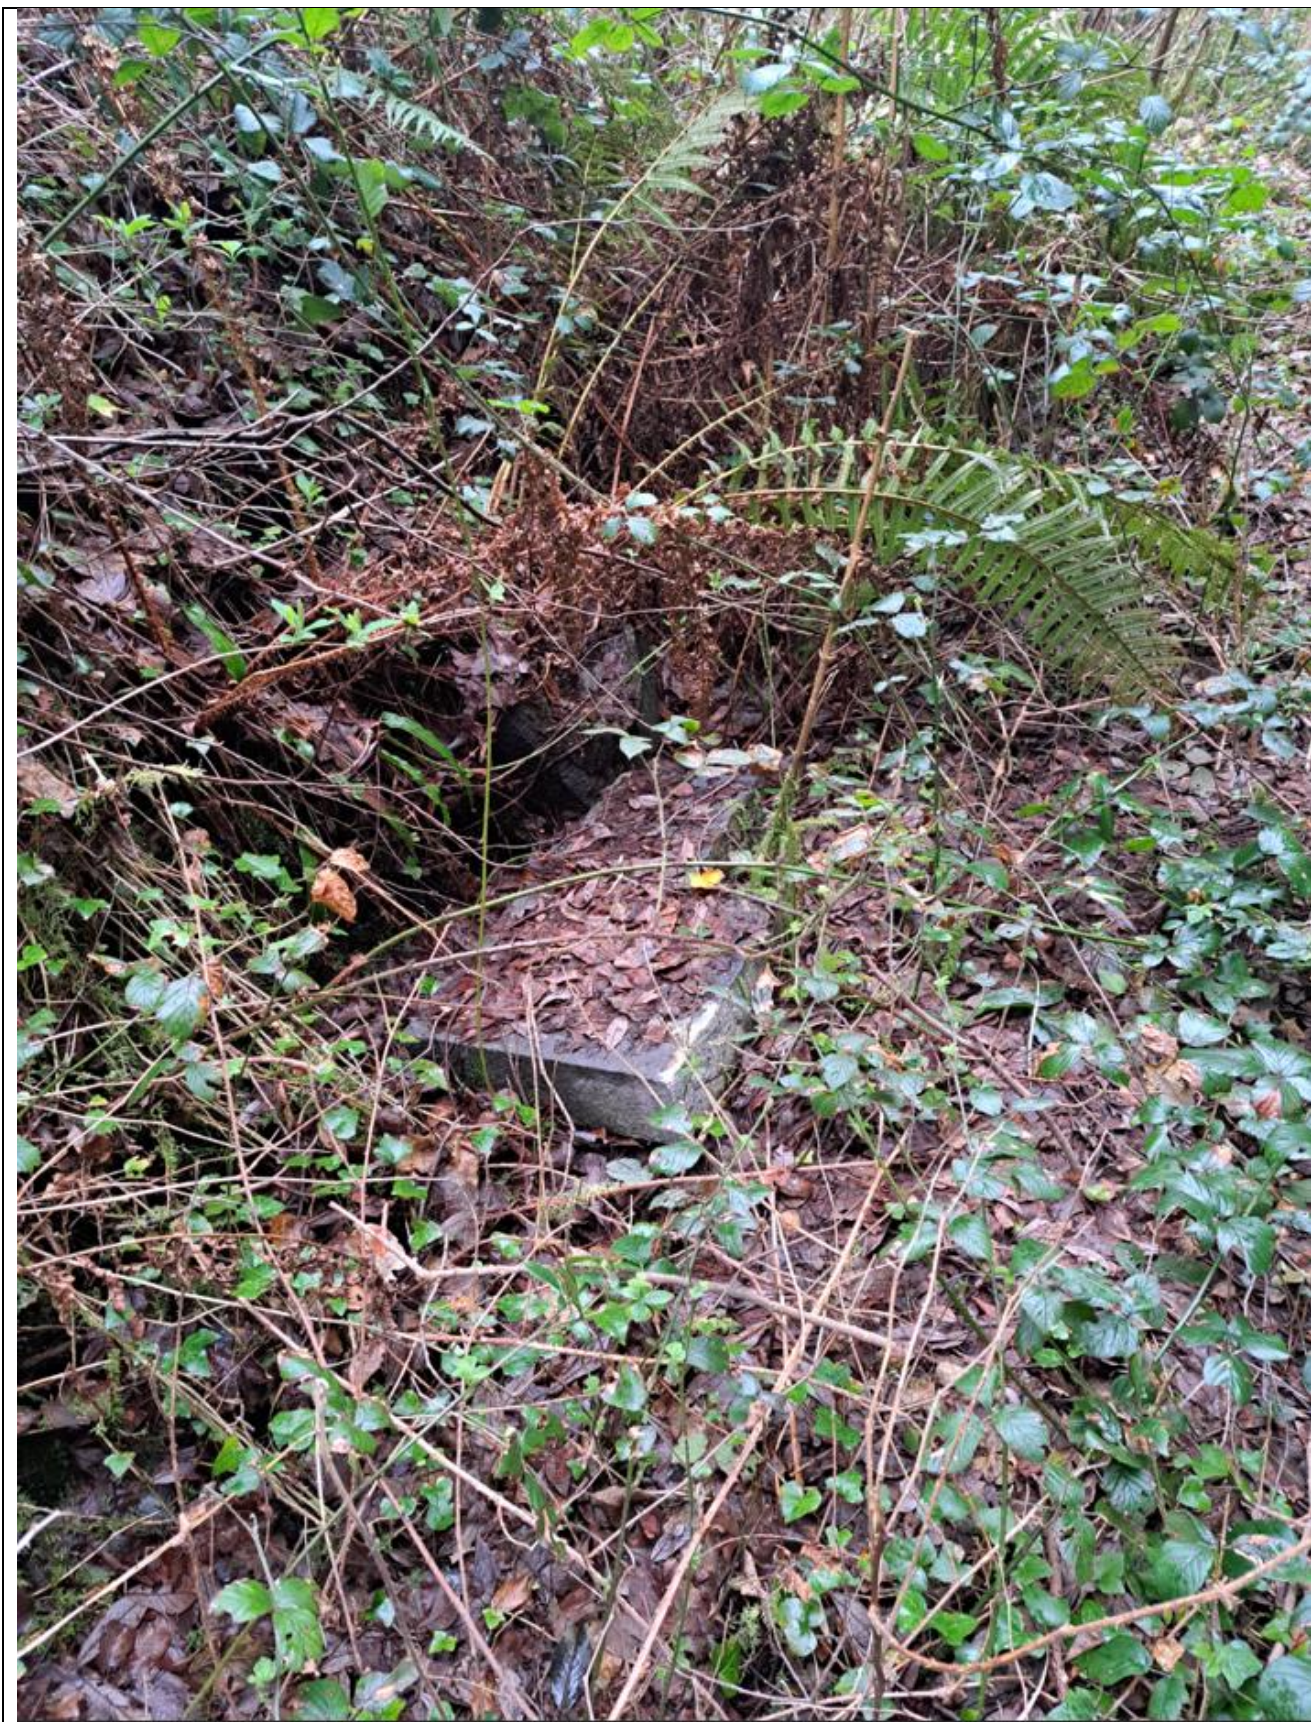
Chimney Works – Remove and replace limestone chimney capping. Some of the stone capping appears to have fallen onto the ground. Provide for new galvanized steel cowls into the chimney pots.

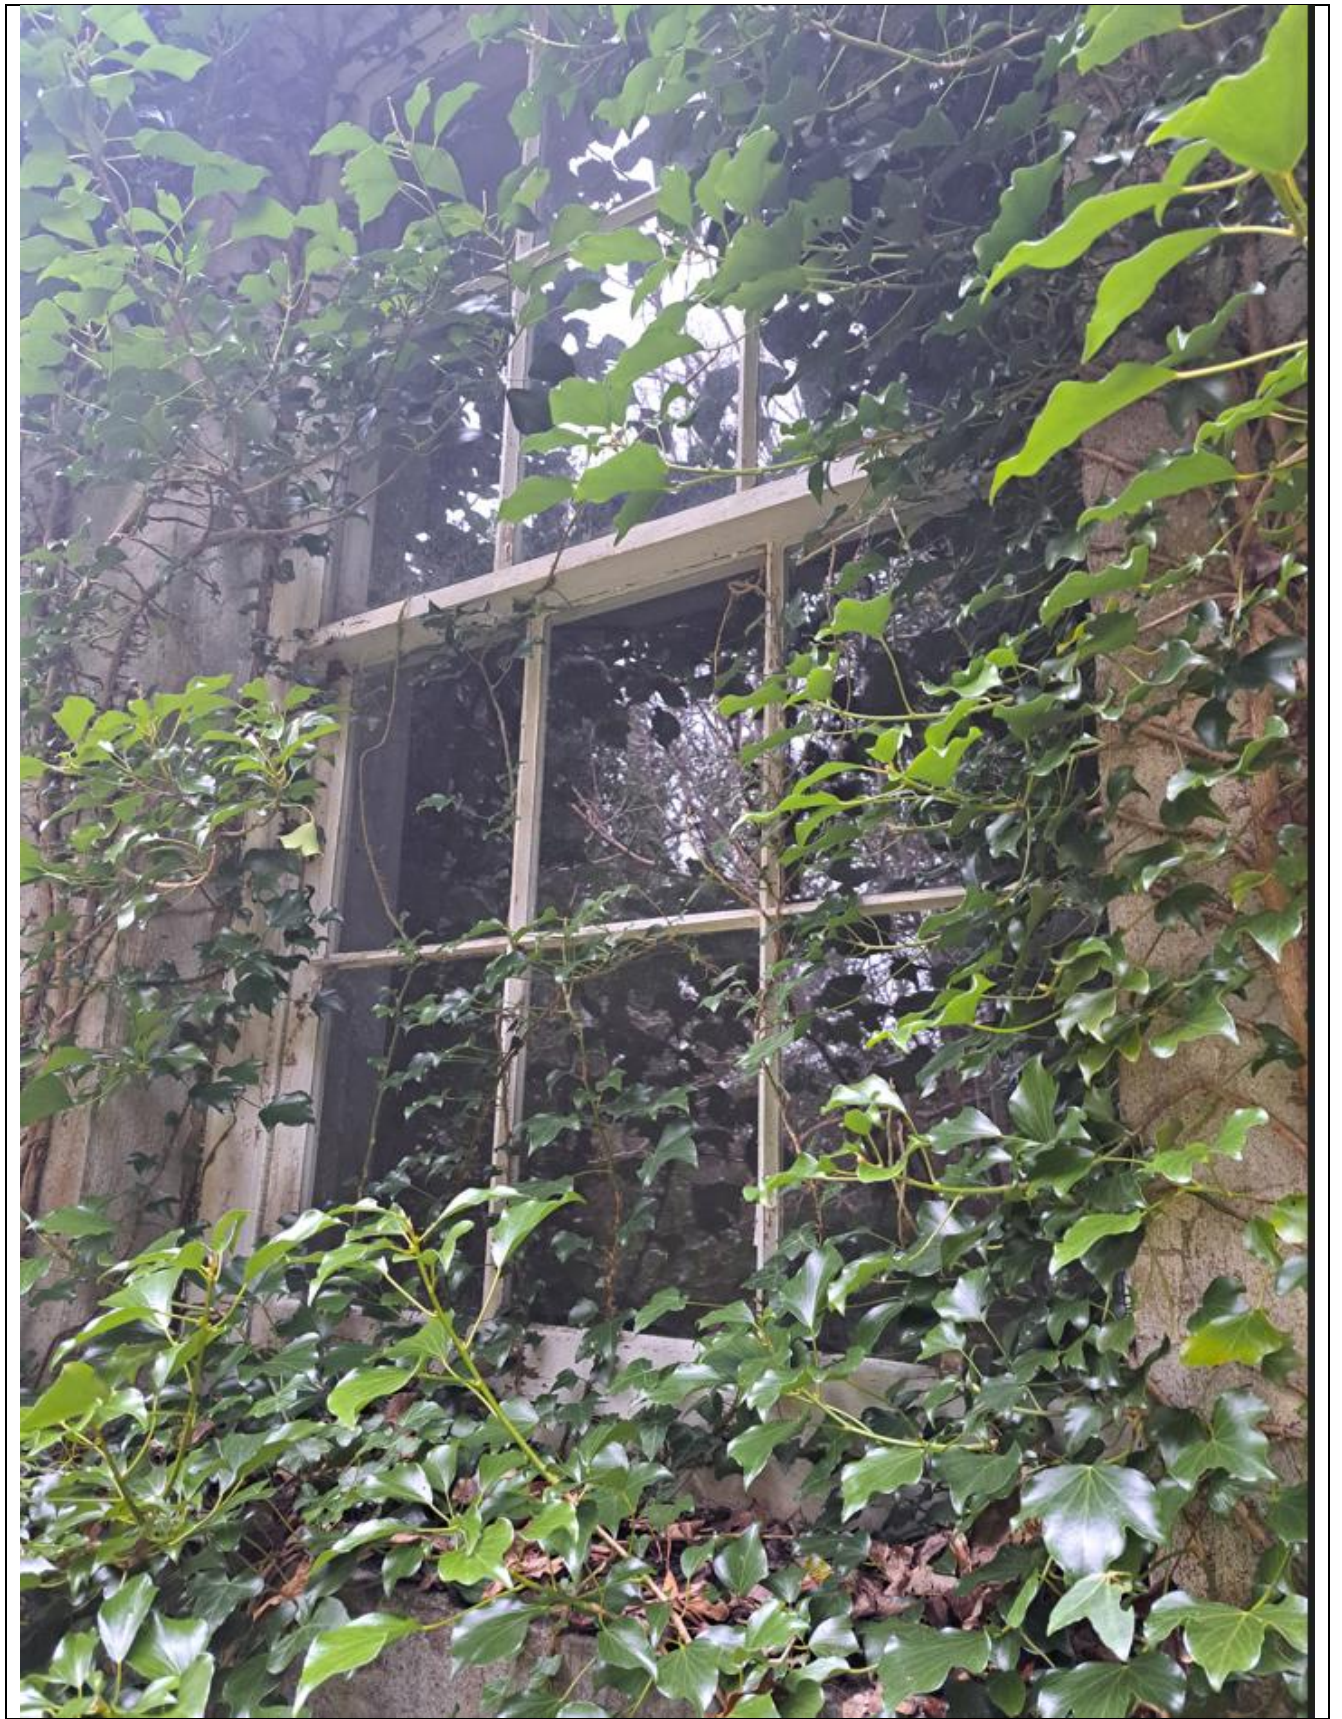
Three number external windows to be sanded, primed and apply two coats of weather proof paint. Replace all ironmongery to bring windows back into use. Include for replacement of one broken single panel of glass

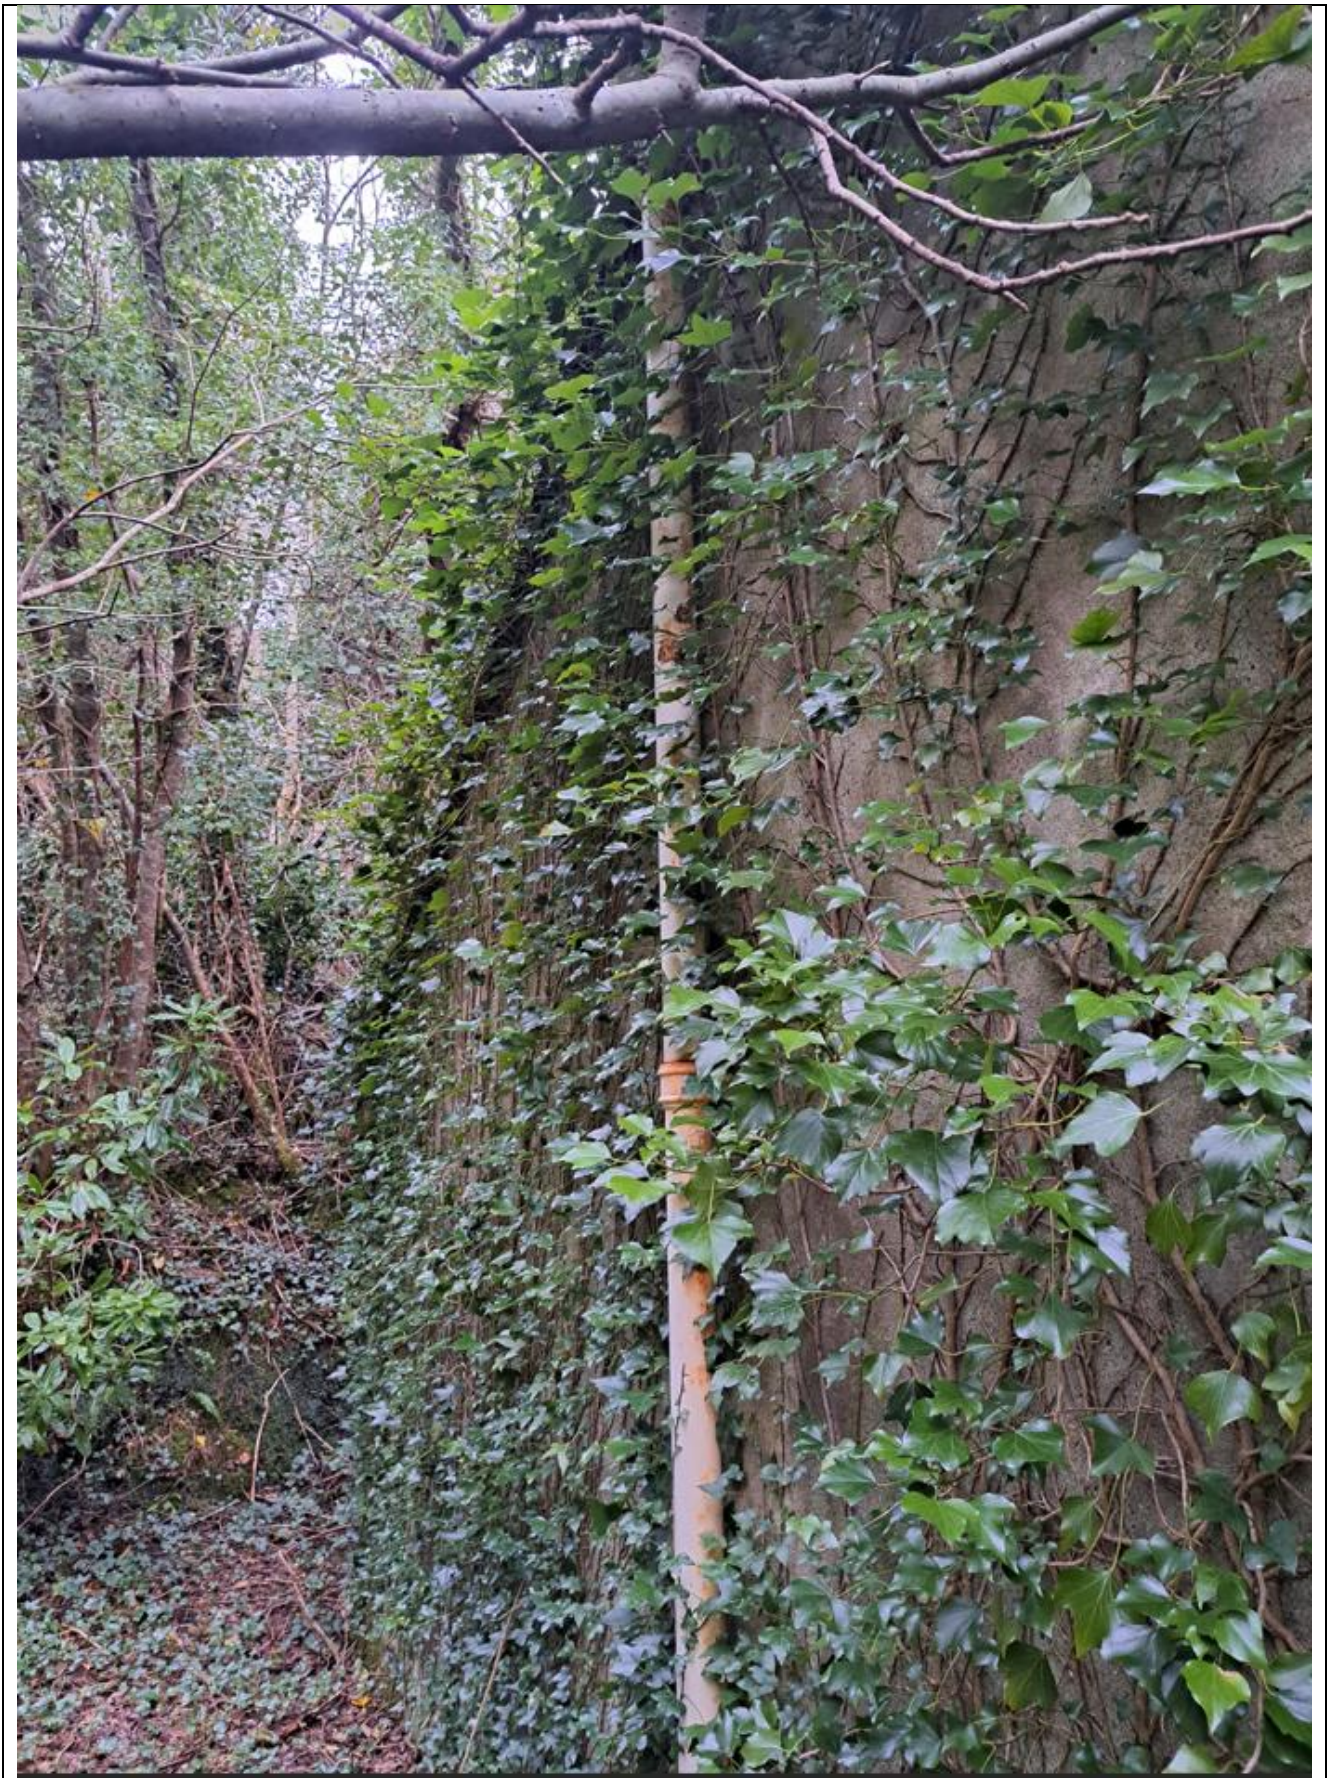
Clean all rain water gutters and down pipes on the building. Undertake sanding and preparation works to the steel gutters and apply primer and two coats of paint to these gutters and downpipes and all fittings.
