## **Derogation Application for repairs to Castlelost Church, Co Westmeath**

**Donna Mullen**

**Wildlife Surveys Ireland Aug 11th, 2025**

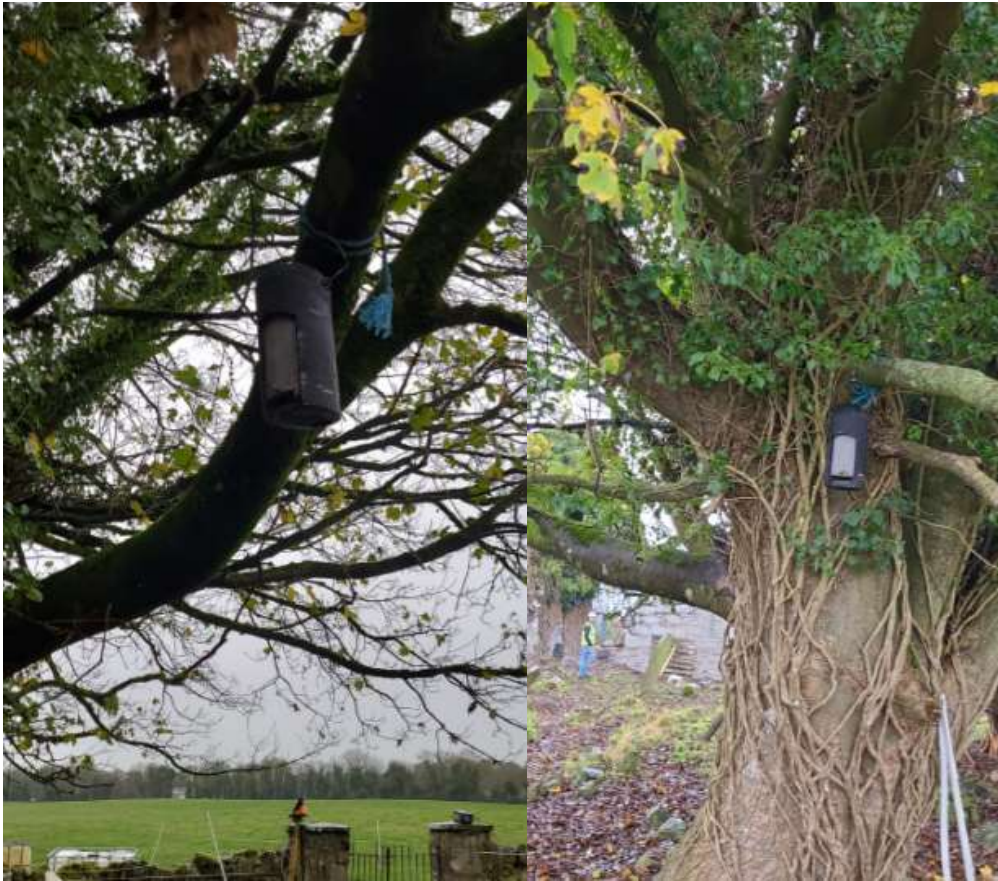
A tree on the site was identified for the bat boxes, which have been purchased and installed.

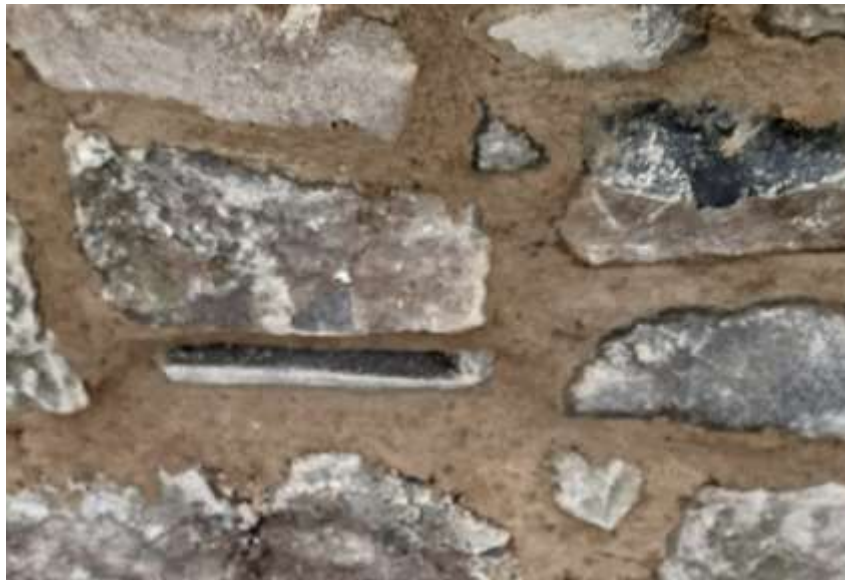
**Installed bat tubes.**

It was not possible to purchase the Schwegler bat tubes, so a similar type – Vivara pro bat tubes, and Woodstone bat boxes have been ordered. I have successfully used these boxes in Meath and Leitrim.

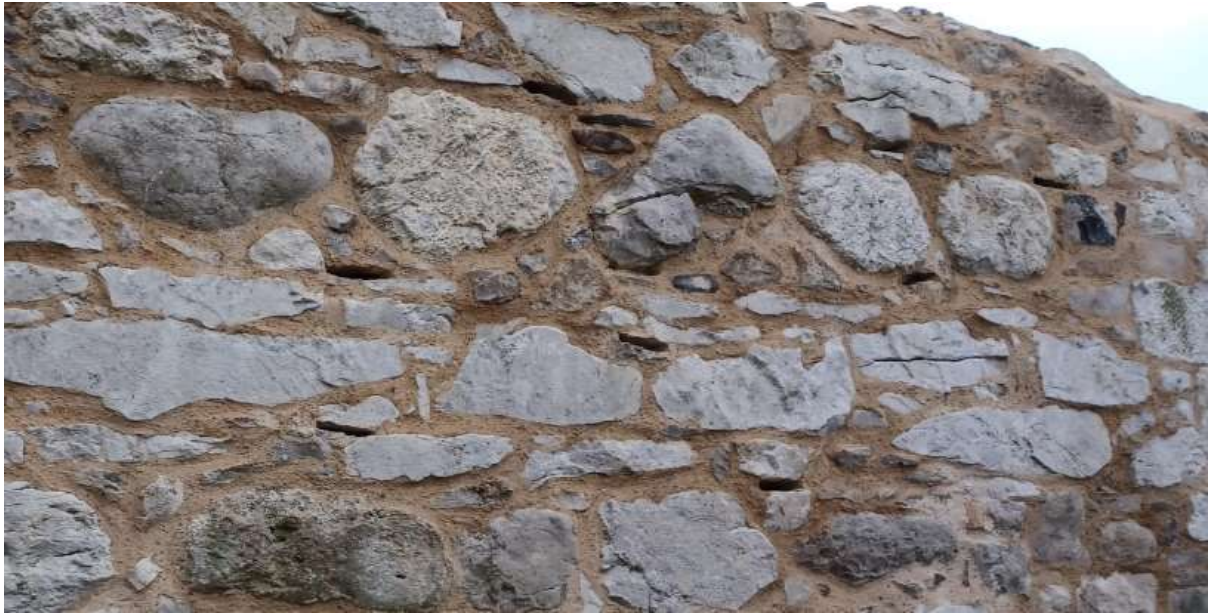
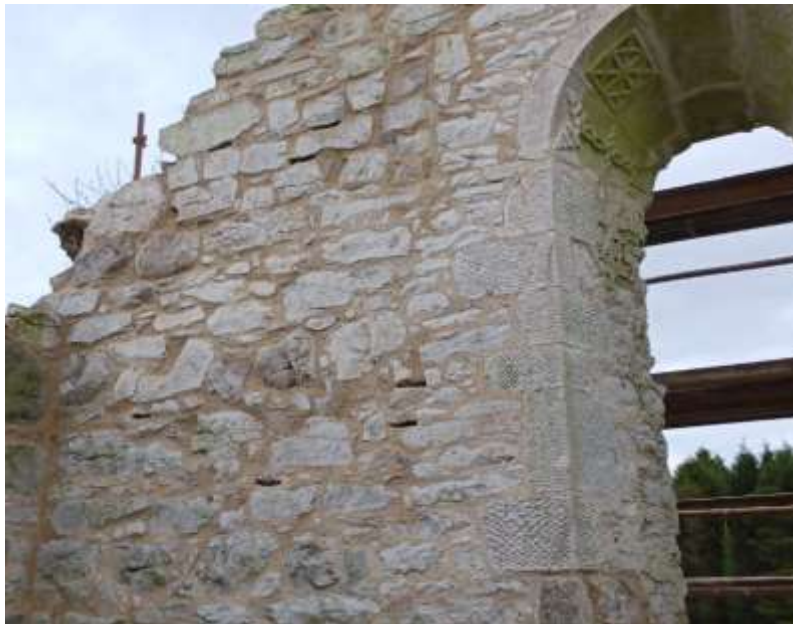
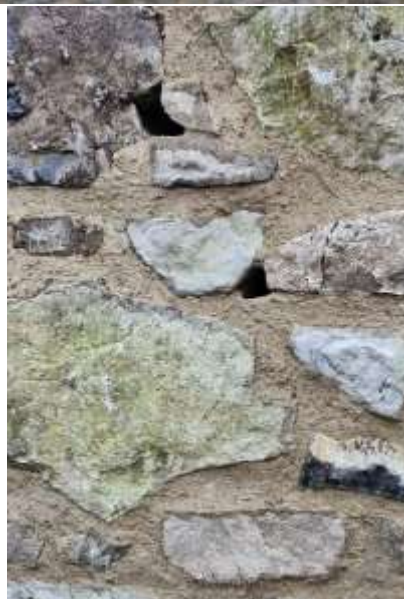
Each wall has at least 30 retained crevices of different depths and sizes.

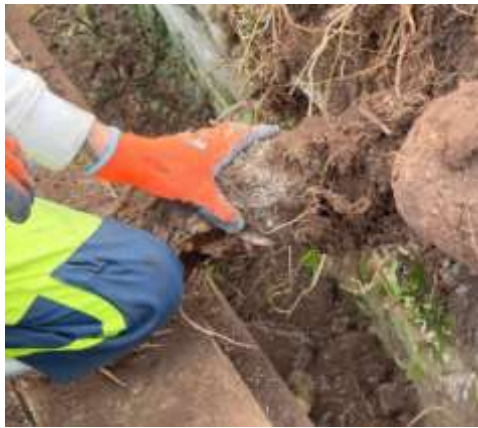
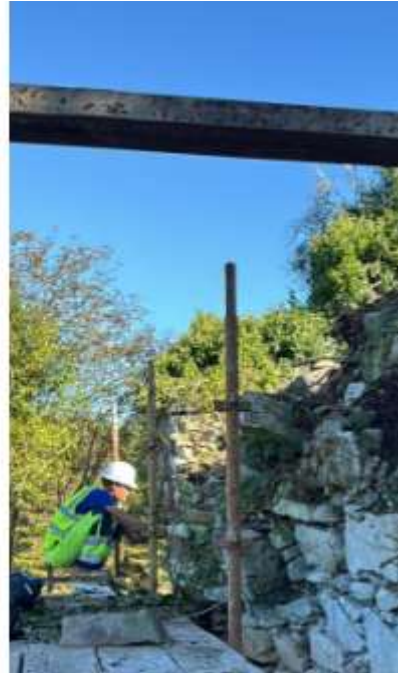
All stonework was undertaken carefully by hand.

On 26<sup>th</sup> September Donna Mullen discovered a brown long eared bat in the underground section of the church. This area was previously a roost and is not scheduled for stonework. The area was made safe from disturbance by people and animals. It was not present on a subsequent visit in October .Pallets blocking one of the roost exits on 25 October, were removed, and goats at the area were securely fenced.

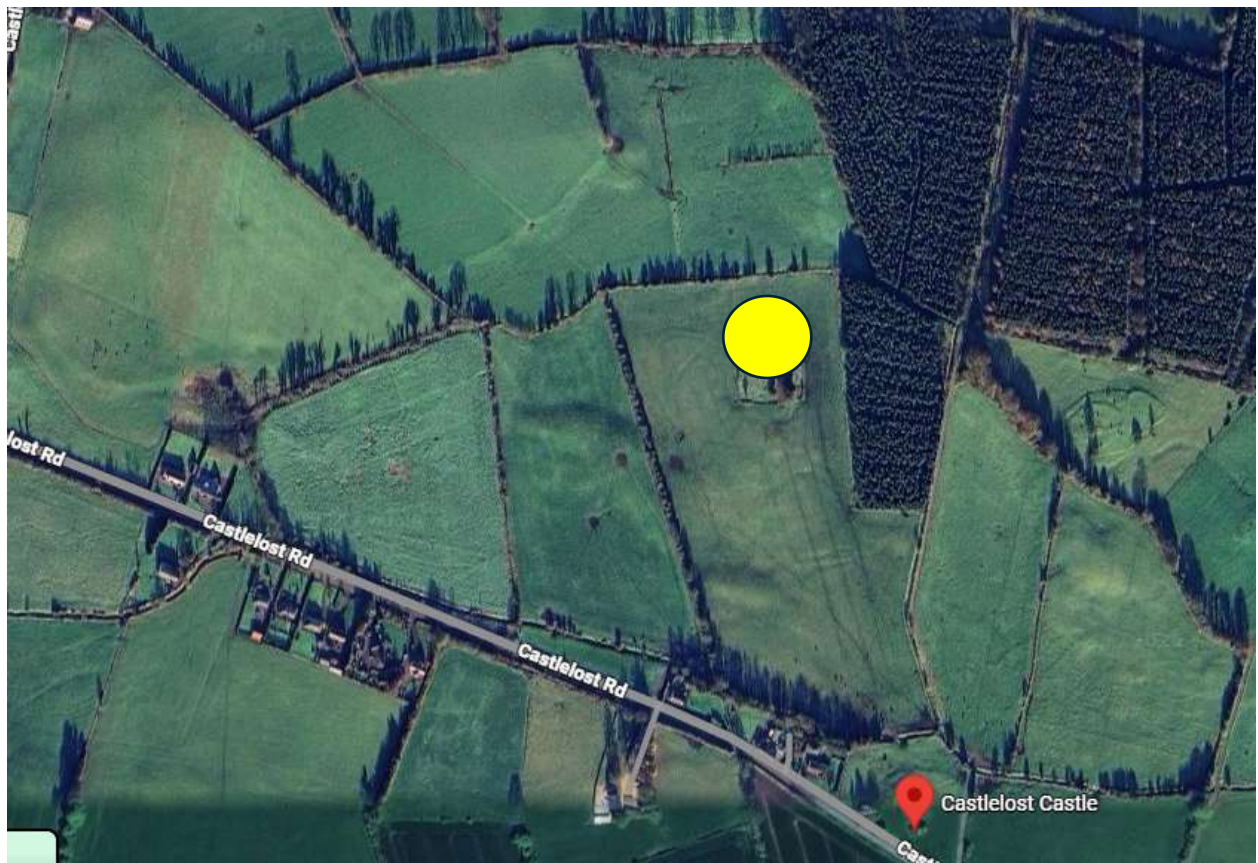
Map of site showing the wider area with ecological features

**Yellow circle = Castlelost church**

The site connects to farmland on all sides, with the castle to the south and a conifer plantation to the east.

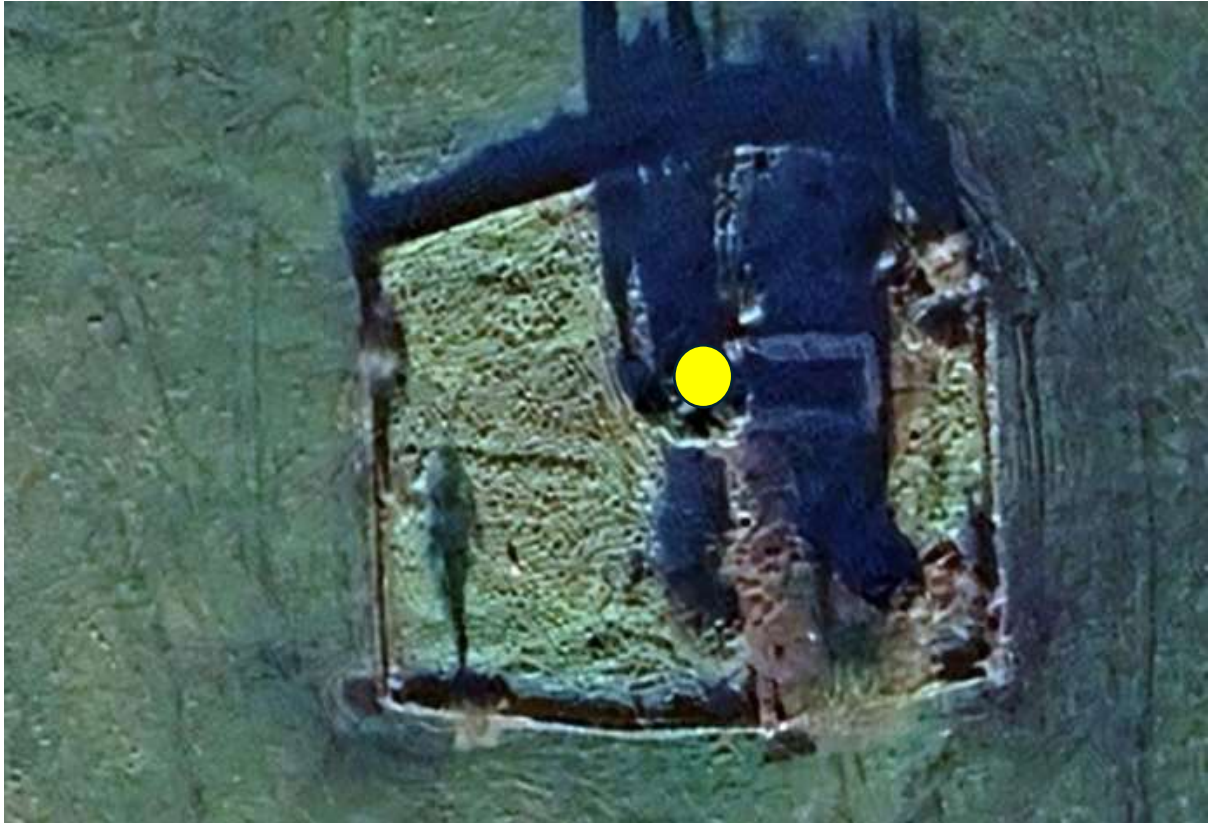
Yellow circle- bat roosting area

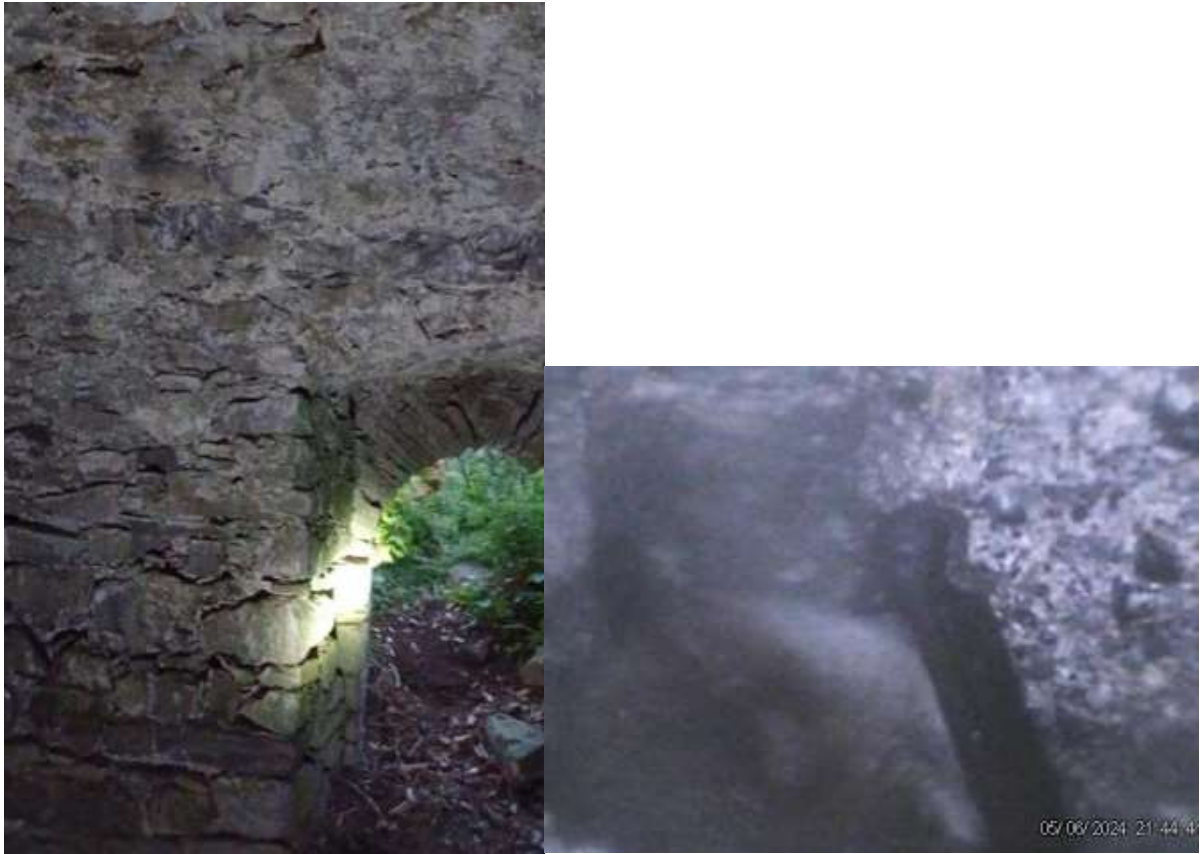
Daubenton's bat roosting area near doorway plus photo taken with a fibrescope in 2024. The brown long eared bat was in a crevice near the roof.

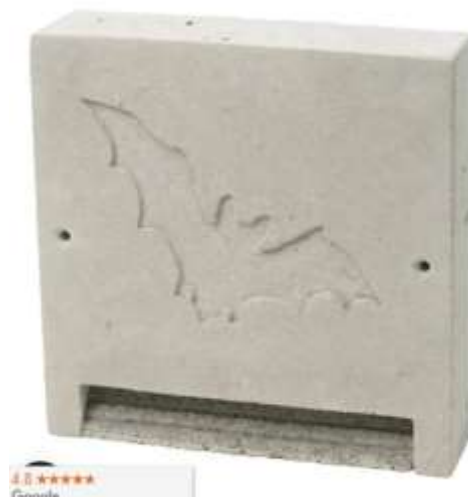
(2) As one bat access area will be blocked, a bat access brick must be fitted in this area, to allow bat access if the other exits are inadvertently blocked. It can be purchased from –

It must be used without the back plate to allow access into the roost area.

As an alternative, a gap can be retained in the existing area.

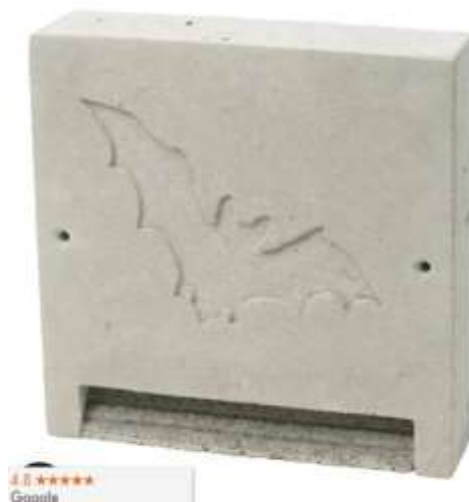
<https://www.veldshop.nl/en/ans-3-bat-box.html>

It must be used without the back plate to allow access into the roost area.

As an alternative, a gap can be retained in the existing area.
