## **Report on the implementation of mitigation measures on the Castlelost church Restoration Project.**

Wildlife Surveys Ireland Ltd

November 2024

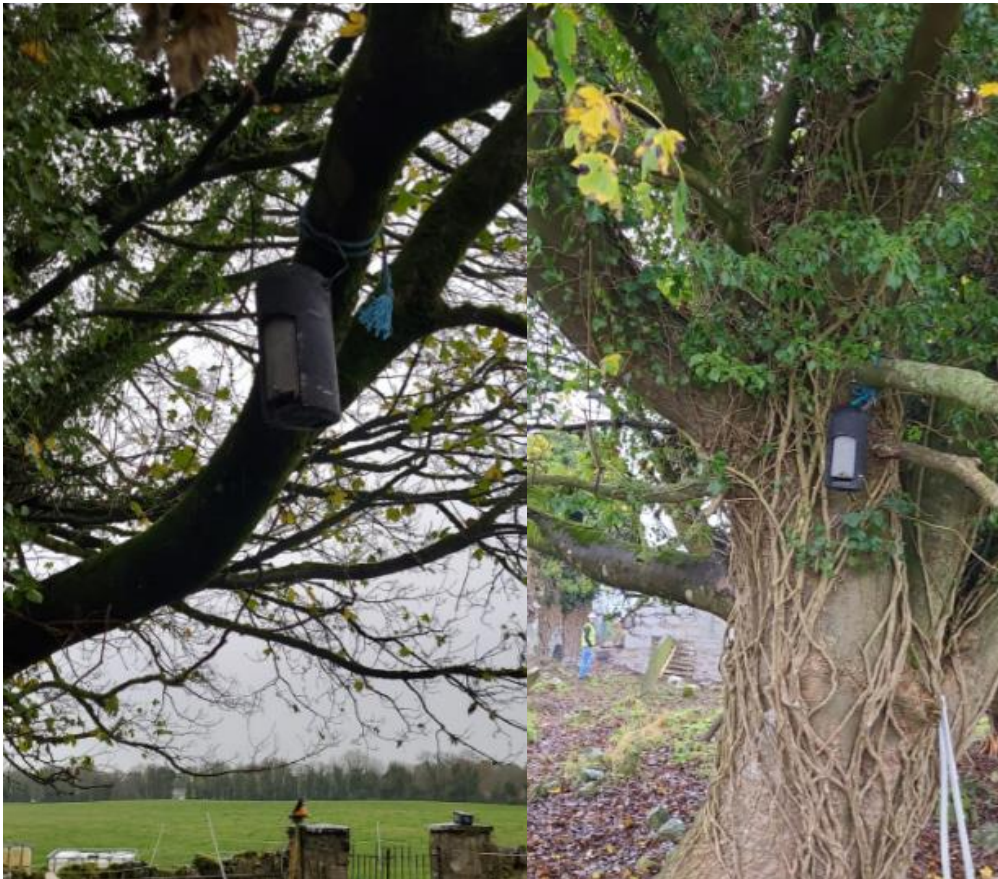
A tree on the site was identified for the bat boxes, which have been purchased and installed.

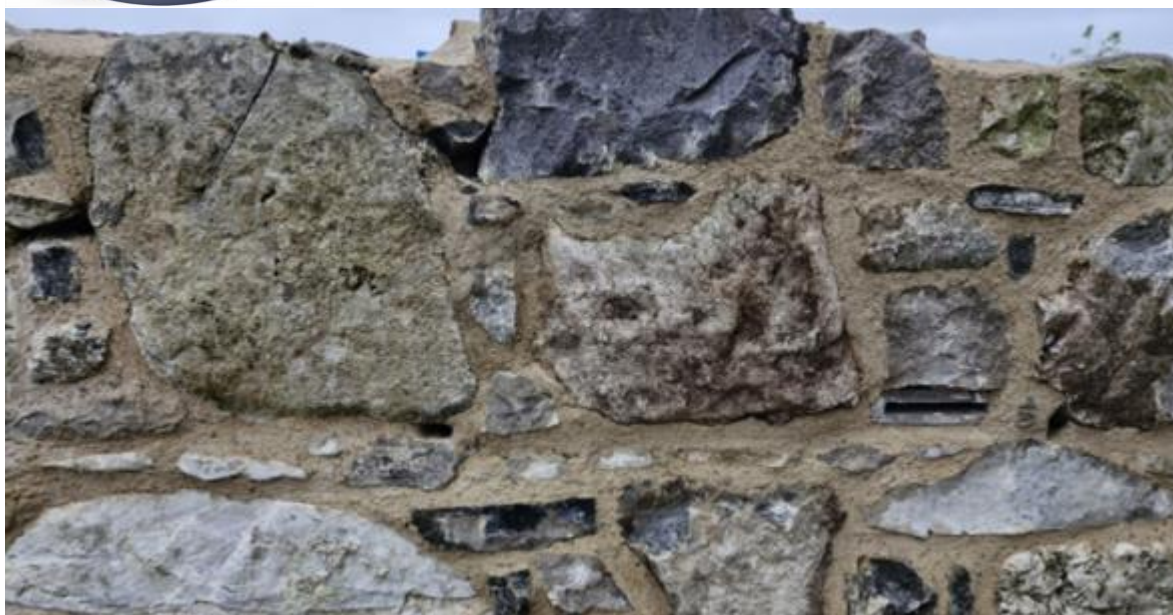
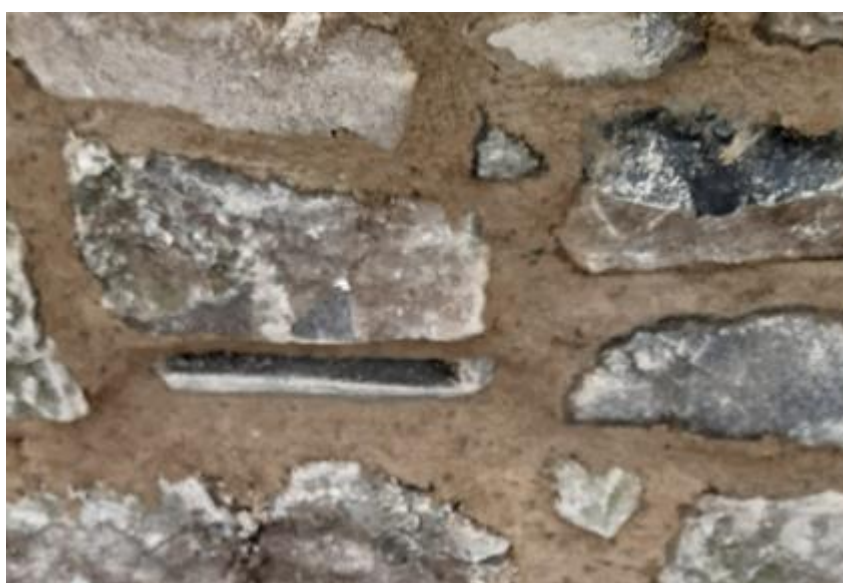
It was not possible to purchase the Schwegler bat tubes, so a similar type – Vivara pro bat tubes, and Woodstone bat boxes have been ordered. I have successfully used these boxes in Meath and Leitrim.

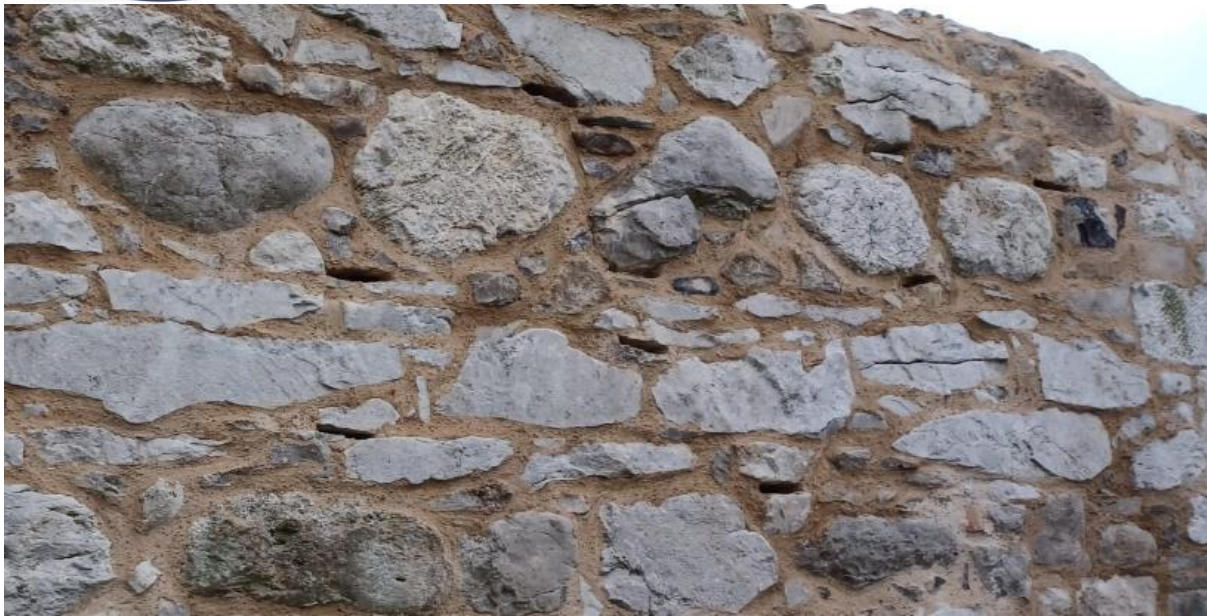
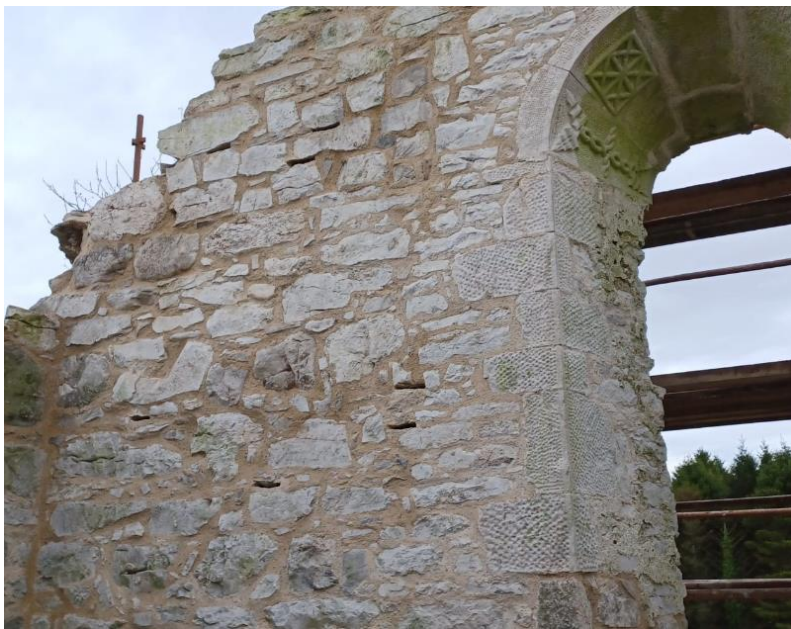
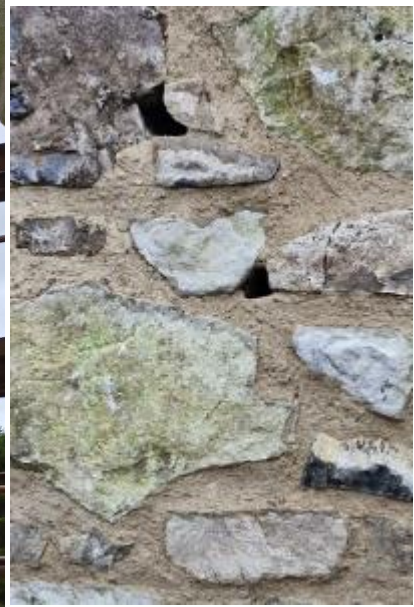
### **Installed bat tubes**

Each wall has at least 30 retained crevices of different depths and sizes.

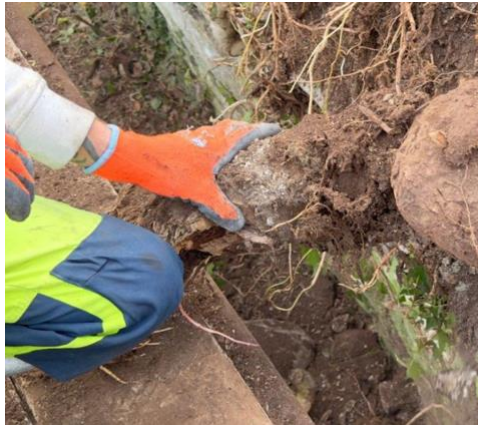
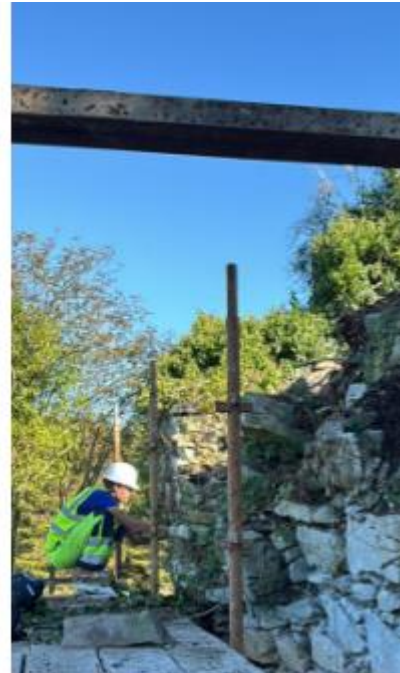
All stonework was undertaken carefully by hand.

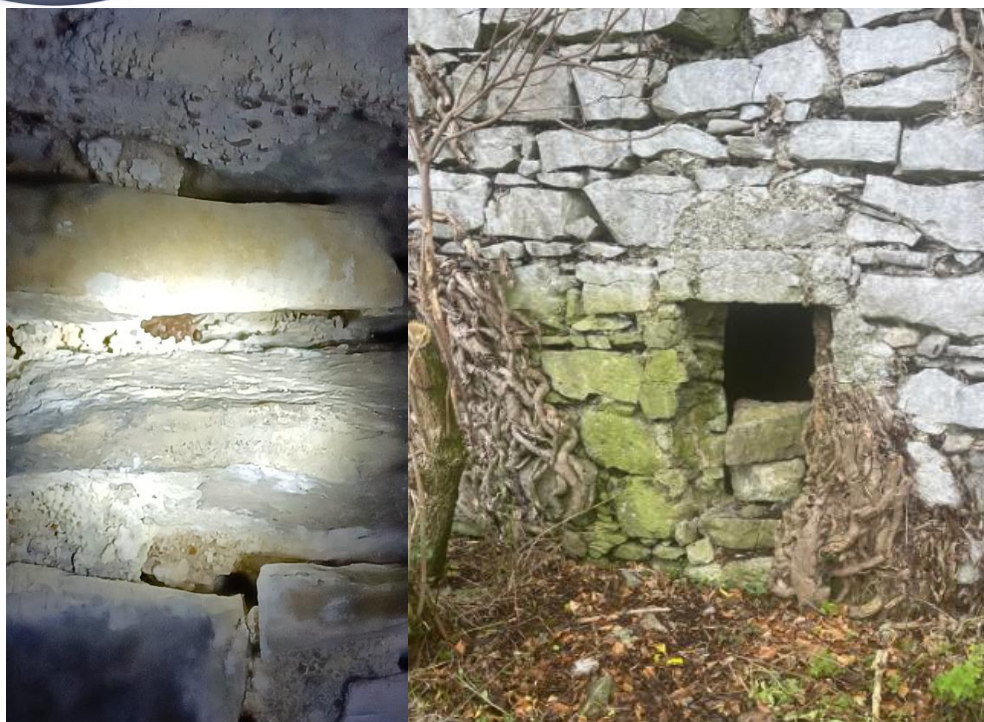
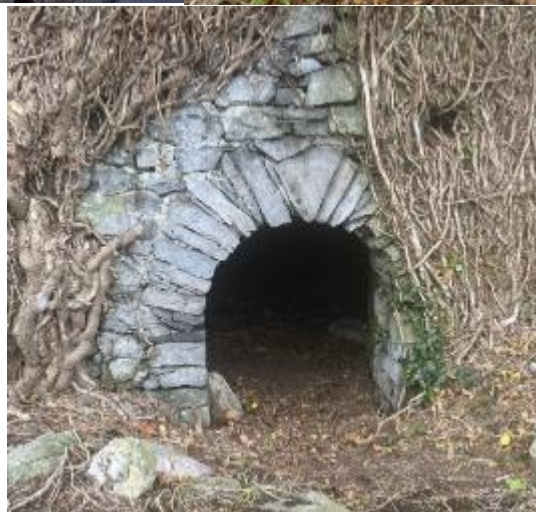
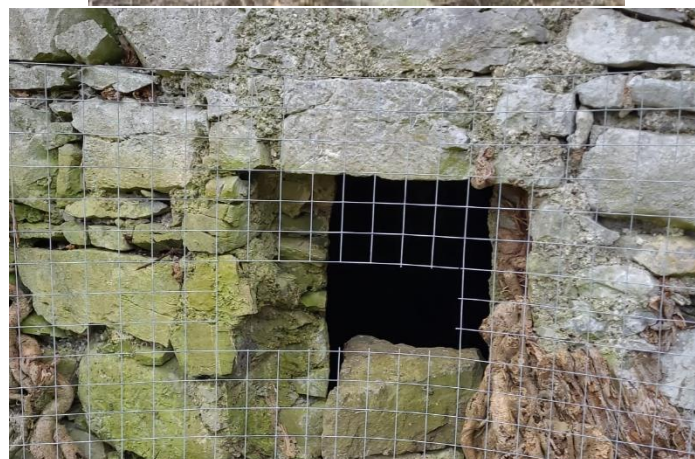
**Bat in crevices and retention of bat access**

On 26<sup>th</sup> September Donna Mullen discovered a brown long eared bat in the underground section of the church. This area was previously a roost and is not scheduled for stonework. The area was made safe from disturbance by people and animals. It was not present on a subsequent visit in October .Pallets blocking one of the roost exits on 25 October, were removed, and goats at the area were securely fenced.

Gaps have been retained in the new stonework, and bat boxes have been built into the new stonework. There was no disturbance to the existing bat roost, and a brown long eared bat was seen continuing to use the roost during the building work.
