**Application for Derogation Under Regulation 54 & 54A of the European Communities (Birds and Natural Habitats) Regulations 2011 (as amended) to**

**Carry Out Renovation Works at Old Domestic Building, Dromore Woods SAC (000353)**

***Supporting Information***

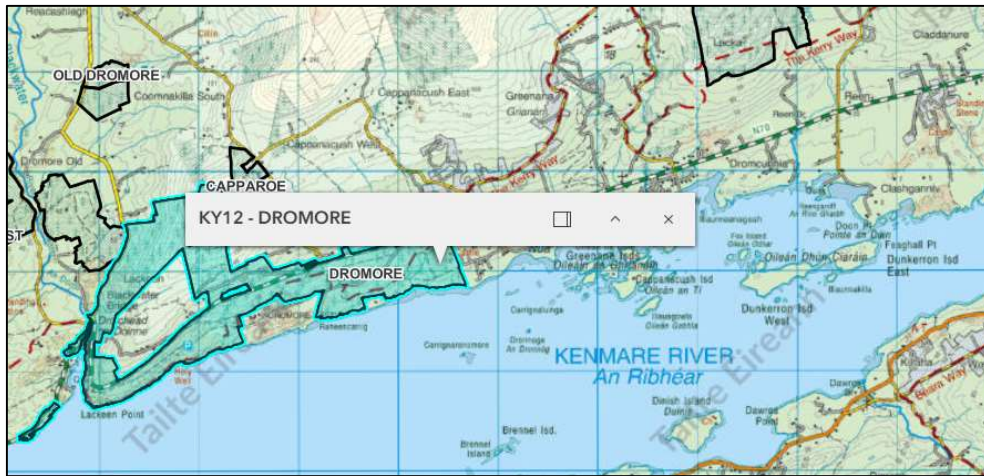
**Figure 1:** Location of Dromore Wood property

The derelict dwelling, known as Furze Point House, is situated within Dromore Wood, approximately 9 km west of Kenmare, Co. Kerry (Figure 1). Dromore Wood is a Coillte property covering over 272 ha, comprising mixed high forest and substantial areas of old woodland. Over 158ha of the property fall within a Coillte biodiversity area and is managed primarily for biodiversity. Dromore is a popular recreation area, and the Kerry Way walking route passes within 150m of the building.

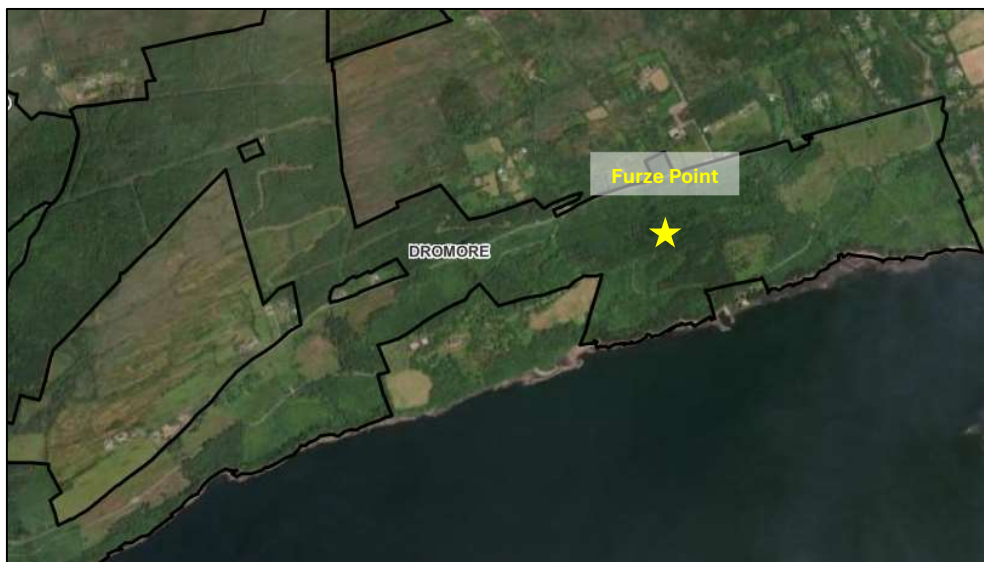
**Figure 2:** Location of Furze Point House within Dromore Wood

Furze Point House is located within the eastern part of the woodland (Figure 2). The building is a large, three-storey stone building (Photo 1). A cellar within the building was previously renovated to provide roosting habitat for wintering lesser horseshoe bat and the building along with the surrounding woodland habitats have been designated as an SAC.

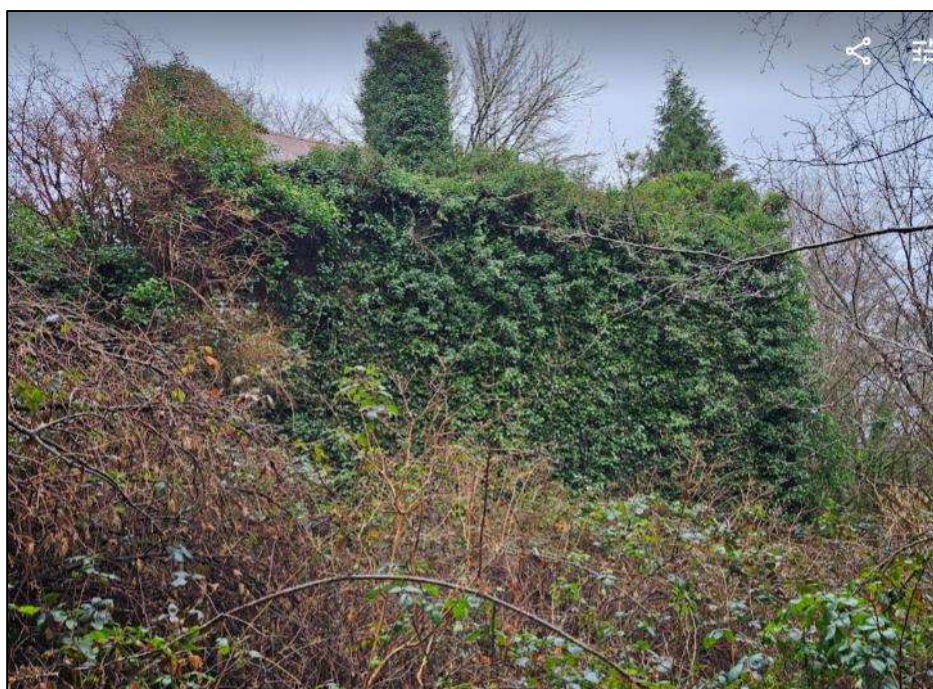
**Photo 2:** Furze Point House, rear view

The building has become overgrown, particularly to the rear and sides (Photos 2-4), and vegetation management is required to maintain access for the bats as well as to facilitate works and future monitoring. Two large beech trees to the front of the building also require tree surgery to avoid potential damage to the building in the future.

- a. Clear scrubby vegetation from around Furze Point House, with brush cutters or similar, to facilitate access. Clearance will include 2-3m from the footprint of the house, whilst maintaining a screening from the public gaze.
- b. Cut the base of the ivy growing on exterior walls of Furze Point House. Cut and treat with an approved herbicide. Leave this to die for a period of time. At a later stage, remove ivy.
- c. Tree surgery required at the front of the house, to reduce the weight on two beeches. Partial removal of crown required.

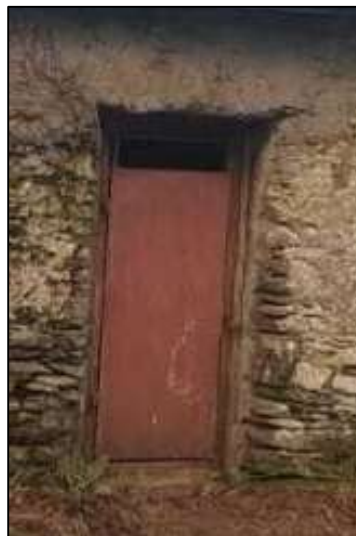
**Photo 6:** Example of a metal door with letterbox opening (Curraglass SAC roost)

opportunities for hibernating bats. Replacing the existing door with a metal door with a letterbox opening (e.g. Photo 6) will prevent disturbance while allowing bat access. Light ingress will be managed by installing a metal sheet over the window and installing a cowl behind the door. A metal sheet is preferable to concrete blocks to preserve the built heritage.

- d. Install galvanized metal plate door with letter box entrance & cowl.
- e. Install galvanized metal plate panel for window.
- f. Check the condition of the lintels for door and window. Replace if necessary.

- h. Install galvanized metal plates to cover the two downstairs windows at the rear that still have their glass.
- i. Install galvanized metal plates to cover the front downstairs windows. Provide a post box entry hole to the bottom right-hand window as one is facing the house.
- j. Replace the existing front door with a galvanized metal door with post box entry hole.

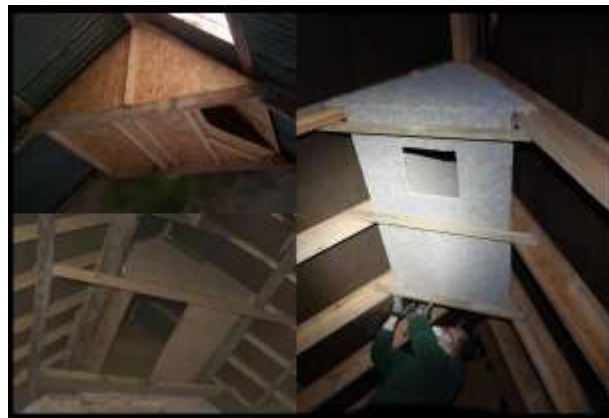
**Photo 7:** Hot boxes' of various design, installed into roof apex<sup>5</sup>

Installing a floor and sectioning the upper floor into two rooms with free access for bats to move between rooms will greatly improve roosting opportunities. The installation of bitumen felt and chicken wire/laths to the metal sheeting roof will provide suitable roosting surfaces. This combined with the installation of a hot box (e.g. see Photo 7) will improve the range and stability of microclimates available. Plywood panels will be used to create this hot box.

- a. Remove stairs and add ladder hooks.
- k. Replace the floor upstairs (panel board or similar). Assess the condition of the joists and replace if necessary.
- l. Use existing wall to section off the rooms. Remove wooden boards on the right side.
- m. Install a hot box made of marine ply in the apex of the roof for the bats in the event of temperatures dropping.
- n. Install bitumen (1F Undertile Felt) or if unavailable, a suitable alternative (with agreement from NPWS) on the underside of the existing glavanised roof and chicken wire/laths under the roof.
- o. Check that the window lintels are in order.

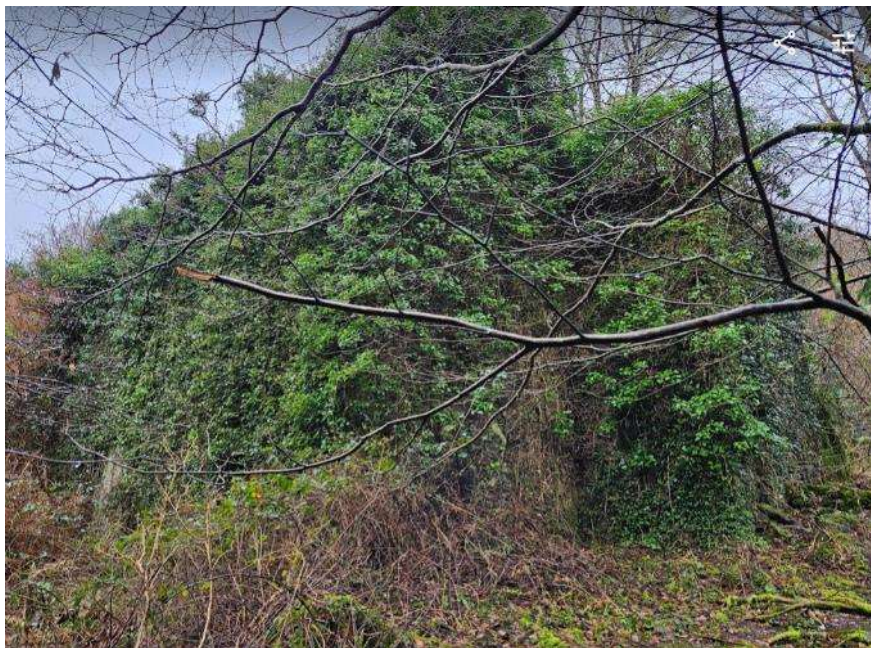
*Photo 3- Rear view elevation and side of house facing Templehoe.*

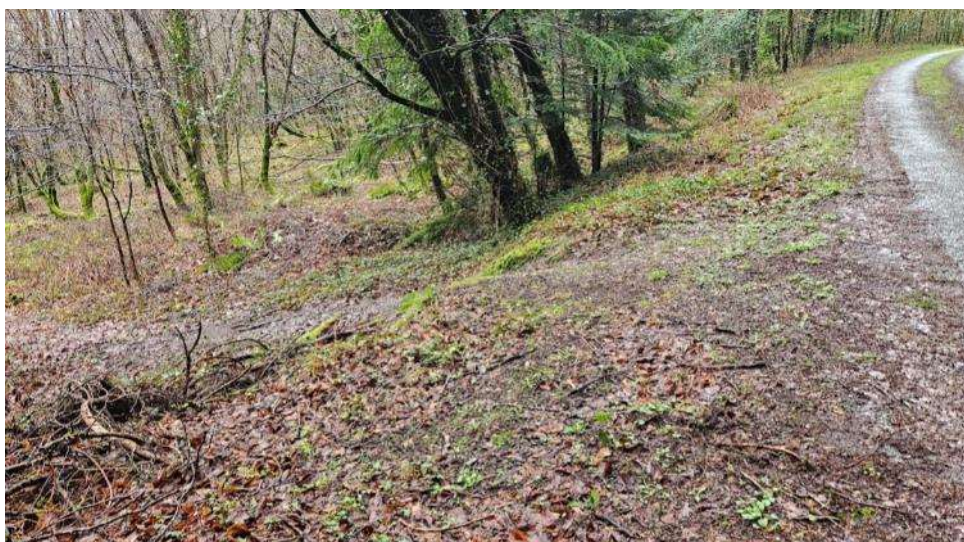
*Photo 6 - Access point from forest road to track leading to the house.*

| <b><u>Access</u></b> <ol style="list-style-type: none"> <li>1. Site accessible from the forest road in Dromore forest property via a 45m+ track. This 45m track will require an upgrade in terms of surfacing to accommodate the delivery of materials and contractors' vehicles. This will entail the cleaning off the existing forest track and the application of surface dressing.</li> <li>2. Scaffolding and ladders to be erected to facilitate access to the internal roof space as per construction guidelines.</li> </ol> | |
