# Supporting Information for Regulation 54 Derogation Application

A Derogation Licence is required for an office building roof repair to commence, in Killarney, Co. Kerry.

The repair works are needed by the ESB Networks on their office building at Tiernaboul, due to structural damage that has led to water ingress and ceiling collapse in Office 7.

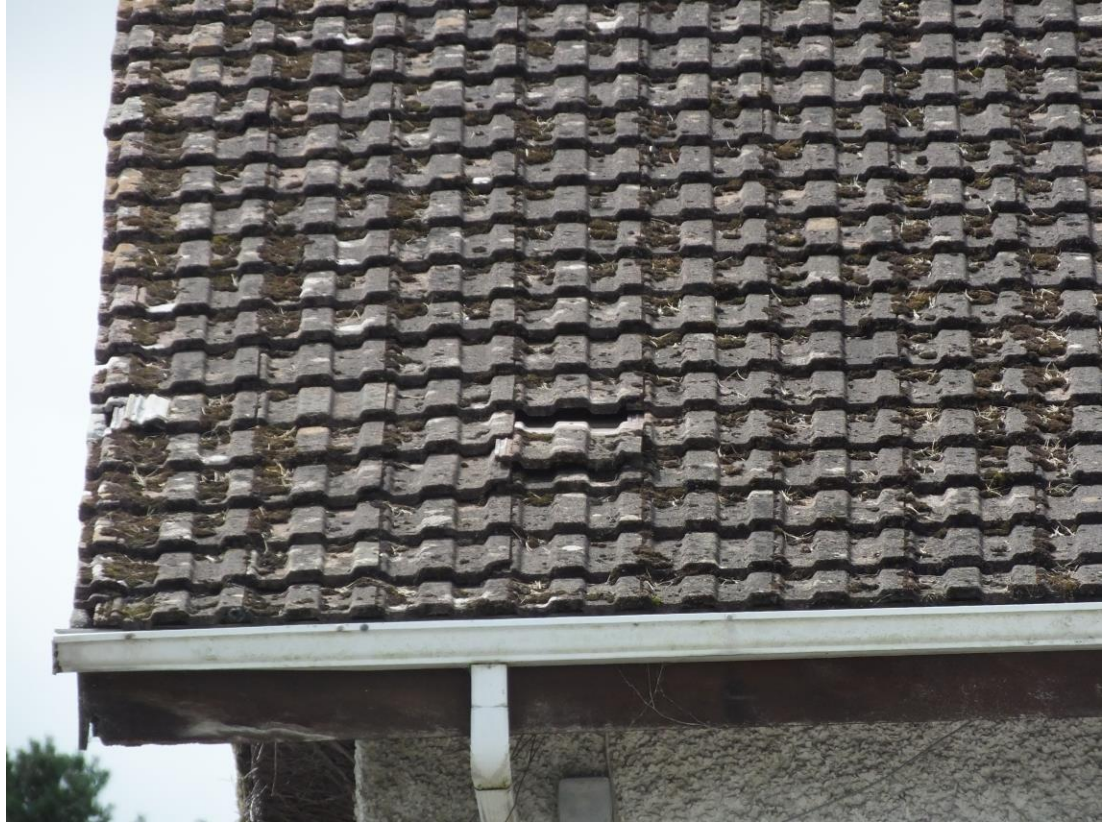
The damaged structure 1

The ESB Networks depot is located on the outskirts of Killarney, adjacent to Pike Wood and close to the Woodford River, within an area of prime bat habitat. Structural damage at the south end of the main building has resulted in water ingress and ceiling collapse in Office 7.

Repair to damage to southern end of the main North-South aligned building, specifically Office 7 and roof tiles.

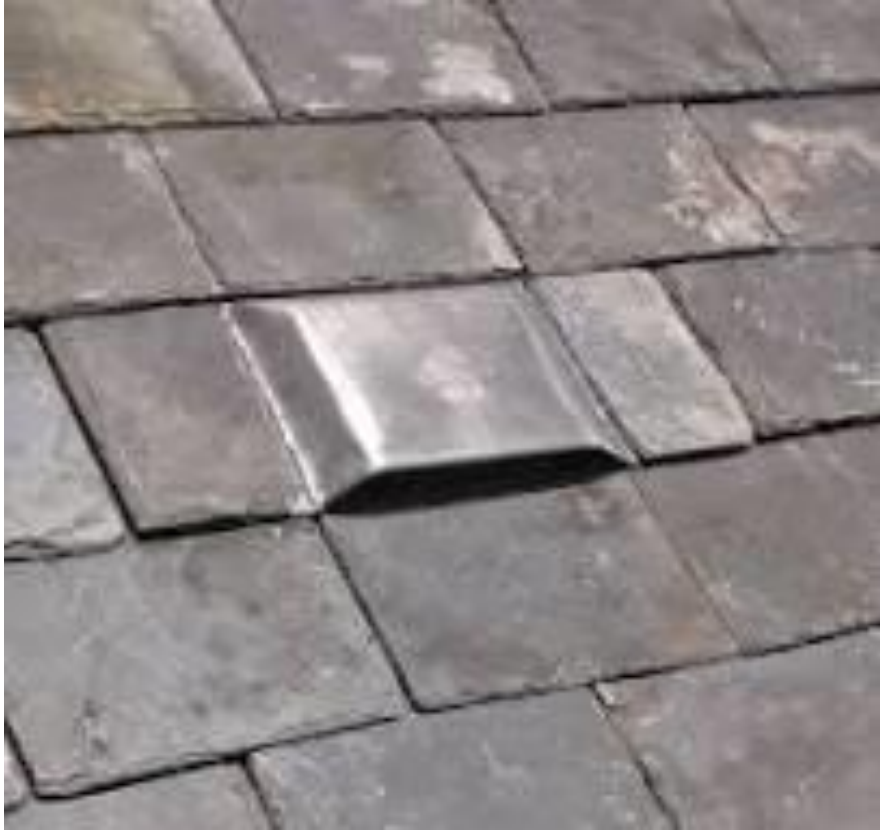
**Proposed Mitigation - Bat Friendly Access tile**

By granting a derogation, the building can be made structurally safe while also safeguarding the bat roost. Mitigation measures include timing works outside sensitive breeding/hibernation seasons, provision of a permanent bat access tile, and ecological supervision during works. This ensures that urgent health and safety repairs can be carried out without compromising the conservation status of the bats.

- Permanent bat access installed.
- Works outside sensitive breeding season.
- Bat-safe timber treatments used.
- Lighting avoided near roost entrances.
- Pre-works check by ecologist to confirm roost status.

Bat access doors have proven effective in maintaining roost use post-repair at other sites, including Clifden House, Co. Galway. Based on survey data and mitigation measures, the roost will continue to support the same species at current or increased levels, maintaining favourable conservation status in the region. The expected post-works roost usage will be equal to or greater than pre-works usage.
