Bat Roost Survey

Westport Convent

Westport, Co. Mayo

**Bat Survey Report**

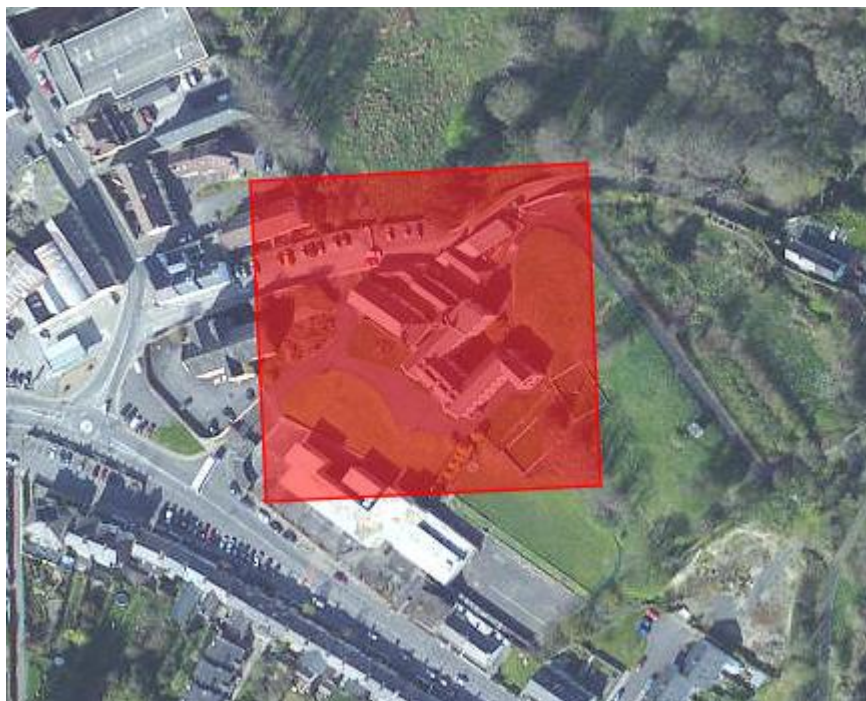
**Figure 2.1: Area of Search for Bat Species**

A search of the National Biodiversity Data Centre (NBDC) for records of bat species previously identified within and in the vicinity of Westport Convent was completed in May 2024 and again in October 2024. All records held by the NBDC for an area of search within and surrounding the convent were downloaded from the NBDC. The extent of this area of search is shown on Figure 2.1.

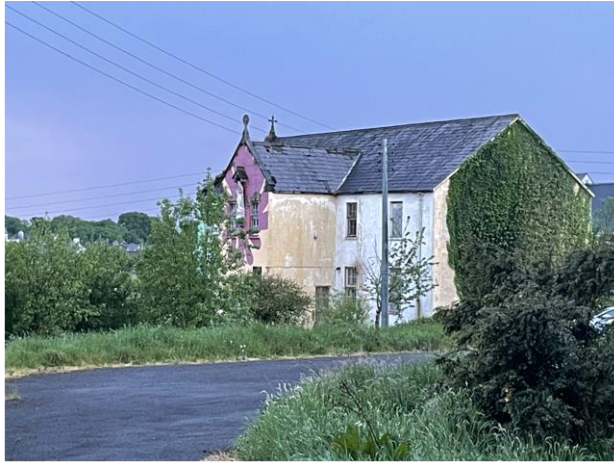
Plate 1: View of former school building from the northeast

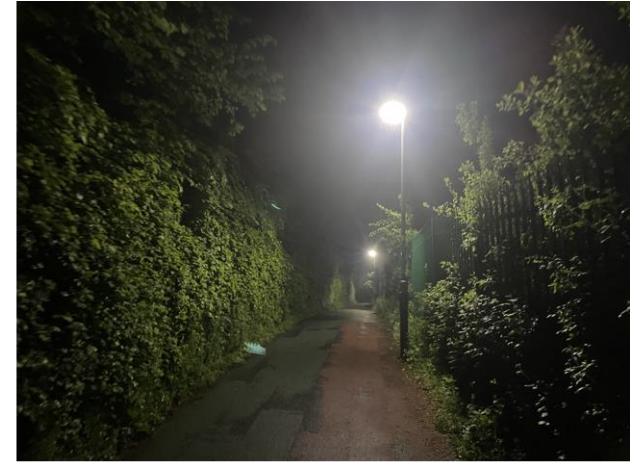
Plate 3: View of bright street lighting along greenway to north of convent site

Landscaping will be provided at the northwest of the site that will aim to provide lighting screening from public lighting to be provided as part of the site renovation and also to provide screening from the existing lighting along the greenway to the east. Figure 6.1 shows the proposed landscaping to be provided. It is also recommended that remedial cowling of the luminaires along the greenway to the east of the site is undertaken to minimise lighting spill from these luminaires into the site and surrounding area.

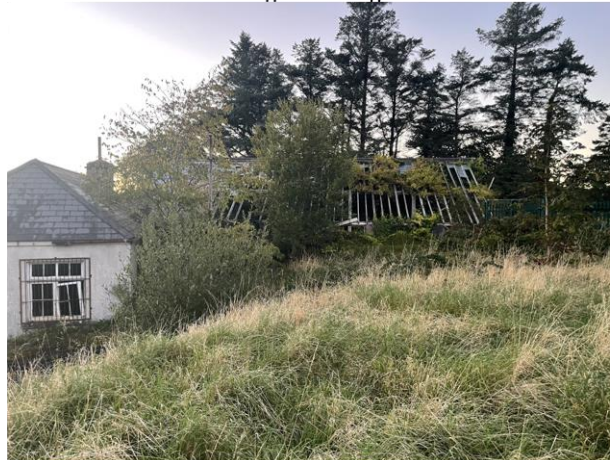
Plate 5: View of west to old kitchen and delapidated glass house

The fifth and final structure on site is the greenhouse. The structure is derelict, only the wooden structure remains with few pieces of glass on the top. No evidence indicating the use of this structure by bats was found.

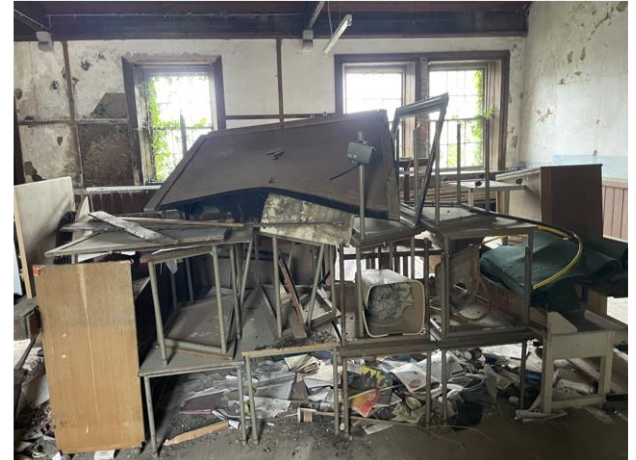
Plate 6: Internal view of upper floor of former school house with bat detector installed. High daytime light levels
