**Derogation Licence Application under  
the European Communities (Birds and  
Natural Habitats) Regulations  
2011 - 2021**

**Supporting Information – Proposed  
Demolition at Ballybeggan, Tralee, Co. Kerry**

Appendix 1 – ‘Bat Survey and Assessment Report’ for the proposed Demolition at Ballybeggan, Tralee, Co. Kerry

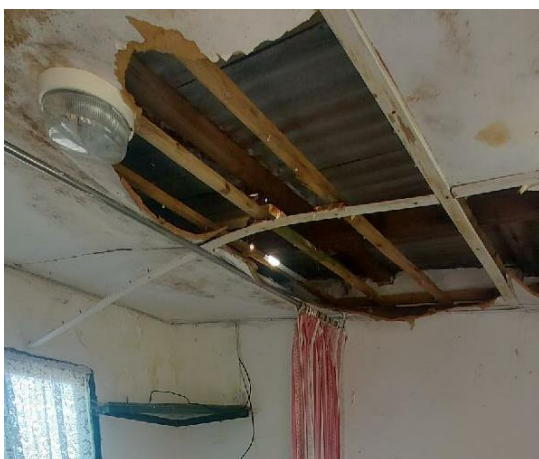
**Plate 1. Damaged roof**

The buildings are all in a poor state of repair and many of them are structurally compromised.

Many of the buildings have no fully intact roof or external wall structures. Buildings have been severely damaged by weather and the ingress of water over time. There are extensive areas of broken windows and glazing along with semi- collapsed roof elements that in themselves are a risk to safety, particularly due to high winds and storm effects.

Consequently, and in terms of public safety, we recommend that the buildings be demolished safely and in a managed fashion and all materials be safely removed from site.

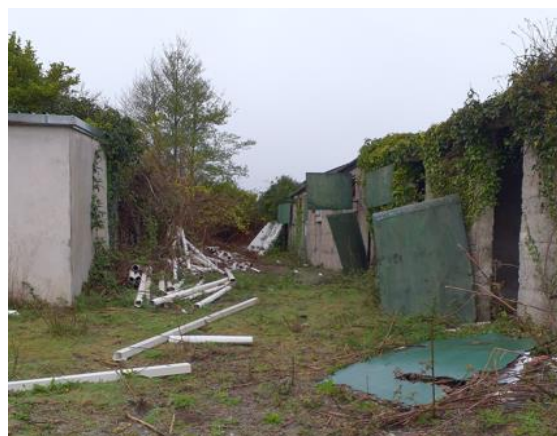
**Plate 4. Damaged stables**

Boundary walls , gate and stable buildings are in a poor state of repair and unsafe. Access to the site is controlled at present but requires full time security.

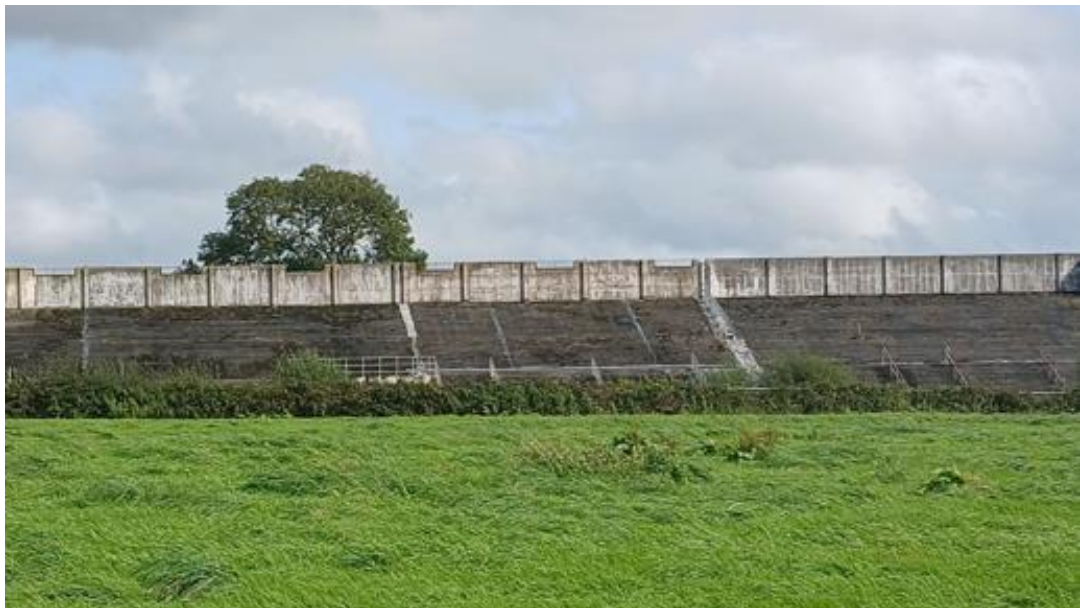
Plate 1. No.1a - Large Stand

This west facing side comprised a large stand with concrete levels and metal railings. This structure is completely open and did not show any evidence of bat use and did not have any roosting potential. See **Plate 1** and **Table 12** below for observations.

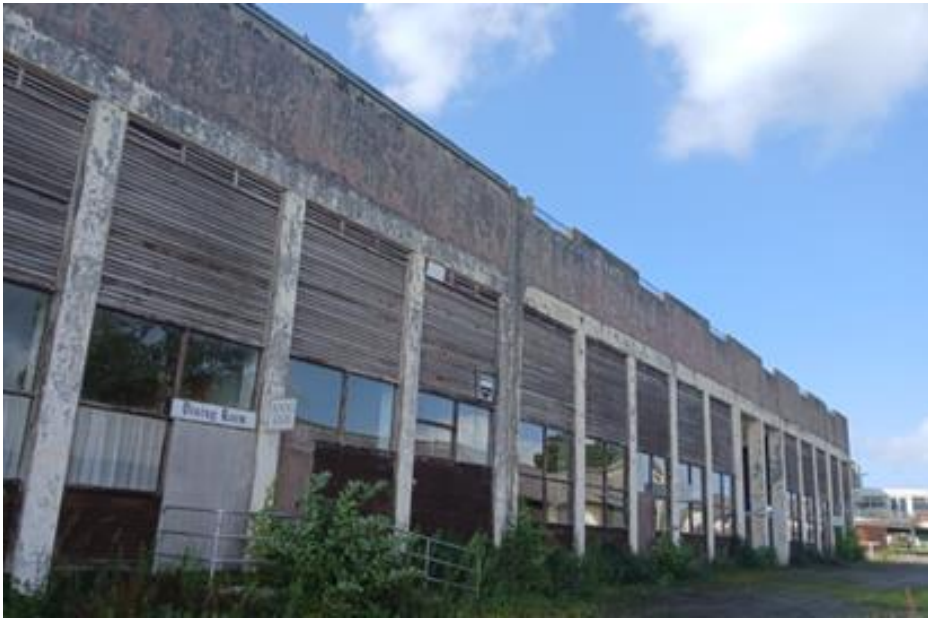
Plate 2. No.1b - Reception Areas Below Large Stand

This is the east facing side of the building which comprised three large bar rooms and a kitchen with a dark cellar-like room to the back. The building is in a state of disrepair with water leaking in through parts of the roof/ceiling, peeling paint, broken tiles and evidence of nesting birds. A pair of jackdaws were present in the bar room furthest south. See **Plates 2, 3 and 4** and **Table 13** below for observations.

| Observations | |
|---|---|
| Evidence of bat use | Yes – In various places there were droppings found on the walls and some discarded butterfly/moth wings on the ground. |
| Potential for bat use | Yes – Several access points observed such as open/broken windows and gaps between wood panels. Inside there were many cracks and small crevices in the walls and peeling paint which may offer roosting potential. |

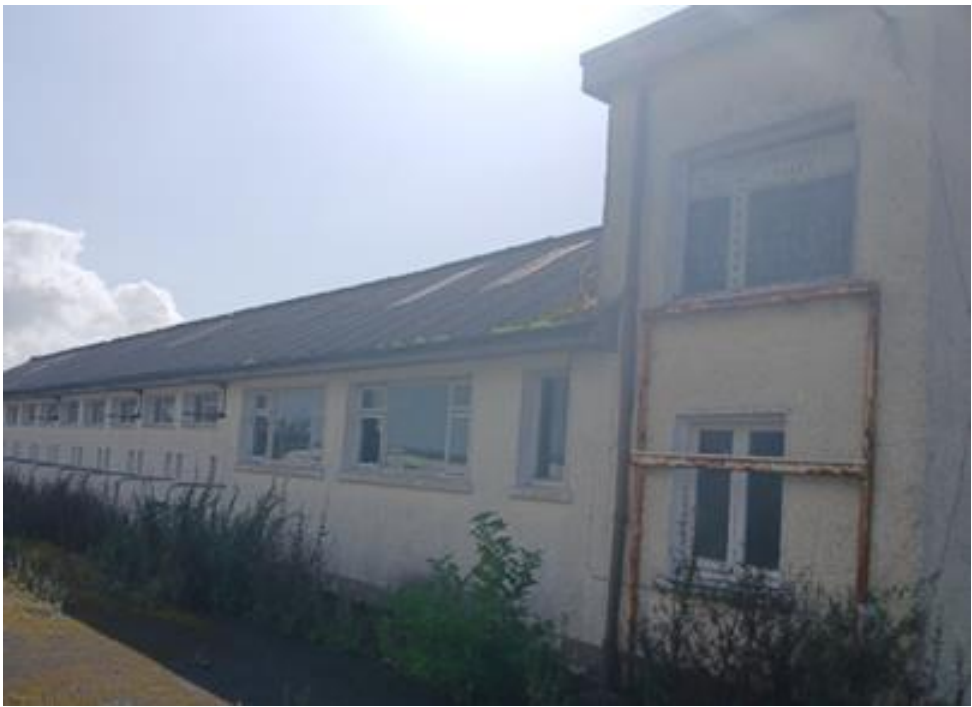
Plate 5. No.2 - Tote Kiosks

Large building with many small windows on the east side, some of which are missing or broken. The west side of the building comprised mainly of large metal shutters. There was one small room above the front door accessed via a small hatch. There were a number of dead birds in this small room and broken windows. Throughout the building there were nesting pigeons along the wooden beams under the roof. The corrugated roof was damaged in a number of places with some parts missing. This has led to the partial collapse of the inner plywood ceiling. See **Plates 5, 6 and 7** and **Table 14** below for observations.

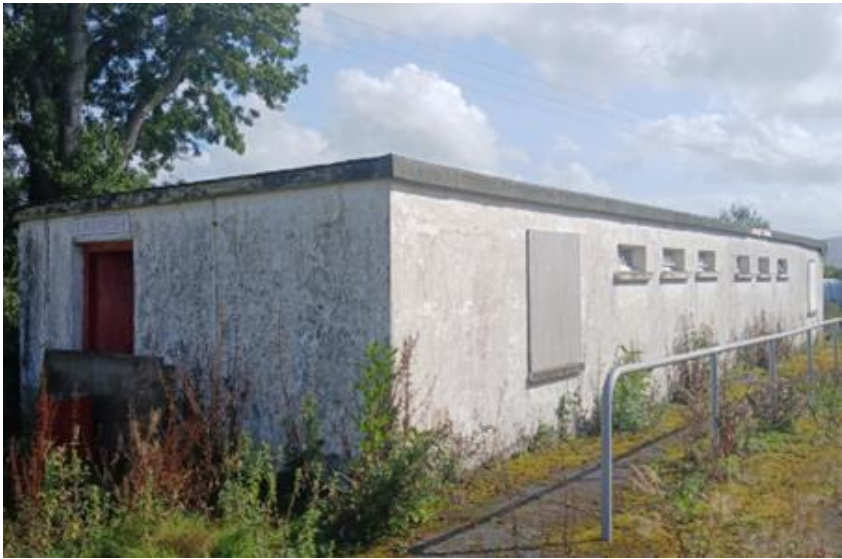
Plate 8. No.3 - Ancillary Building no. 1

A large ‘L’ shaped building with men and women’s toilets which featured a number of stalls and sinks with tiles inside. The women’s toilets are accessed from the north and men’s from the south. The walls appeared solid from the outside and inside. The roof is flat with supporting wooden beams on the inside. Ivy was growing quite vigorously in the men’s toilets, growing through gaps in the roof. See Plates 8, 9 and 10 and Table 15 below.

| Observations | |
|---|---|
| Evidence of bat use | Yes – Many droppings found in the men’s toilet on some of the cisterns and tiles on the walls. |

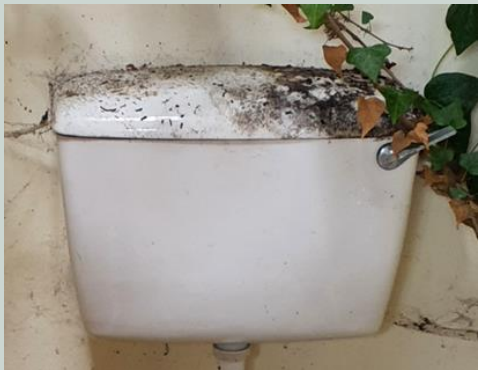
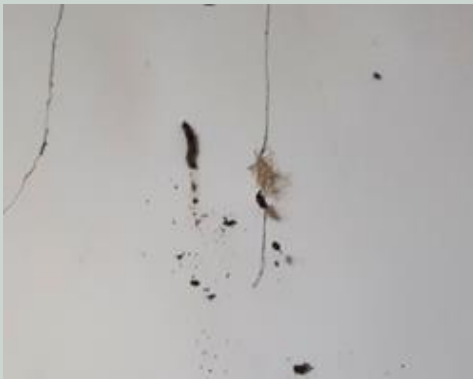
| Observations | |
|---|---|
| <p>Plate 9. Droppings on toilet cistern</p> | <p>Plate 10. Droppings on the wall</p> |

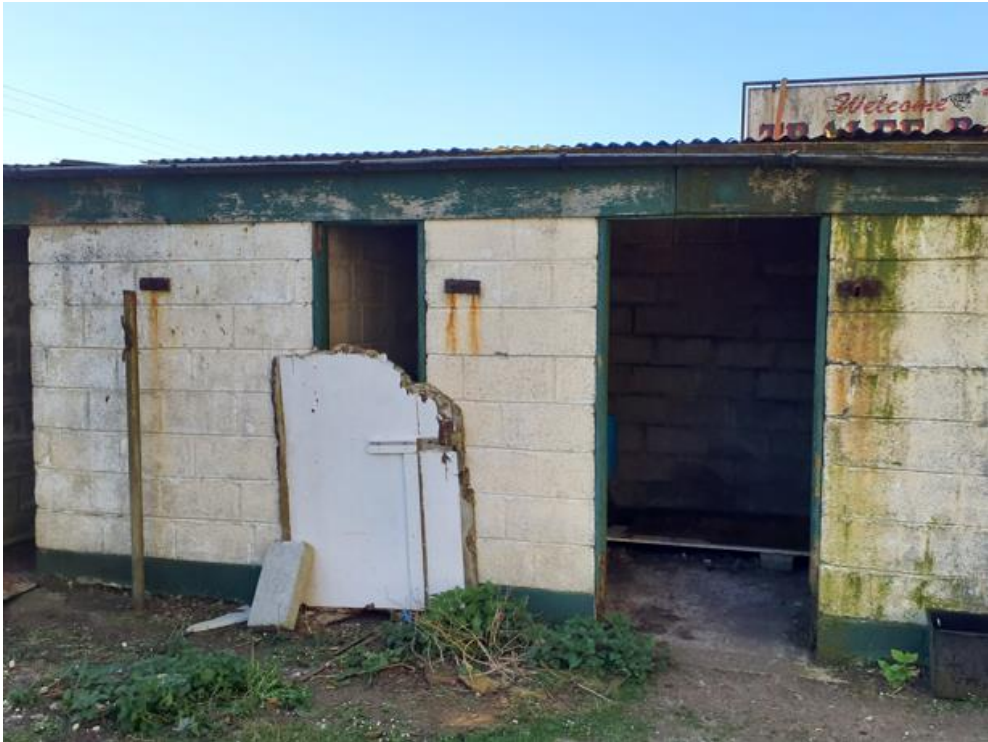
Plate 11. - No.4 - Working Entrance Building

Small structure comprised a small number of old ticket stalls with solid walls and corrugated tin roof. The walls were in good condition, but the roof was rusty and damaged with a few holes and some panels missing. There were no doors on any of the stalls at the front. There was one square hole in the wall which appeared to be a type or ‘window hatch’ with a few old swallows nests inside. There was no evidence of bat presence within the structure. See **Plate 11** and **Table 16** below.

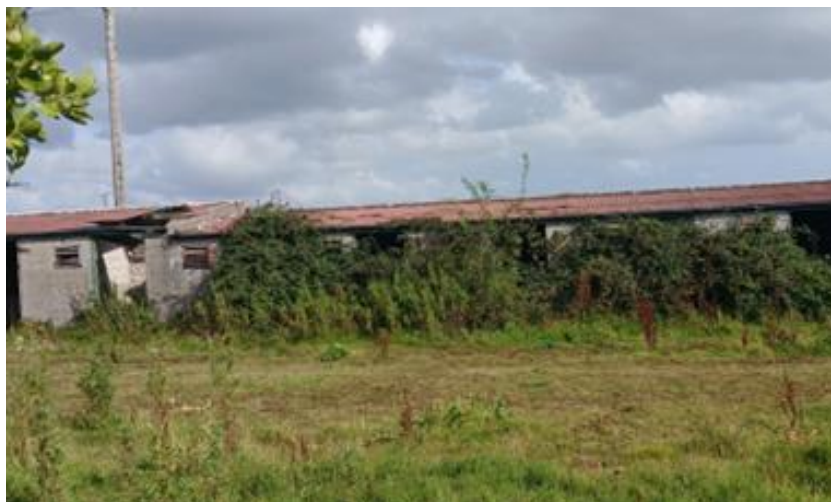
**Plate 12. No.5, 6 , 7, 8, 13, 15 - Stables**

The stables in buildings No. 5, 6, 7, 8, 13 and 15 all have corrugated tin roof, many with holes, rust and some have collapsed fully or partially leaving some stalls damp and open to the elements. Old swallows’ nests were observed inside, and many of the stables were damp inside from rain water seeping in. There was no evidence of bat presence within the structure See **Plate 12** and **Table 17** below.

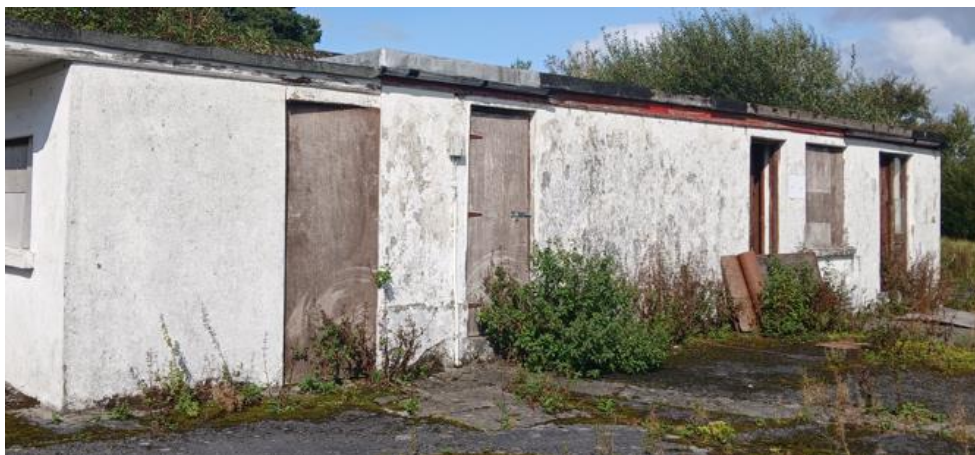
Plate 13. No.9 - Ancillary building no.2

This small building comprised a flat roof with small rooms containing electrical equipment and fuse boxes. It appeared these rooms had been well-sealed/boarded up for an extended period of time prior to survey access to the building. The building appeared solid with no obvious signs of damage and each room was dry with no water damage. Each window was tightly boarded up and there were many cobwebs within the rooms, indicating a lack of bat activity within. There was no evidence of bat presence within the structure. See **Plate 13** and **Table 18** below.

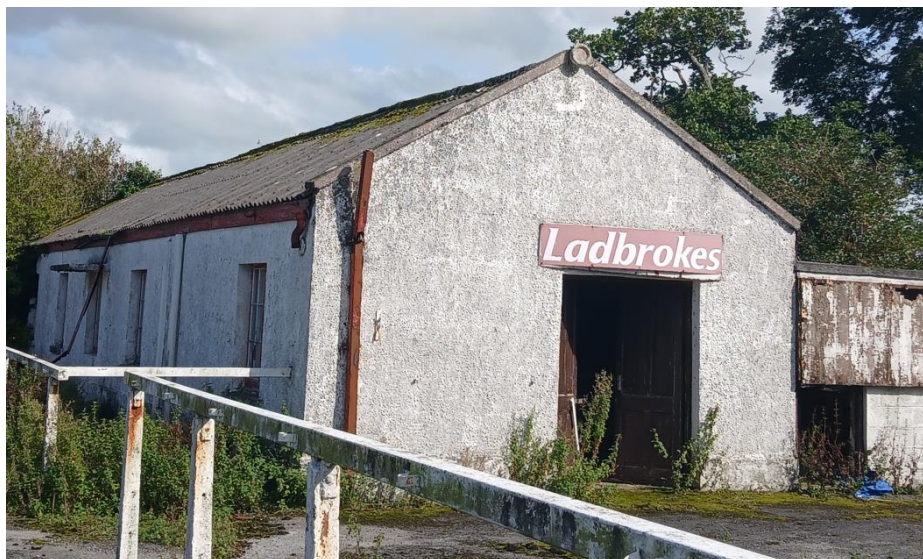
Plate 14. No.10 - Ancillary building no.3

This building had a large room when entering through the door on the west of the building leading to some smaller rooms (bathroom) and hallways. Areas of the roof had holes and gaps and throughout this building the ceilings were all very damp and some areas had dripping water coming through the light fixtures causing partial ceiling collapse in places. Most windows appeared to be intact and two exterior doors on the east side of the building leading outside were nailed shut. See **Plate 14** and **Table 19** below. There was no evidence of bat presence within the structure, however, due to health and safety concerns, a full PRA of the building was not carried out.

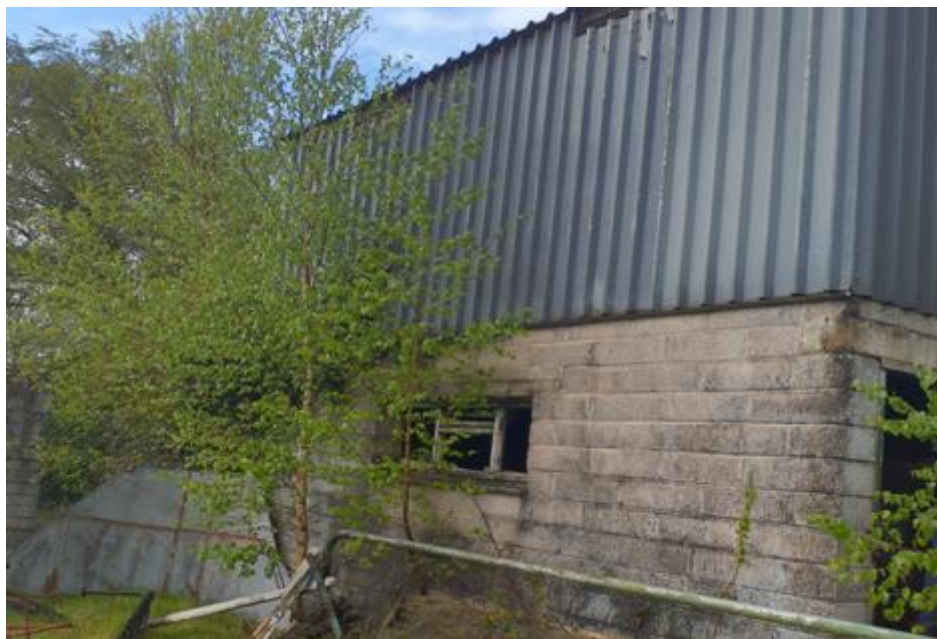
Plate 15. No. - 11 Stewards tower

A small structure called the 'stewards tower' with a room on the ground floor with block walls and some metal beams supporting the corrugated roof/ceiling and the floor of the first floor. The ceiling was damp and showed signs of water damage. There were gaps between the stone blocks and metal beams and ivy growing in from outside. The door and the windows were broken. The first floor had a room with corrugated walls and roof. This room was not accessed due to safety. The wood on the stairs was rotten and the ceiling of the lower floor was damaged making them unsafe. See **Plate 15** and **Table 20** below.

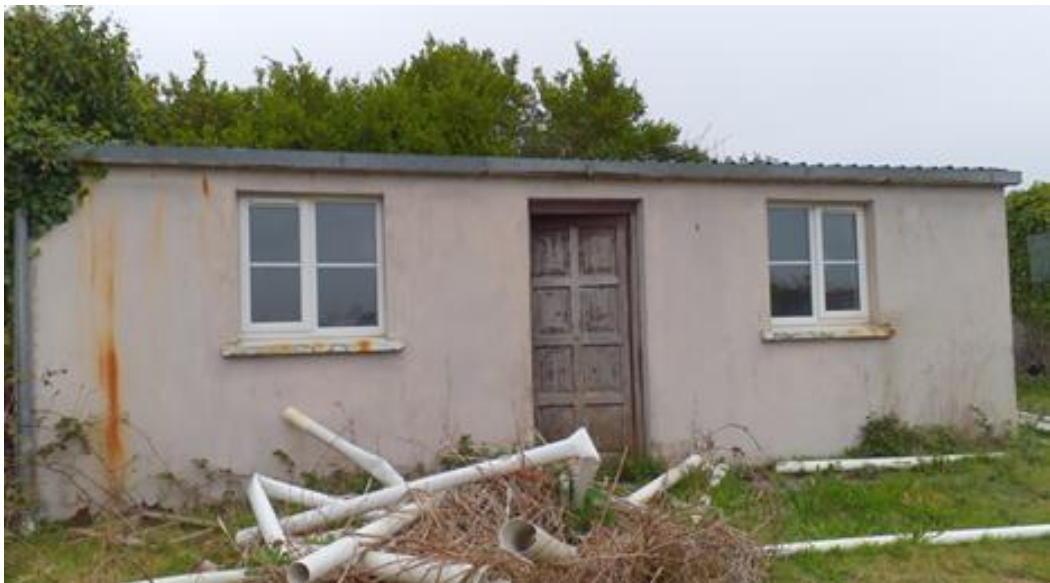
Plate 16. No. 12 - Ancillary building no.4

This was a small building with solid block walls and a corrugated tin roof that was likely used as a kitchen/canteen facility as there were cupboards, worktop, old fridge and sink. The roof was supported with mostly metal beams with some wooden beams and panels. Some ivy was growing through the gaps between the back wall and the roof. The back of the building and one side was heavily covered with ivy. There was evidence of bat presence within the structure; see **Plates 16, 17 and 18** and **Table 21** below.

| Observations | |
|---|---|
| Potential for bat use | Yes – Potential access point via the door which is ajar and potential gaps between the wall and the roof. Inside, some wood panels and beams with gaps between may offer roosting potential. |

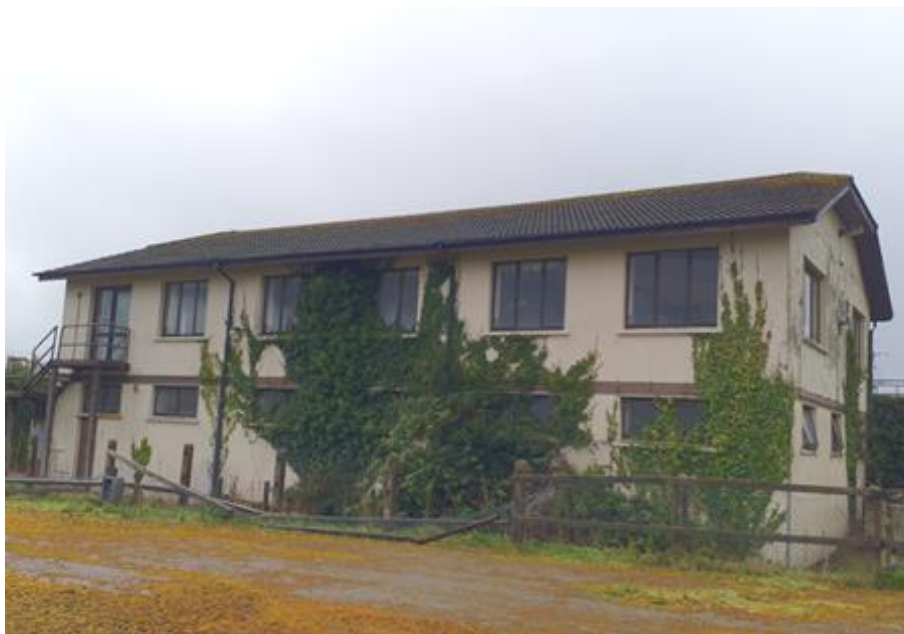
**Plate 19. No.14 - Jockeys Facilities**

This was a large building with solid walls and a tiled roof. The ground floor comprised a number of rooms which included showers, sauna, toilets and office rooms. The first floor comprised one large function room with a small office area, kitchen and a door leading to a stairwell on the eastern side. There was also a hatch leading to a large attic space. The building was largely in good condition with no major structural damage and no obvious roof tiles missing. There were some cracks and holes in parts of the wooden fascia along the roof and a number of broken windows, mostly on the southern side (front) of the building. Dense ivy was present on the north side and east side of the building. See **Plate 19** and **Table 22** below.

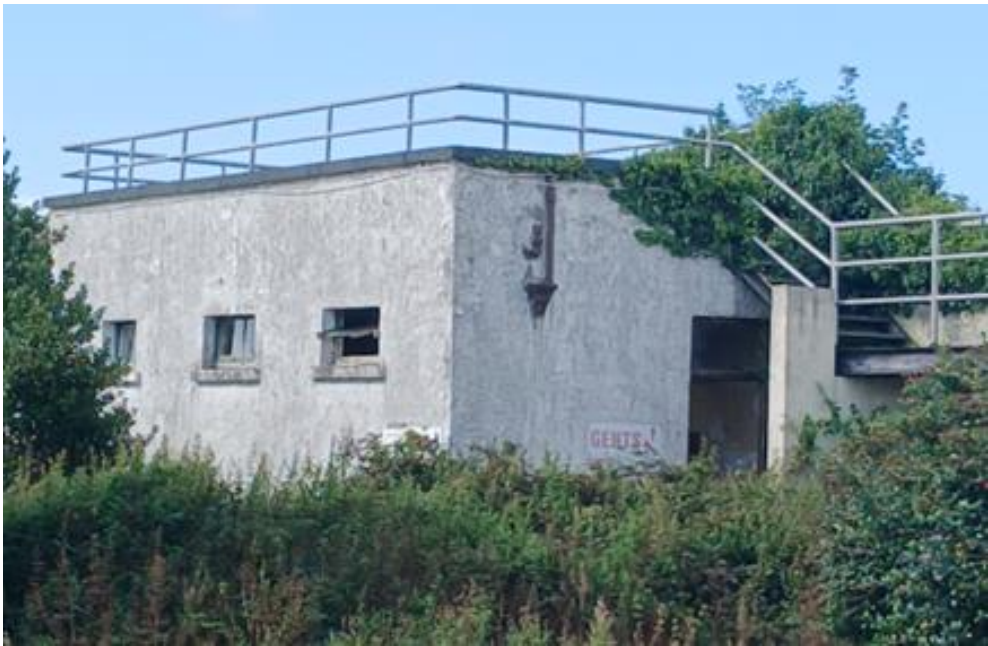
Plate 20. No.16 - Male WC Block

This building comprised a small toilet block with solid walls with a flat roof. The entrance door was broken and lying on the ground. Two windows were intact, with one window open and one window broken and missing its pane of glass. Inside were a number of toilet stalls, urinals and sinks with mirrors. There was also a small hole in the ceiling, perhaps where a light fixture once was. Dense ivy cover above and beside the door. See Plates 20, 21 and 22 and Table 23 below.

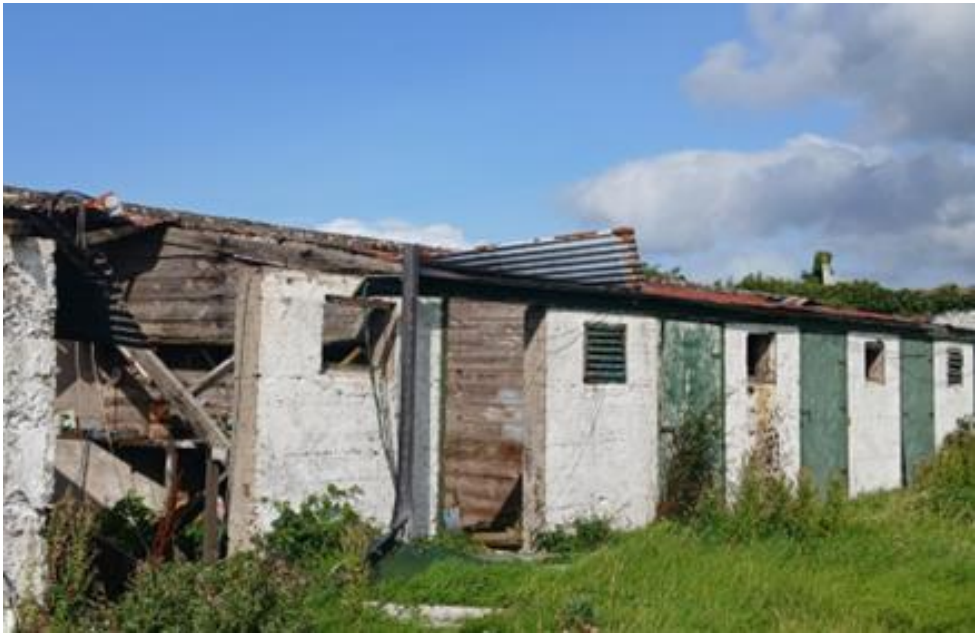
Plate 23. No. 17 - Stables no.7

Structure No. 17 comprised a number of stalls/small rooms. Some of these stalls had a missing roof, partially collapsed roof, or differing levels of damage leaving them open to the elements. Stalls with relatively intact roofs were drier inside and appeared more structurally sound. There were a lot of bird droppings observed and some old swallow nests between the metal beams and roof in two of the stalls. See **Plate 23** and **Table 24** below.

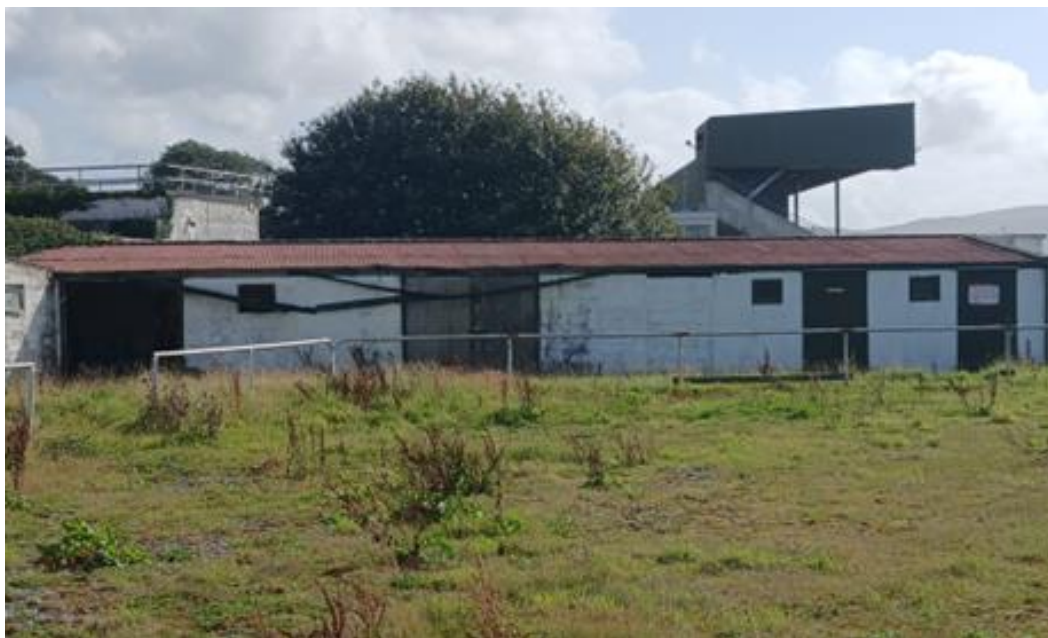
**Plate 24. No. 18 - Stables no.8**

Structure No. 18 comprised a number of stalls/small rooms with solid block walls and corrugated tin roof. Mostly used for storage. One part was open with no doors, and the other three rooms had doors. The roof was mostly intact with some rust and small holes here and there. The walls were in good condition and the windows not boarded up appeared to be intact and closed. See **Plate 24** and **Table 25** below.

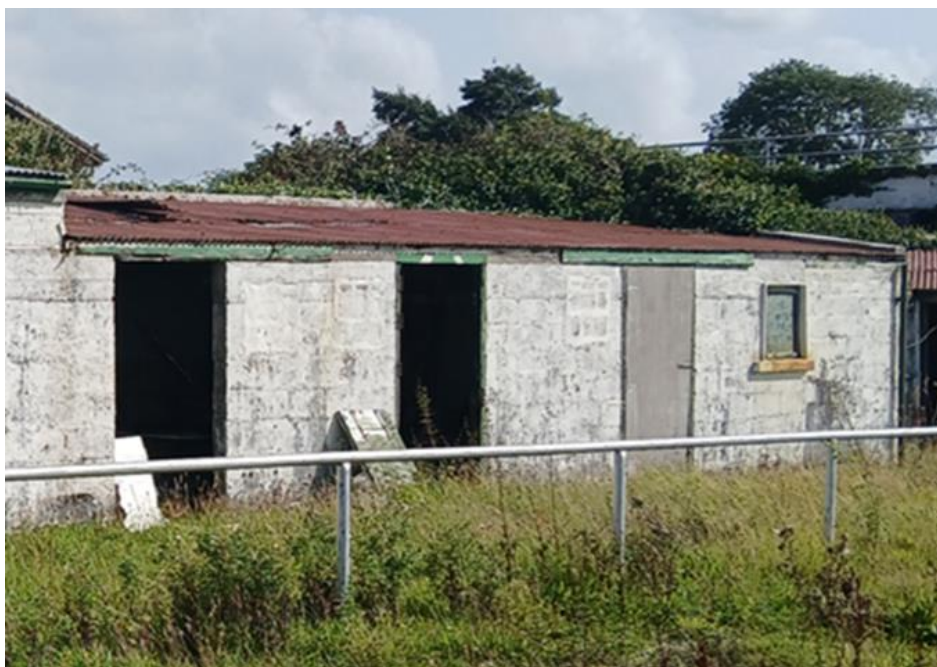
**Plate 25. No. 19 - Stables no.9**

Structure No. 18 comprised three stalls/small rooms. These were being used for the storage of horse racing signs and fences, and one had chairs and a small kitchen area. The roof was quite rusty with parts missing. The walls appeared solid and in good condition. There were clear signs of water damage from rain getting in through the damaged roof. Along some of the metal and wooden beams were a number of old swallows' nests. See **Plate 25** and **Table 26** below.

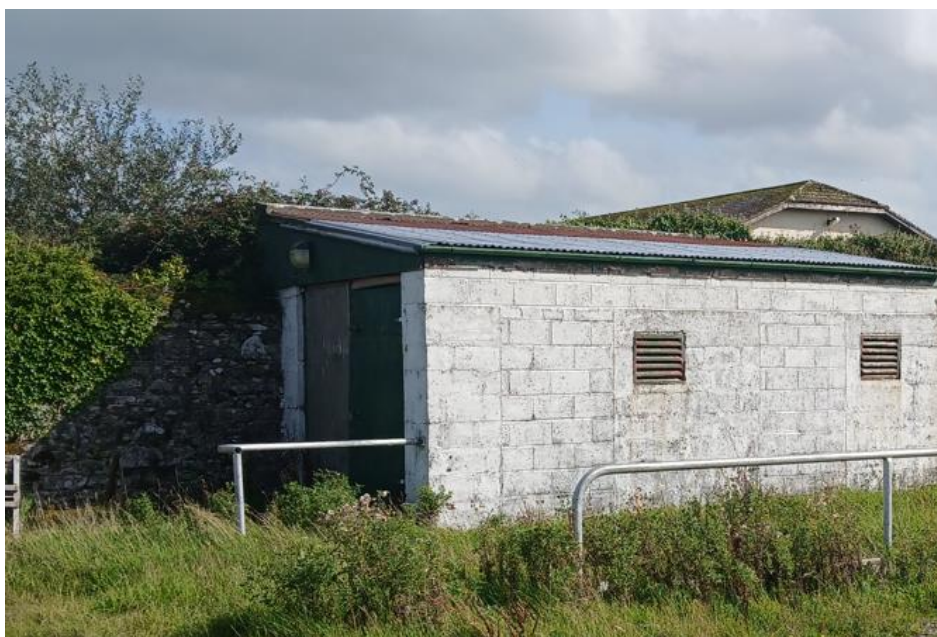
Plate 26. No. 20 - Stables no.10

This small building comprised one room with solid block walls and corrugated tin roof. This building was used for storing signs and fencing. Both the walls and roof were in good condition, and the room was dry with no signs of rain coming in. Dense ivy was growing along the roof on the eastern side. Lots of rabbit droppings in one corner and a few old swallows' nests between the wooden beams and the roof. See **Plate 26** and **Table 27** below.

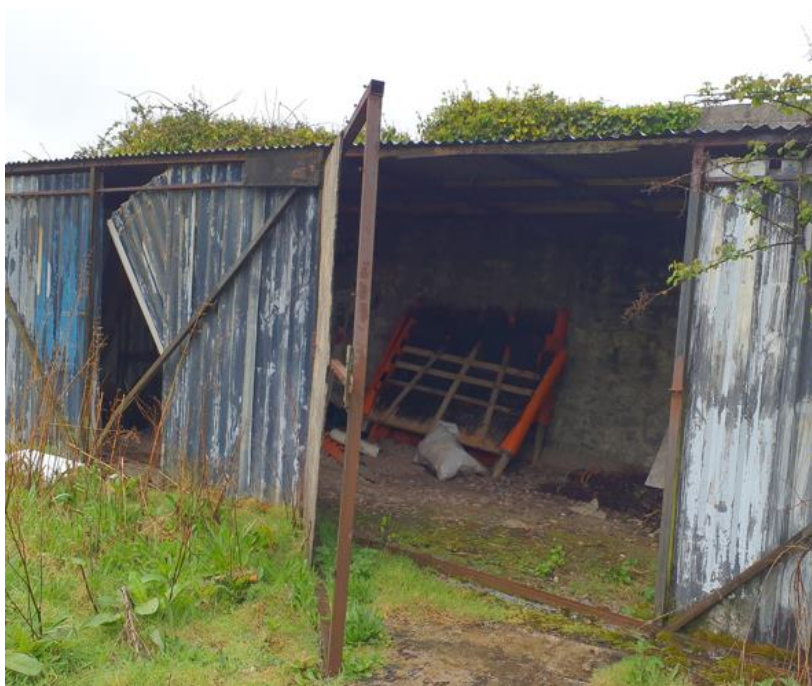
Plate 27. No. - 21 Stables no.11

Structure No. 21 comprised a small shed with stone wall at the back and corrugated tin roof, doors and outer walls. Metal panels were missing off the main door and some of the wall panels were damaged or missing. The roof was mostly intact with some small holes and rusted parts. The shed was currently being used to store various horseracing equipment. See **Plate 27** and **Table 28** below.

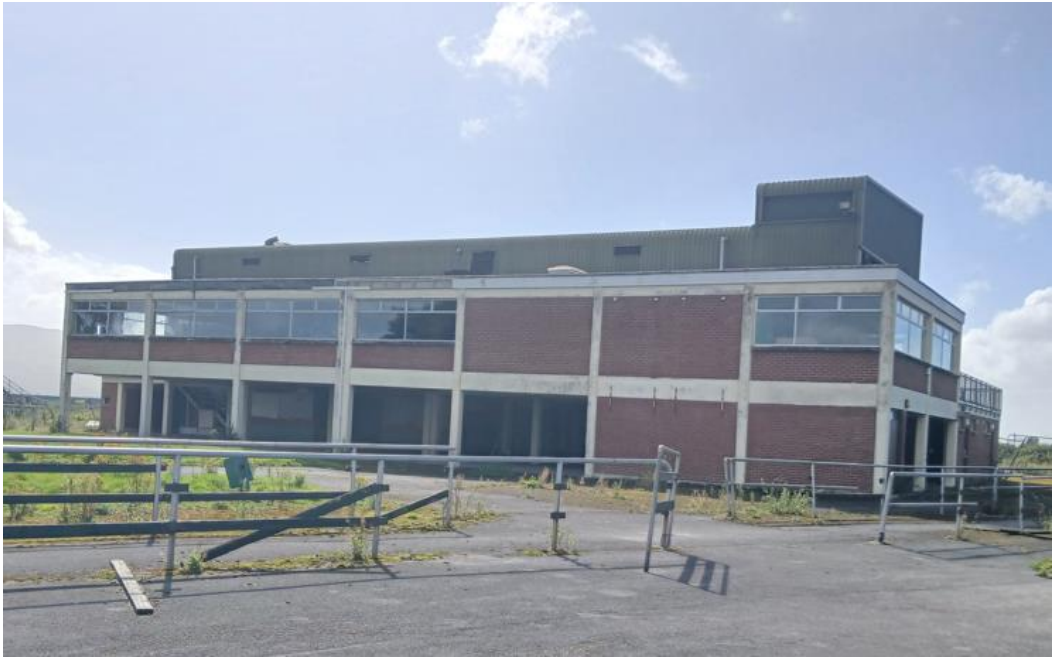
Plate 30. 24b - Reception Areas beneath the Spectator Stand

To access the 1st floor there were two sets of stairs leading from outside, one located at the north site and the other one located at the northwest of the building. There was also an enclosed stairwell accessed via a door on the ground floor at the northeast side of the building. The 1st floor comprised a large bar with two adjoining rooms. Some of the windows had been boarded up whilst some remained broken with glass still attached. There were jackdaws actively nesting within the gaps between the walls and ceiling and were observed entering through a hole on the wooden panels on the southside entrance. There was some signs of water damage in some of the corners from rainwater. See Plates **30** to **34** and **Table 31** below.

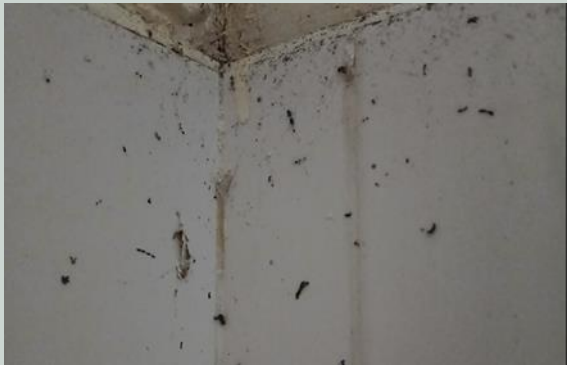
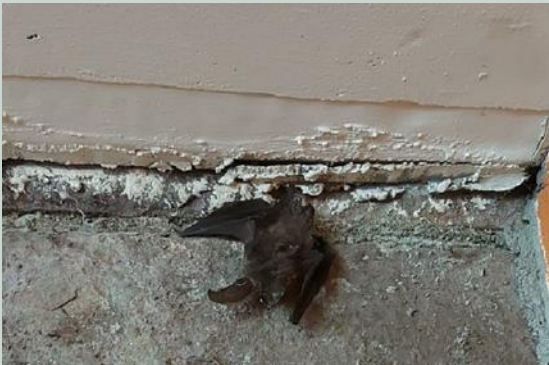
| Observations | |
|---|---|
| Potential for bat use | Yes - A number of potential access points via open/broken doors, broken window and gaps and holes in wood panelling along the top of the first floor. Peeling paint and gaps between the walls and roof provide roosting potential. |
| Plate 33. Droppings on wall in toilet on ground floor | Plate 34. Deceased brown long-eared bat found on a wall on the 1st floor |

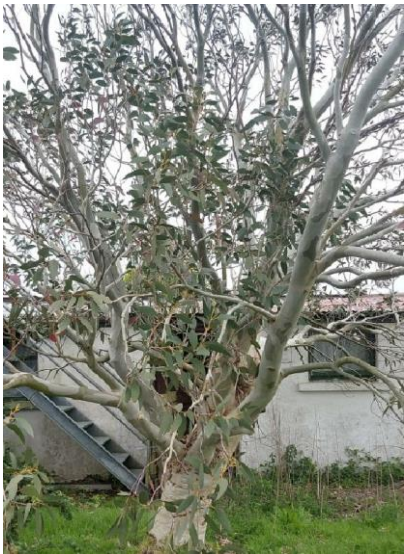
Plate 35. Eucalyptus Tree Assessed

During ground-level assessment there were no potential roost featured such as hole, cracks and crevices observed. Additionally, no evidence of bats (droppings, staining etc.) was recorded. Having regard to guidelines in Collins (2023), this tree all was classed as having ‘negligible’ suitability for roosting bats. See **Plate 35** below.

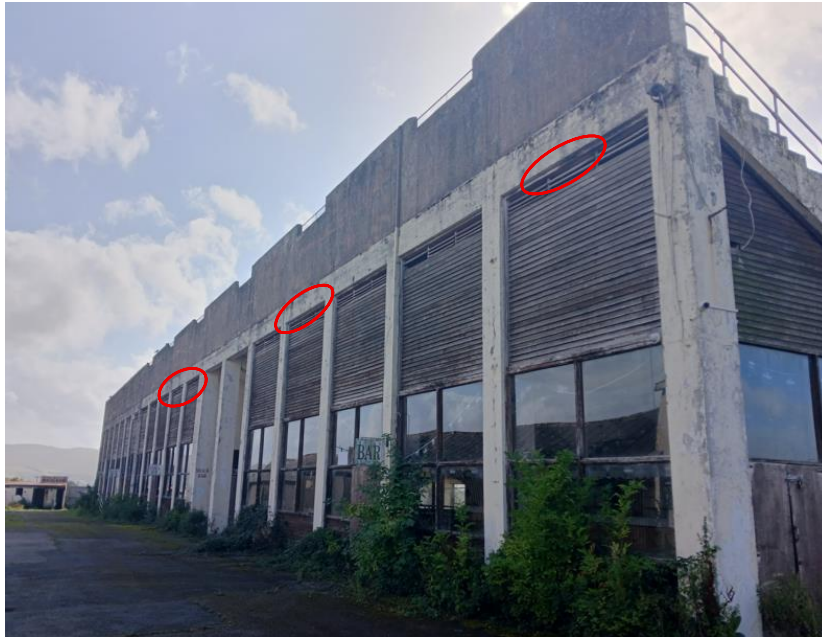
was the most common species recorded, and soprano pipistrelle was recorded on one occasion entering the building. See **Plate 35** showing the exit and entry points on the building.

**Plate 36. Exit and Entry Points on Building No. 1b used by bats**

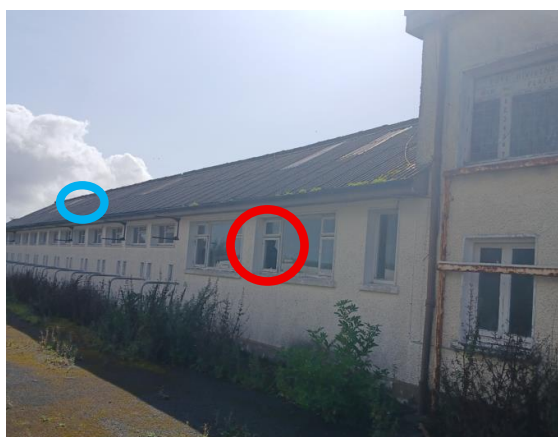
On the second survey night there were three observations of common pipistrelle exiting a hole in the roof on the west side of the building (marked in yellow in **Plate 37** below). Also on the second survey night, both common pipistrelle and brown long-eared bats were recorded on a few occasions entering and exiting a broken window on the east side of the building (marked in red in **Plate 36** below). Activity began at 22:30 and ceased at 23:32.

Plate 37. Exit/entry points east side of building no. 2 used by bats

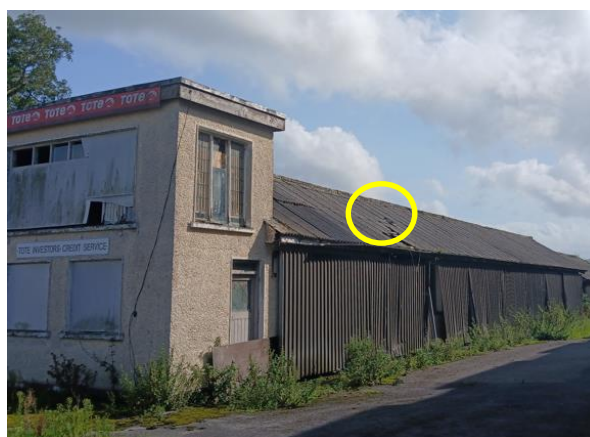
Plate 38. Exit/entry points west side of building no. 2 used by bats

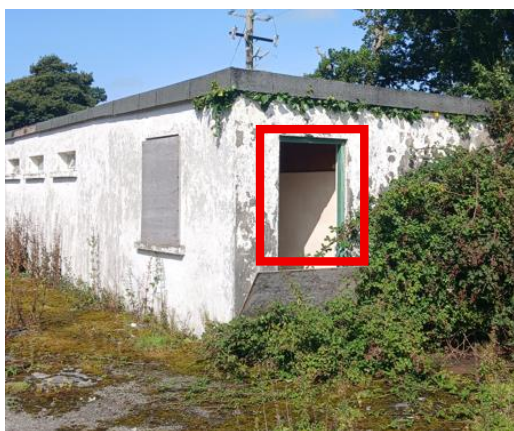
On the second survey night, one soprano pipistrelle was observed at 22:24 exiting the female toilet block (marked yellow in **Plate 39**).

Plate 39. Door to male toilets (southern end) of building No. 3 used by bats

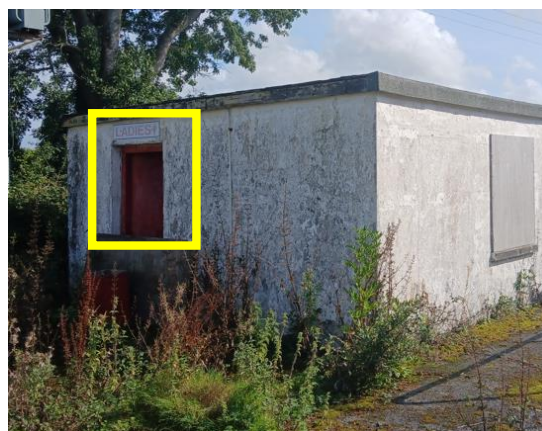
Plate 40. Door to ladies' toilets (northern end) of building No. 3 used by bats

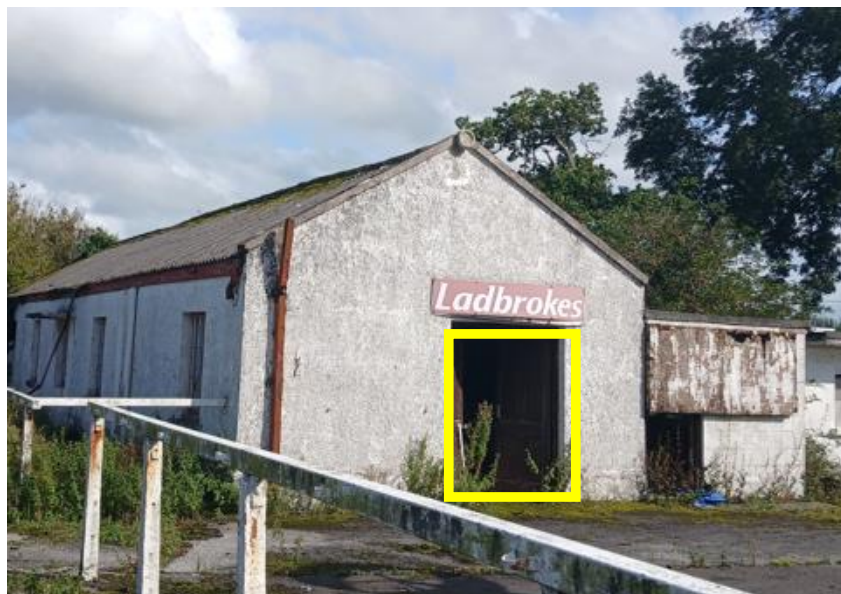
This building was surveyed on one night. On a number of occasions, a bat was observed exiting and entering through the door on the west site of the building (marked in yellow in **Plate 40**). In a few instances the bat flew in and out a few times before flying off. Most of the observations pertain to common pipistrelle and on one occasion soprano pipistrelle. Activity began at 22:29 and ceased at 23:41.

Plate 41. Exit and Entry point of building No. 10 used by bats
