# Site of Residential Development at Leopardstown Road Planning Ref D17A/0337/C8

## Bat Survey

Version: 7<sup>th</sup> of August 2025

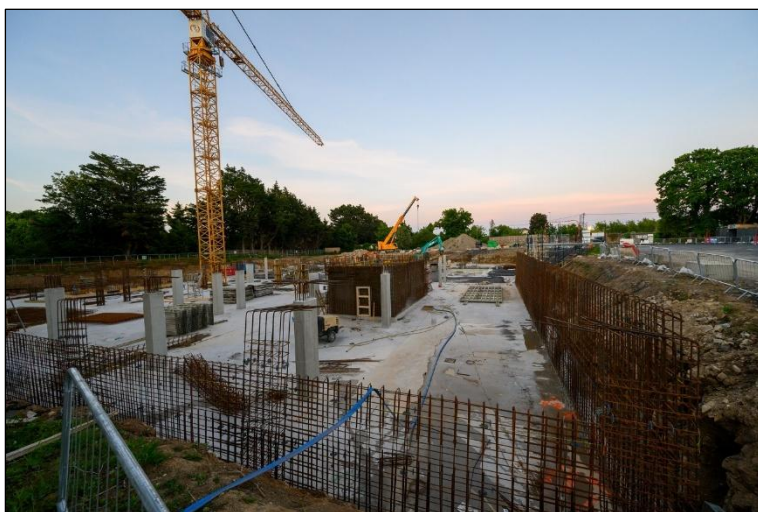
**Plate 1** Construction works were already underway at the site at the time of the current survey.

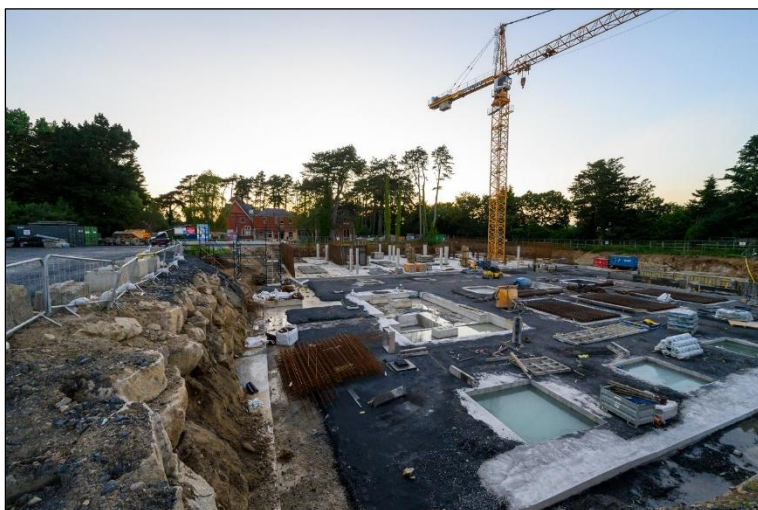
**Plate 2** View of the site with St. Joseph's House in the background. Extensive construction works on the site were ongoing at time of the survey.

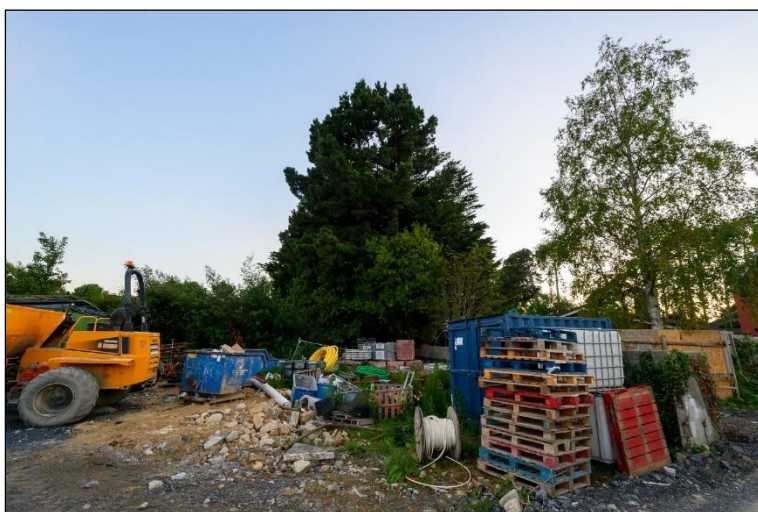
**Plate 3** Construction disturbance on the site at the time of the current survey.

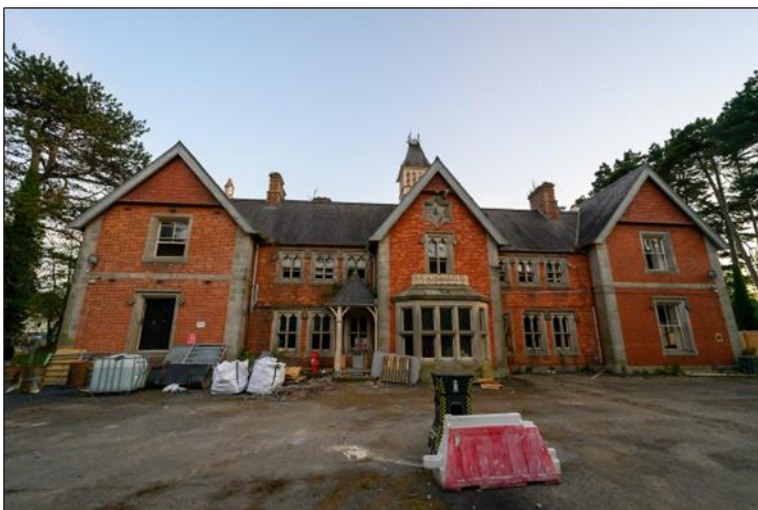
St. Joseph's house is derelict and has not been occupied for some time. The house was inspected in detail and a number of potential entry/exit points for bats were recorded. There were numerous gaps in the soffits, eaves, and roof that had potential to be used by bats. No evidence of bat activity was visible on the outside of the building. The areas around the building were searched for bat droppings and none were found. However, the survey was completed in a busy construction site and it would be expected that most signs of bats would have been dispersed by the activities. It was also not possible to check areas in the roof to rule out previous usage by bats, due to access issues.

**Plate 6** Front view of St. Joseph's house, June 2025.

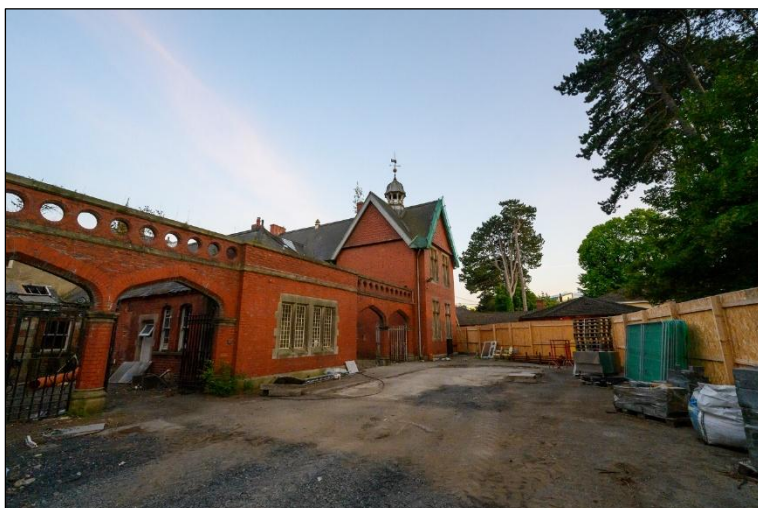
**Plate 7** View of the northern side of St. Joseph's house, June 2025.

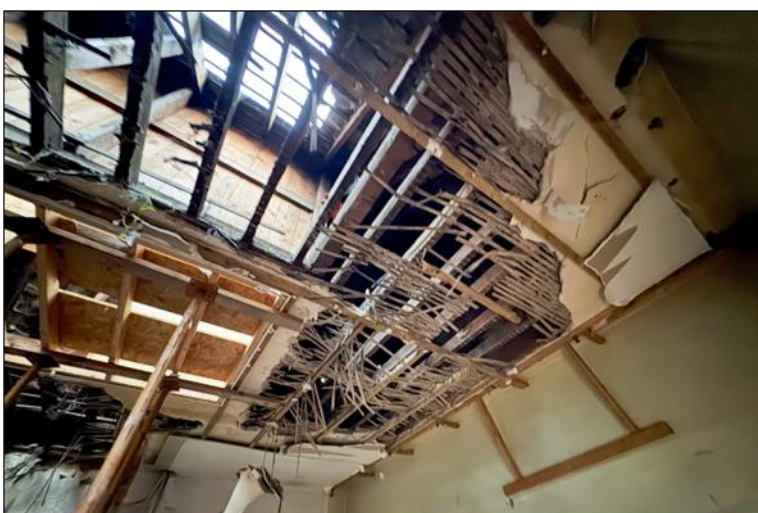
The main remaining St. Joseph's house building suffered substantial damage due to a fire caused by vandalism. Fire can have the following ecological consequences for bats:

**Plate 9** The internal areas of St. Joseph's house could not be inspected due to health and safety issues. However, it was confirmed that the building had been damaged by fire, and internal works had been completed (cleaning out etc.).

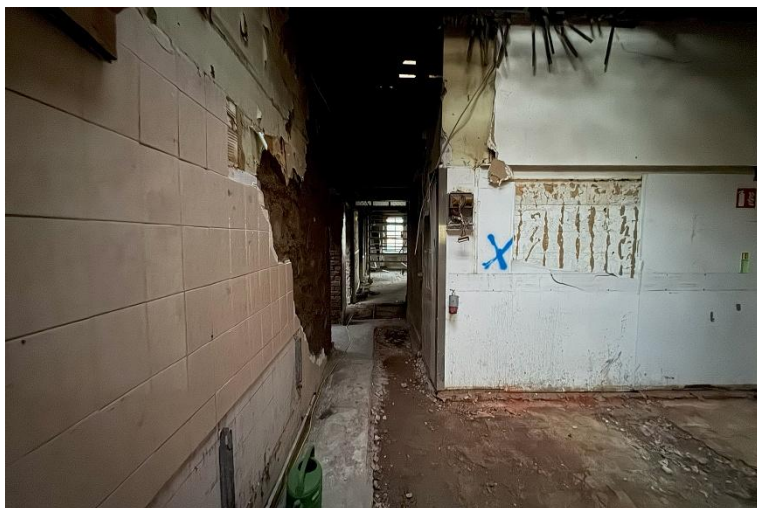
**Plate 10** Internal areas of house – cleaned out after the fire.

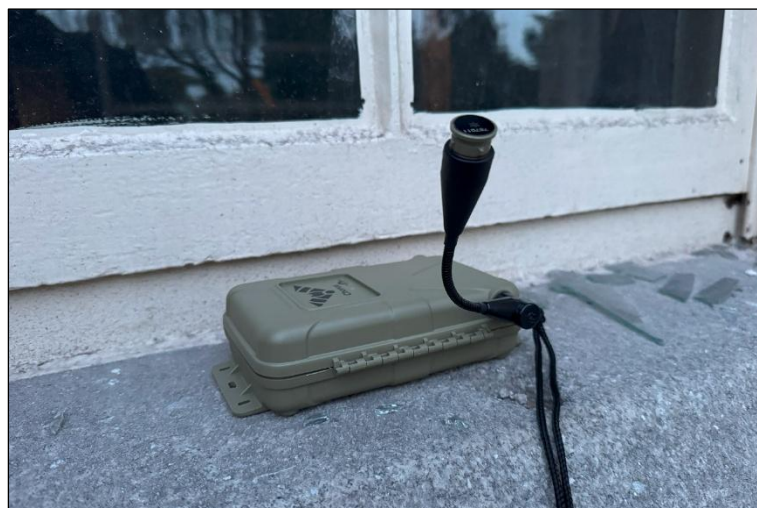
**Plate 12** One of the three Anabat static detector placed at St. Joseph's house, June 2025.

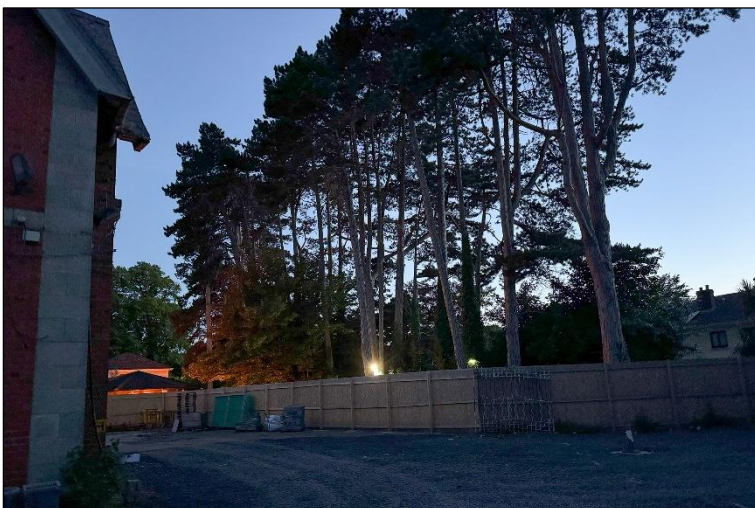
**Plate 15** Common Pipistrelles were recorded foraging around these trees. Note how this area is also affected by lighting, but was one of the darker areas of the site.

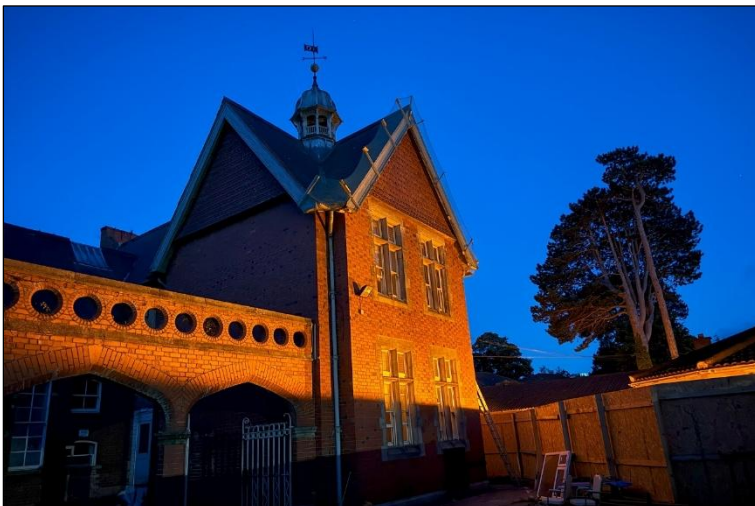
**Plate 18** Much of the site was affected by light spill commencing from outside the site.

The proposed development will likely result in increased lighting on the proposed development site which can cause habitat loss. Increased lighting will impact commuting and foraging bats. The site is, however, already affected by light spill from adjoining areas.

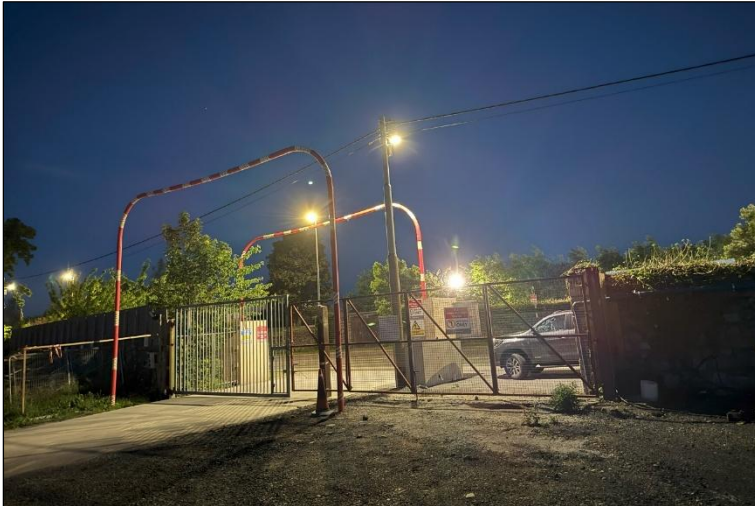
It is noted again that each bat pass does not equate to the number of individual bats flying in the vicinity of the recording device but is representative of bat activity levels. Some species, such as the Pipistrelles, will continuously fly around a habitat, so it is likely that a series of bat passes within a similar time frame (i.e. separate audio files within a small time frame) represent one individual bat. Overall, the survey confirmed that small numbers of Common Pipistrelle were roosting in St. Joseph's House (2-3 individuals). Two Leisler's bats were either roosting in trees on the site or roosting nearby. The site is of limited value to bats for foraging and commuting, and only minor bat roosts are present. The site is already very impacted and disturbed, affected by light pollution, especially light spill from the floodlight on the GAA grounds.

**Plate 19** Floodlight in the adjoining Silverpark GAA grounds was causing excessive and unnecessary light spill at the site entrance.
