## Lesser horseshoe bat roost, Transformer Building, Ardnacrusha, Co. Clare: Derogation Application Supporting Information

**Project Name & Location:** Lesser horseshoe bat Roost, Transformer Building, Ardnacrusha, Co. Clare

***RE: Application for a Derogation Licence to undertake investigative works in Transition Room and Basement of the Transformer Building, Ardnacrusha, Co. Clare.***

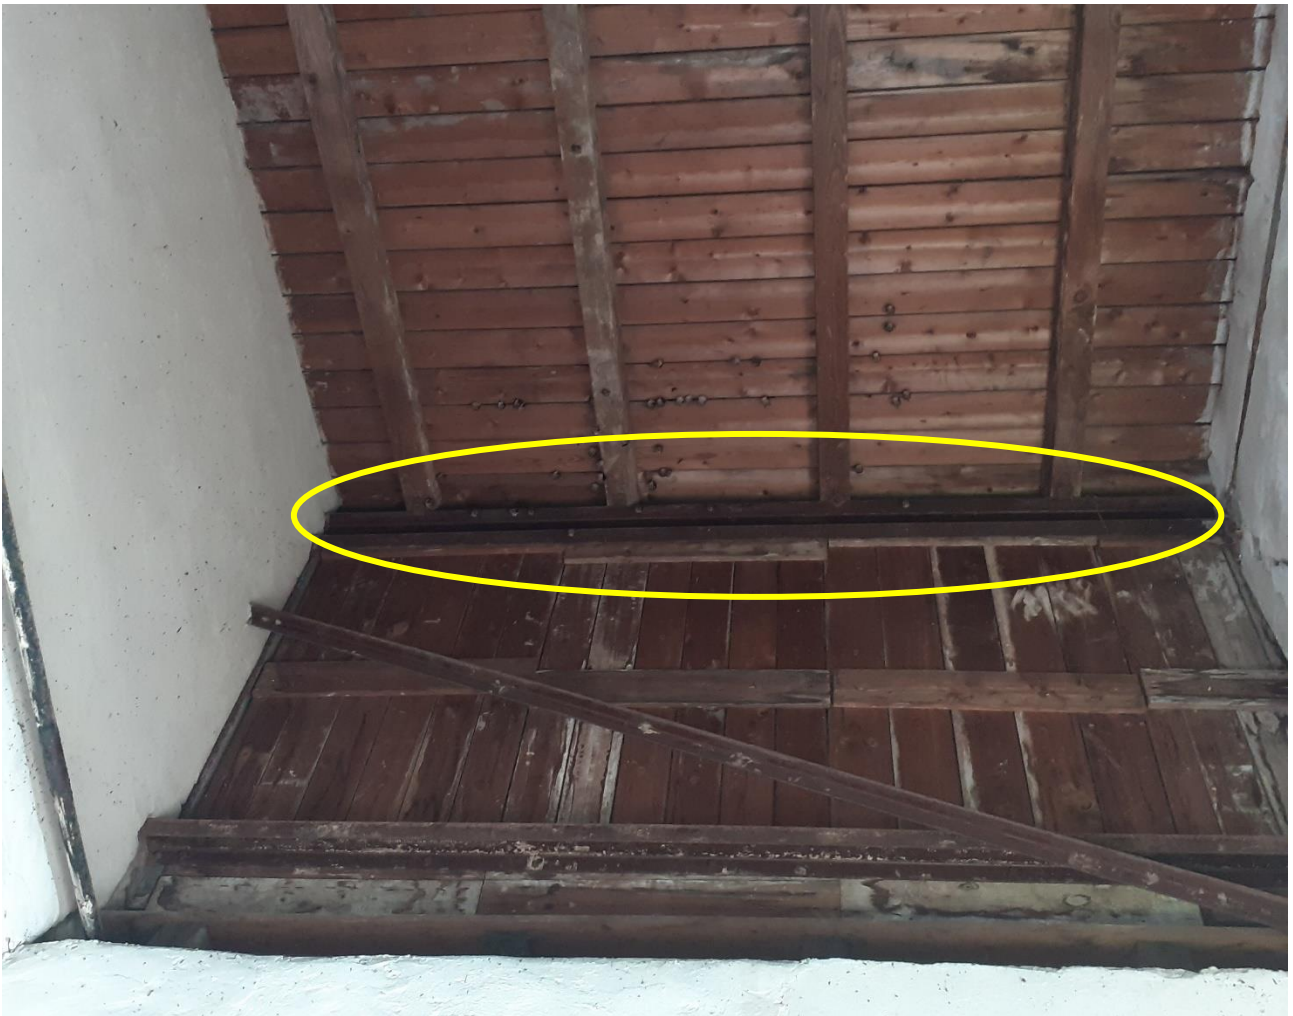
Plate 3: Rafter space in Part C, Substation Room (Lesser horseshoe bats visible – highlighted in yellow).

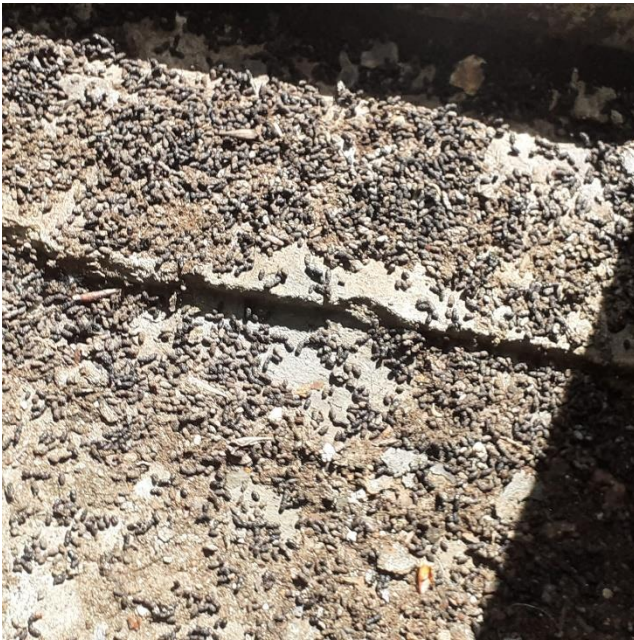
Plate 4: Bat droppings on substation floor (Part D).

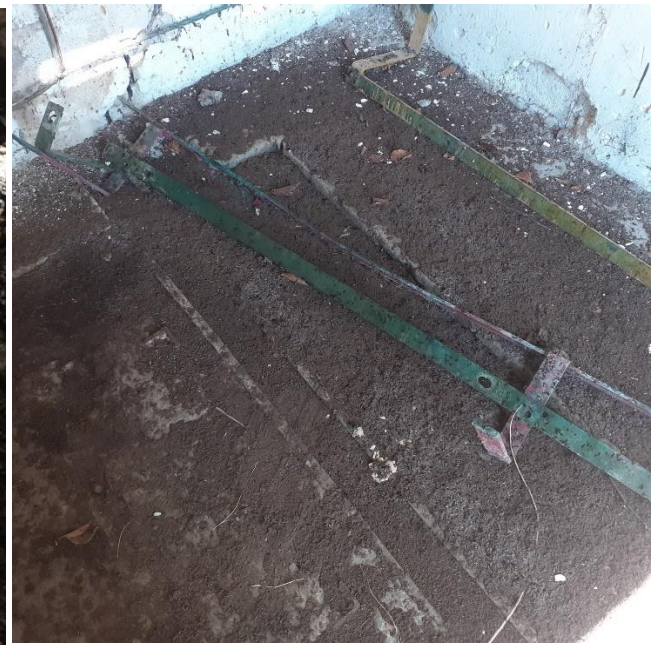
Plate 5: Extent of old bat droppings present on the substation floor (Part C).

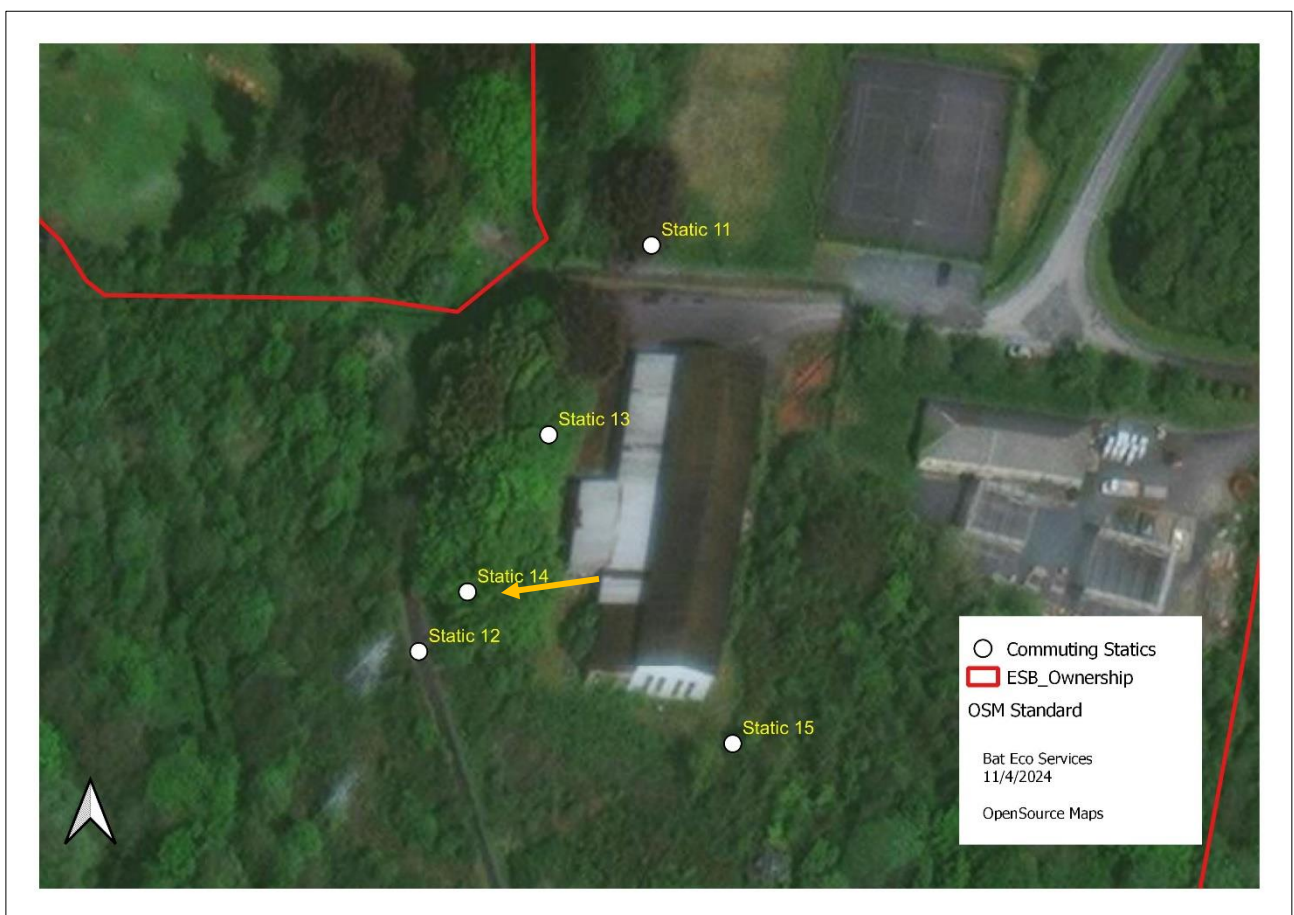
Figure 5: Location of static units around the perimeter of transformer building, Ardacrusha, Co. Clare (Orange Arrow – exit point recorded for lesser horseshoe bats).

- To exit the Transformer Building, the bats return along the same routes as described above for accessing the various spaces named. Upon exiting, the bats fly in a direct line to the boundary fence of the Transformer Building as described by the Orange Arrow on Figure 5.

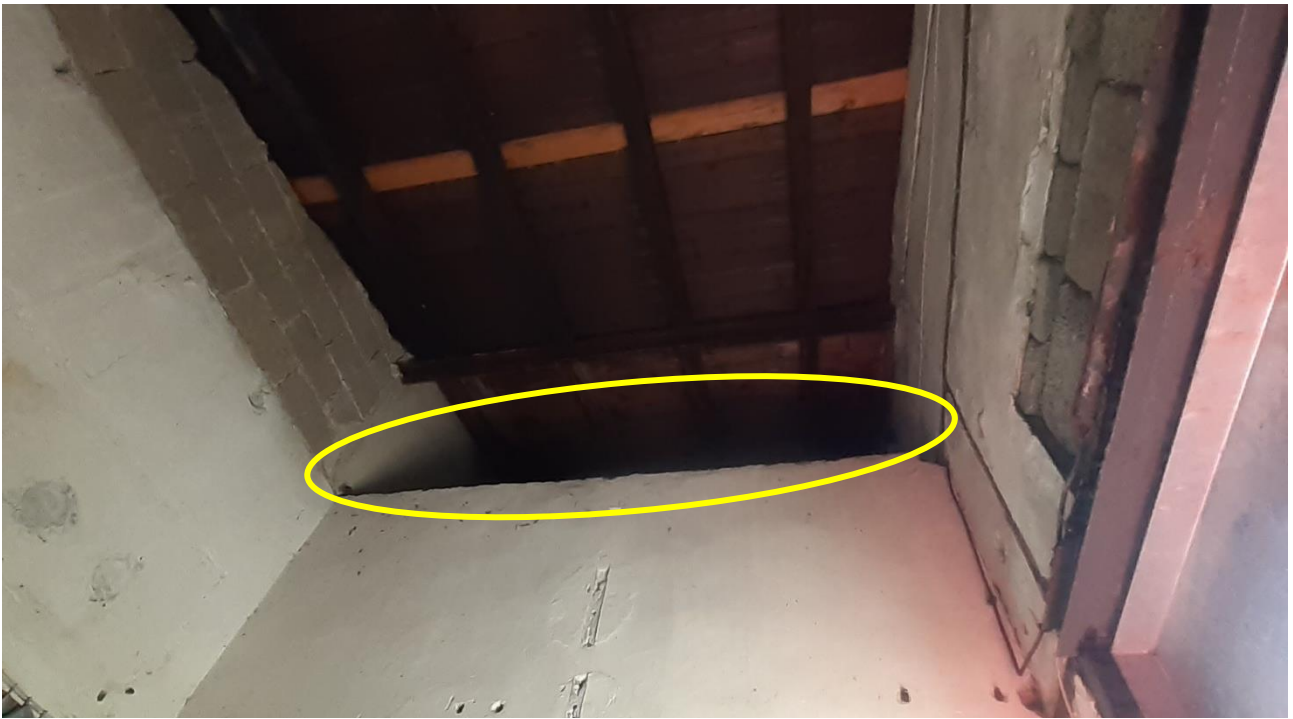
Plate 6: Internal wall in between the two rooms (Part C and Part D) of Substation Room. (Yellow Circle).

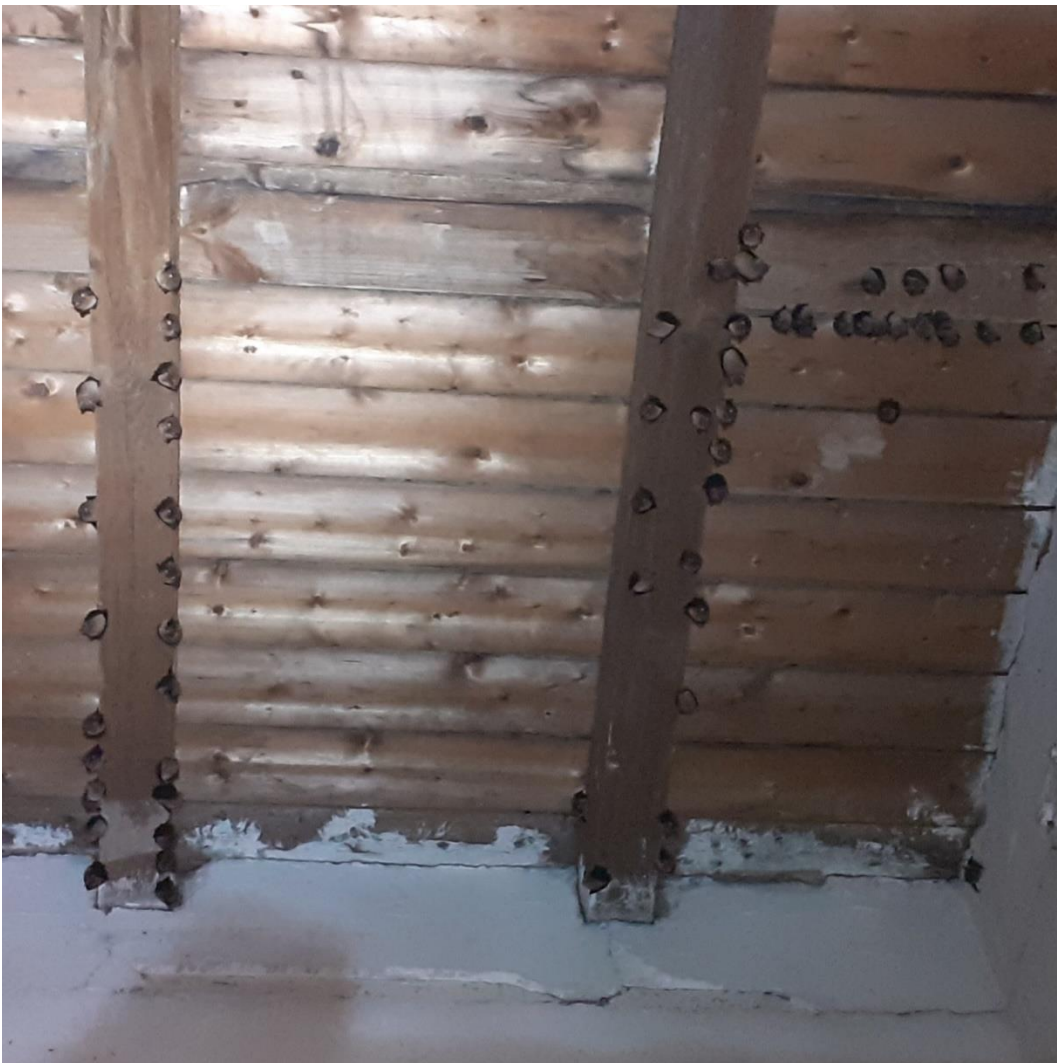
Plate 7: Lesser horseshoe bats in Part B of Transition Room on the 10<sup>th</sup> May 2024.

- The bats enter the Transformer Building through gaps along the wall plate (facia/soffit area – external wall) of the Transition Room (Part A) via the Red Arrows shown on the figure below (Figure 4b). Please see Plate 1 (Yellow Rectangle). Bats were recorded roosting in Part B during both daytime inspections completed to-date (3<sup>rd</sup> and 10<sup>th</sup> May 2024).

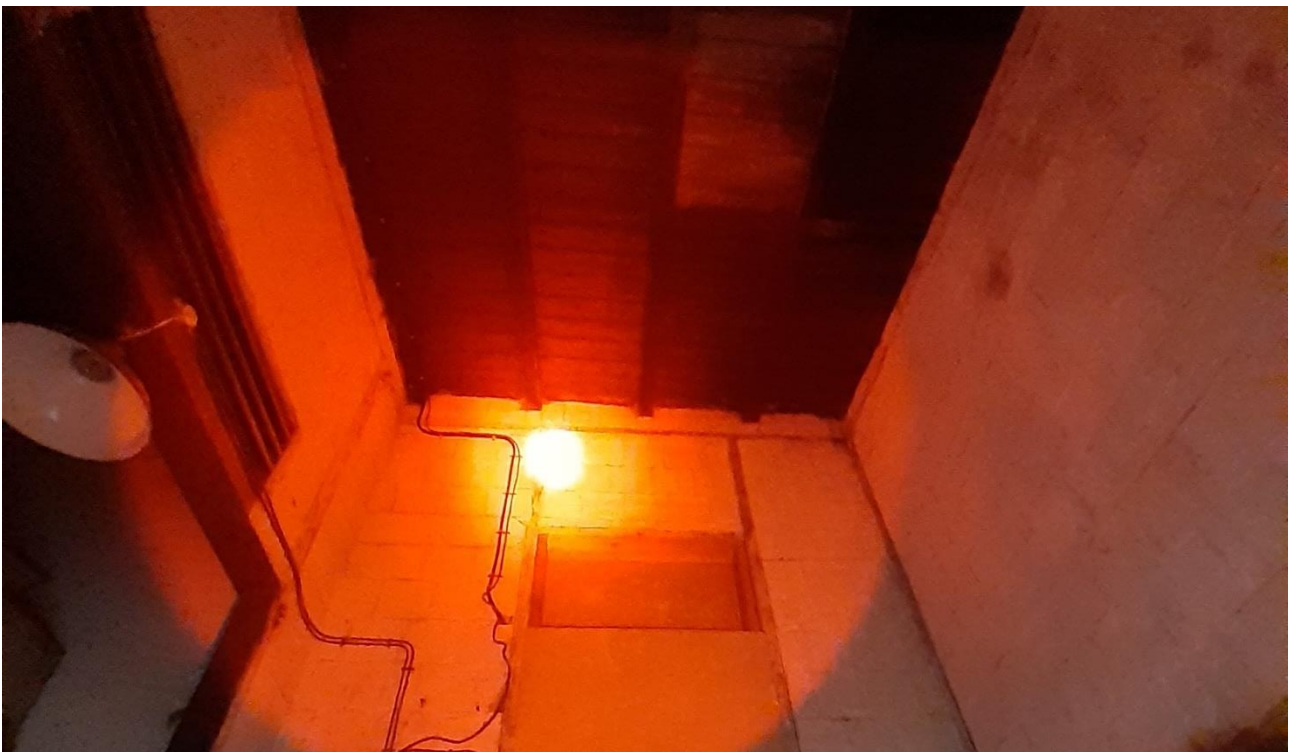
Plate 9: Internal space of Part A, Transition Room (depicting the wall shared with the main space of the Transformer Building. Entrance/Exit into the main space of the Transformer Building is at the rafter level highlighted by the Red Torch.

- To access the Basement, the bats fly through a “post box” entrance at the rafters/wall plate following the Purple arrows (Figure 4b). This brings the bats into the main space of the transformer building (Please see Plate 2 – thermal imagery of the access point).

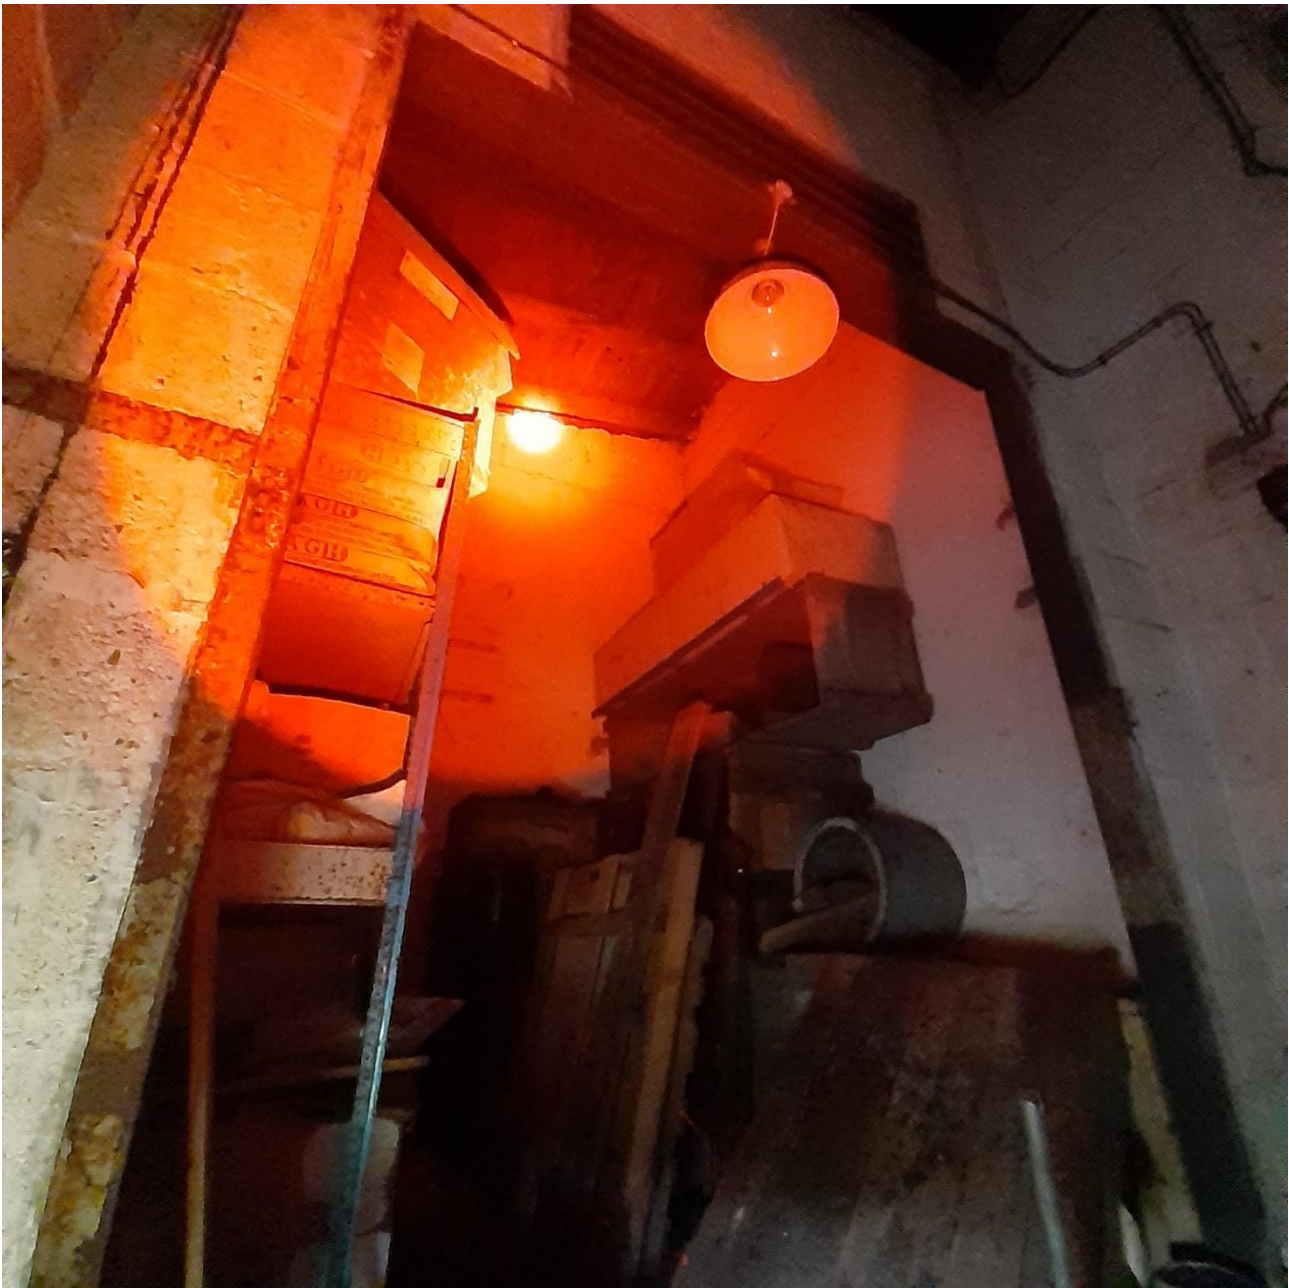
Plate 10: Internal space of Part B, Transition Room – primary space for roosting lesser horseshoe bats roosting in this room.

The Transition Room was unknown to ESB staff until dusk surveys recorded lesser horseshoe bats emerging from gaps along the wall plate. As a result of this, ESB staff investigated the presence of this space and access was provided to a room deemed as the “Transition Room” on the 3<sup>rd</sup> May 2024 and during this daytime inspection seven lesser horseshoe bats were counted. A total of ten daytime counts were completed of the lesser horseshoe bats roosting in this room and this ranged from one individual to 89 individuals. Higher number of bats were recorded roosting in the space during the maternity season with a small number of bats during the cooler months of the year. The bats were recorded primarily roosting in Room B (Figure 4b).

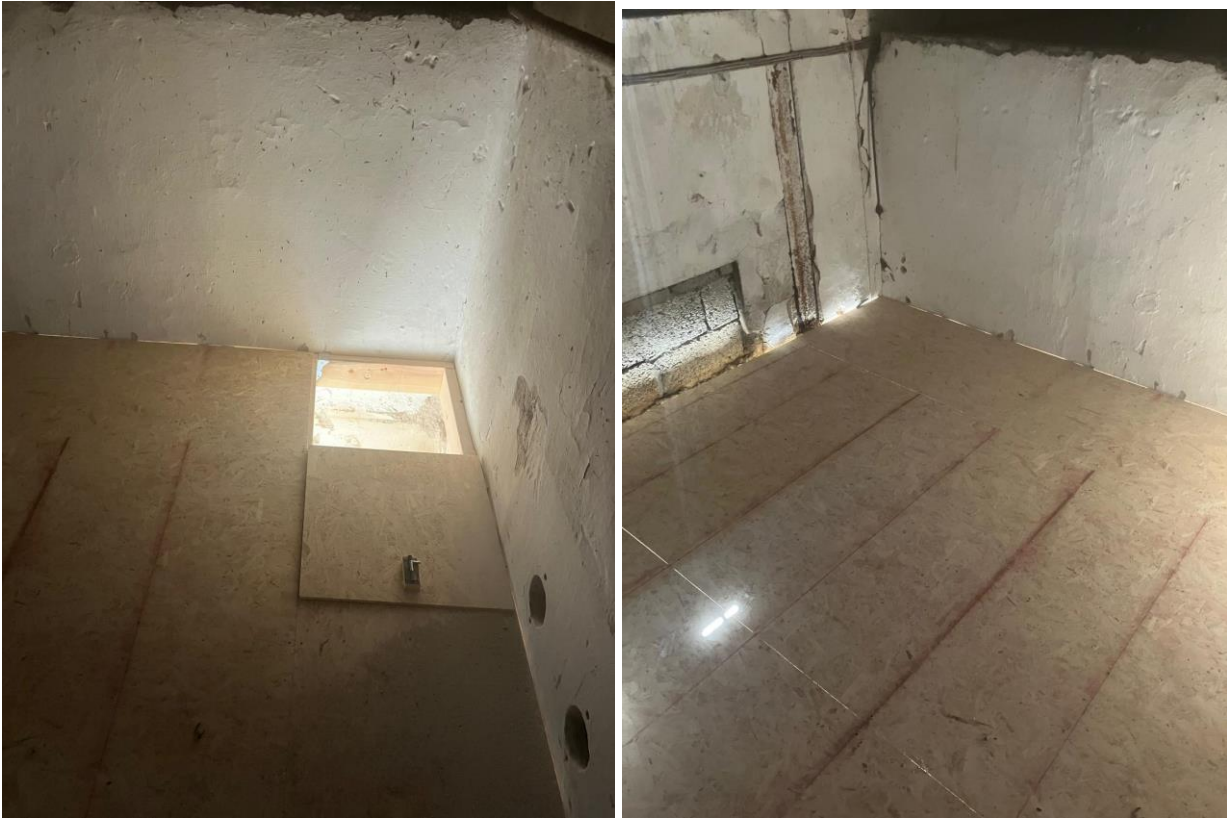
Plate 11a,b: New loft floors completed on 30<sup>th</sup> April 2025.

The new loft rooms were constructed because the equipment in the operating substation would have generated heat. Therefore the removal of such equipment may reduce the temperature within the retired Substation rooms. To mitigate for this, loft rooms were created to reduce the volume required to be heat by solar radiation and therefore aim to maintain the temperature levels preferred by the colony. This is being monitored by temperature data loggers.

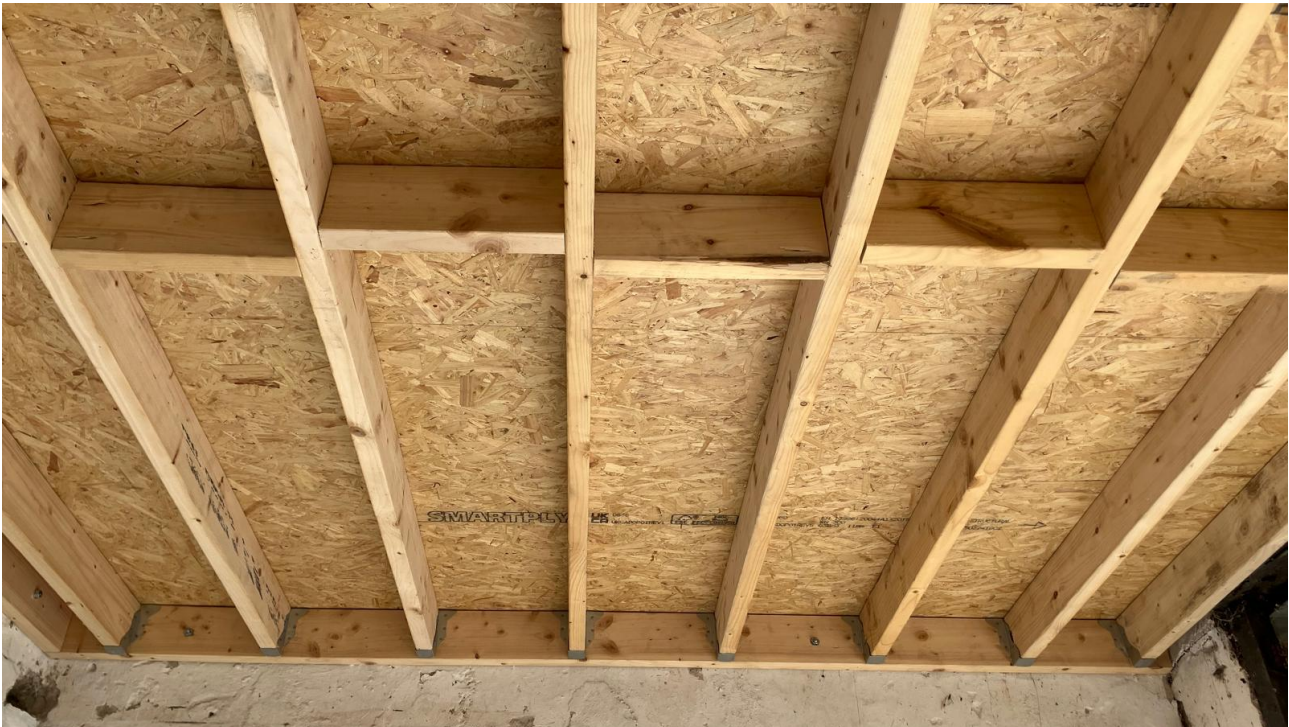
Plate 12: The underside of new loft floor completed on 30<sup>th</sup> April 2025.

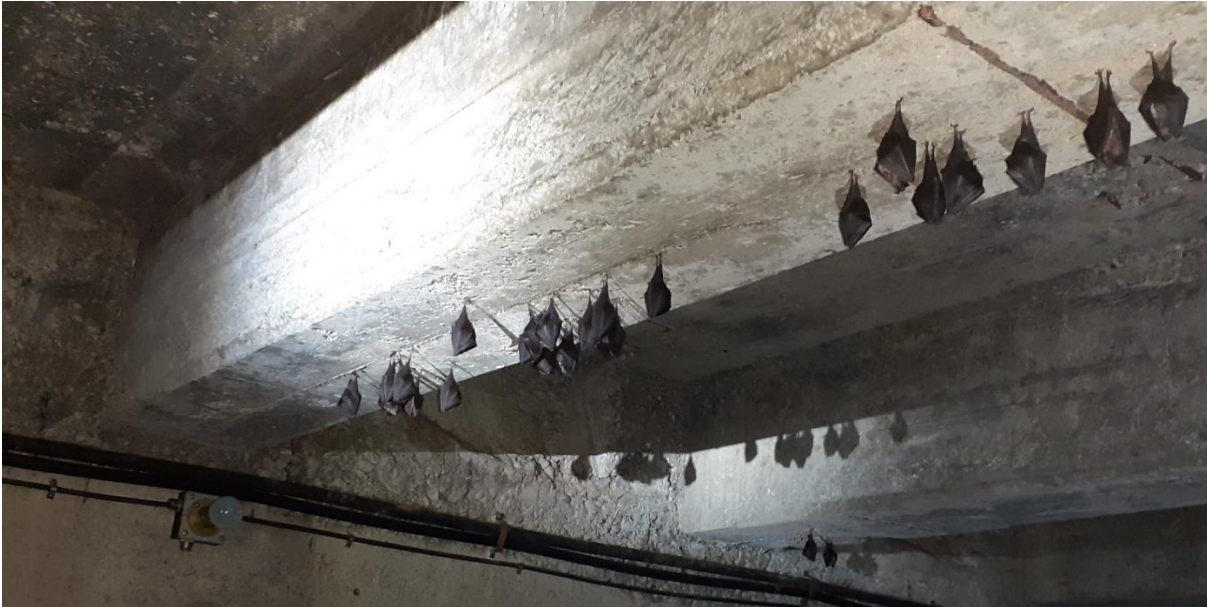
Plate 14: Lesser horseshoe bats in torpor within the basement(4<sup>th</sup> March 2024).

The basement was inspected during 16 of the 18 site visits undertaken. Lesser horseshoe were recorded roosting in the basement during 12 of these visits with numbers ranging from one individual to 59 individuals. The highest number of bats was recorded on the 3/12/2024. But the number of bats varied greatly and it likely to be influenced by the external air temperatures. Generally, during

the summer months, the number of bats in the basement were greatly reduced, reflecting that the colony was primarily roosting in the maternity spaces of the Substation and Transition Room. The location of bats roosting in the basement was primarily at the northern end of the basement, adjacent to the Northern Tunnel (Figure 2). Occasionally, lesser horseshoe bats were recorded roosting in the Northern Tunnel (approx. 2m into the tunnel), but never in the Southern Tunnel.

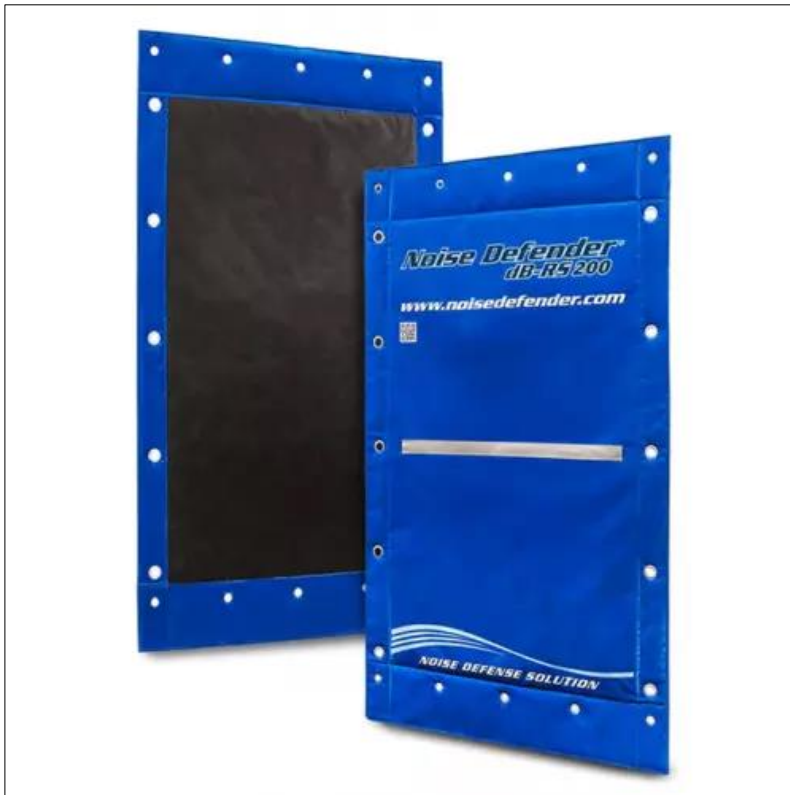
Plate 16: Noise defender acoustic barrier Source: [www.hermeq.ie](http://www.hermeq.ie).

Prior to proposed drilling works, a sound proof “room” will be constructed in the Transition Room around the area of operation. This temporary room (i.e. Work Room) will be constructed using a timber frame lined with sheets of plywood. An acoustic barrier (Noise Defender Acoustic Barrier (from [www.hermeq.ie](http://www.hermeq.ie) – this is a high-grade lightweight noise absorption panel that can be attached to the inner walls and ceiling of the “Work Room” ) will be attached to the sheets of plywood to reduce noise and vibration within the Transition Room. Typically, a drill emits 80 dB of noise but the specifications of this barrier states that it absorbs up to 361 dB.

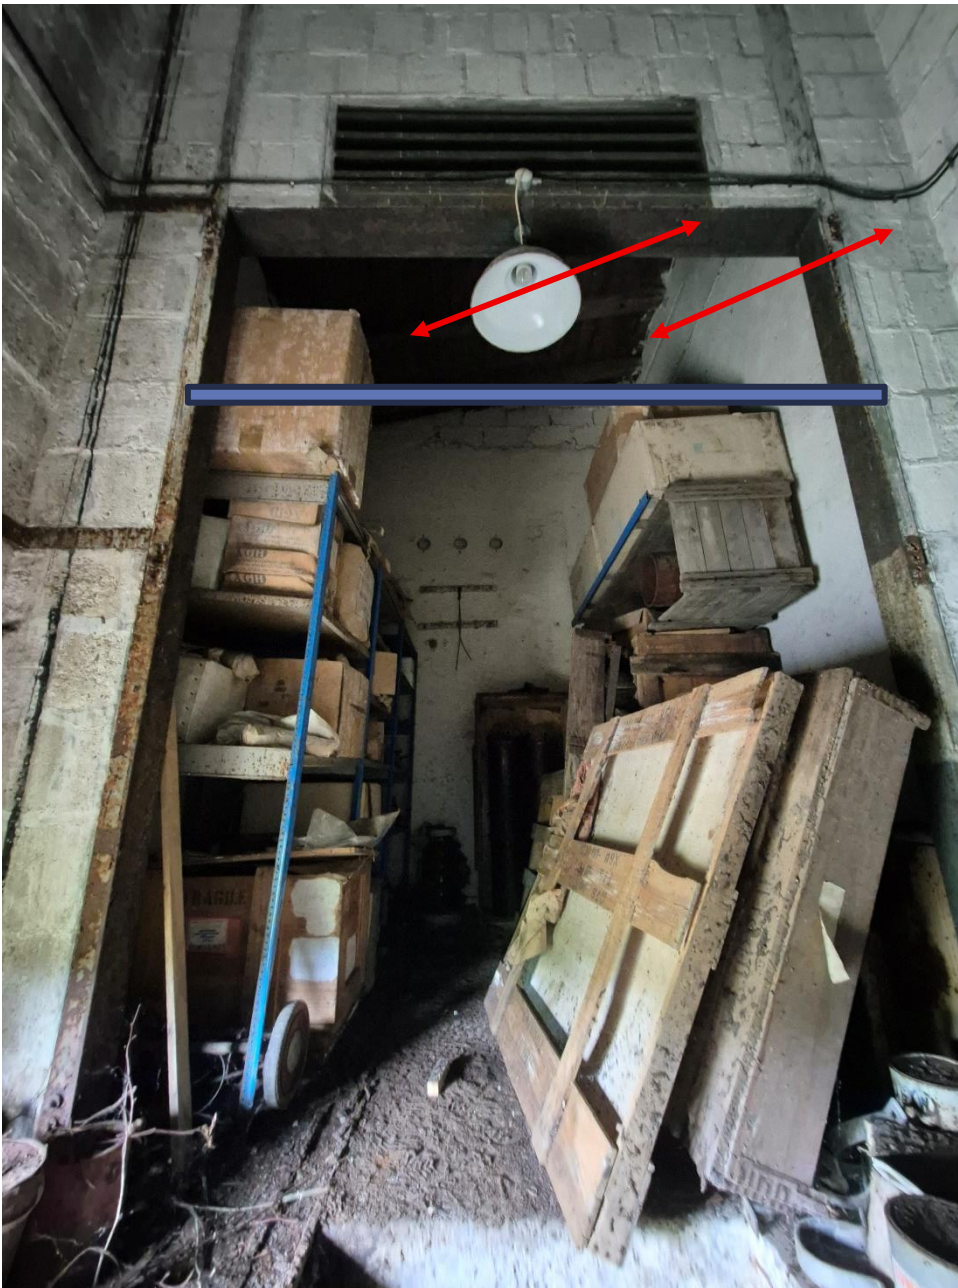
Plate 18: Room B of Transition Room.

Red Arrows – bats will continue to enter Room A and be able to fly to Room B, into the Substation Loft and/or to the Basement. This gap is approximately 50cm high and the width of the entrance into Room B (see next photograph). The “Work Room” will be constructed at the height of the Blue Lines which will provide enough work space for drilling investigation.
