DEROGATION LICENCE APPLICATION – SUPPORTING INFORMATION

**PROPOSED MOTOR SALES AND SERVICE BUILDINGS,
CREGGAN UPPER,
DUBLIN ROAD,
ATHLONE, CO. WESTMEATH**

Michael Moore Car Sales Ltd.

JULY 2025

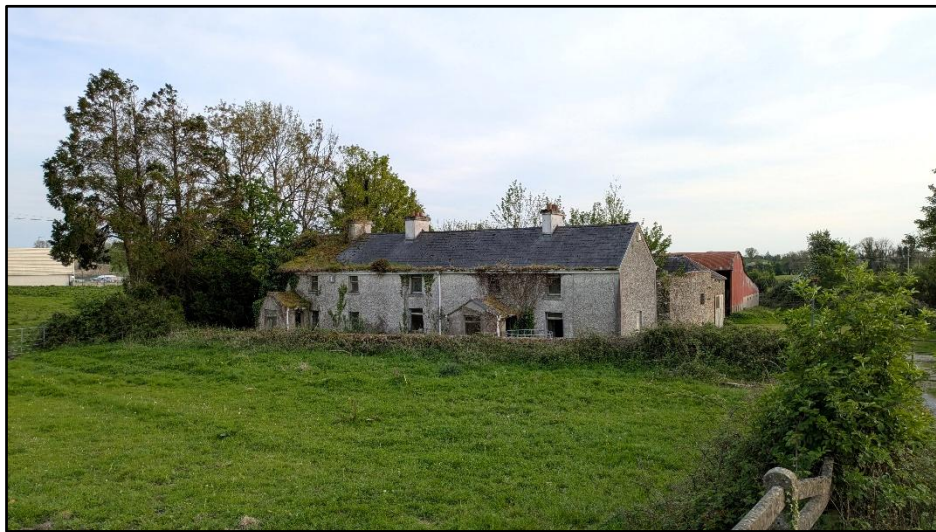
FIGURE 1. FARM BUILDINGS WITHIN PROPOSED DEVELOPMENT SITE.

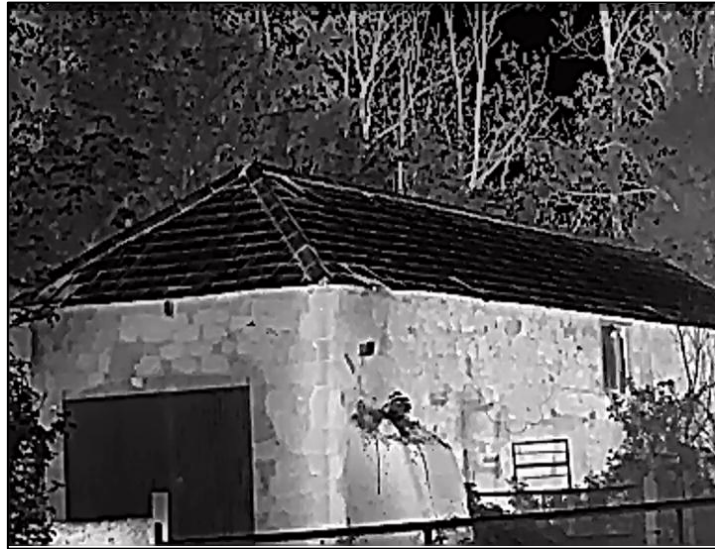
A high-sensitivity thermal imaging camera was also utilised as a survey aid, as per Fawcett Williams (2021), during the April 2025 survey. Thermal imaging significantly improves the detectability of bats emerging/re-entering roost sites, as the camera is not restricted by the available visible light. Cameras were focussed on features identified during the roost inspection survey. Footage was then reviewed following the survey to ensure no potential emergence was missed during the survey.

FIGURE 4. EXAMPLE OF THERMAL IMAGING CAMERA FOOTAGE.

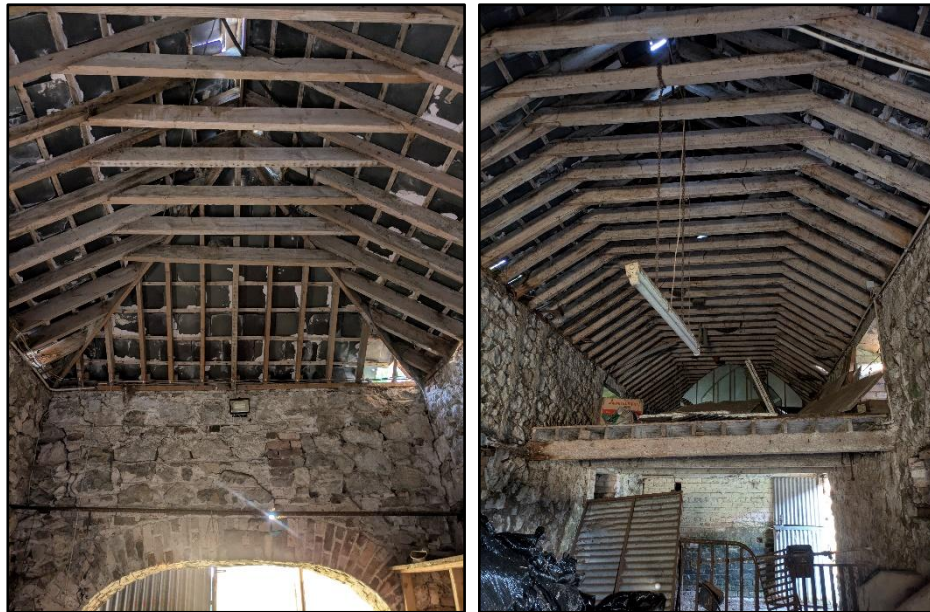
The outbuilding is stone-built with a slate roof. The rafters back directly onto the slates and the roof is overall in good repair.

A small number of droppings, consistent with pipistrelle bat droppings, were found in the stone outbuilding during the April 2025 roost inspection survey. These droppings, approximately 15-20 in total, were found on the floor in the western end of the outbuilding. No further droppings were recorded within the structure.

FIGURE 6. INTERIOR OF STONE OUTBUILDING WITHIN PROPOSED DEVELOPMENT SITE.

The existing structure on-site will be removed as part of the proposed development. This includes the likely common pipistrelle bat roost within the stone outbuilding.

- The demolition of the stone outbuilding and farmhouse should be undertaken outside of the main period for roost usage where possible (i.e. outside of April to September);

- Should works to these structures be undertaken during the active bat season (March/April – September/October) it should be immediately preceded by bat emergence surveys and roost inspection surveys to determine whether any bats are utilising the structures;

- Should bats be recorded emerging they will require exclusion from the structures (i.e. blocking of entry/exit points once bats have emerged). Physical removal by hand by a suitably qualified bat specialist may be required should exclusion not be possible. In this instance bats will be placed in a bat box for release on the evening after capture. Note: Should significant bat roosts be identified in any structure during the emergence surveys (i.e. maternity roosts), in consultation with NPWS, works to the subject structures may be constrained to outside the period of roost usage (i.e. outside of April to September); and

- A qualified ecologist and/or the local NPWS conservation officer will be present to over-see the initial demolition works. It is recommended that for demolition, the roof structures should be removed first, and the building left for a minimum of 24 hours in order to facilitate any potential bats present to exit the structures.

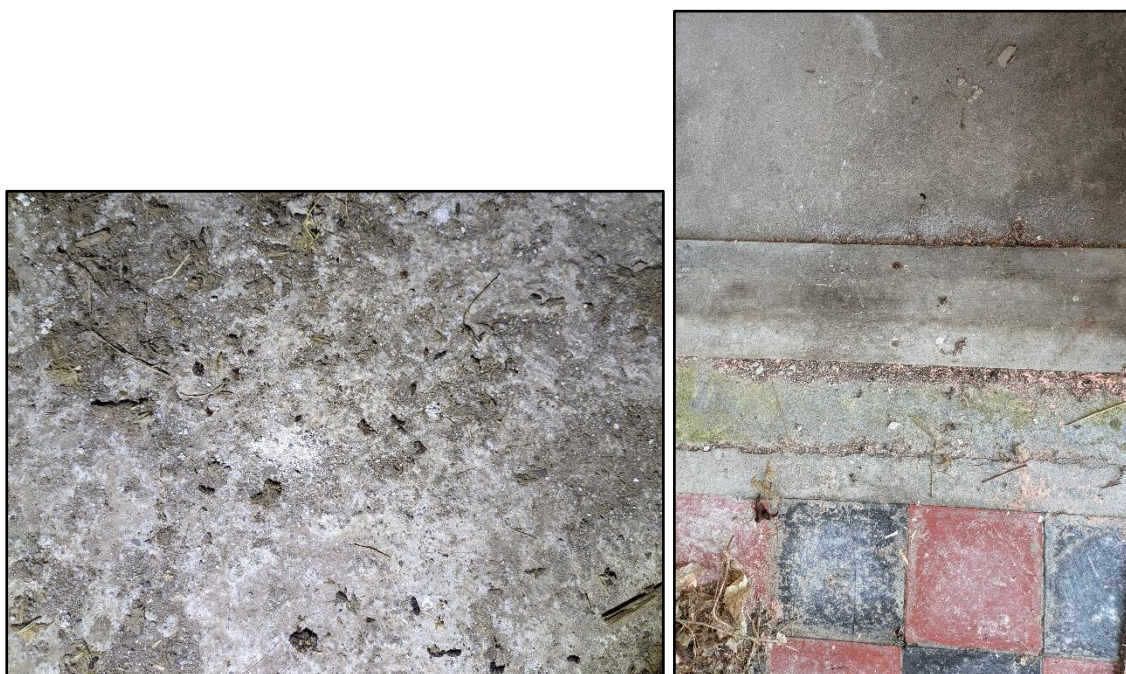
A small number of droppings, again consistent with pipistrelle bat droppings, were also found on the ground in the front porch of the farmhouse during the April 2025 roost inspection survey. There are no roosting features present within the interior of the porch. The exterior door of the porch is left open, and it is considered that the droppings recorded here relate to pipistrelle bat(s) foraging in the porch space, which provides a sheltered location likely harbouring insects on the wing for foraging.

FIGURE 7. SMALL NUMBER OF BAT DROPPINGS ON FLOOR OF STONE OUTBUILDING AND PORCH OF FARMHOUSE.

A small collection of bat droppings was recorded within the stone outbuilding during the roost inspection survey in April 2025. A review of thermal camera footage revealed a single common pipistrelle leaving the building through an open door at approximately 22-minutes post-sunset. While it is possible that this bat was foraging within the sheltered building and entered through an open door, owing to the timing

of the observation and adopting a precautionary approach, it is considered that this bat was roosting in the outbuilding.

A total of 4no. bat boxes (Schwegler 2F and 1FF of similar comparable designs) will be erected on the exterior of the existing building directly south-east of the proposed development site within the Michael Moore Audi Athlone development, which is within the applicant's ownership. The boxes should be erected as follows: 2no. (one 2F and one 1FF design) on south-facing elevation and 2no. (one 2F and one 1FF design) on the west-facing elevation, with boxes to be minimum 4m in height, or approximately 1m from apex. The bat boxes will be installed prior to the demolition of the existing structures and under guidance from a suitably qualified ecologist.

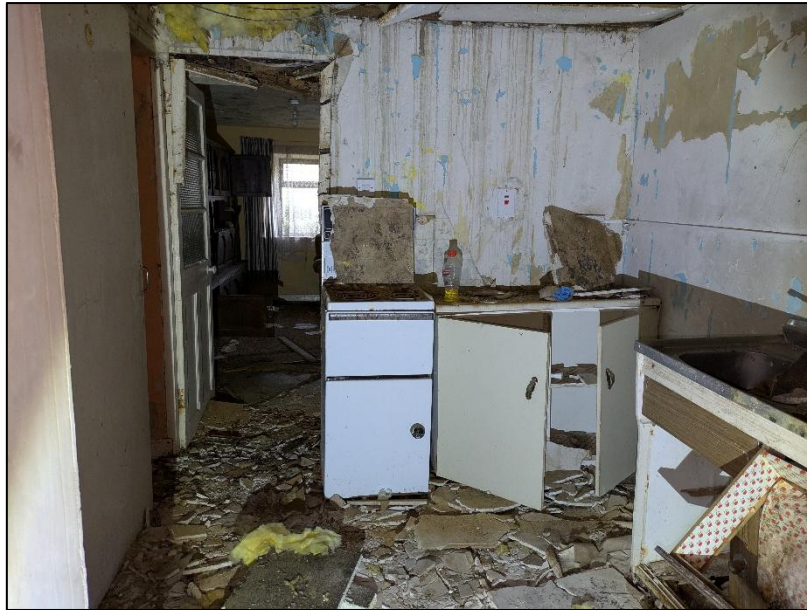
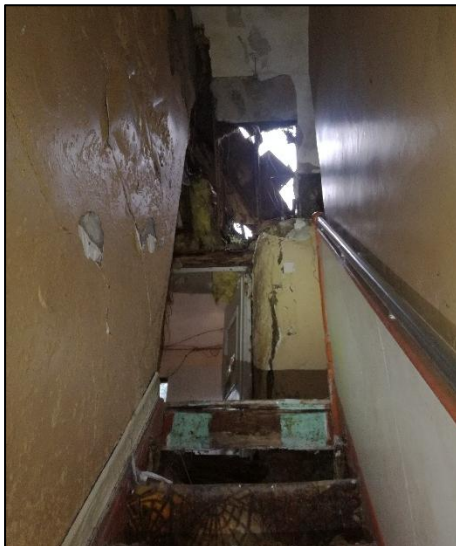
The proposed development site encompasses a derelict farmhouse and associated outbuildings & barn. The buildings are in a poor state of repair and there is evidence of previous anti-social behaviour. The farmhouse has evidence of fire damage and previous vandalism. The stairs are and upper floor have collapsed in places and are structurally unsound. There is ongoing deterioration and collapse in the ceilings (see Figure 9 overleaf). The proposed development site is situated close to large population centre of Athlone and there is a high likelihood of further anti-social activity within the buildings on-site, which comprises a significant health and safety risk to the public. Members of the public entering the site and buildings would be at risk of serious injury due to the deteriorated state of the buildings.

FIGURE 8. EXAMPLE OF DAMAGE AND UNSAFE CONDITIONS WITHIN EXISTING BUILDINGS ON-SITE.
