# Bat Derogation Licence Application

Foynes to Limerick Road  
(incl. Adare Bypass)

September 2025

**Project:** Foynes to Limerick Road (including Adare Bypass)

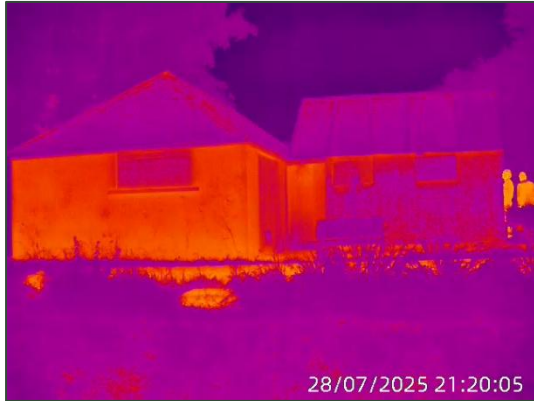
**Plate 2.1** Thermal perspective overlooking the front/western aspect of the derelict cottage (S01) with surveyors in background.

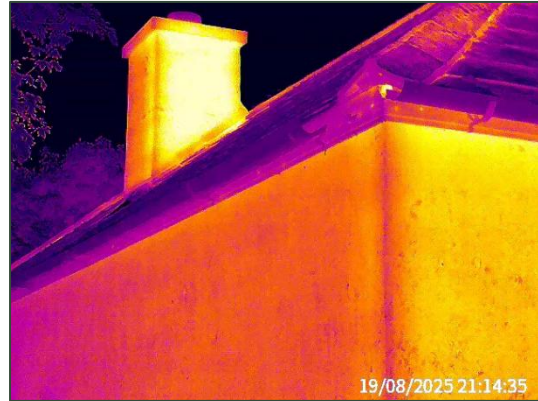
**Plate 2.2** Thermal perspective overlooking the northern aspect of the derelict cottage (S01).

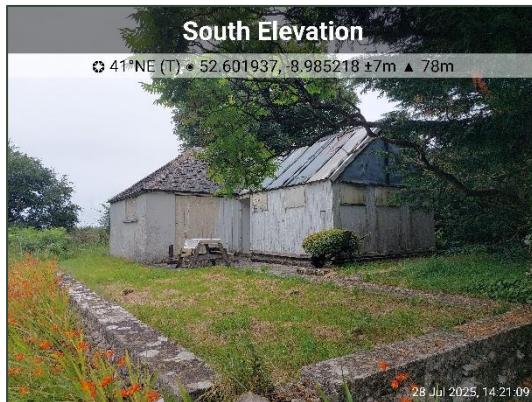
**Plate 3.1** View of disused cottage.

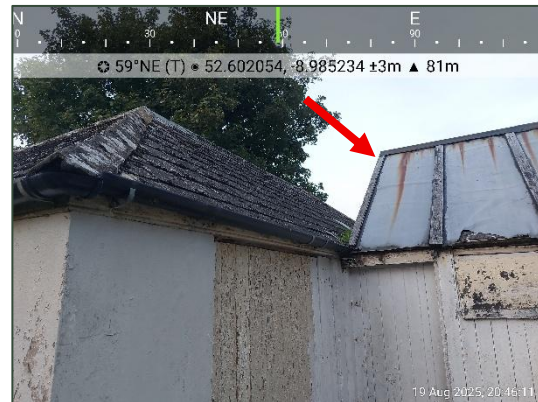
The disused cottage is composed of two distinct sections that are connected through interior spaces. The main section (north) is composed of blockwork walls and synthetic tile roof with chimney. All windows have been boarded up but gaps are present. The roof presents multiple gaps through degraded mortar on ridge tiles, loose replaced synthetic slate, and gaps in the leadwork surrounding the chimney. The interior of the main section is composed of a ground floor and enclosed attic space with open access hatch. The ground floor and attic space were heavily cobwebbed throughout (see **Plate 3.5**). An inaccessible void is present between the tiles and underlay. No evidence of roosting bats was evident within the main section.

The adjoining section (south) is composed of timber construction with roofing composed of thin lead sheeting. This sheeting is peeling in multiple sections which provides clear access/egress (see **Plate 3.3**). The apex of this roof structure showed a clear open entryway approximately 30mm diameter also (see **Plate 3.2; 3.6**). The interior of the adjoining section was similarly heavily cobwebbed.

**Plate 3.2** Close-up view of disused cottage, showing two distinct roofing styles. External view of access/egress near interior bat droppings shown in red arrow.

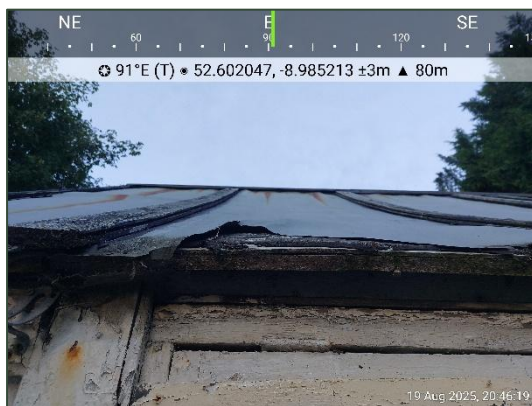
**Plate 3.3** View of lead roofing of southern adjoining section.

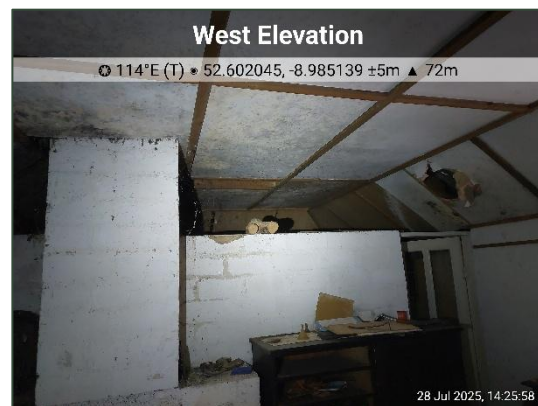
**Plate 3.4** Interior view of northern main section, showing enclosed attic space.

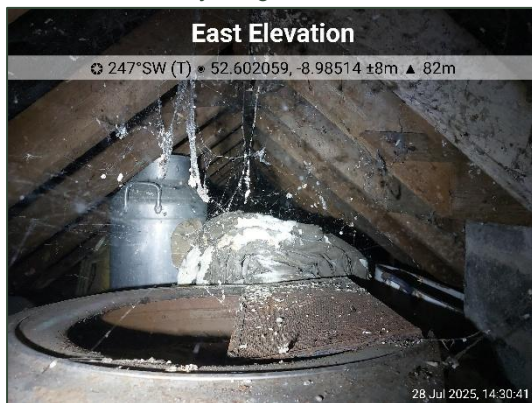
The initial internal inspection of both sections disturbed a large number of cobwebs. Repeat internal inspections following a period of approximately 3 weeks showed abundant cobweb reformation throughout, indicating a general lack of internal flight. Additionally, no new bat droppings were recorded on repeat inspection.

**Plate 3.5** View of enclosed attic space within main section. Note heavy cobwebbing throughout.

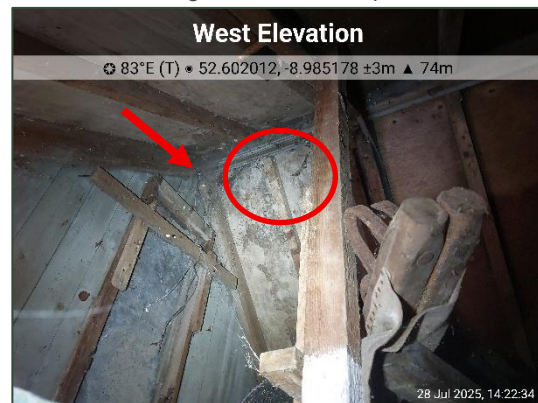
A small number of relatively fresh bat droppings were identified suspended near the apex in cobwebs near the previously described apex entryway. These droppings were collected and sent for DNA analysis with Surescreen Scientifics. Testing results confirmed these droppings were attributed to Soprano Pipistrelle (see **Appendix A**).

**Plate 3.6** Location of bat droppings (red circle) and access/egress point (red arrow) in roof apex of southern section.

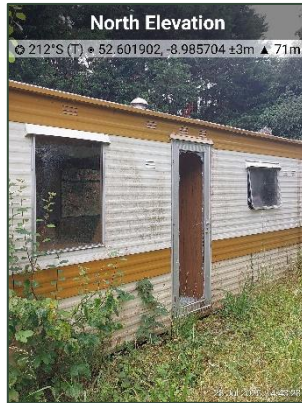
A lone-standing mobile home is located adjacent to the disused cottage (see **Plate 3.7; 3.8**). No evidence of bat roosting, historic or contemporary was associated with this structure.

**Plate 3.7** View of mobile home.

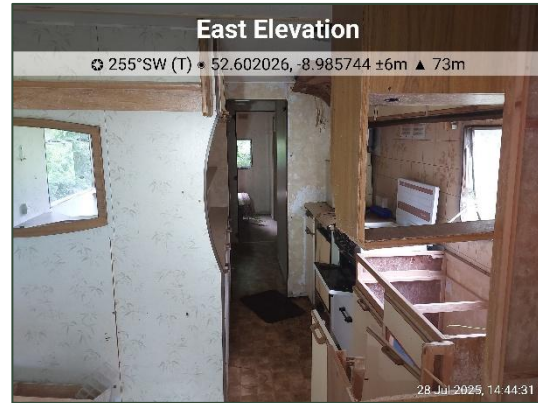
**Plate 3.8** Interior view of mobile home.

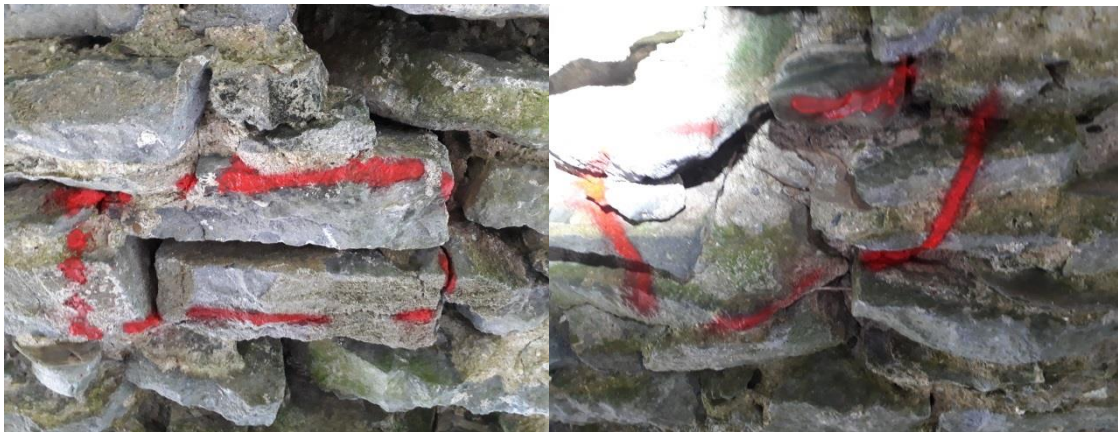
**Plates 5a, b** Crevices containing bats circled in water-based red paint

- Undertake dusk / dawn surveys to determine if the buildings are being used by bats.
- Examine the stonework crevices with an endoscope to determine if bats are present. Crevices found to have bats present should be marked as shown in Plates 2a and b.
- Each crevice that is deemed empty should be blocked up with bubble wrap to prevent bat entering until the structure is to be demolished. Alternatively, once sections of the structure are deemed bat free, wrap in hessian material (see Plates 5a and b) to prevent bats from roosting in the walls post-inspection.
- Once the ruin is deemed bat free, remove in the presence of a bat specialist.

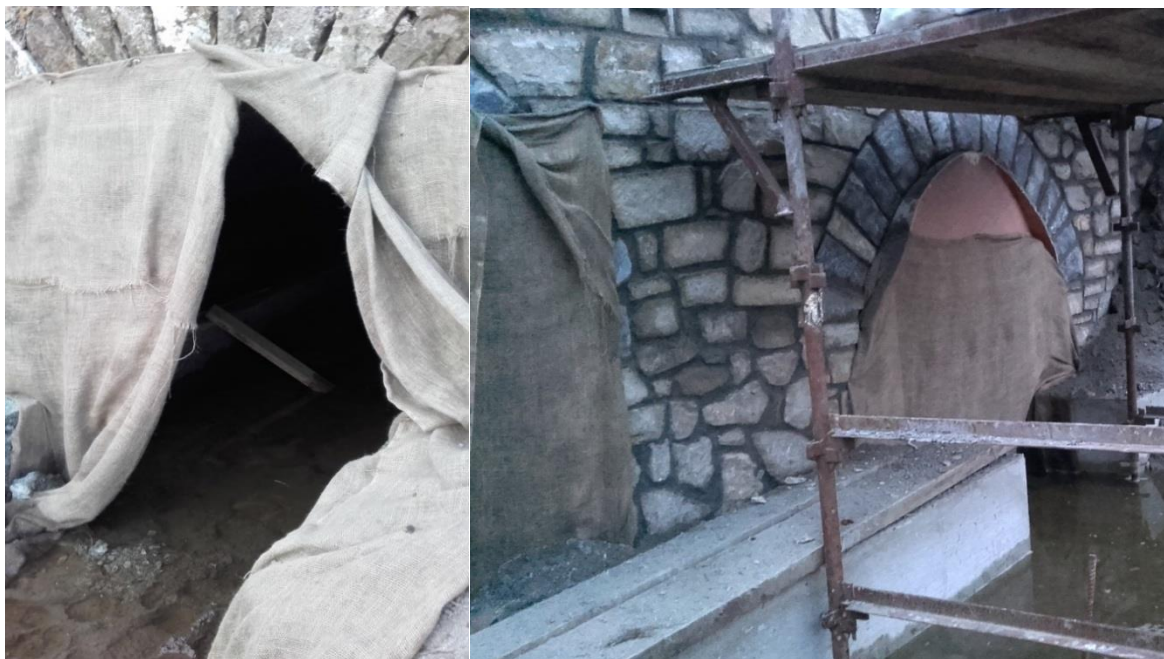
**Plates 6a, b** Example of hessian material curtains for sealing bridge arches
