Keenogbane, Co. Monaghan

SUPPORTING INFORMATION FOR DEROGATION APPLICATION

August 2025

Fiach Ecology

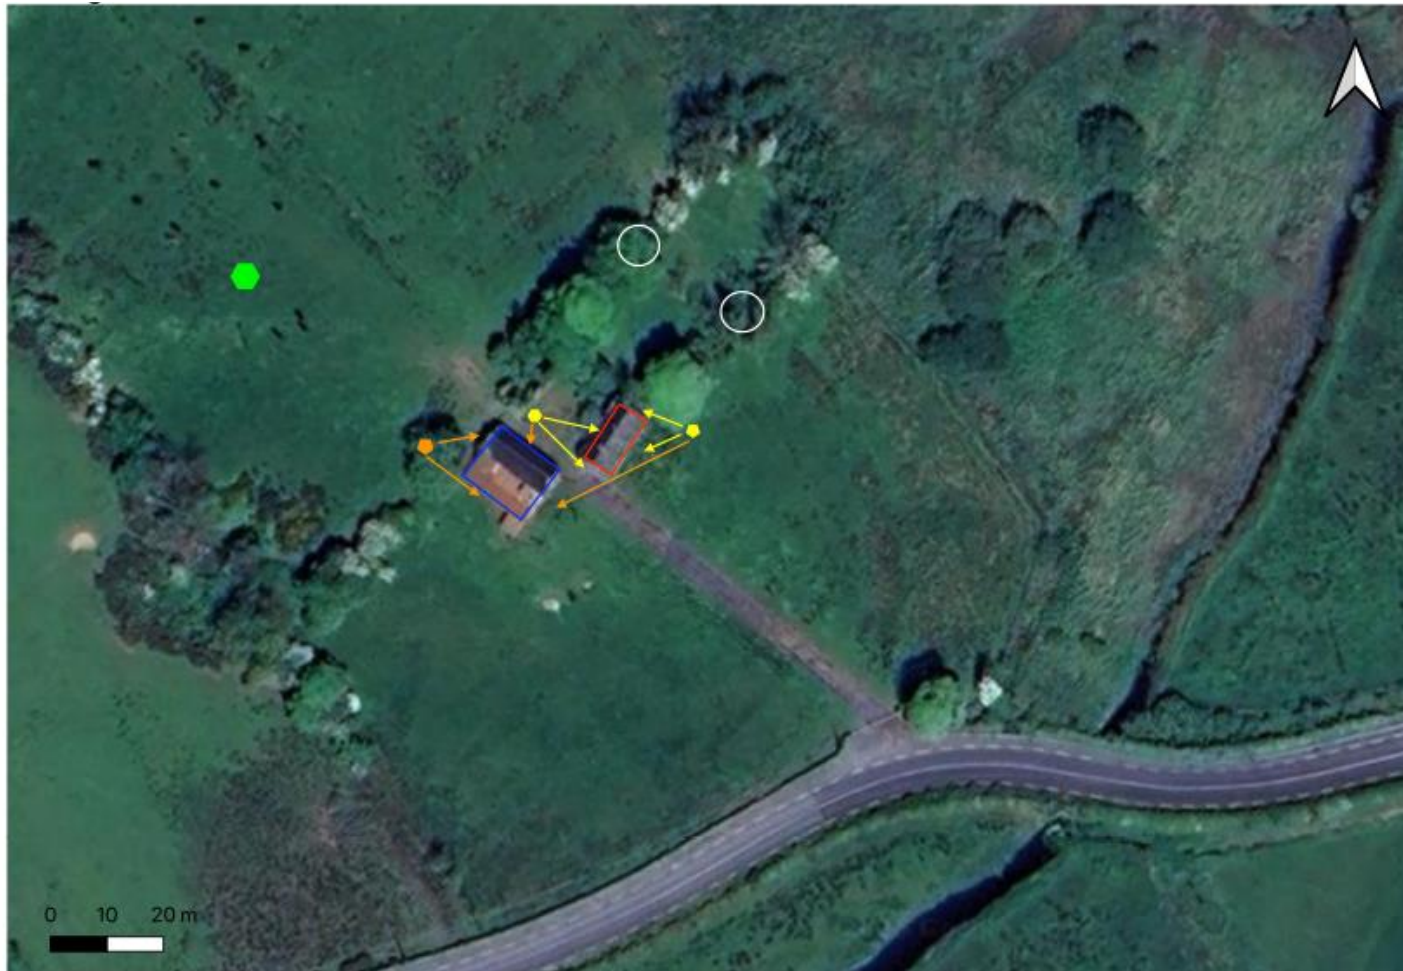
Figure 2. Map of surveyor locations, sightlines and key structures. The red box outlines the original farm house. The blue box outlines the stone barn. Yellow annotations show bat emergence surveyor locations and sightlines during first bat survey. Orange annotations show additional surveyor location (surveying barn) and additional sightlines, for second bat survey. The two white circles show the approximate location of the two ash trees which were identified as having cavities that could host bats.

Two mature ash trees with cavities were identified in the treelines running NE-SW, between the house and the reed bed (Figure 2). These cavities could host bat roosts, though they were quite low, <3m from ground level, somewhat limiting their suitability.

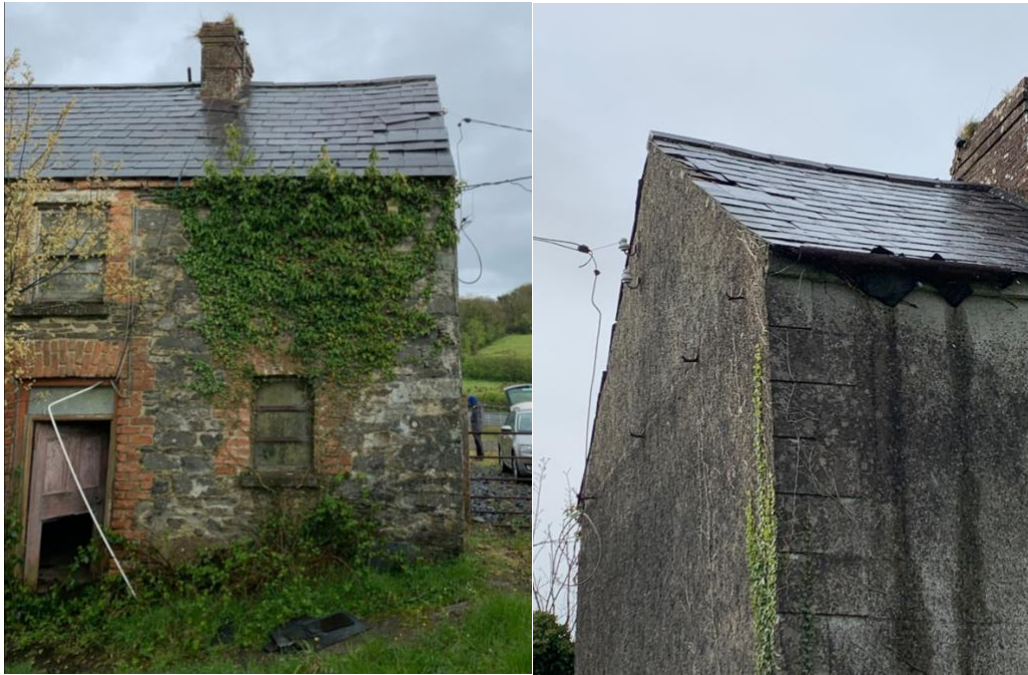
Both the house and stone barn have several Potential Roost Features (PRFs), illustrated in the figures below (Figure 3, Figure 4, Figure 5 and Figure 6). The house has a number of entry points into the attic space via slipped roof slates at the west end of the house, alongside the chimney where the flashing has been removed or fallen and via cracks in the brick and mortar. Internal searches of the house returned no evidence of bats using the house, i.e. no bat faeces visible on internal walls, though only a partial internal inspection of the attic space could be completed due to the structural instability of the floors making further investigation dangerous. Some views of the attic were possible via fallen ceiling timbers and the open access hole for the attic, so it was possible to obtain a general sense of the suitability of the attic as a roost. The attic was not insulated, had no signs of bats, contained cobwebs throughout but the cobwebs were not overly extensive.

Figure 3. Loose slates on the N and S side of the roof.

A Soprano pipistrelle was observed emerging from the house during the first emergence survey. Specifically the bat emerged from the SE facing wall from a gap in the brickwork just below the soffit (see righthand photo, Figure 4). While there was a lot of bat activity around the house for the rest of the survey no other bats were observed entering or exiting the house at that time. During the second emergence survey a Soprano pipistrelle was observed re-entering the house at the SW gable end, climbing through a hole under the ridge tile (righthand photo, Figure 3).

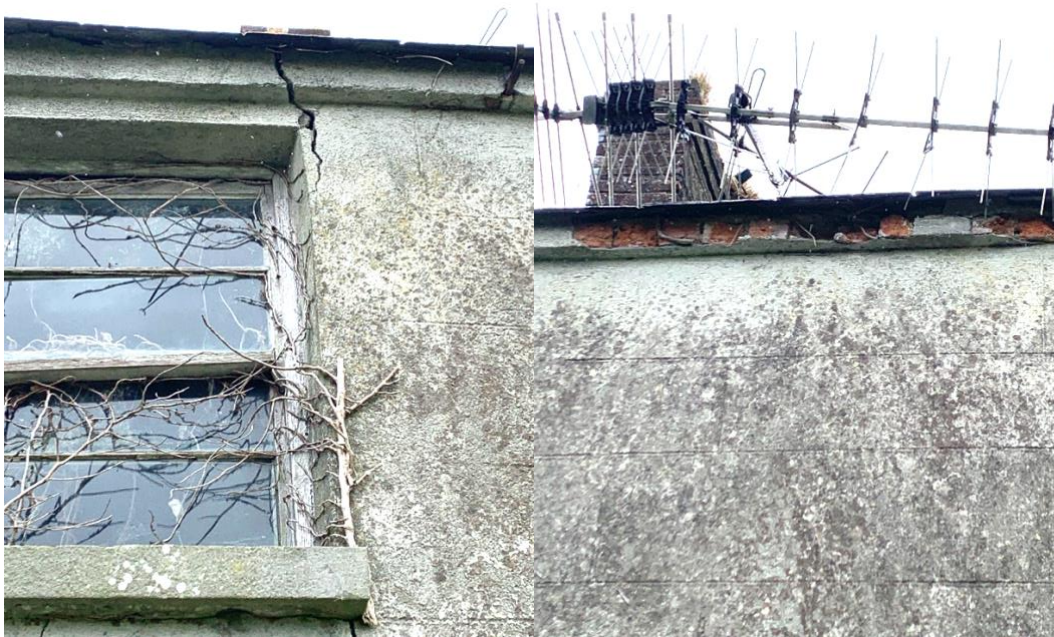
Figure 4. Cracks in masonry and render creating cavities and potential access points to interior of house.

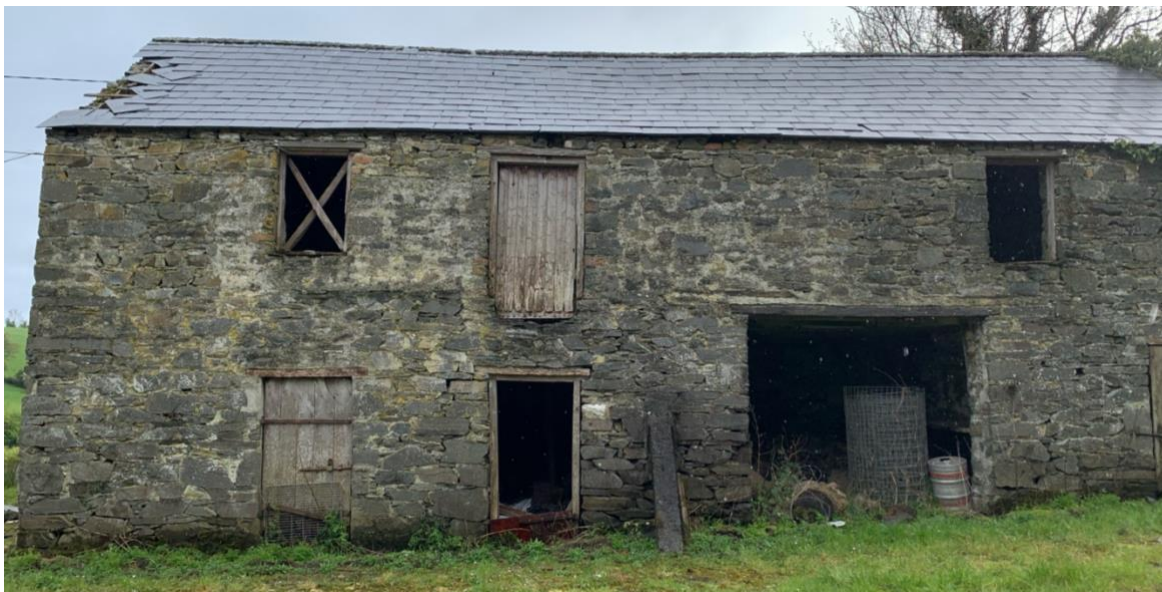
The barn consists of two stories; the lower story consists of a series of unconnected rooms accessed via external doorways (Figure 5). The upper story (the loft) is a single open chamber with an uninsulated slate roof. The lower story contains some nooks and crannies that could potentially host low numbers of bats or opportunistic individuals (Figure 6). The loft does not contain any PRFs, though could serve as a foraging space or as a rain shelter for bats foraging outside.

Figure 5. External view of stone barn from courtyard.

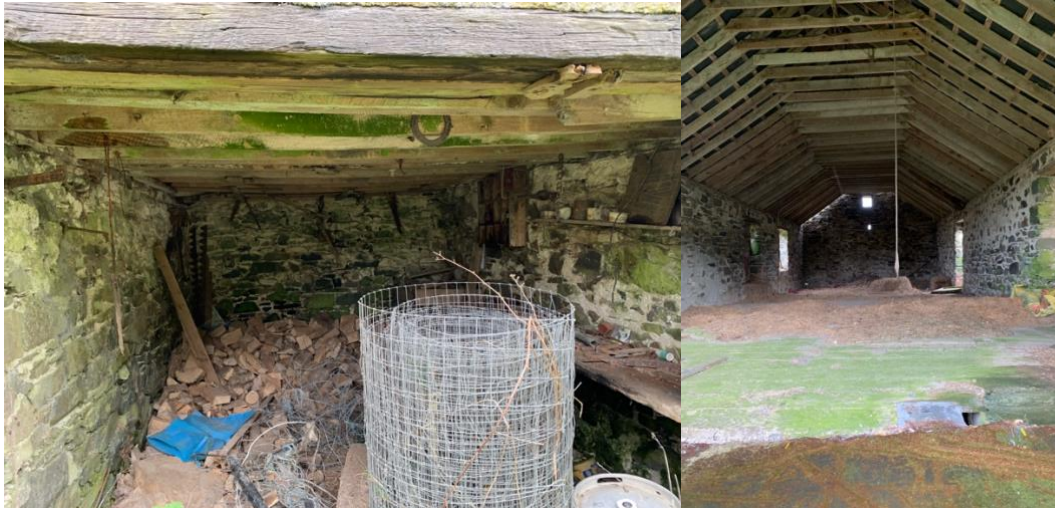
Figure 6. Interior photos of the lower and upper stories of the barn, respectively.
