# **A SURVEY OF THE AQUATIC VEGETATION OF LOUGH SEWDY, WESTMEATH, 2022**

**Nick Stewart  
5/1/2023**

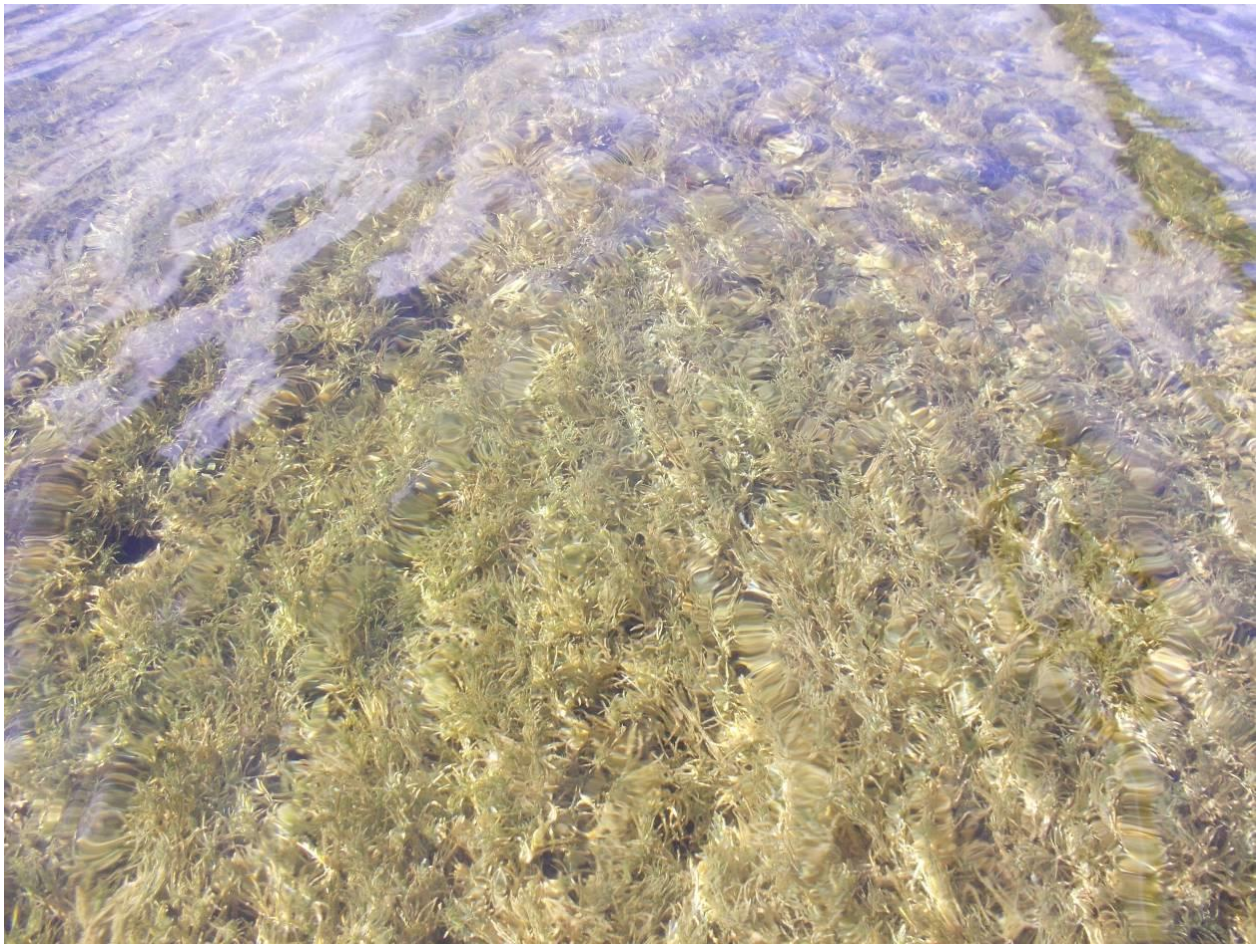
It was noticeable that there was a contrast between the *Chara* beds, which were quite bedded down and matted and often did not reach above 50 cm below the water surface, while the *Myriophyllum* beds were more vigorous and regularly reached up to the water surface. It is thought that this was because of the dry summer for much of which the water level was significantly lower than at the time of survey. With higher water levels after recent rains the *Myriophyllum* with its natural buoyancy due to air-cells would have been able to grow rapidly towards the surface. However, charophytes have no natural buoyancy and would have to build against each other to grow upwards. It is presumed that this contrast in growth would become less obvious when water levels have been higher for longer. However, this ability to overtop the *Chara* could give the *Myriophyllum* an advantage in certain conditions.

*Beds of Chara subspinososa (rudis)*

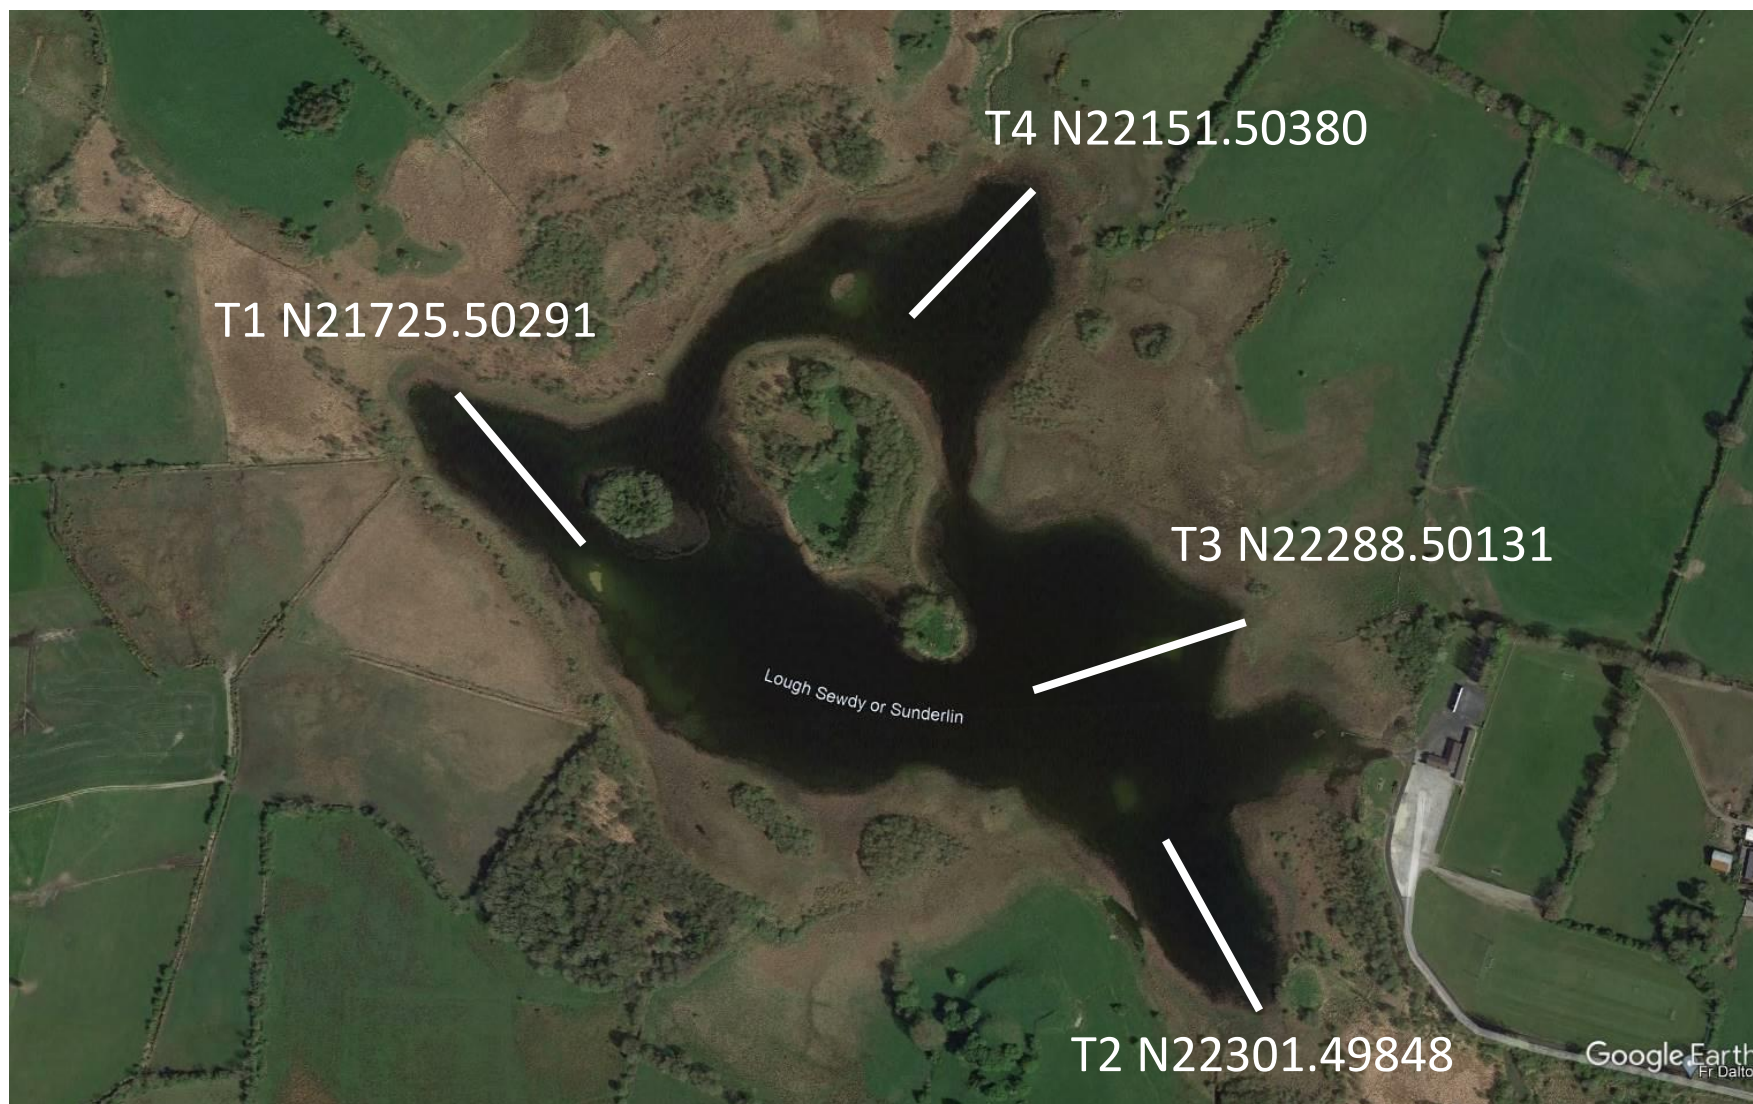
The results of the transect surveys are presented in a spreadsheet submitted with this report. The transect locations are indicated in appendix 2 of this report. The key metrics for calculating the Free Macrophyte Index and Water Framework Directive status are given in table 2. This results in a status that is high in the “Good” status band. As will be discussed later this seems a fair assessment of the status of the lake, based on the experience of the author with Water Framework Directive and other aquatic surveys elsewhere. In other words it appears to be in reasonably good condition but not pristine.

*Lough Sewdy, transect locations*
