ECOLOGICAL SURVEY OF THE GRAND CANAL 1991

Part 1
Survey Report

**Prepared for:
The Wildlife Service and Waterways Section,
Office of Public Works. 1992.**

**By
Marie Dromey
Brigid Johnston
Sinead Keane**

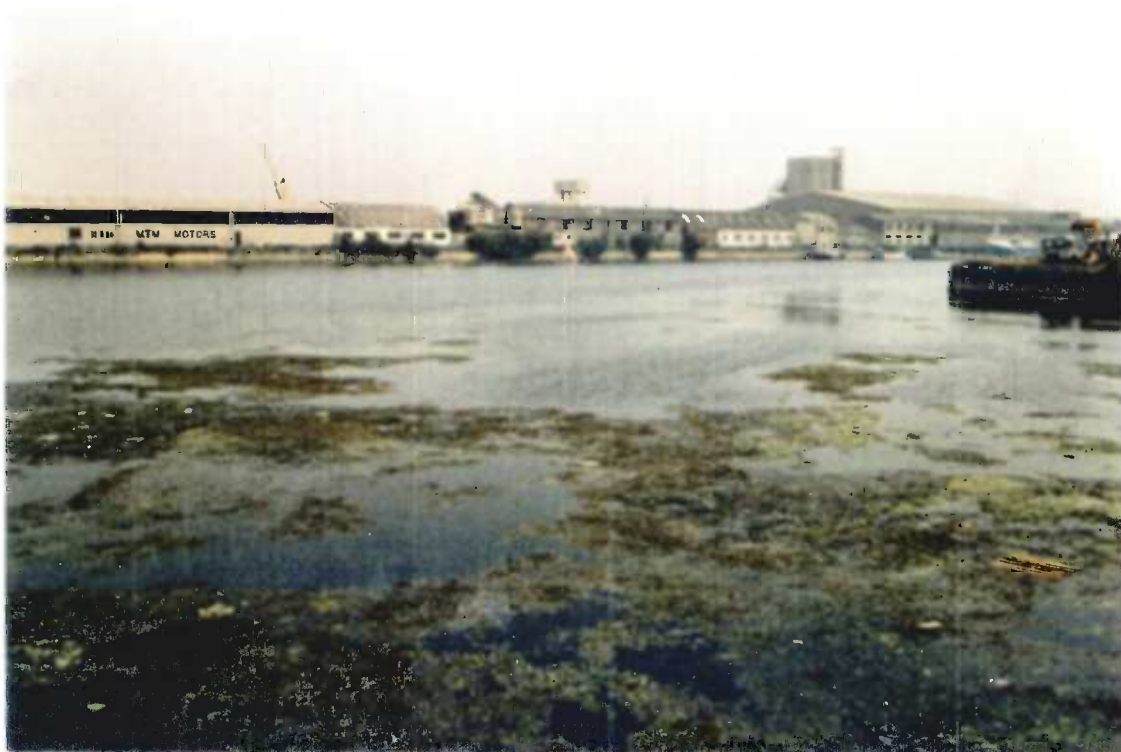
Plate 1: 3rd September 1991. Ringsend Basin. The dominant aquatic plant is Ceratophyllum demersum, which thrives in nutrient-rich waters. Its presence is preferable to excess algae, which could become dominant if the Ceratophyllum is over-controlled. (ASI 20 in County Dublin).

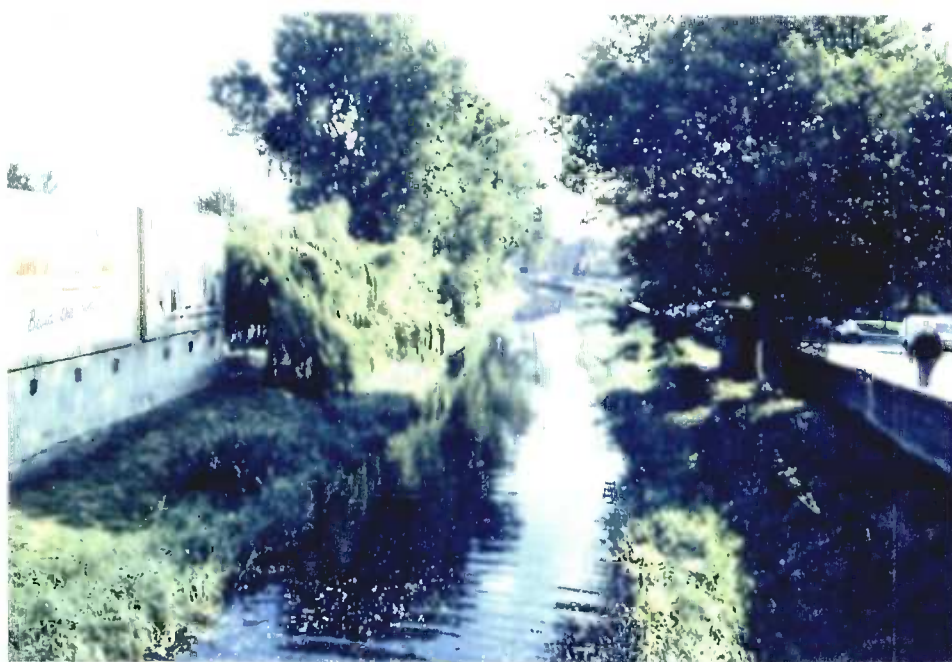
Plate 2: 25th August 1991. km 3, taken from Latouche Bridge and looking east. Good examples of reed fringe along both banks dominated by Glyceria maxima. This stretch of channel is not sprayed. (ASI 20 in County Dublin)

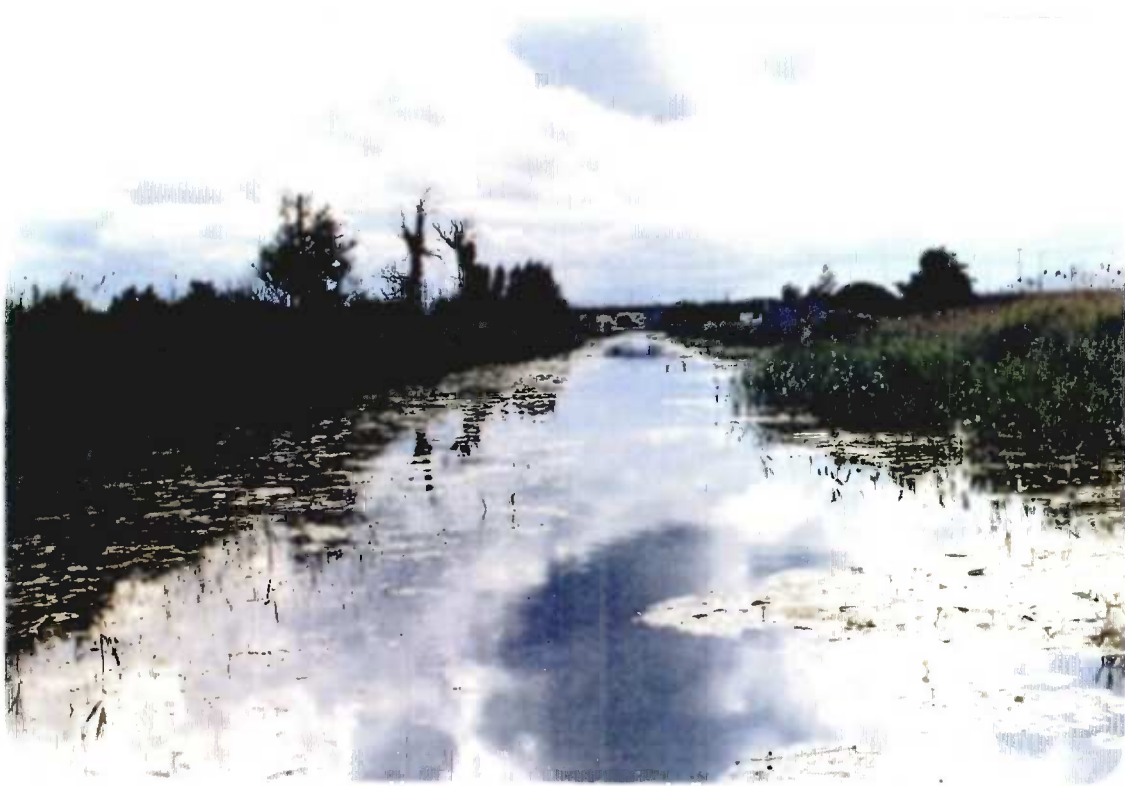
Plate 3:30th June 1991. km 10 taken from Lock 8 on the Main Line, looking west towards the new M50. Guinness Filter Beds to the right. Aquatic diversity is good and the reed fringes are species-rich. This stretch of channel is not sprayed. (ASI 20 in County Dublin).

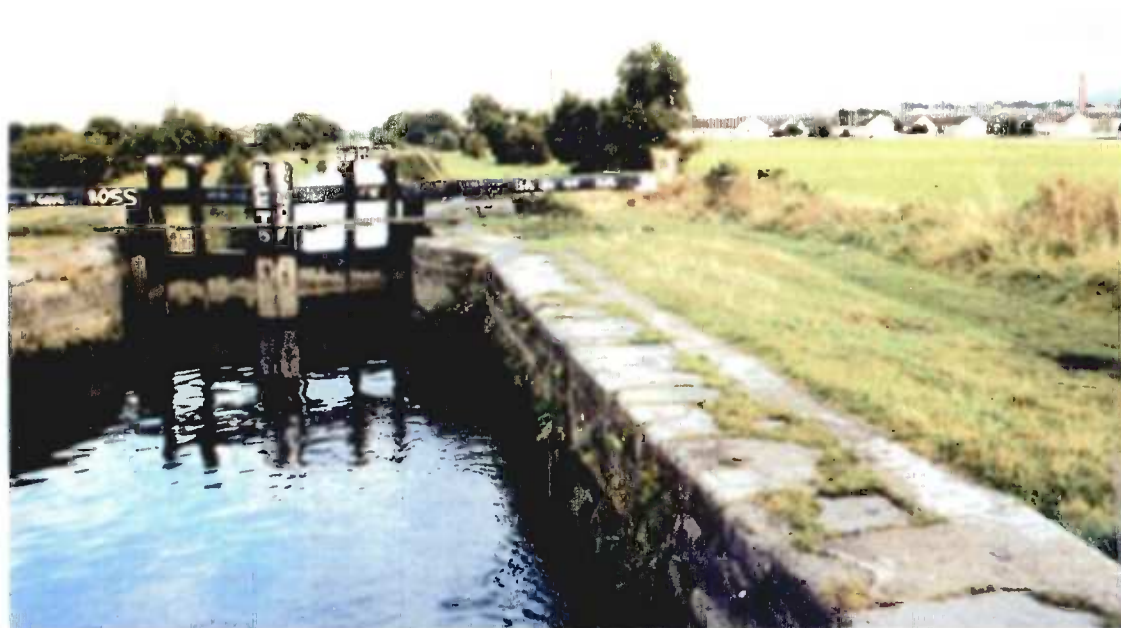
Plate 4:26th September 1991. km 13 Taken from Lock 11 and looking east towards Lock 10. The southern boundary is not defined. This makes the canal very accessible as a dumping ground. Many items of furniture were found in the canal immediately west of Lock 11. (ASI 20 in County Dublin).

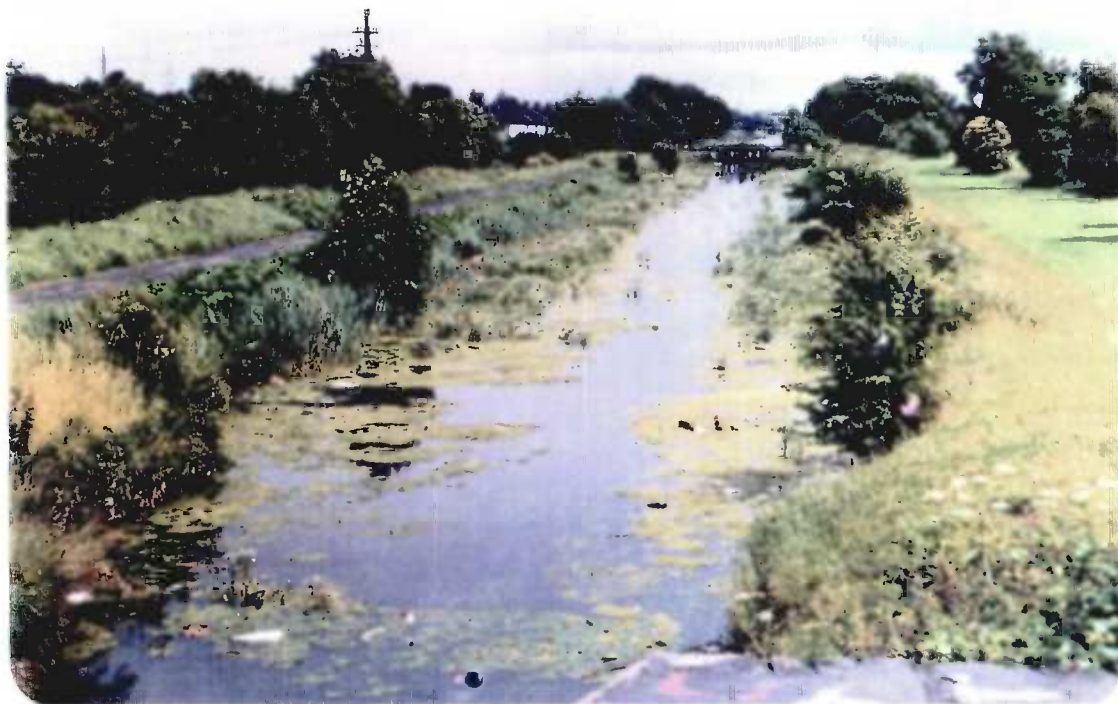
Plate 5:30th June 1991 km 13. Taken from Lock 11 and looking east along the Main Line. There is a lot of rubbish and algae in the channel. There is also very good aquatic diversity and healthy reed fringes. This stretch of channel is not sprayed. (ASI 20 in County Dublin).

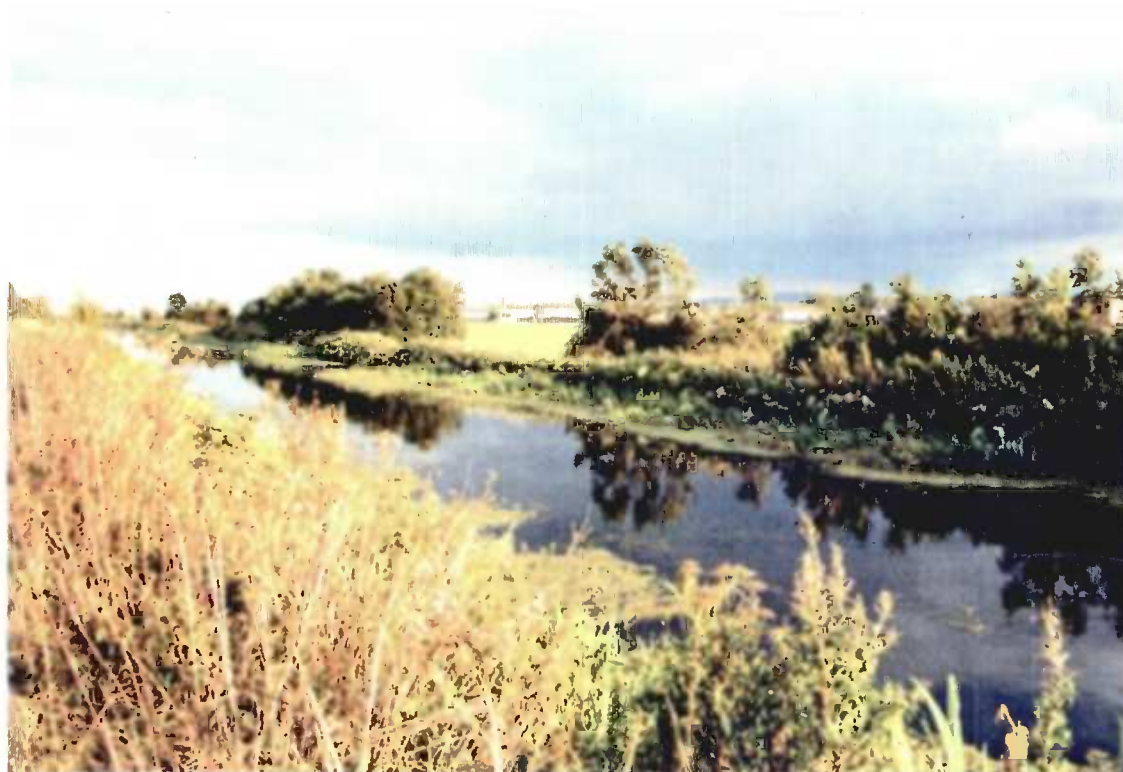
Plate 6:26th September 1991. km 13/14. Looking east towards Lock 11 on the Main Line. The southern boundary along this stretch is not defined and often parts of the south bank are overgrown. The north bank, though grazed, is overgrown. Very good aquatic diversity and healthy reed fringes present. This stretch of channel is not sprayed. (ASI 20 in County Dublin)

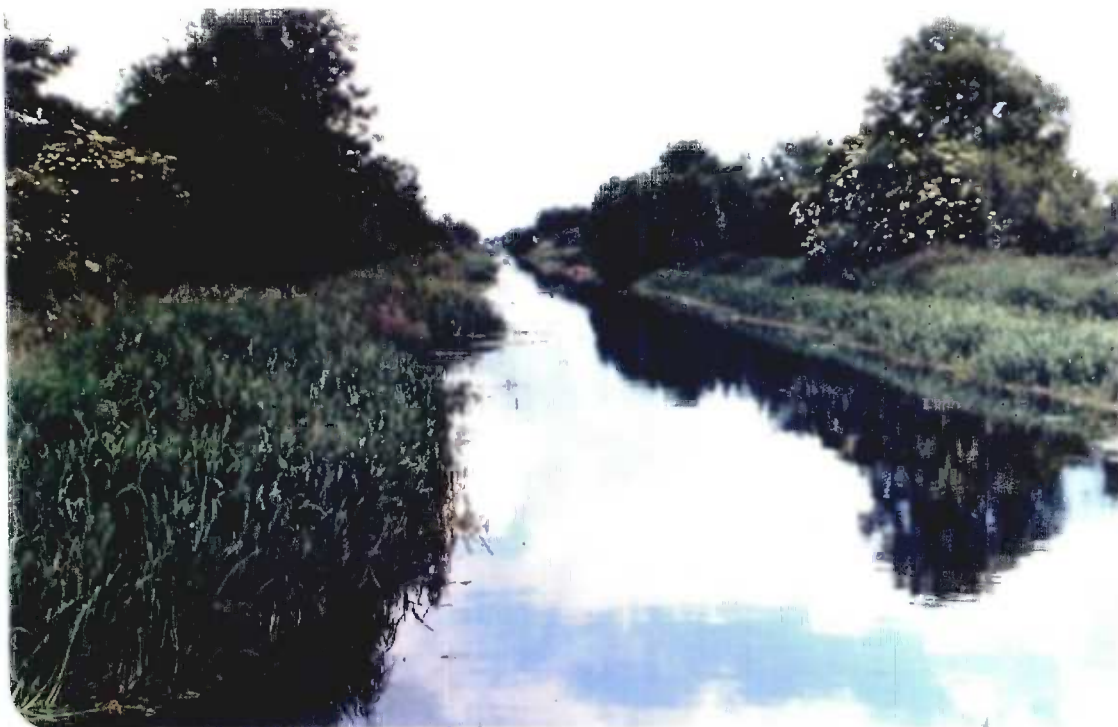
Plate 7: 27th June 1991. km 20. Looking east from Hazelhatch on the Main Line. There is very good aquatic diversity along this stretch and very healthy reed fringes dominated by Glyceria maxima and Phragmites australis. This stretch of channel is not sprayed. The bank and towpath (N) are species-rich and nutrient-poor. There is a species-rich fen at the toe of the embankment (N). (ASI 18 in County Kildare).

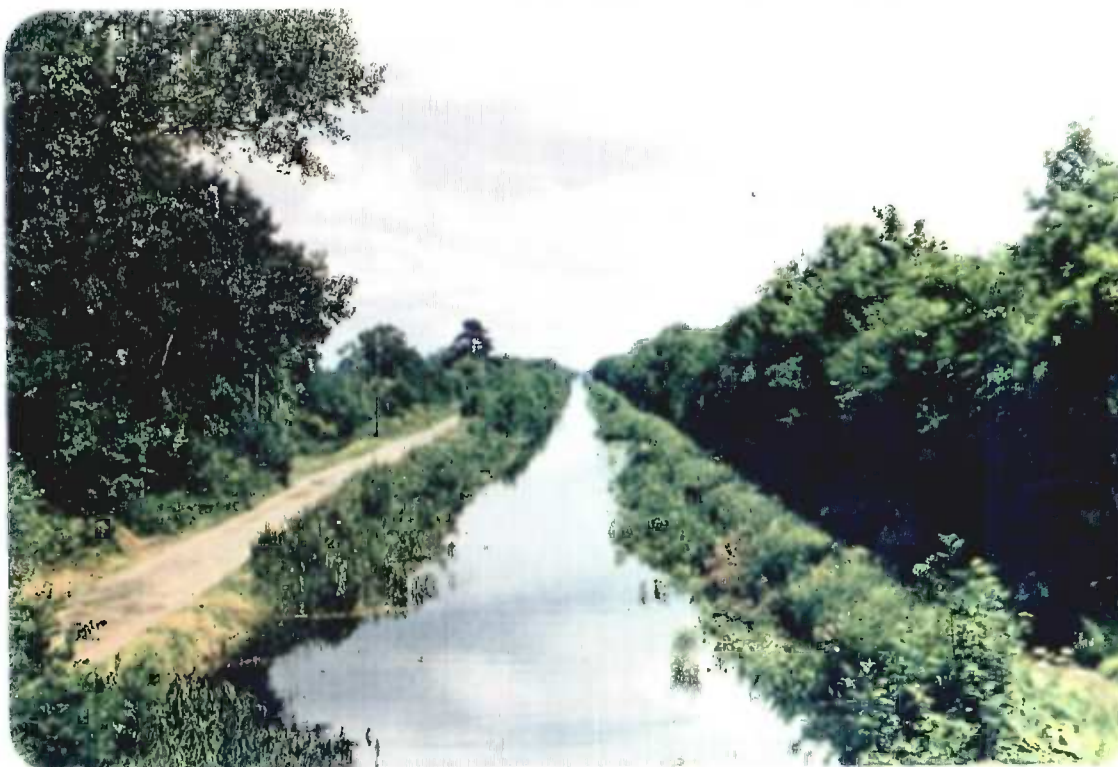
Plate 8: 2nd July 1991. km 22. Taken from Aylmer Bridge and looking east towards Hazelhatch along the Main Line. Healthy reed fringes. This stretch of channel is not sprayed. Species-rich banks which were not cut during 1991 ensuring diversity for 1992. Species such as Oak, Ash, Hazel, Sycamore, Spindle and Beech present along the southern boundary. (ASI 18 in County Kildare).

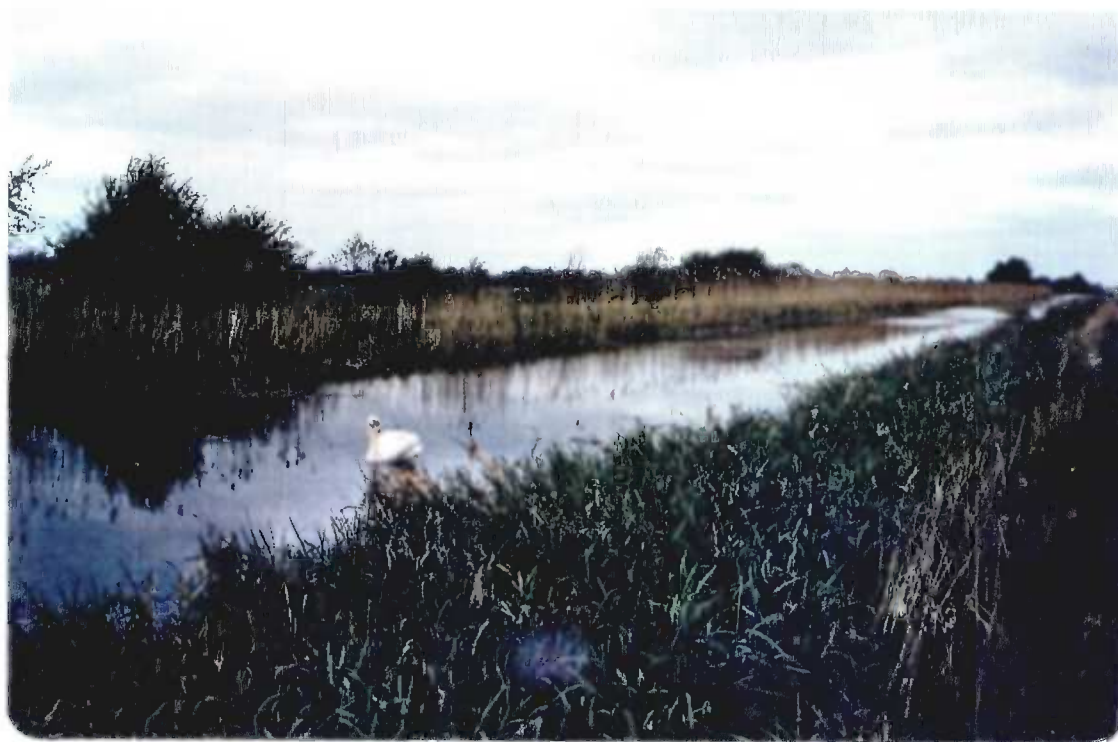
Plate 9: May 1991. km 30. Taken from the south bank and looking east to Lock 15 along the Main Line. Very healthy reed fringes dominated by Phragmites australis and Glyceria maxima. This stretch of channel is not sprayed. Many swans and moorhens present. (ASI 18 in County Kildare).

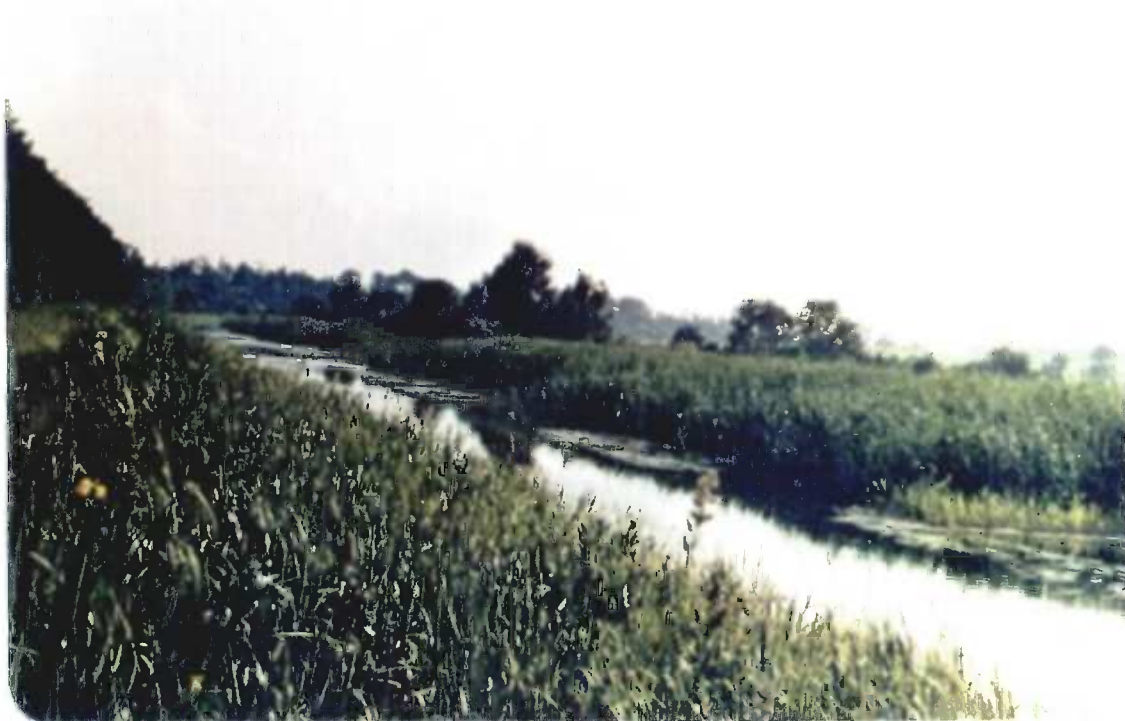
Plate 10: 2nd July 1991. km 31. West of Lock 15 and looking west along the Main Line. This stretch of channel is not sprayed and supports very healthy reed fringes. Calcareous meadow exists along the south bank with mature Beech along the southern boundary. (ASI 18 in County Kildare).

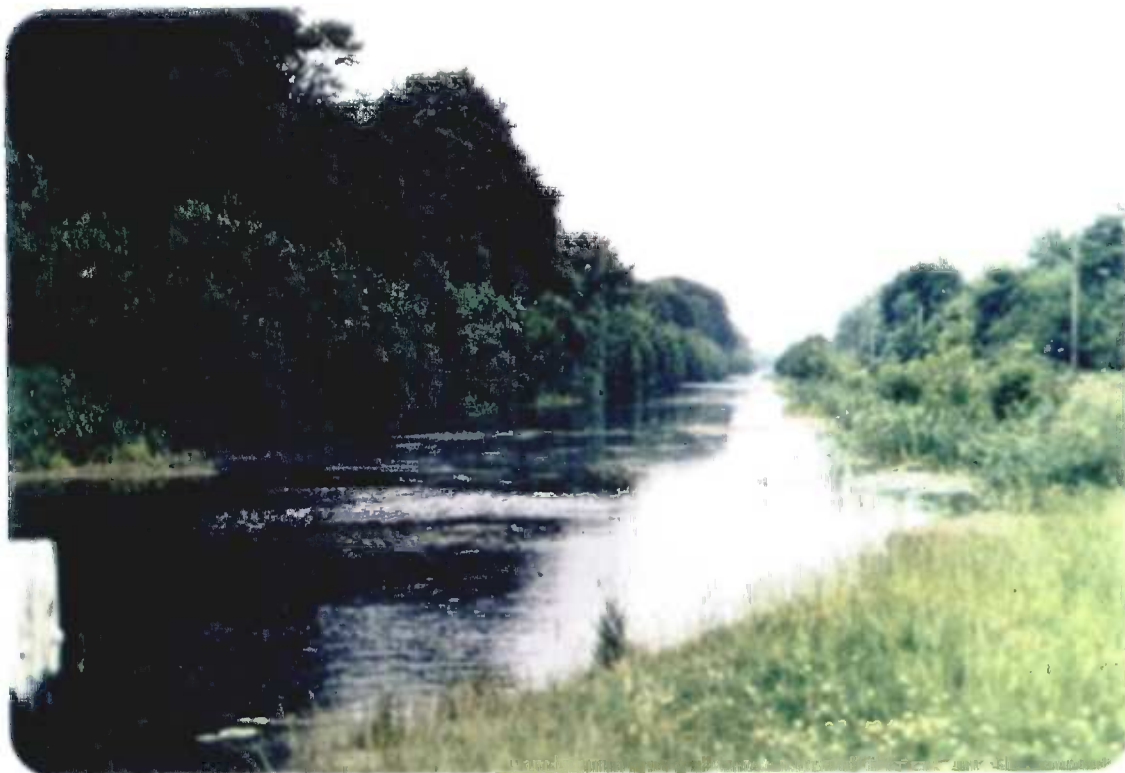
Plate 11: 3rd July 1991. km 38. Taken from Lock 17 and looking west along the Main Line. Good aquatic diversity and a diverse and healthy reed fringe. This stretch of channel is not sprayed. The towpath becomes impassable (N). (ASI 18 in County Kildare).

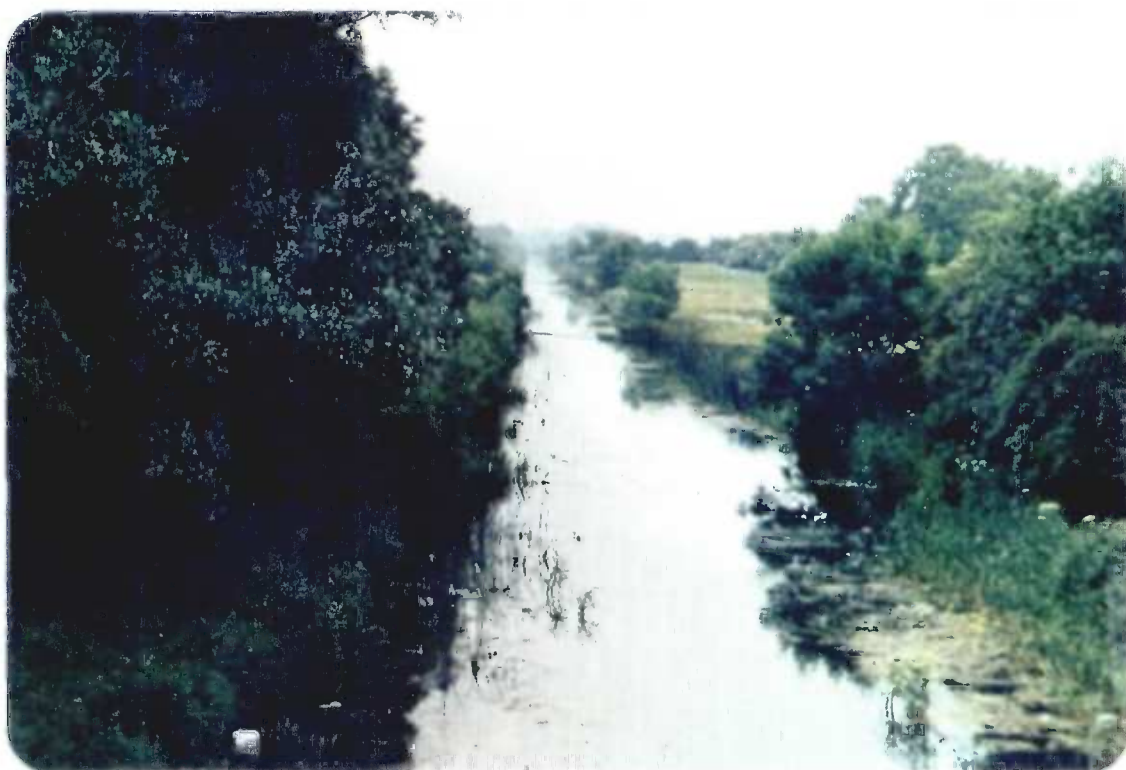
Plate 12: 13th August 1991. km 42. Looking east from Bonyng Bridge along the Main Line. Healthy reed fringes and a high aquatic diversity present. This stretch of channel is not sprayed. Large species-rich calcareous meadow on the south bank. The north bank becomes impassable both sides of Cock Bridge. (ASI 18 in County Kildare).

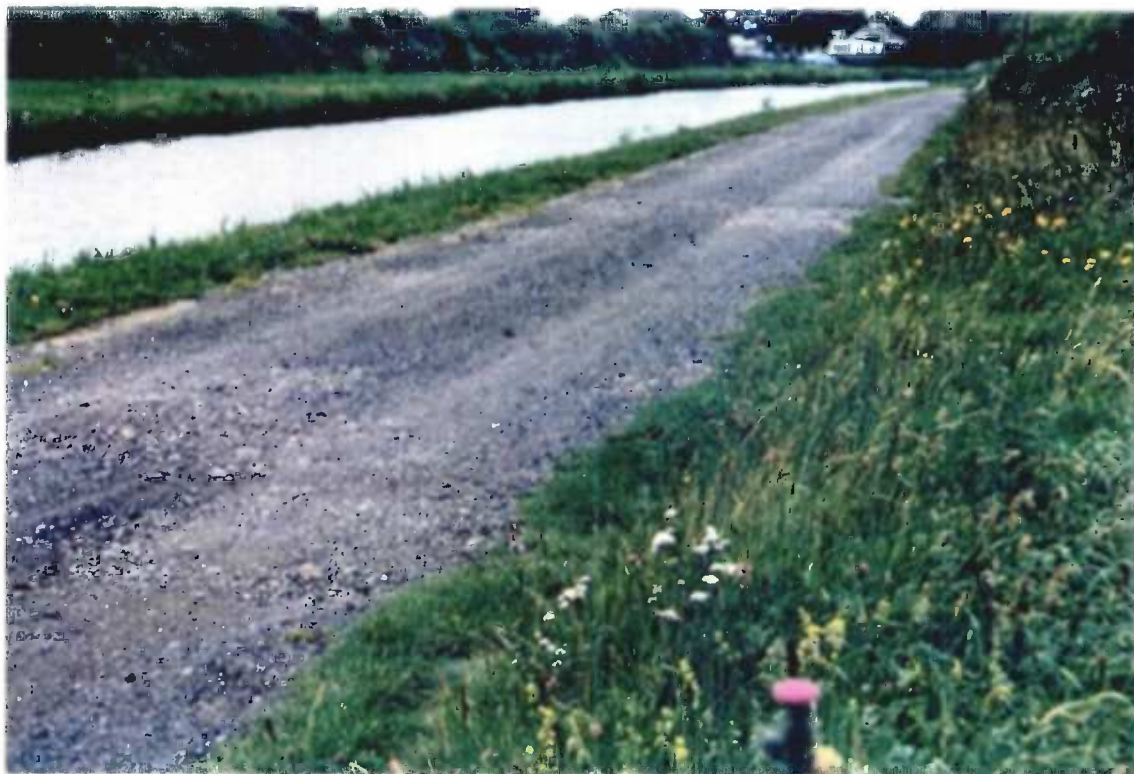
Plate 13: 18th July 1991. km 56. Looking west towards Ticknevin Bridge on the north bank of the Main Line. Little reed fringe and poor aquatic diversity. Both banks are cut too frequently. Flowers will not get an opportunity to seed and so diversity will be reduced the following year. High diversity evident in the uncut calcareous meadow of the boundary verge. (ASI in County Kildare).

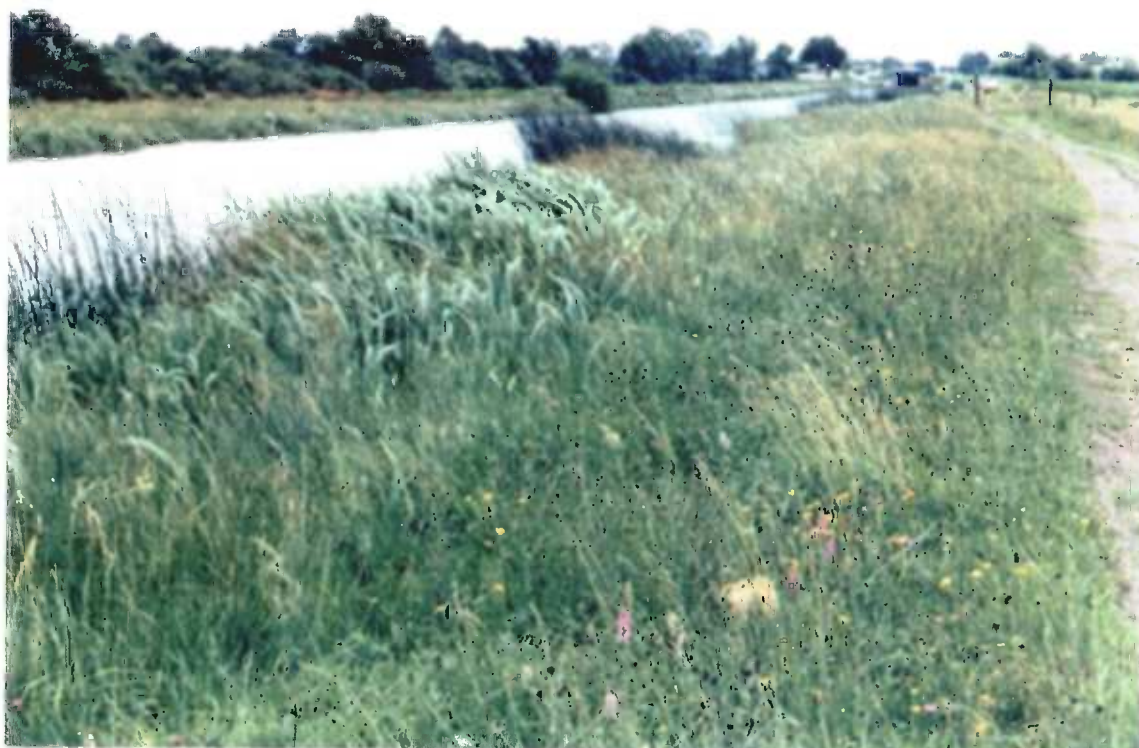
Plate 14: 18th July 1991. km 58. South bank looking east towards Lock 20 along the Main Line. Healthy reed fringe, species-rich berm and calcareous bank including Common Spotted Orchid. This stretch of channel was not treated with herbicides in 1991. However, it is proposed to use Casoron and the mowing bucket in 1992.

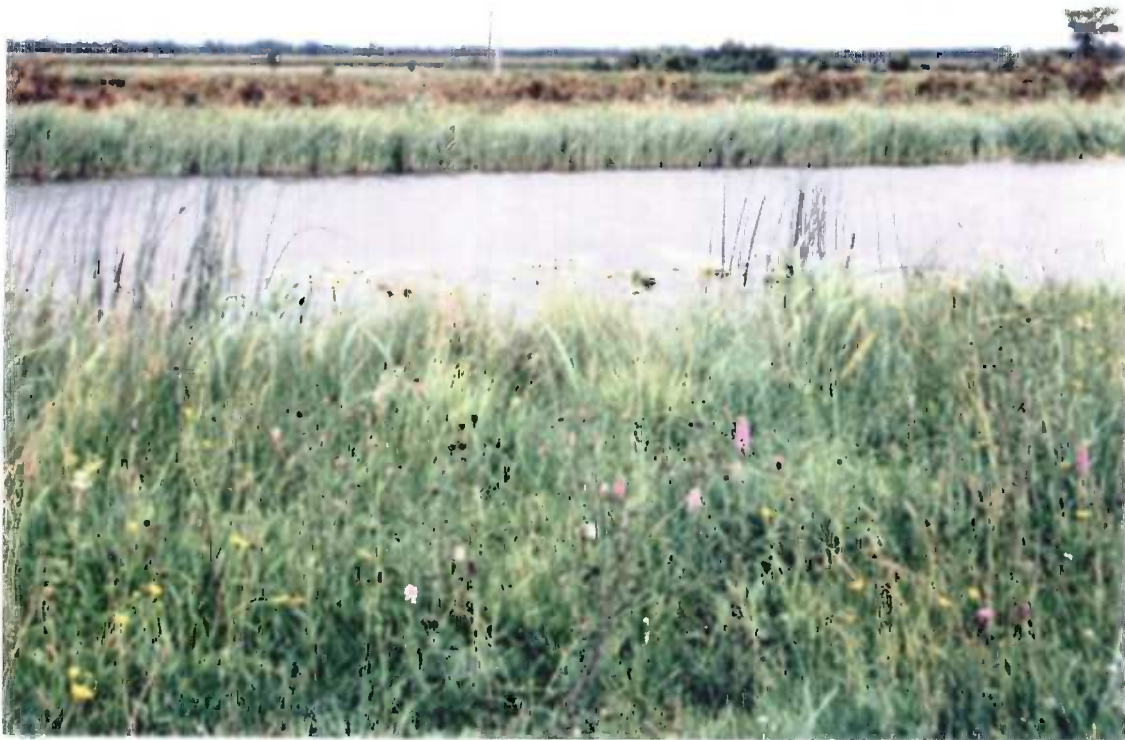
Plate 15: 18th July 1991. km 58. South bank looking north just west of Lock 20 on the Main Line. Two healthy reed fringes and species-rich berm and calcareous bank. This stretch of channel was not sprayed in 1991. However, it is proposed to use Casoron and the mowing bucket in 1992. The grass of the bank was not cut early in the season so diversity is maintained.

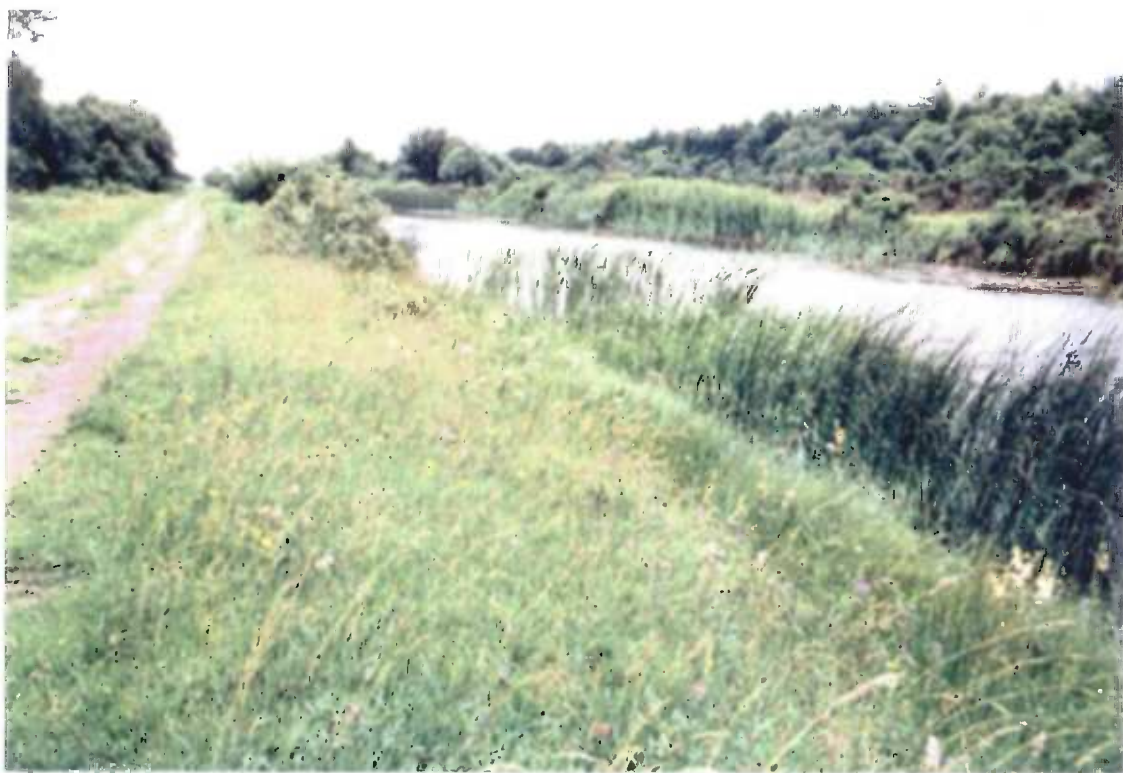
Plate 16: 18th July 1991. km 59. South bank looking west (West of Lock 20) along the Main Line. All canal zones healthy and supporting a diversity of species. The management along this stretch of both aquatic and terrestrial habitats was minimal i.e. no sprays and no cutting. Ecological diversity is assured. The terrestrial canal zones can be cut at the end of the growing season after the grasses and herbs have set seed.

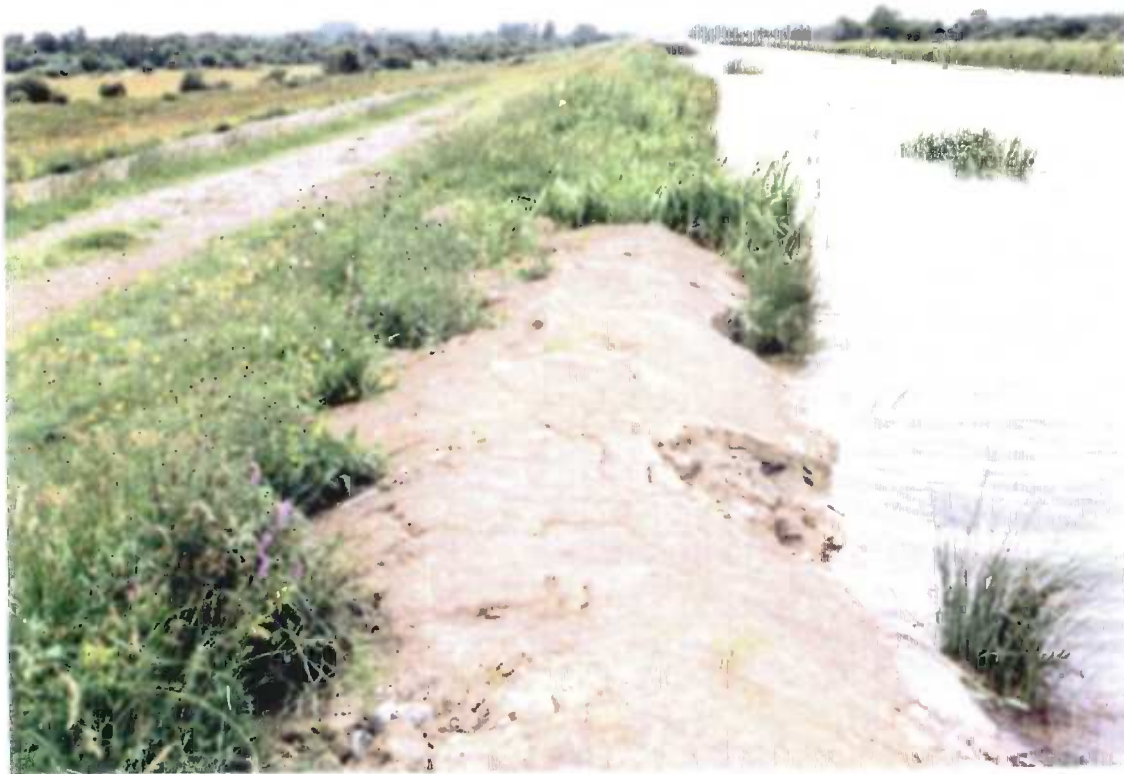
Plate 17: South bank looking west along the Main Line towards Blundell Aqueduct km 60. A small stretch of bank was repaired using clay. Revegetation is very slow on clay because the clay is very hard and organically poor. Without the vegetation to stabilize the clay, it is eroded by wash from the boats.

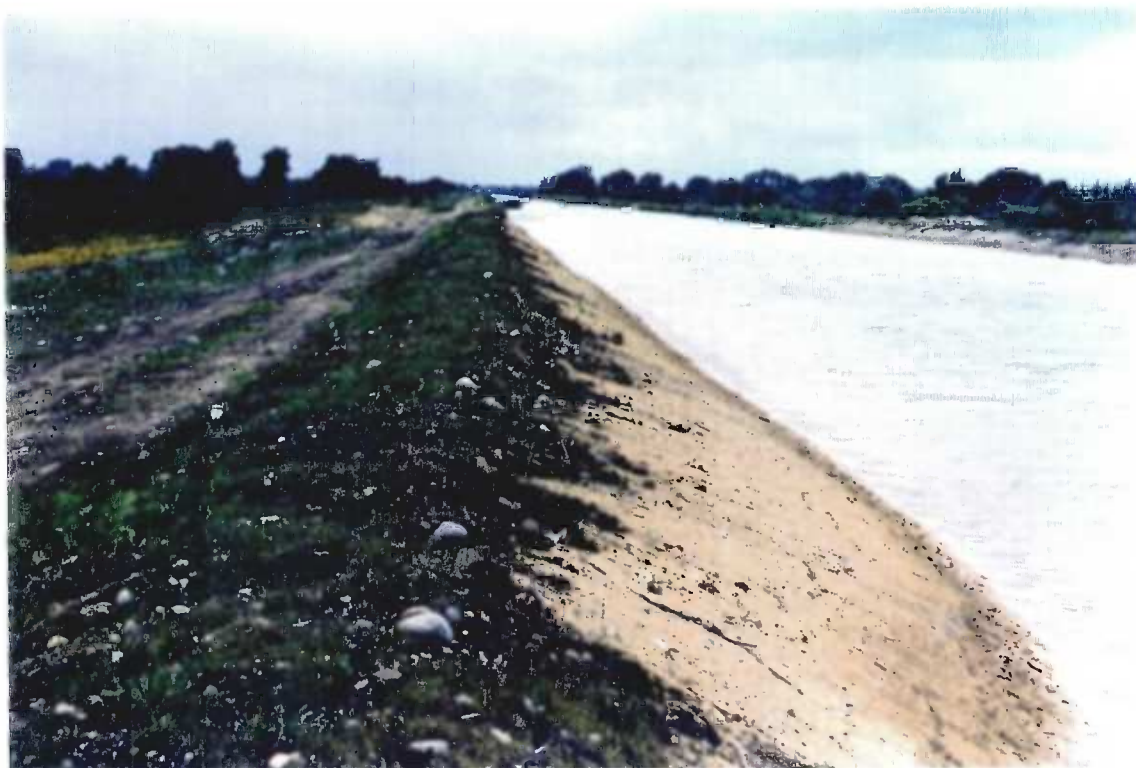
Plate 18: 18th July 1991. km 60. On the south bank of Main Line and looking west towards Blundell Aqueduct. The banks have been repaired and partly covered in peat. Peat-covered area can support vegetation. The uncovered clay is too hard for revegetation and without the vegetation to stabilize it, the clay is washed back into the channel.

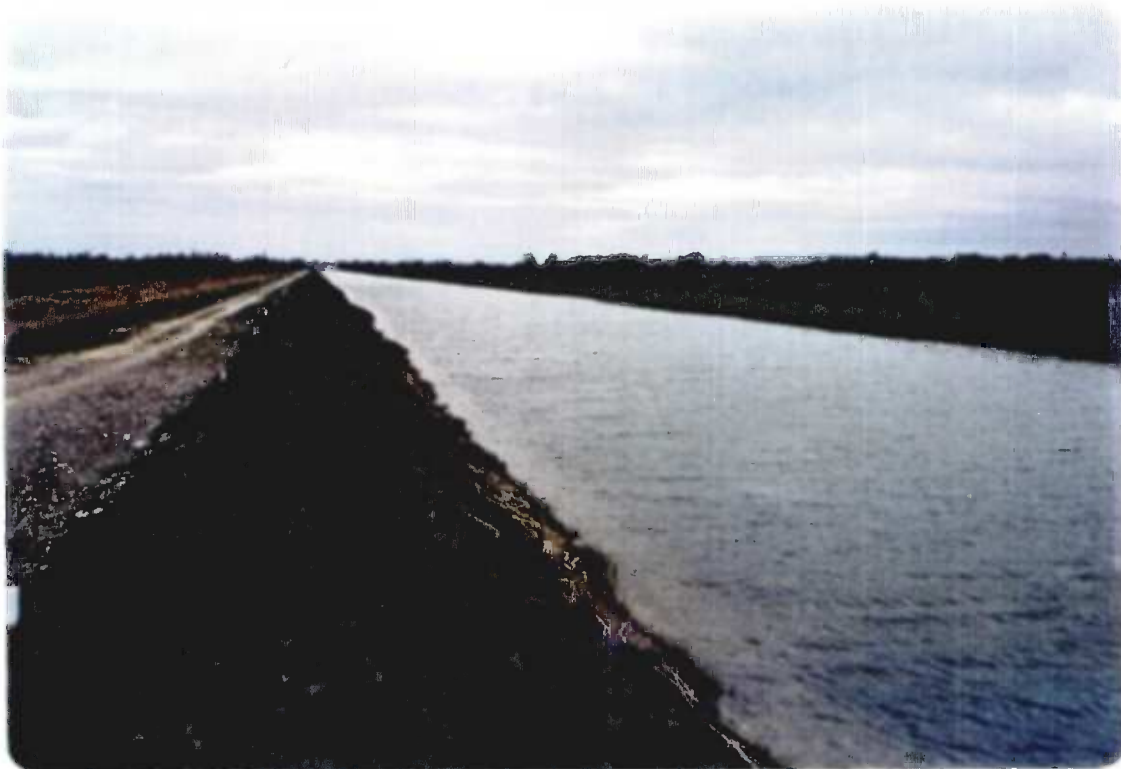
Plate 19:16th May 1991. km 62. On the south bank of the Main Line and looking west immediately west of Blundell Aqueduct. The banks were repaired using clay, which was then covered in peat and reseeded. If it was not reseeded, natural revegetation would have occurred on the peat.

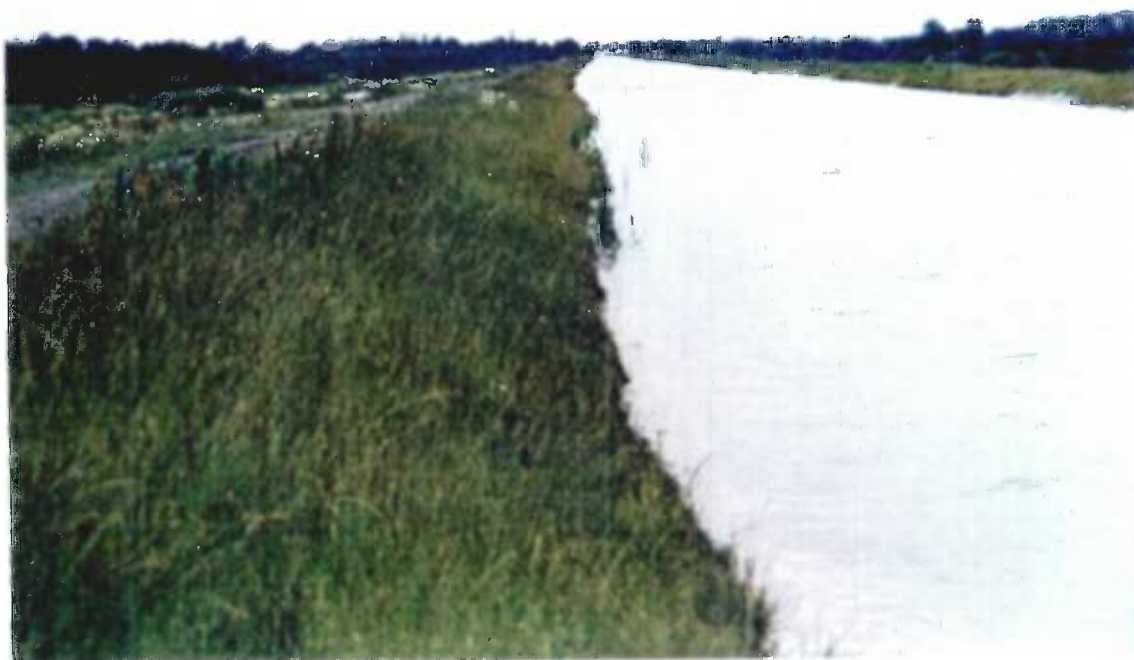
Plate 20:18th July 1991 km 62. As for Plate 19 but two months later. The vegetation growing on the bank stabilizes it and prevents erosion.

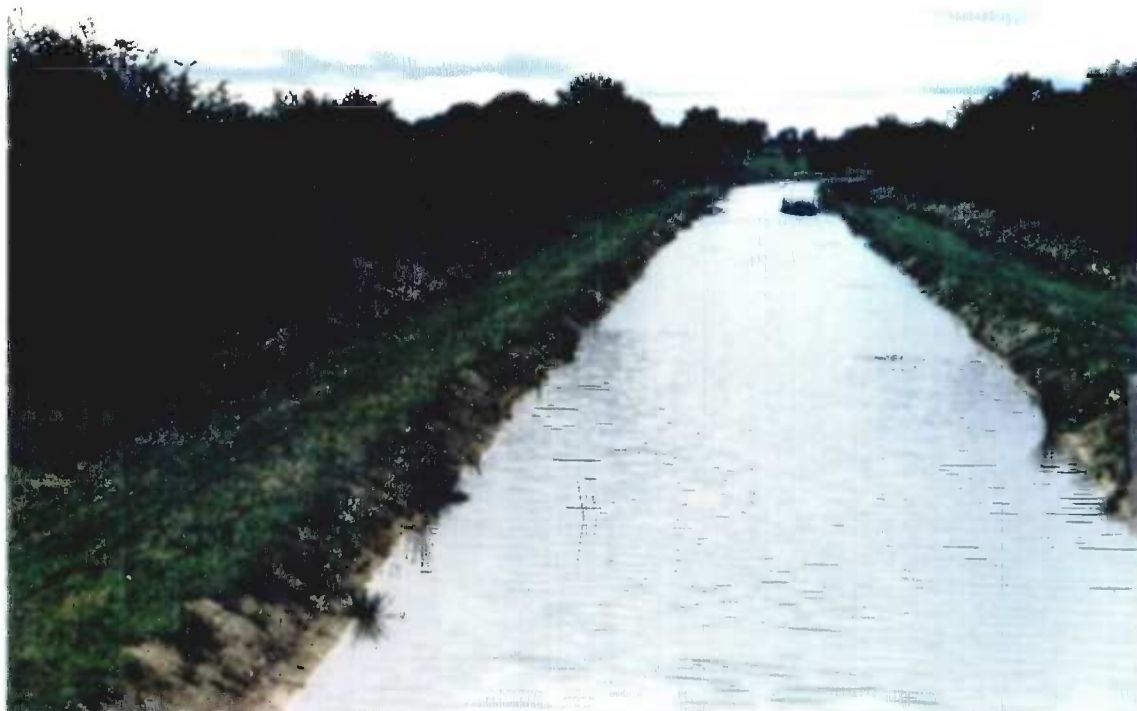
Plate 21:19th July 1991. km 65. Taken from Rathmore Bridge on the Main Line and looking west. The clayed banks were not covered in topsoil/peat so revegetation is proceeding very slowly. A wide band of species-rich grassland was cut along both banks mid-season so reducing ecological diversity over a wide area (a bank 1m wide can be cut for pedestrian access). Species-rich hedgerows and boundary verges (which were not cut).

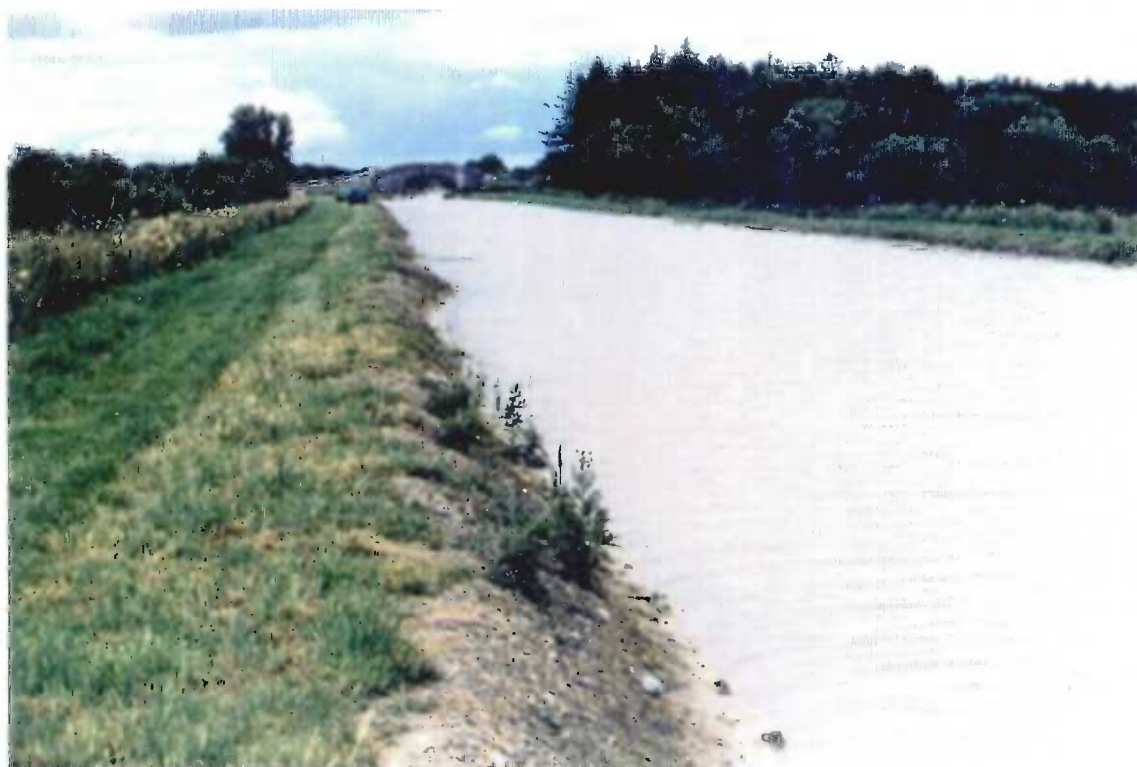
Plate 22:19th July 1991. km 69. Looking east to Trimblestown Bridge from the south bank of the Main Line. Picture shows repaired banks not covered in topsoil/peat. Wide band of grassland cut along both banks in mid-season so reducing the ecological diversity over a wide area; species-rich boundary verge. (ASI 30 in County Offaly).

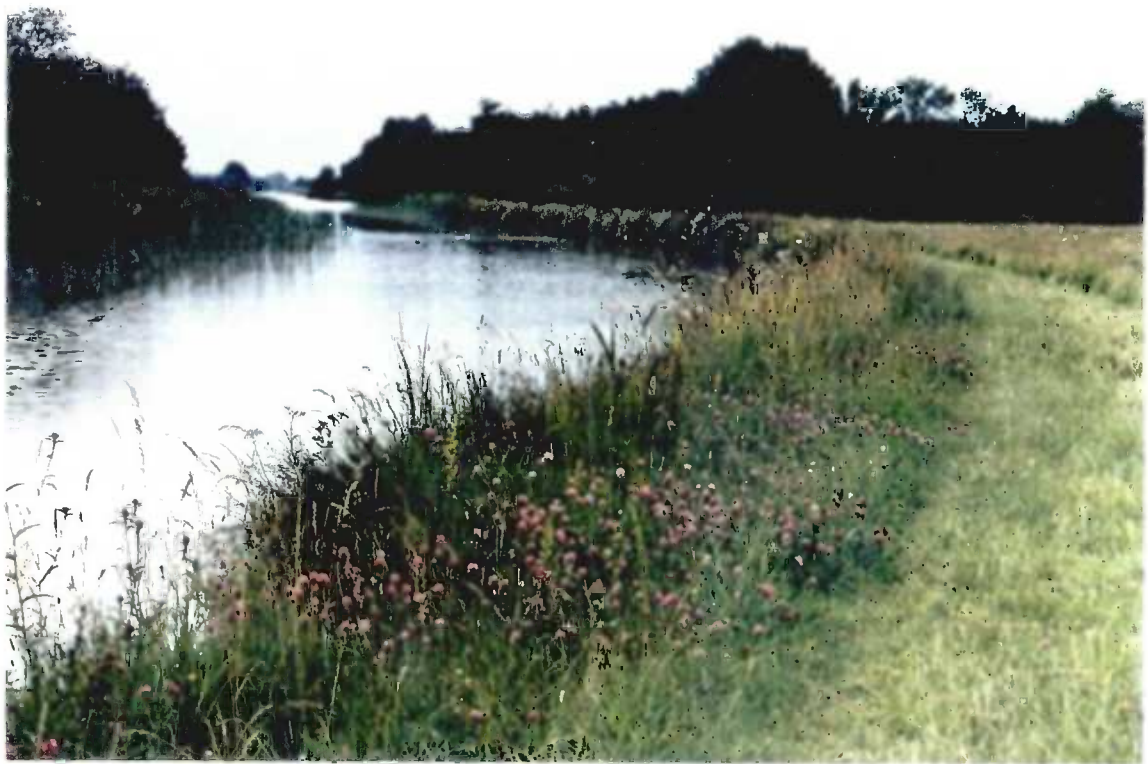
Plate 23: 21st July 1991. km 75. Looking west immediately west of Toberdaly Bridge on the Main Line. A 2m wide band of species-rich grassland was cut and the cuttings were not removed. Cuttings enrich the soil which can then produce a species-poor sward. Species of the nutrient-poor grassland such as the yellow Bedstraw, and Quaking grass can be seen.

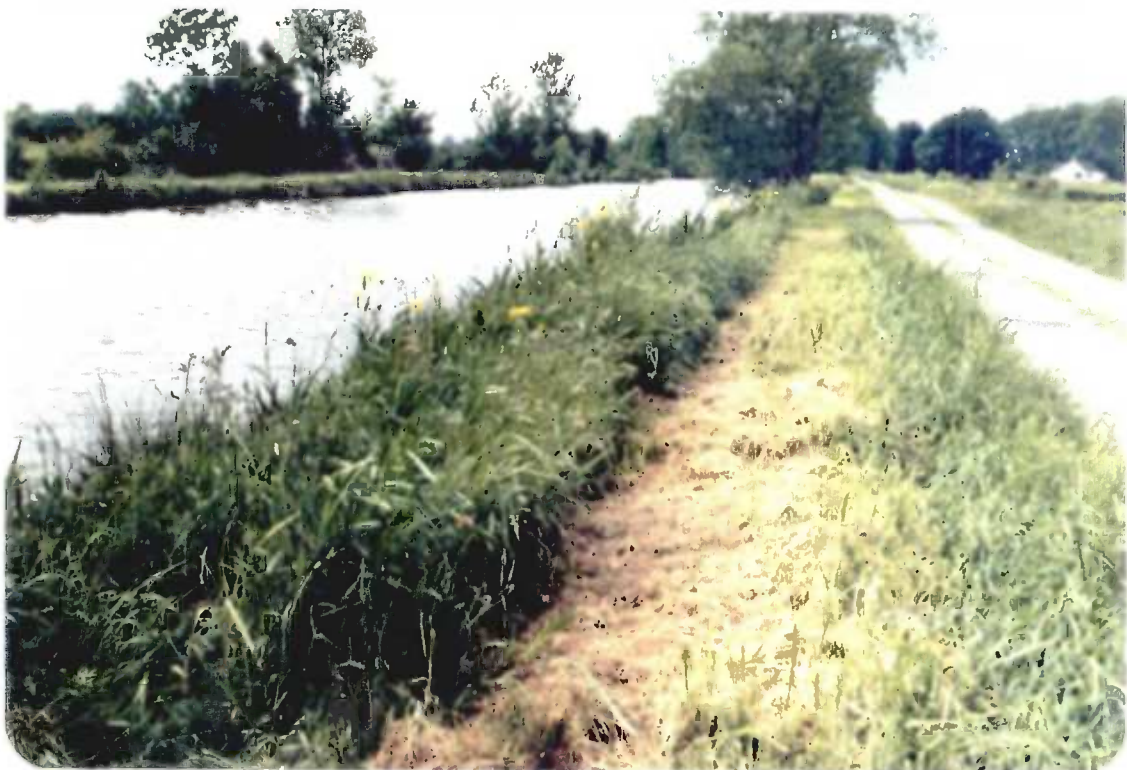
Plate 24: 9th June 1991. km 90. Looking west towards Tullamore on the Main Line. Nutrient-rich species-poor grassland of the bank which has been cut. The cuttings have not been removed and thus act as fertilizer which will encourage the more competitive grasses. A wide bank along the south bank has also been cut and many shrubs removed. This is not necessary along a rural stretch of canal.

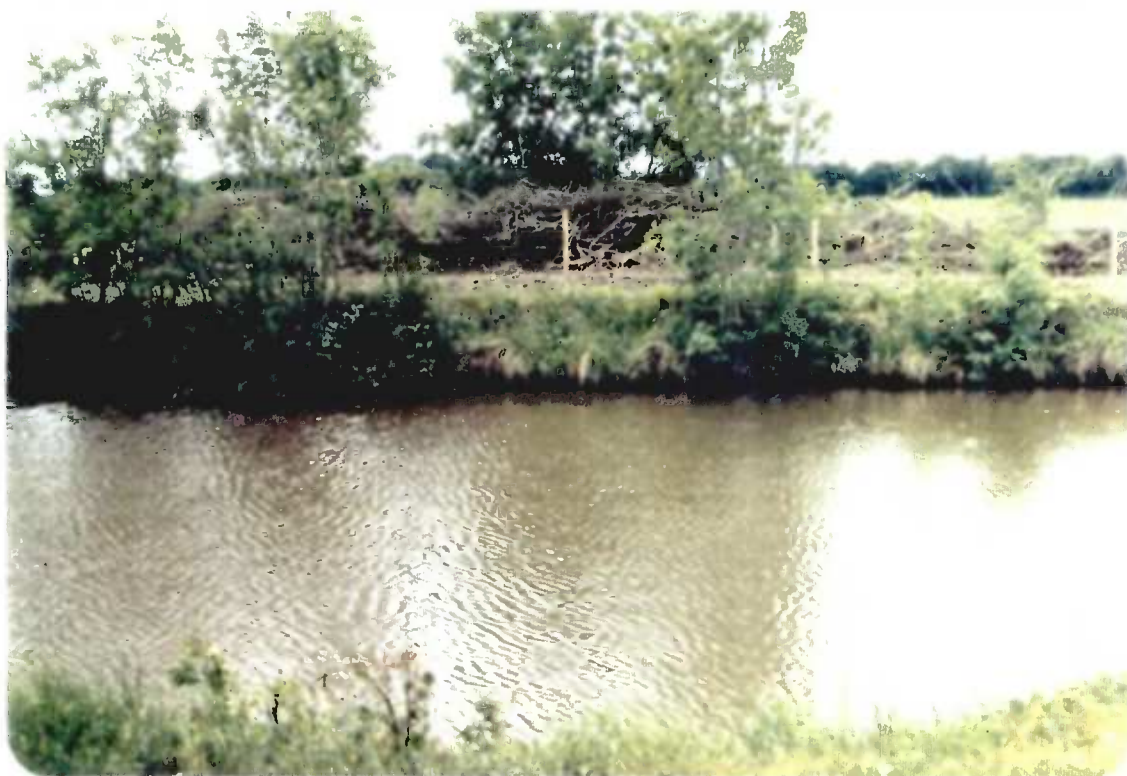
Plate 25: 9th June 1991. km 91. Taken from the north bank of the Main Line between locks 23 and 24 west of Daingean. No reed fringe along this entire stretch. Casoron was used here in 1991. It is proposed to leave this stretch free of herbicides in 1992. Wave action has undercut the banks. Trees/scrub being removed from the south bank.
