ECOLOGICAL SURVEY OF THE GRAND CANAL 1991

Part 1
Survey Report

**Prepared for:
The Wildlife Service and Waterways Section,
Office of Public Works. 1992.**

**By
Marie Dromey
Brigid Johnston
Sinead Keane**

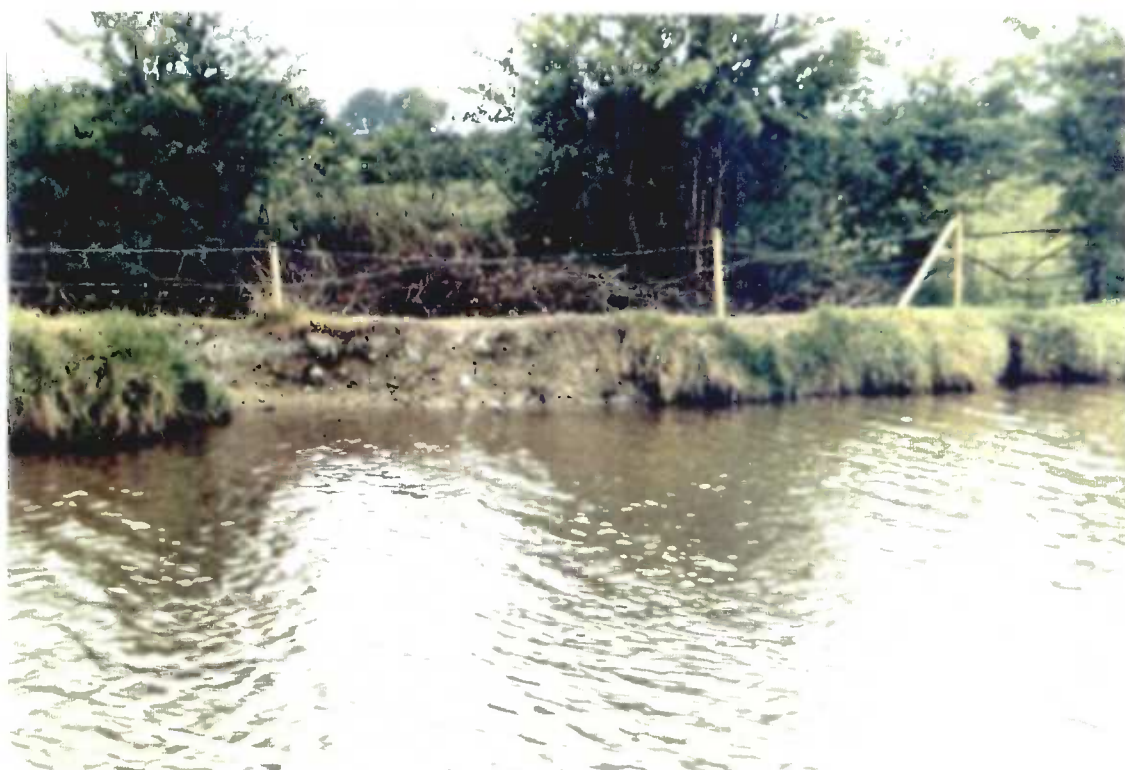
Plate 26: 9th June 1991. km 91. As for plate 25. The bank where it was undercut has fallen into the channel.

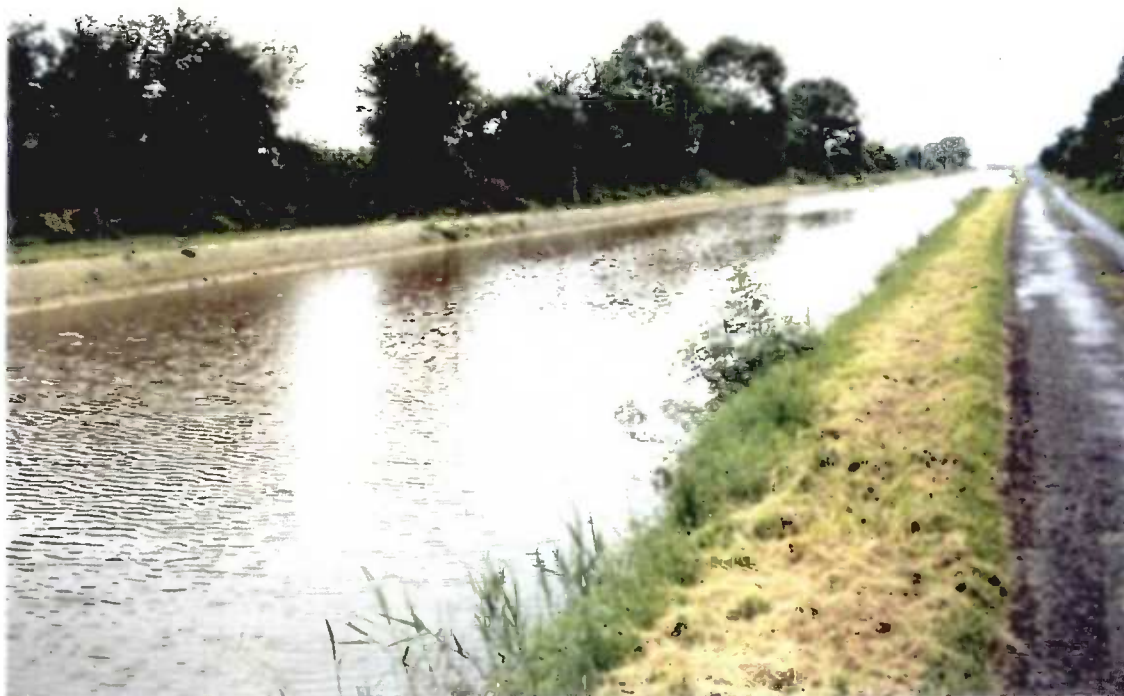
Plate 27: 20th July 1991. North bank looking westwards between 24th and 25th locks on the Main Line. Clayed south bank has not been covered in topsoil. Bank verge (N) is cut too frequently and the cuttings not removed. No reed fringe. It is proposed to leave this stretch of channel free from herbicides in 1992.

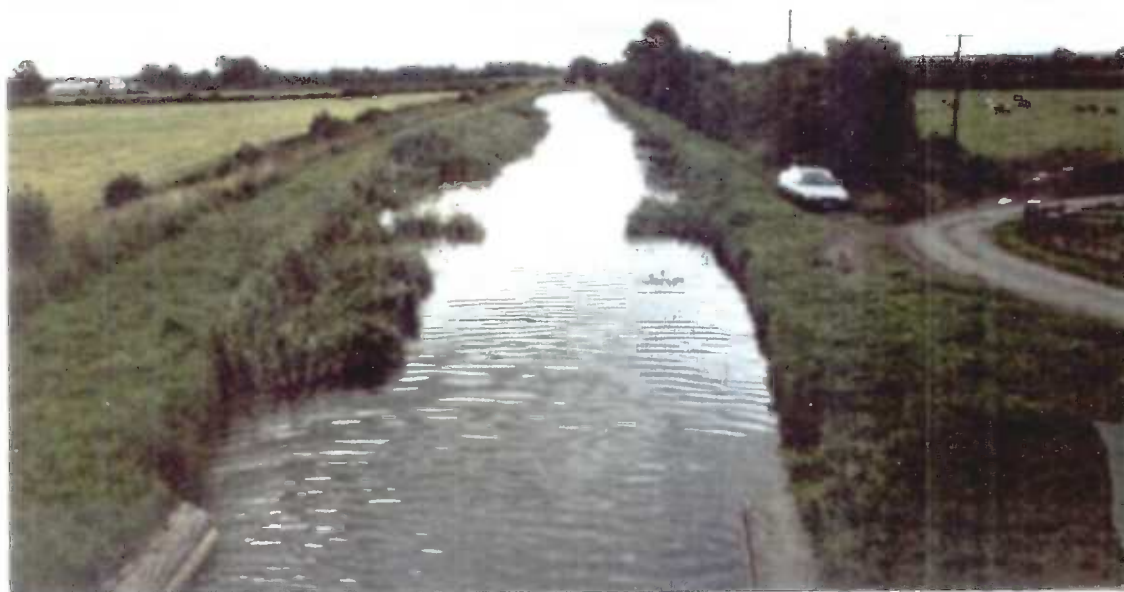
Plate 28: 24th July 1991. km 105. Looking east from Becan's Bridge back towards Rahan on the Main Line. This stretch of channel was free from herbicides in 1991. It is proposed to use some Roundup in 1992. Healthy reed fringe evident along parts of the stretch.

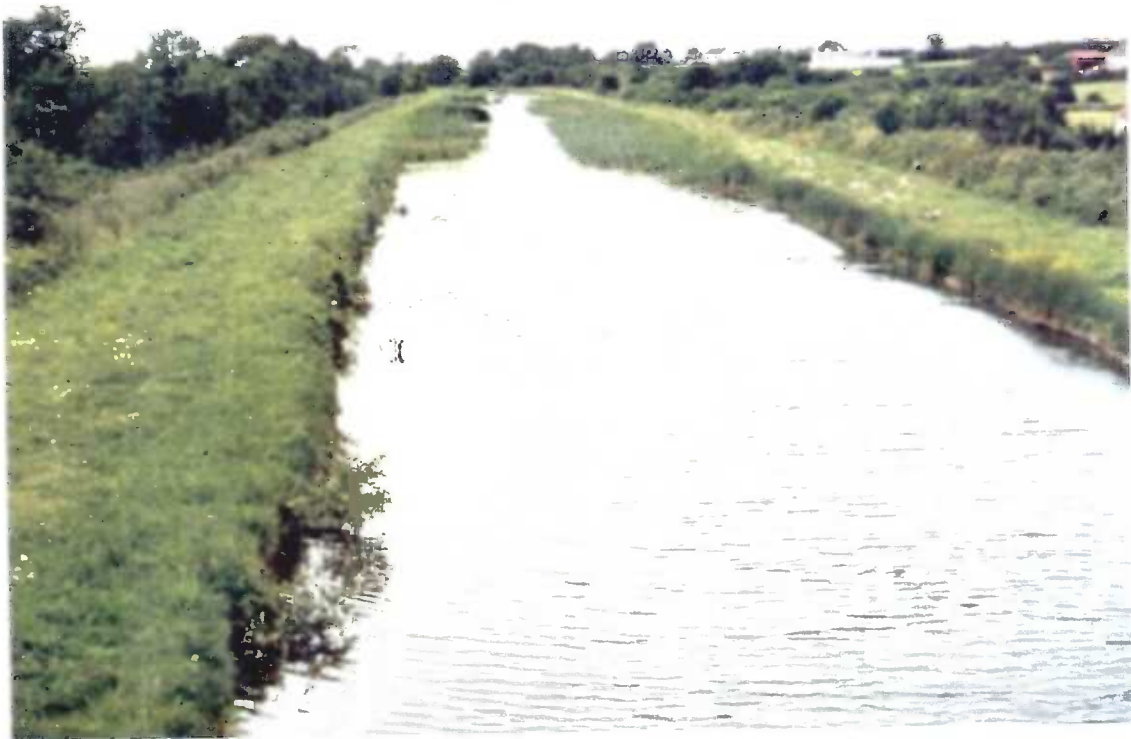
Plate 29: 24th July 1991. km 105. Looking west from Becan's Bridge. Healthy reed fringe which was not treated with herbicide in 1991. However, it is proposed to use Roundup along some of the stretch in 1992.

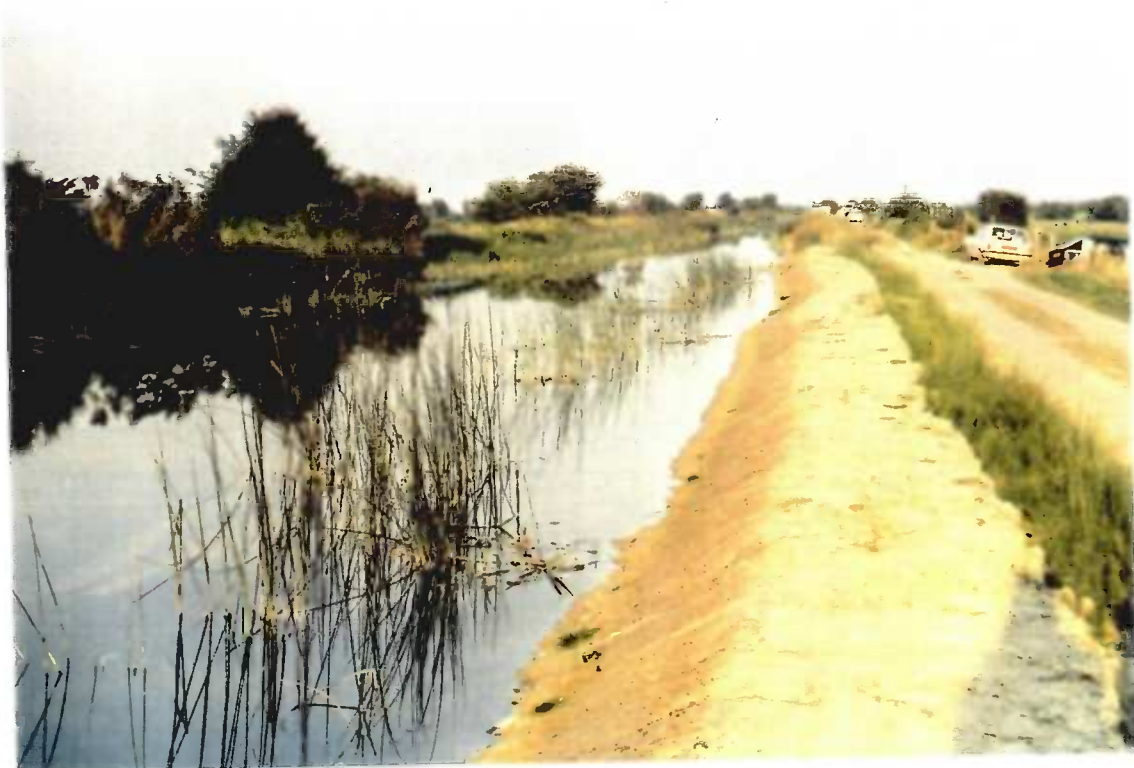
Plate 30: 8th September 1991. km 118. South bank of Main Line just west of Macartney aqueduct and looking eastwards. Bank which has been repaired but not covered in topsoil.

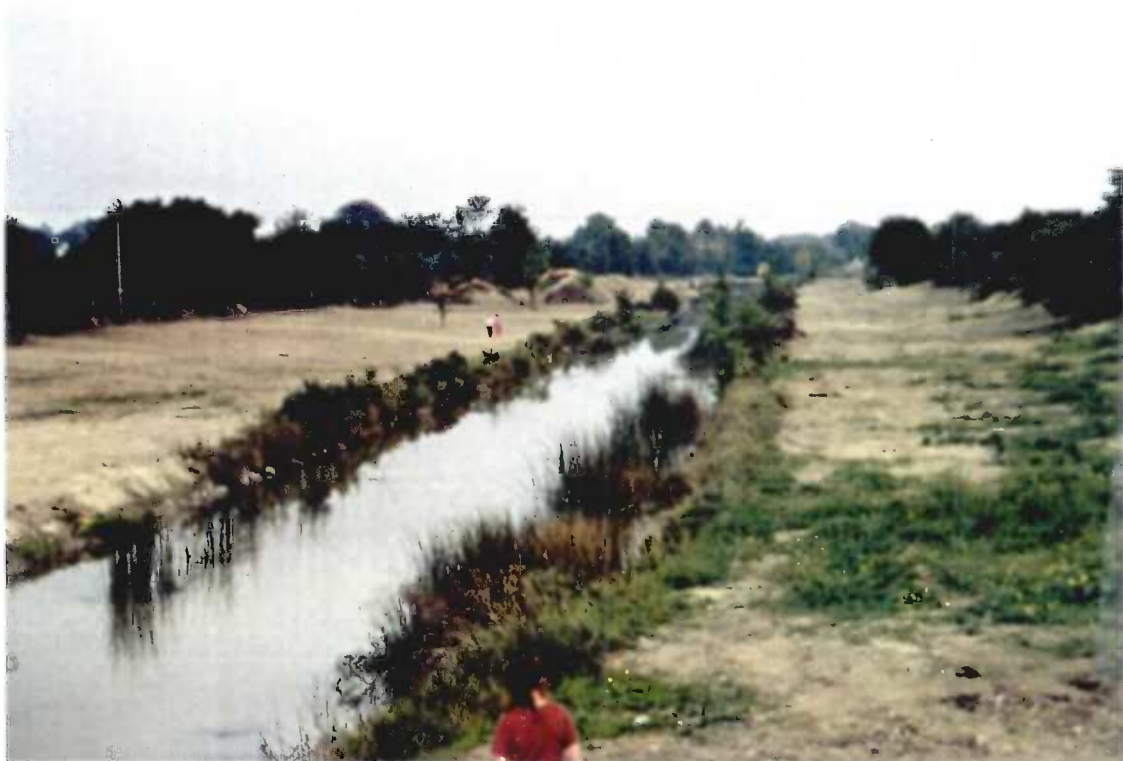
Plate 31: 9th September 1991. km 122. A view east along the Main Line from Noggus Bridge. On 10th June 1991 both stretches of canal bank were impassable. By the 9th September a very wide band of scrub was completely removed from both banks with the loss of a very rich ecological habitat.

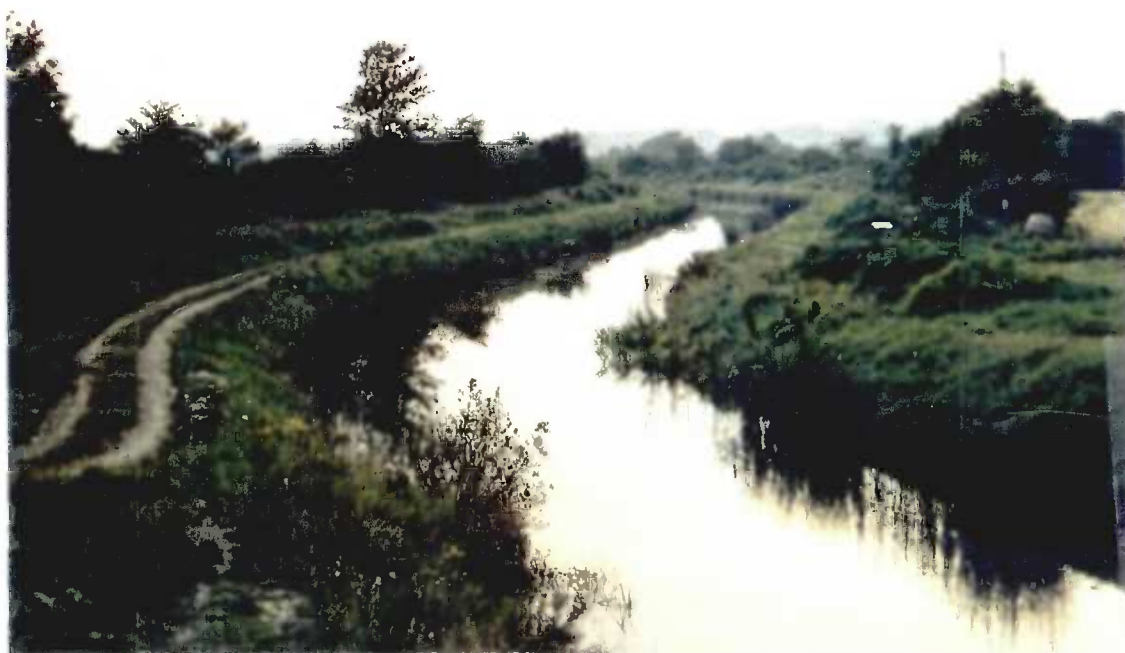
Plate 32: 9th September 1991. km 122. View west from Noggus Bridge along the Main Line. Rough grassland along both banks. Very little reed fringe evident. Roundup and localised Casoron were used in 1991 and it is proposed to use some Roundup in 1992.

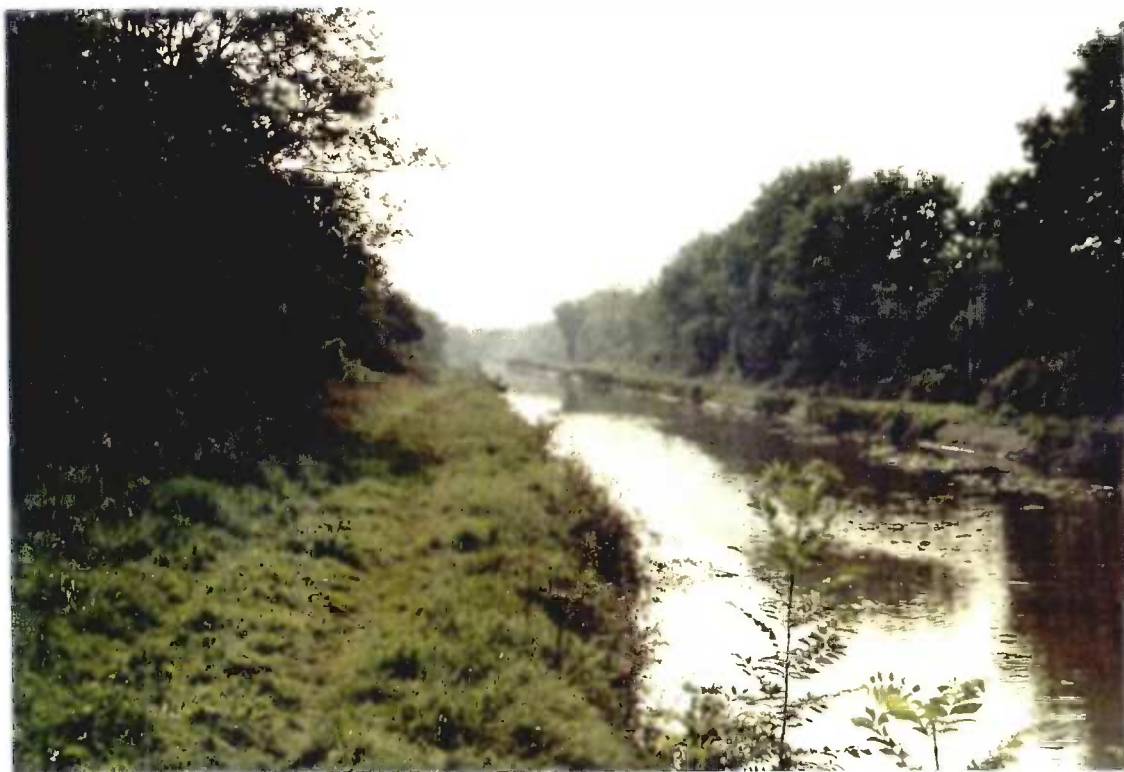
Plate 33: 9th September 1991. km 125. Looking west towards Glyn Bridge along the Main Line. Species-rich boundary hedgerow including Hazel, Guelder Rose and Oak. Little reed fringe evident. This stretch of channel was sprayed with Casoron in 1991 and it is proposed to use Roundup in 1992.

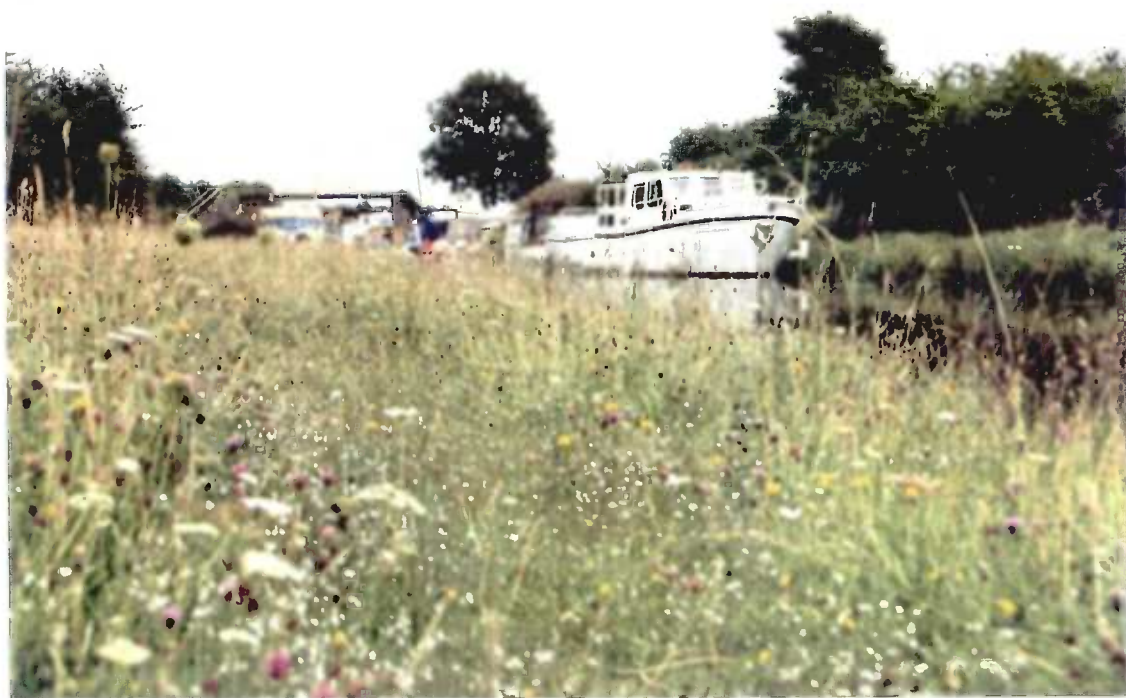
Plate 34: 13th August 1991. km 31. Photograph taken at the start of the Barrow Line. Species-rich calcareous meadow on the bank and towpath supporting such plants as Eyebright, Ox-eye daisy, Wild Carrot and Quaking Grass. This grassland was not cut so maintaining its ecological diversity.

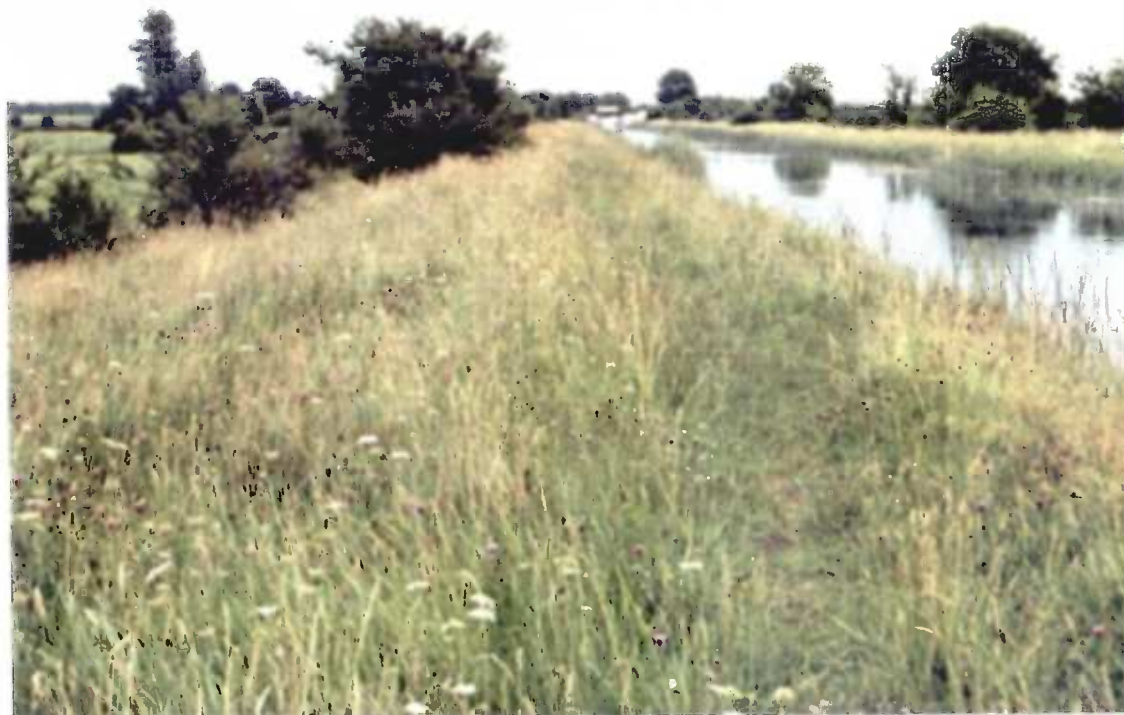
Plate 35: 13th August 1991. km B1. Diverse calcareous meadow along the bank. It is ungrazed and uncut. Photo taken at the start of the Barrow Line.

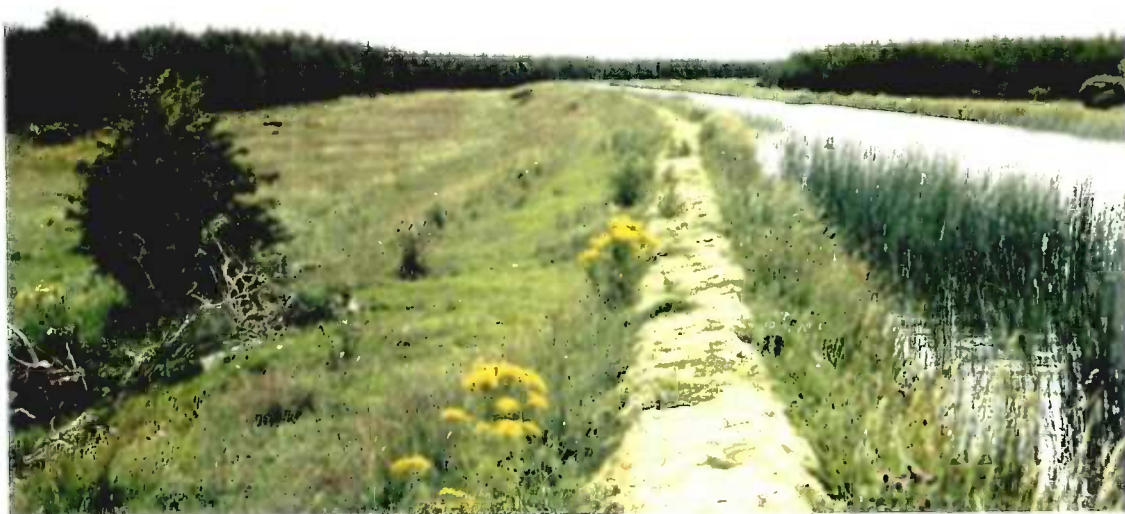
Plate 36: 15th August 1991. km B11. Looking east towards Glenaree Bridge on the north bank of the Barrow Line. The photograph shows the large area of fen at the toe of the embanked canal. A similar fen area exists on the south bank. The orchid, Epipactis palustris was found here. In addition there is a high diversity of both habitat and species in the area.

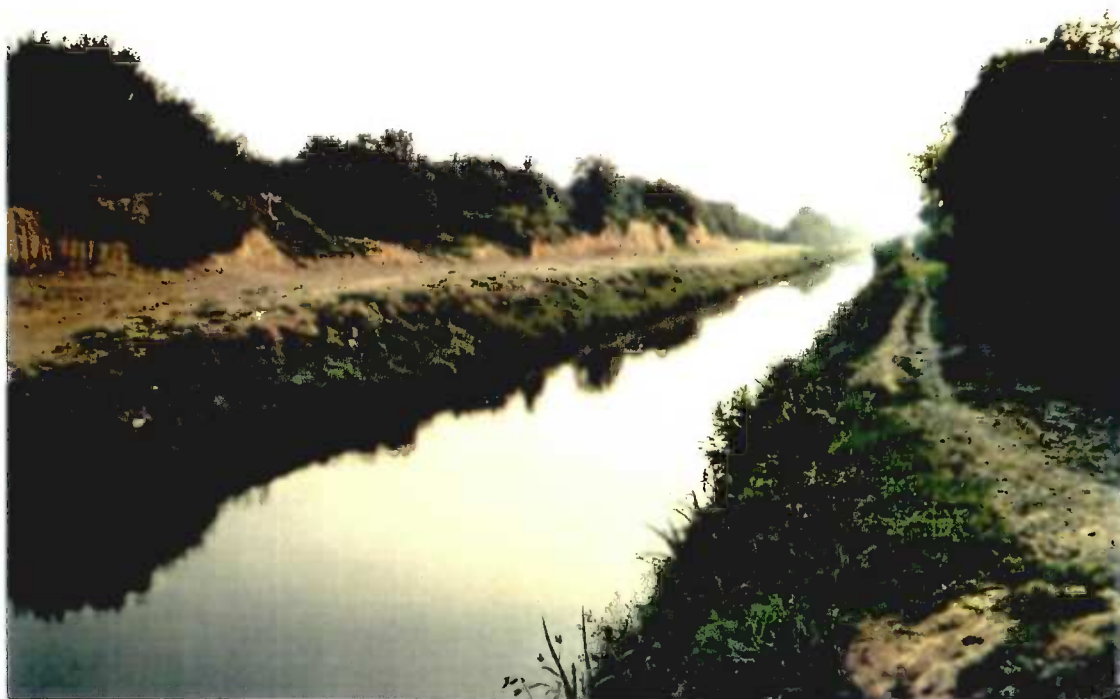
Plate 37: 10th September 1991. km B24. Taken from the bridge at the 25th Lock and looking west towards Clogheen Bridge. The south bank was cleared by 17th June 1991 but by September, revegetation was very slow. The soil has compacted making it very difficult for plants to grow.

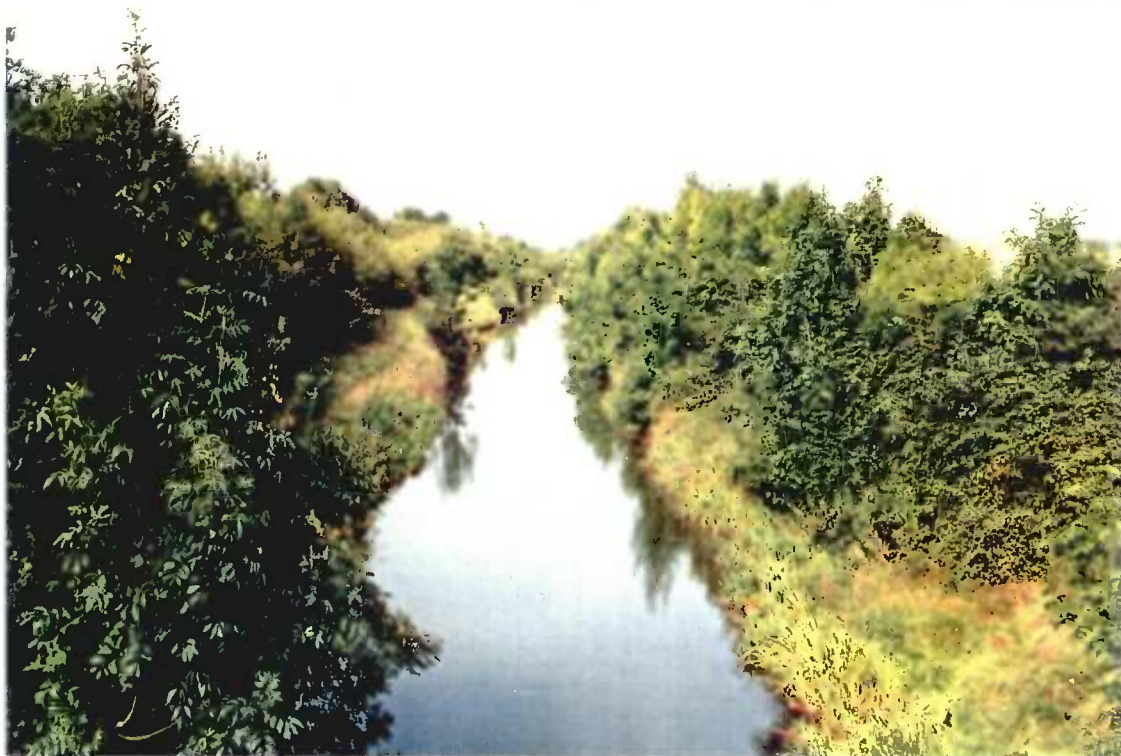
Plate 38: 11th September 1991. km B30. A view east from Fisherstown Bridge on the Barrow Line showing the species-rich hedgerow. It may be necessary to cut and spot-treat tree stumps of the east bank.

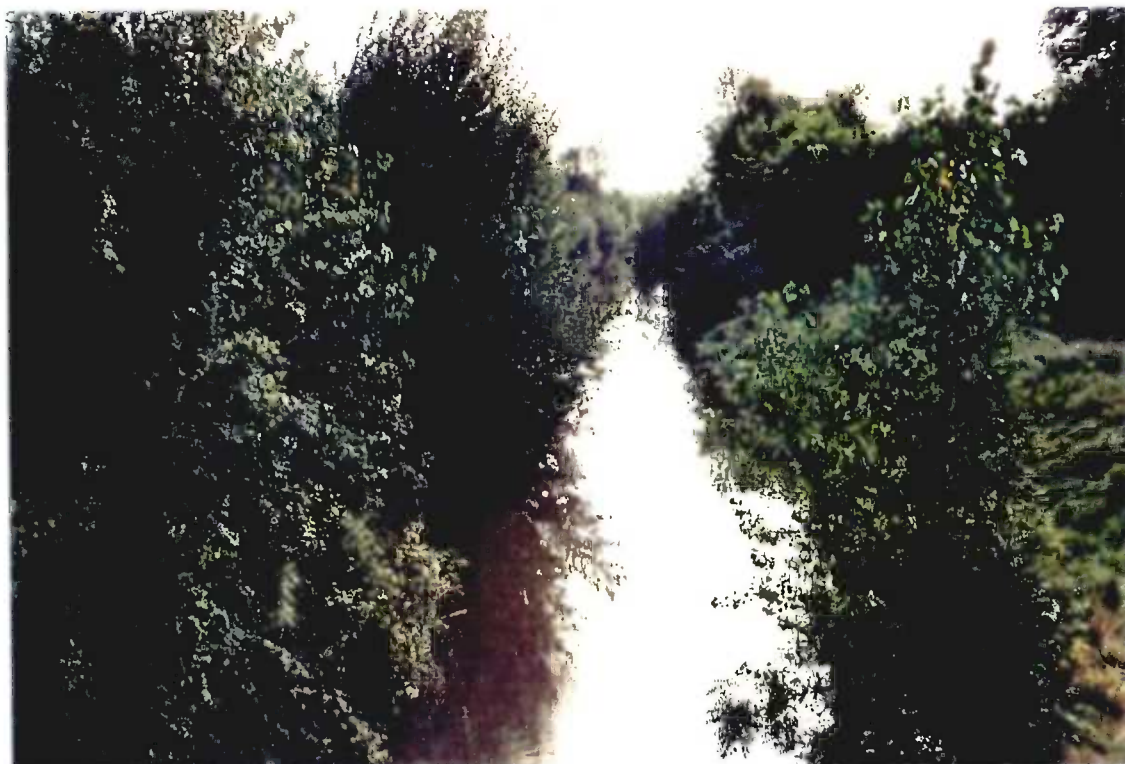
Plate 39: 11th September 1991. km B30. A view west from Fisherstown Bridge on the Barrow Line showing overgrown banks. It may be necessary to cut and spot-treat tree stumps on one bank. Wholesale clearance of the banks should not be carried out.

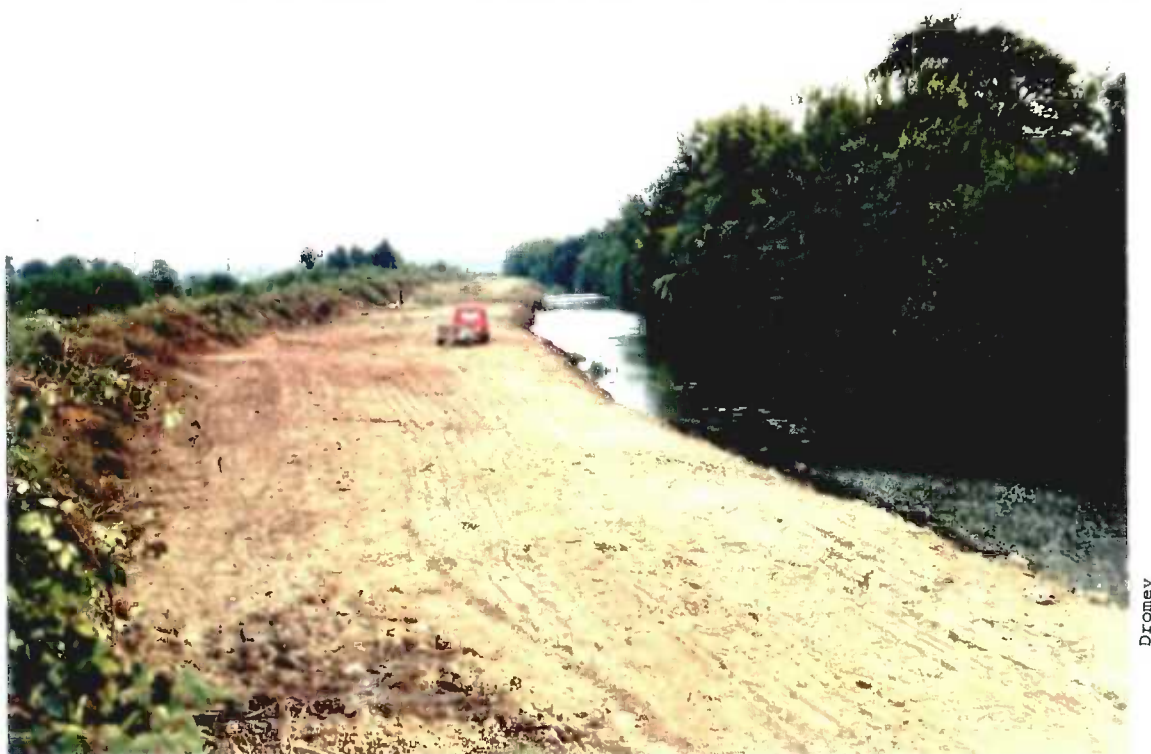
Plate 40: 11th September 1991. A view west from Milltown Bridge on the Barrow Line. On the 8th June 1991, this stretch of bank was covered in scrub and impassable. A very wide area along one bank was cleared. At least half the cleared area should be left in scrub. The soil is compacted which will make it difficult for revegetation.

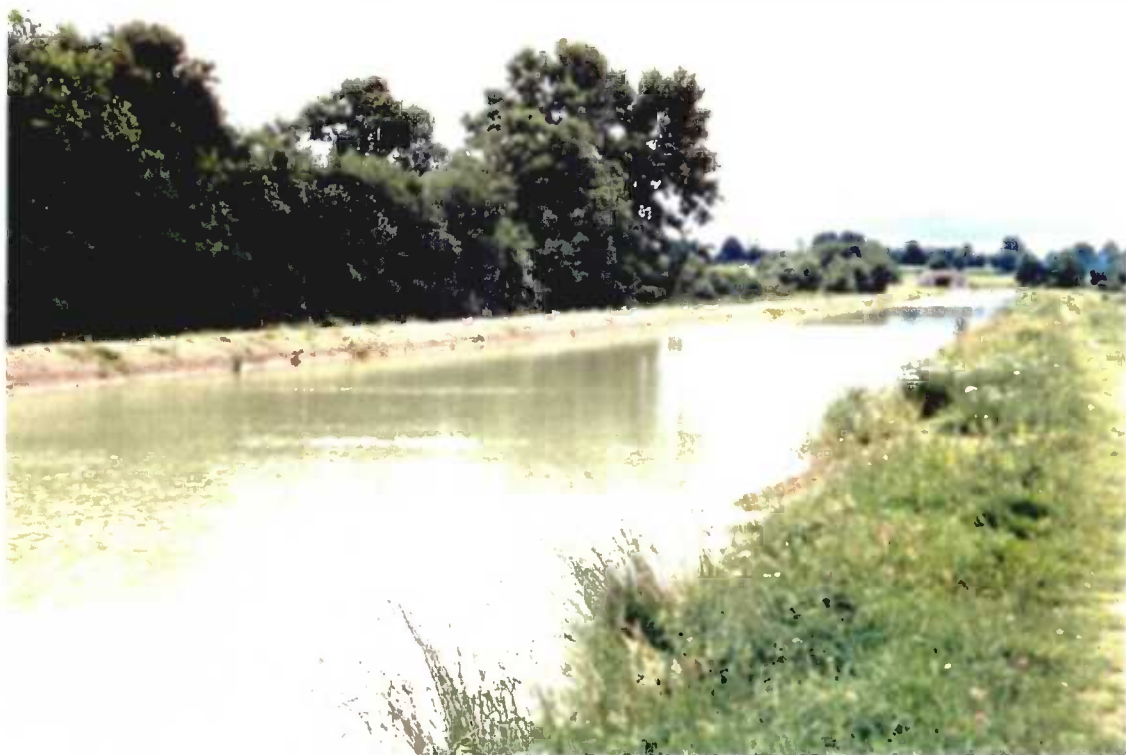
Plate 41: 19th July 1991. Edenderry Branch of the Grand Canal - on the north bank looking south to Downshire Bridge. Clayed bank is not covered in topsoil which will make it difficult for revegetation.

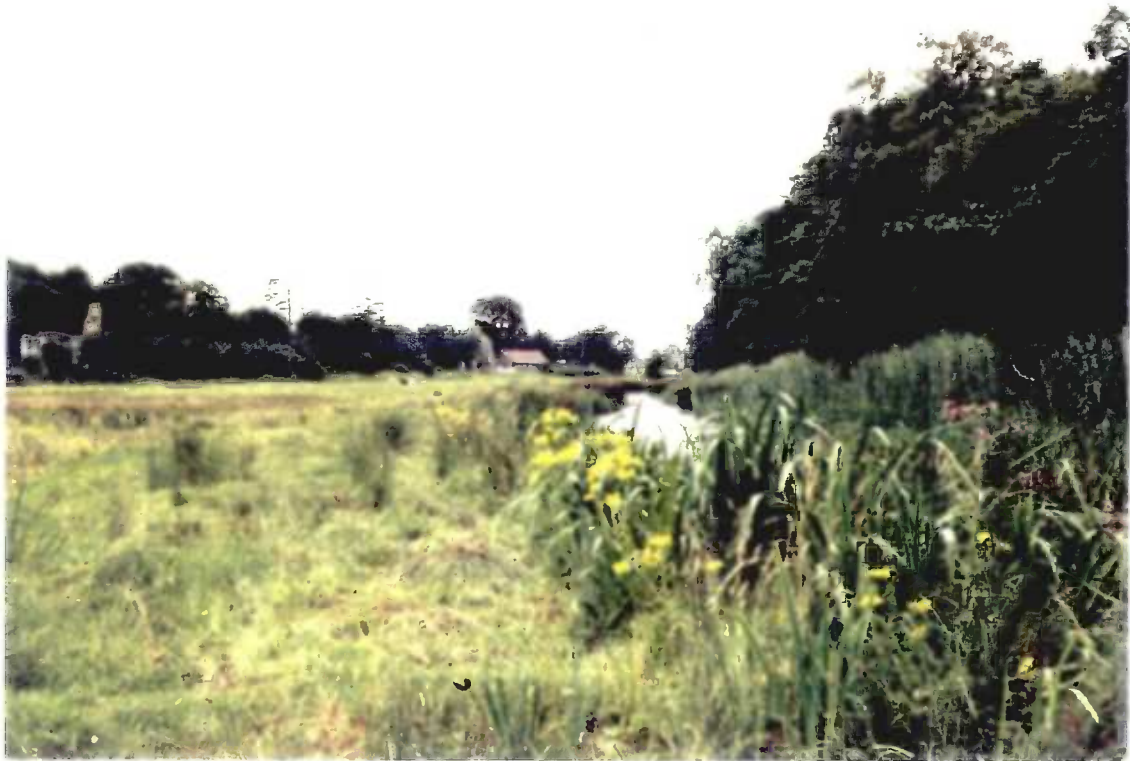
Plate 42: 8th August 1991. km N5. Photo shows the Naas Branch of the Grand Canal with healthy reed fringes, good aquatic diversity and rich bank. Many swans and moorhens present.

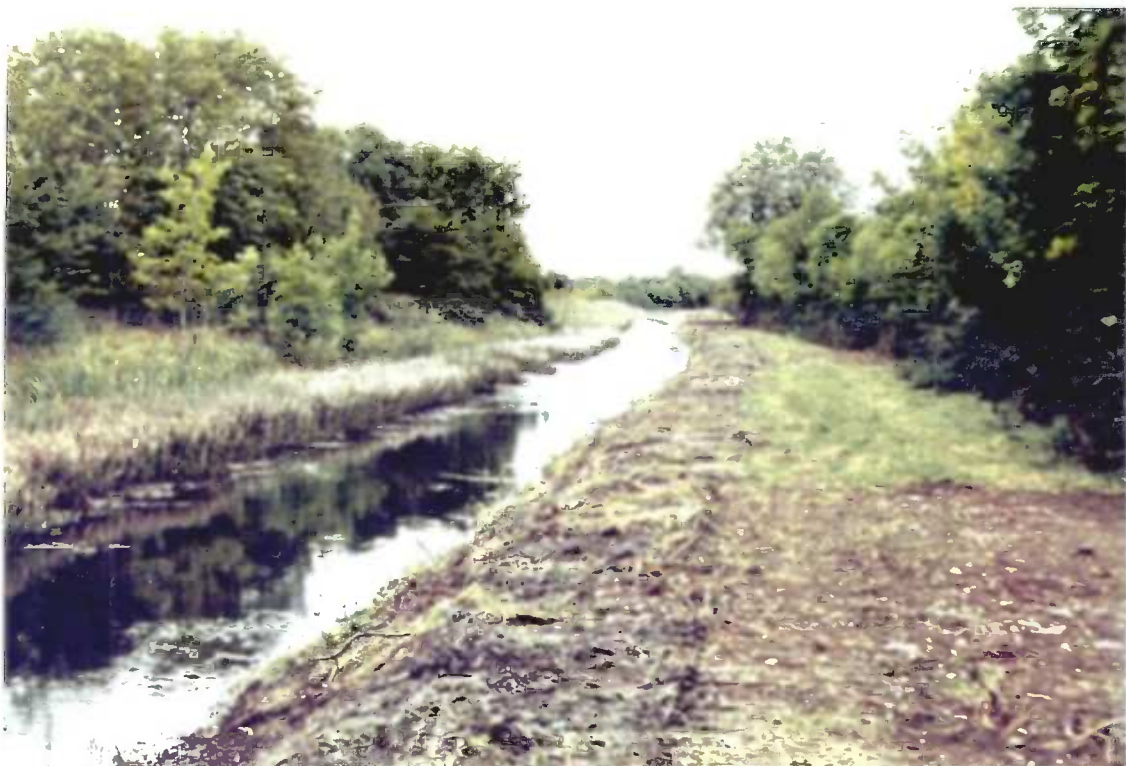
Plate 43: 2nd October 1991. km N 6/7. Naas branch along the east bank looking north. Part of the disused canal being dredged from one bank leaving the other intact. The spoil/dead reeds are pulled to the bank and not deposited on the towpath. (ASI)

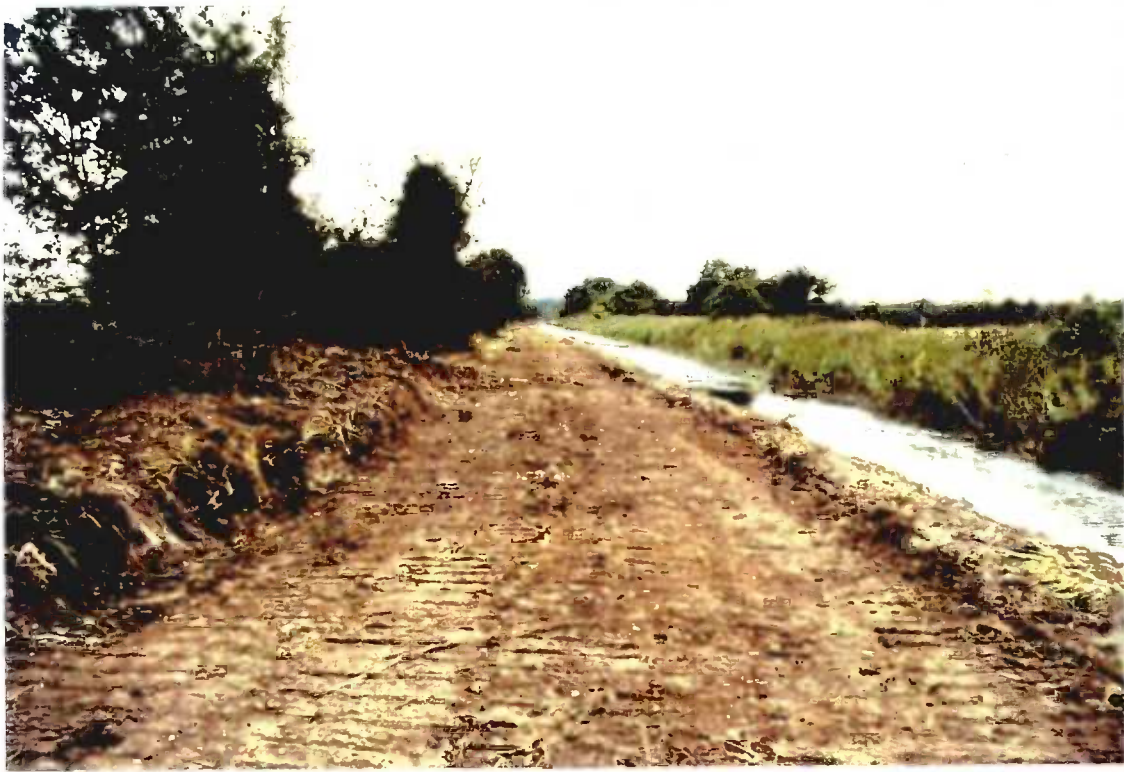
Plate 44: 2nd October 1991. km 6/7 East bank looking south. Dredging of one bank only and the deposition of some reeds along the bank. Both of these practices are environmentally friendly. However, depositing reeds along the boundary results in reeds growing there. They will choke out the natural vegetation. The dead reeds should be buried in a trench. (ASI)

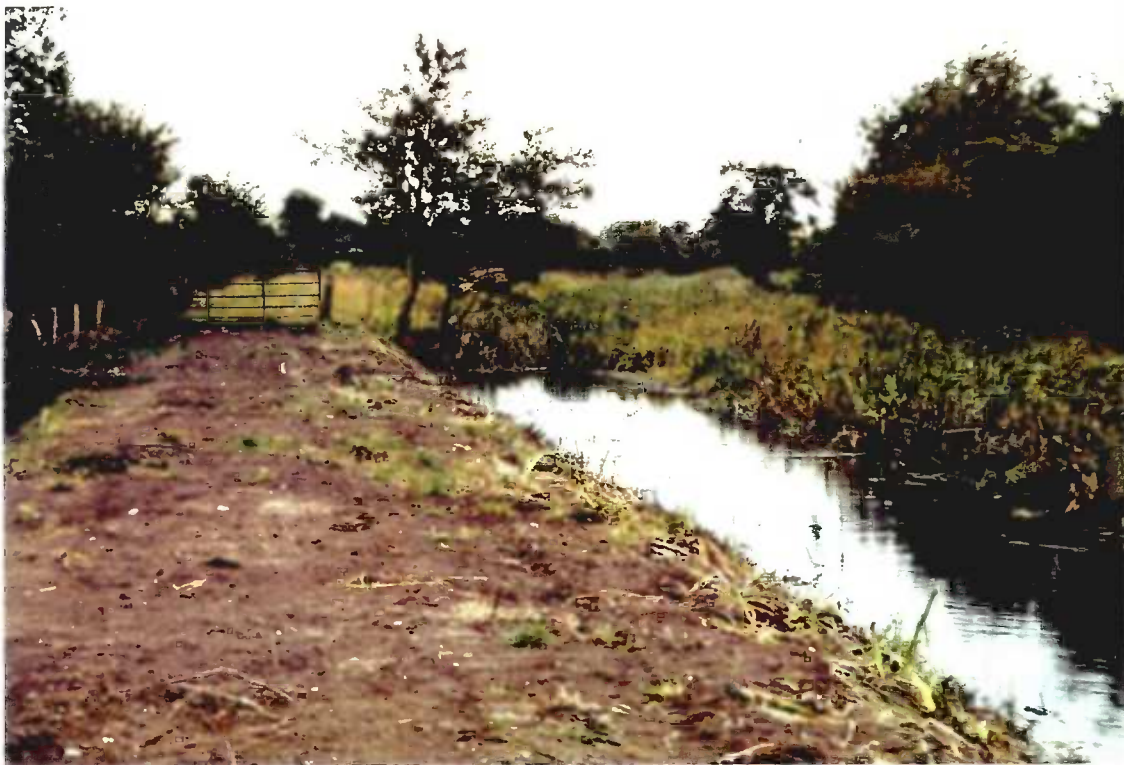
Plate 45: 2nd October 1991. Naas Branch on the east bank and looking south to highlight the differences between dredged/undredged stretch. (ASI).

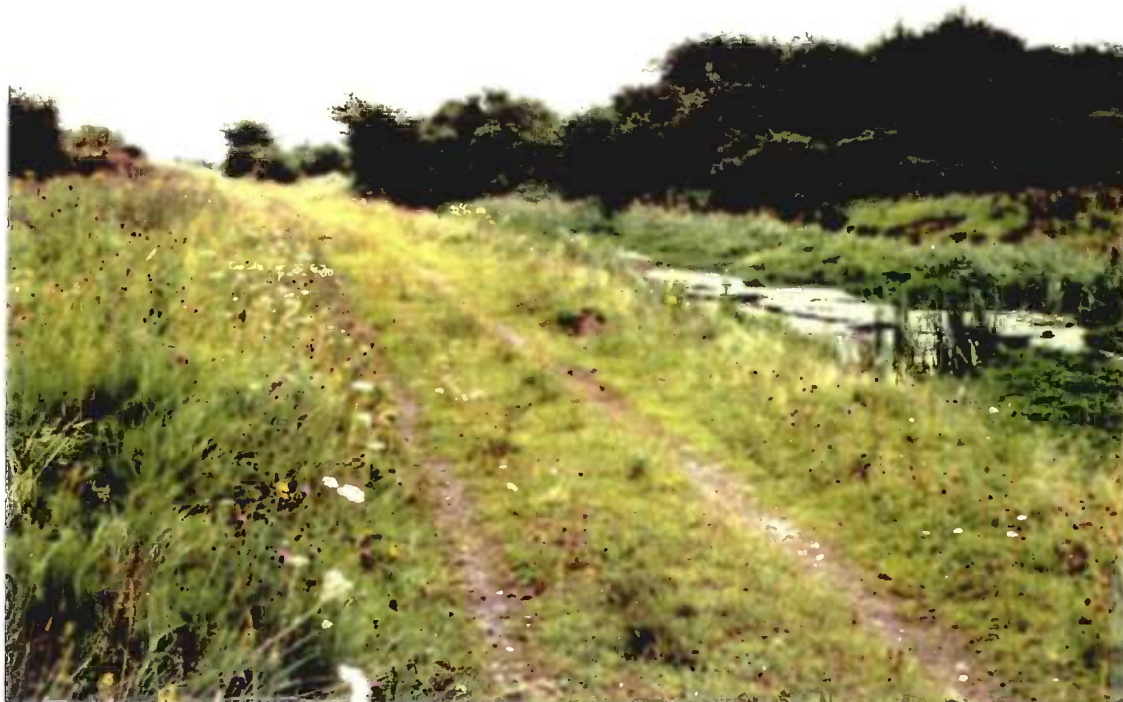
Plate 46: 9th August 1991. km N11. North bank of Naas Branch looking east towards Hoare's Bridge. Species-rich calcareous bank and boundary verge which is lightly grazed. Very high aquatic diversity also evident. (ASI)

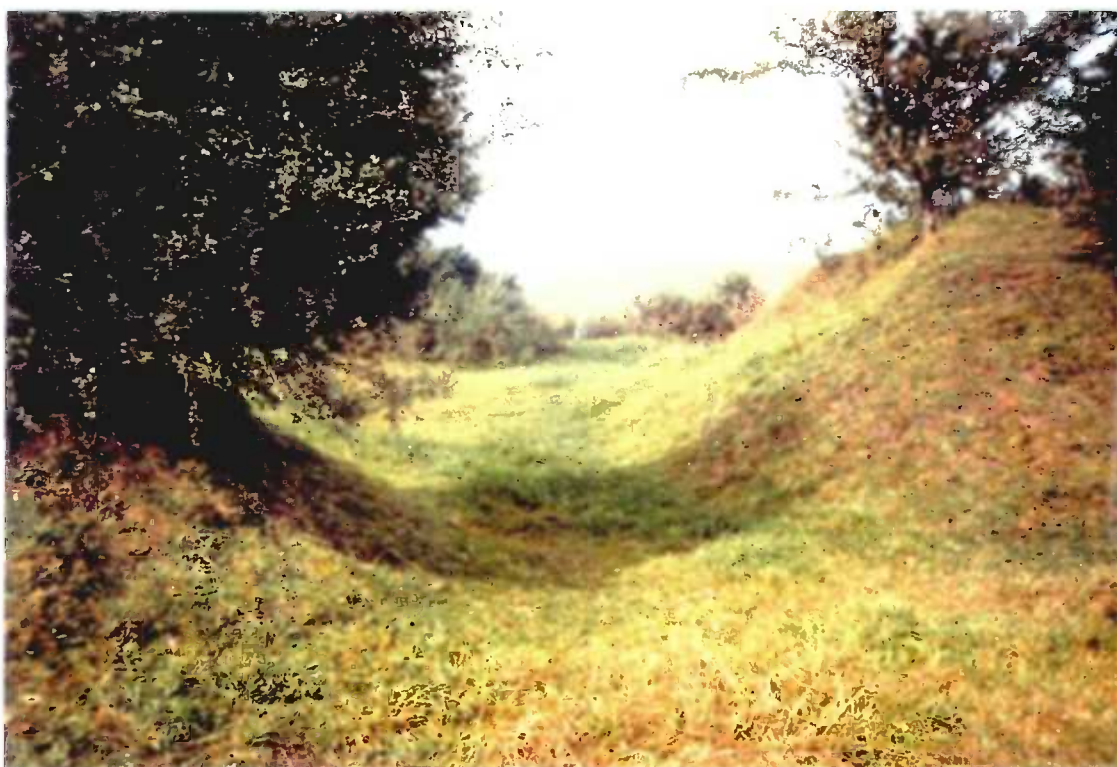
Plate 47: 13th August 1991. km N12. Calcareous grassland, grazed by sheep along the west bank of the Naas Branch. These heaps are nutrient-poor and were probably deposited at the time of the previous dredging approximately 60 years ago. (ASI)

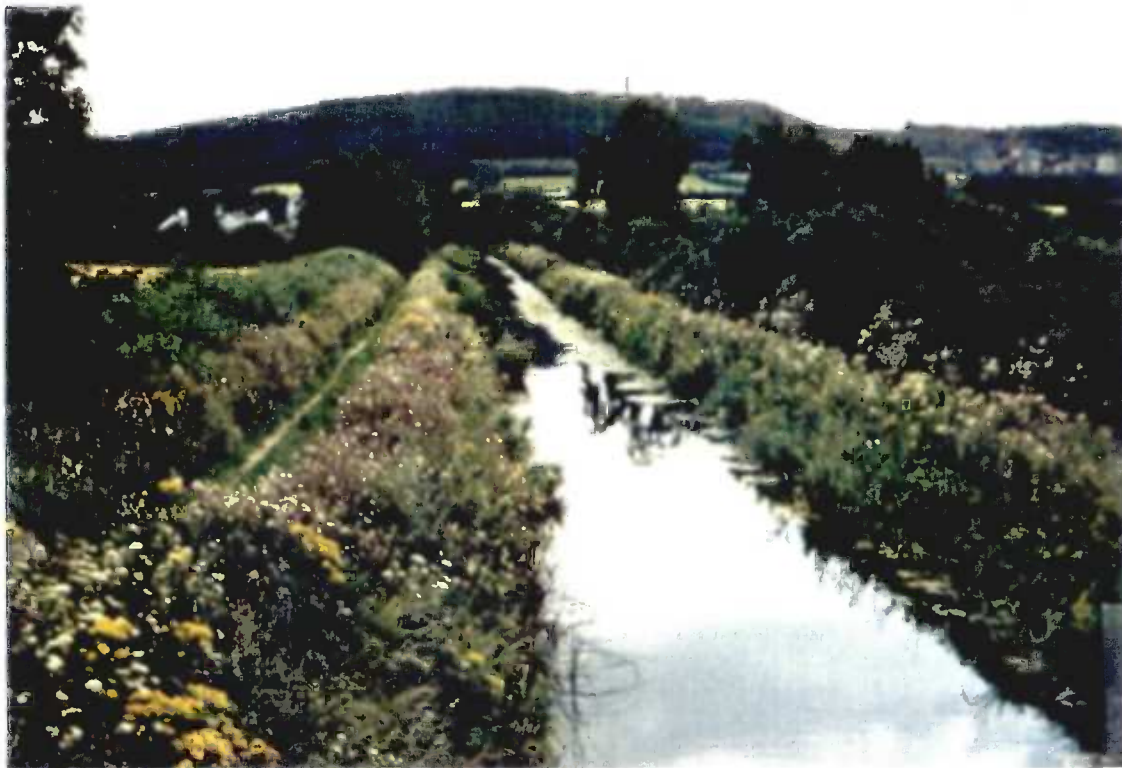
Plate 48: 12th August 1991. km M5. Taken from Pim Bridge on the Milltown Feeder and looking south towards the Hill of Allen. This stretch was dredged in 1990. Thistles are the dominant species one year later. Cut them down in June to prevent seeding and another crop the following year.

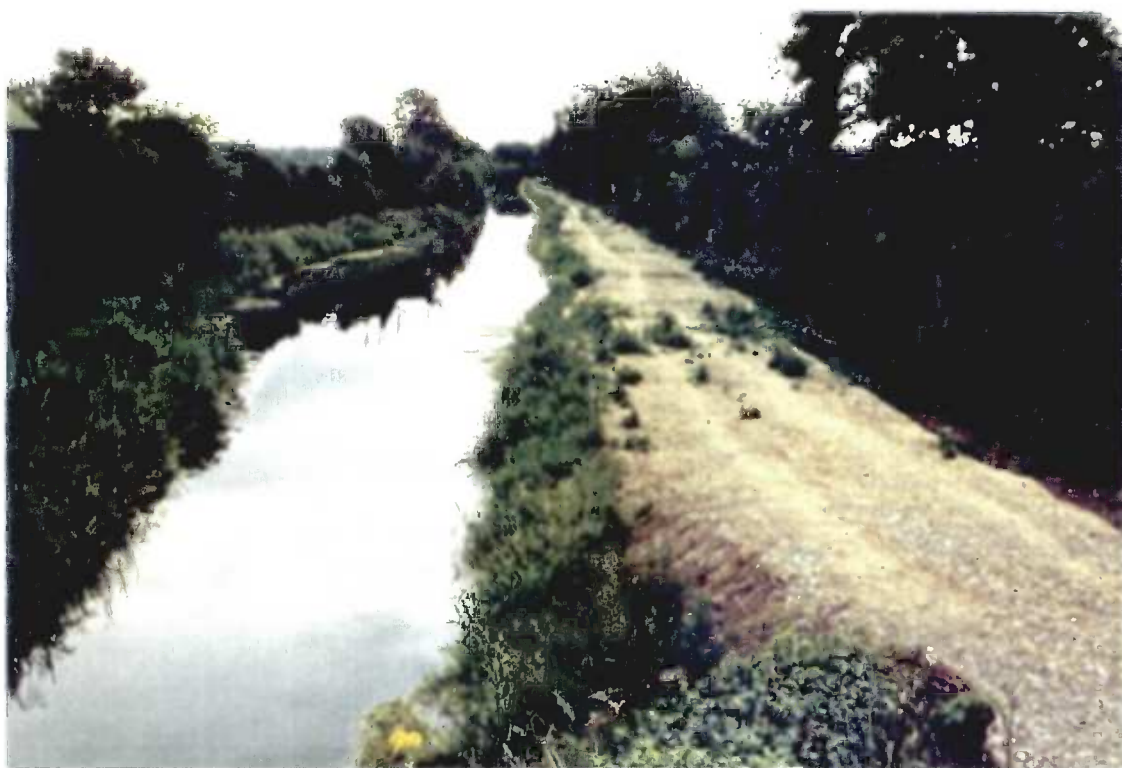
Plate 49: 12th August 1991. km M11. Looking south from Milltown Cross Roads Bridge. Healthy reed fringes developing one year after bank repairs. The soil of the towpath is compacted making it difficult for revegetation.

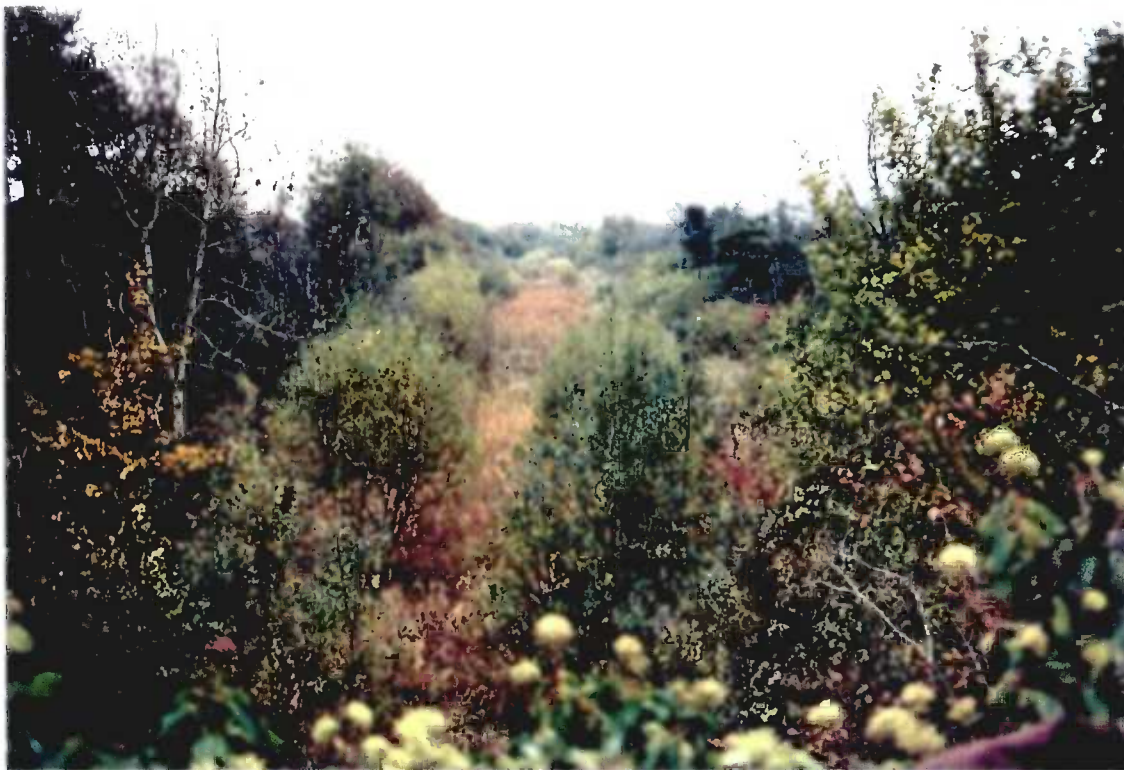
Plate 50: 28th October 1991 km K2. View south from Brook's Bridge on the disused Kilbeggan Branch. The channel is wet at this point and supports Phragmites australis. There are some birch trees present also. Both banks support scrub/trees.

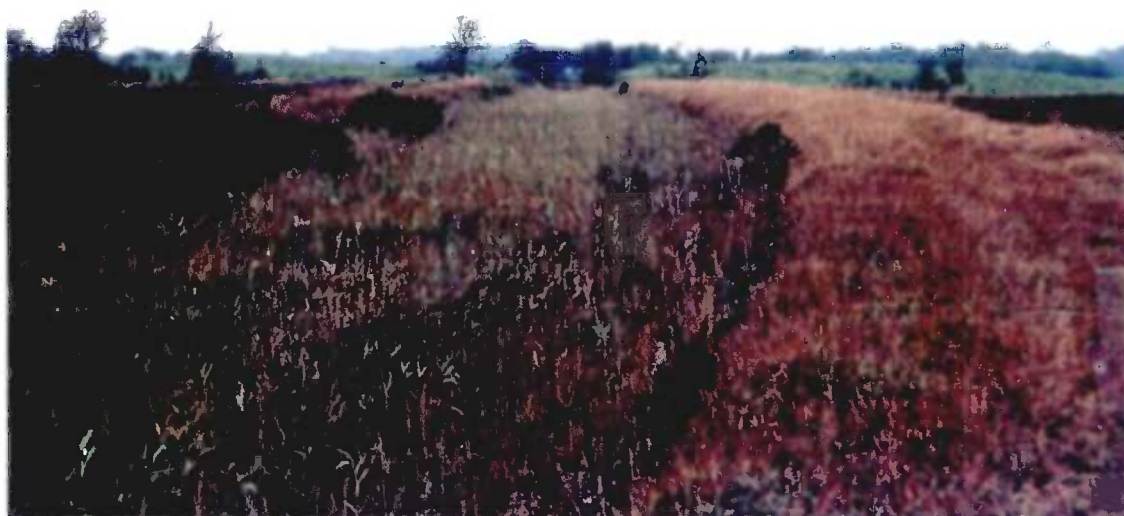
Plate 51: 28th October 1991. km K6. View north on the Kilbeggan Branch, of the Grand Canal on the approach to Whelan's Bridge. The canal passes through Bracklin Bog. The towpath is very interesting as both acid and lime-loving plants exist side by side. Many aquatic species present in the channel. It is necessary to define boundaries. Spoil to be deposited outside of the bog or in a deep trench which will then be covered.
