ECOLOGICAL SURVEY OF THE GRAND CANAL 1991

Part 1
Survey Report

**Prepared for:
The Wildlife Service and Waterways Section,
Office of Public Works. 1992.**

**By
Marie Dromey
Brigid Johnston
Sinead Keane**

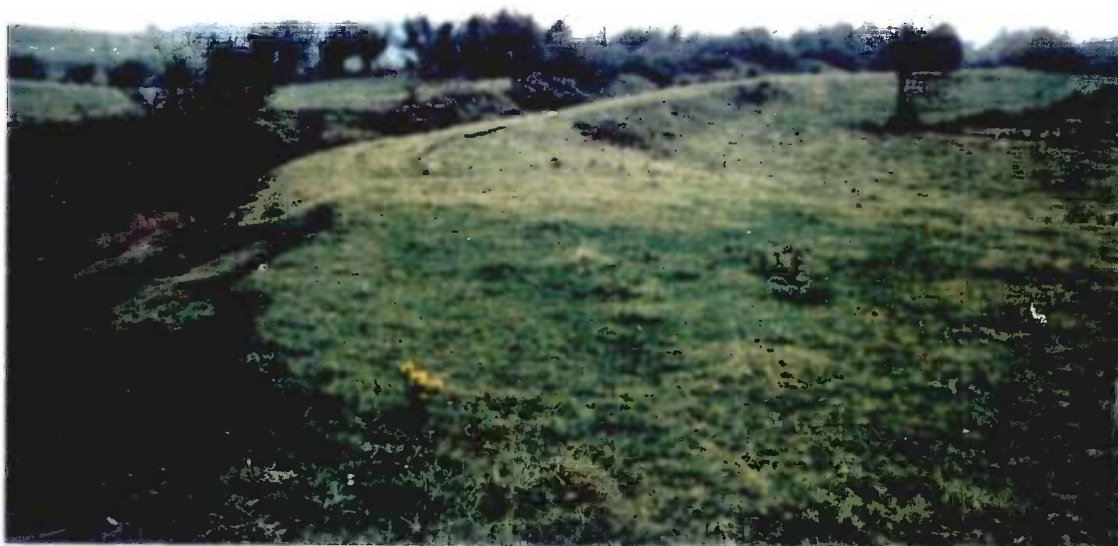
Plate 52: 28th October 1991. km K7. View north from Whelan's Bridge on the Kilbeggan Branch of the Grand Canal. This stretch of disused channel and towpath is presently grazed. Esker mounds dominated by Hazel along the west bank. It is necessary to define boundaries along both banks. Spoil should be deposited in a trench which will then be covered in topsoil.

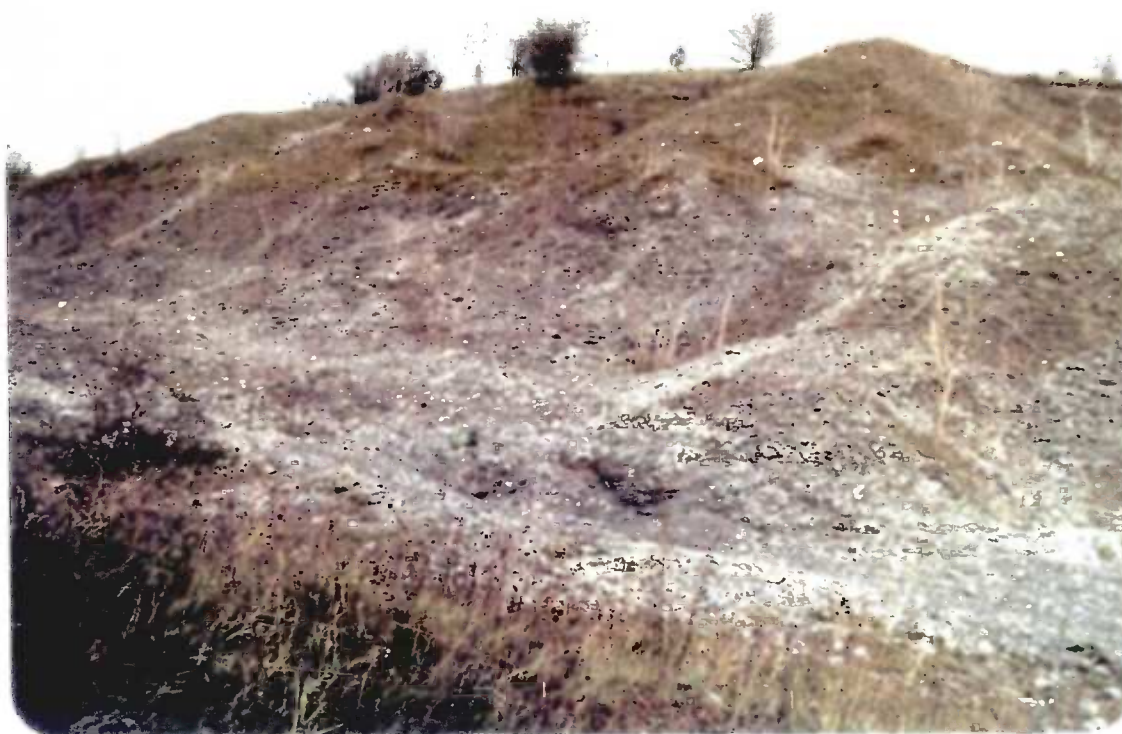
Plate 53: 28th October 1991. km K8. Rahugh Esker - an ASI of International Importance, No. 1 in Co. Westmeath - on the east bank of the disused Kilbeggan Branch. The site is important because of its nutrient-poor soils which support many nationally rare species. Spoil to be deposited away from the Esker.

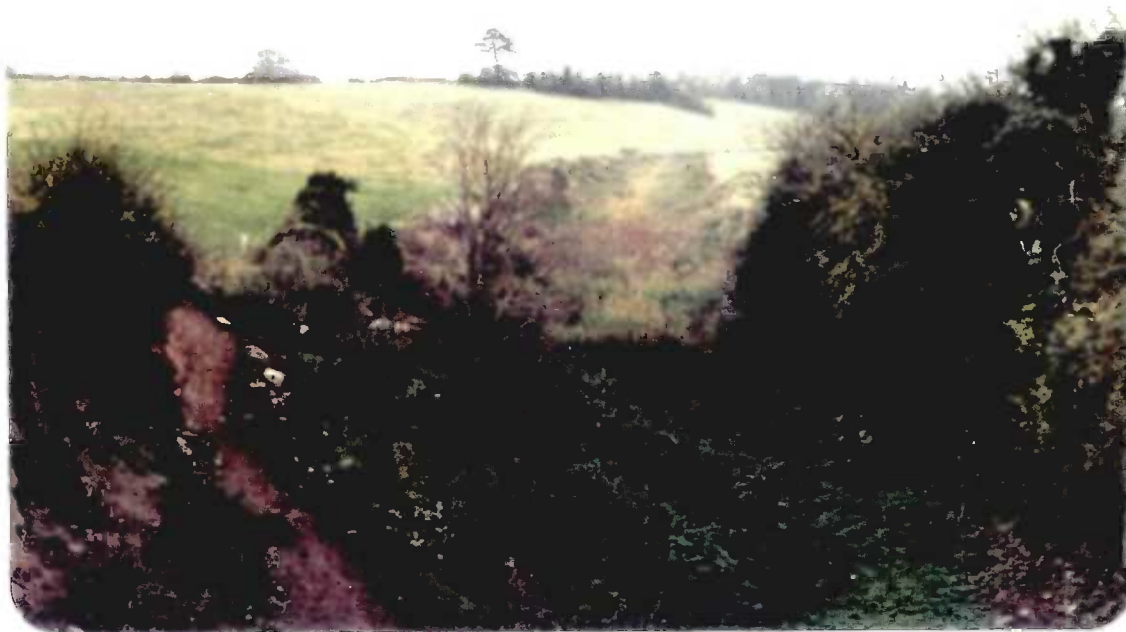
Plate 54: 28th October 1991. km K10. A view south from Grange Bridge on the disused Kilbeggan Branch. Trees/shrubs of the east bank were cut by a local Fás Scheme. The channel between here and Lowertown Bridge further south is dry and grazed for much of its length. Both boundaries need to be defined.

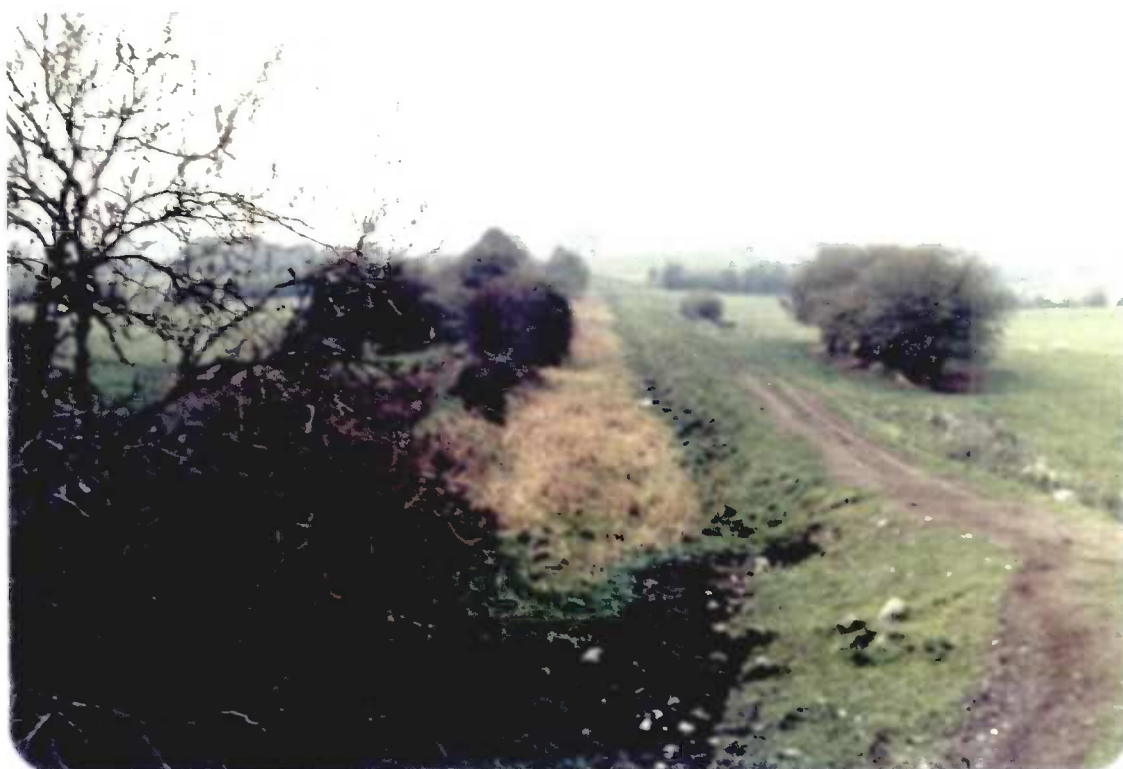
Plate 55: 28th October 1991. km K11. Looking north from Grange Bridge on the disused Kilbeggan Branch. Sheep graze this stretch of towpath. Water present in the channel at this point. Spoil to be buried in a trench and covered. It is necessary to define boundaries. Esker in the distance through which the canal cuts.

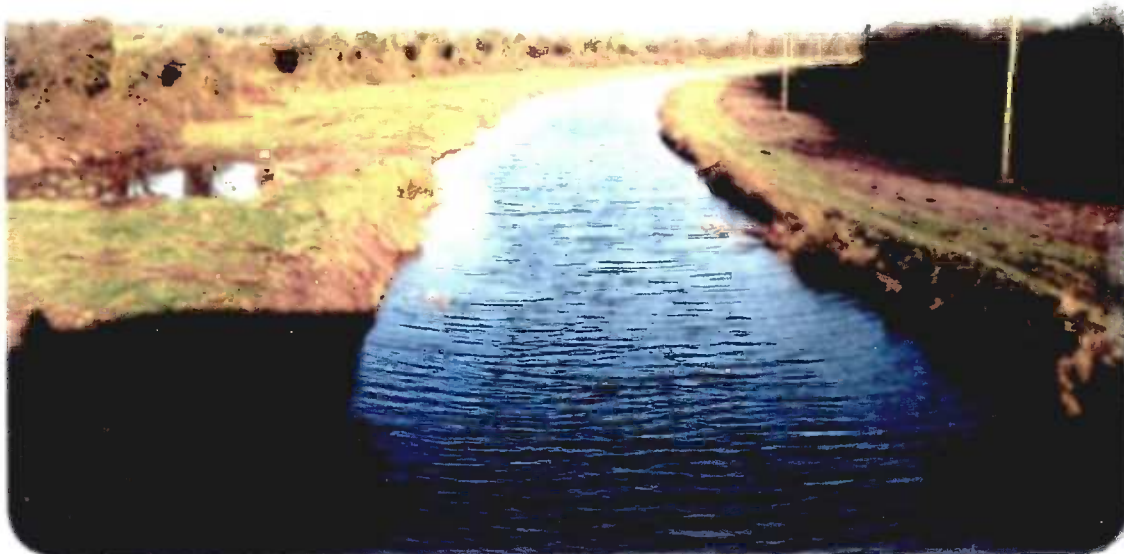
Plate 56: 9th January 1992 km B16. Taken from Wilson's Bridge on the Barrow Line and looking north. The east bank has been cleared of scrub which was present in September 1991. Clearance is approximately 10 metres wide.

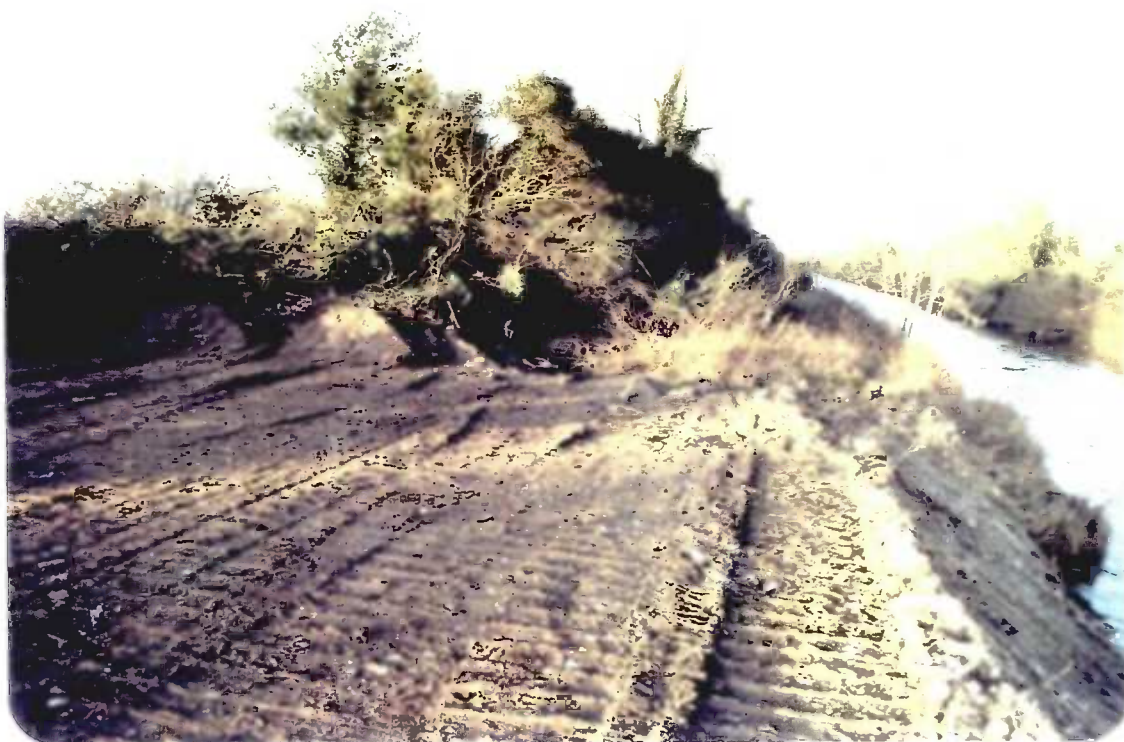
Plate 57: 9th January 1992. km B 34/35. Looking north along the west bank of the Barrow Line. Levelling of old bank mound which raised the height of towpath and results in a steeper bank. The path has been levelled for a width of 13-16 metres. The old towpath of approximately 3 metres is just beyond levelled section.

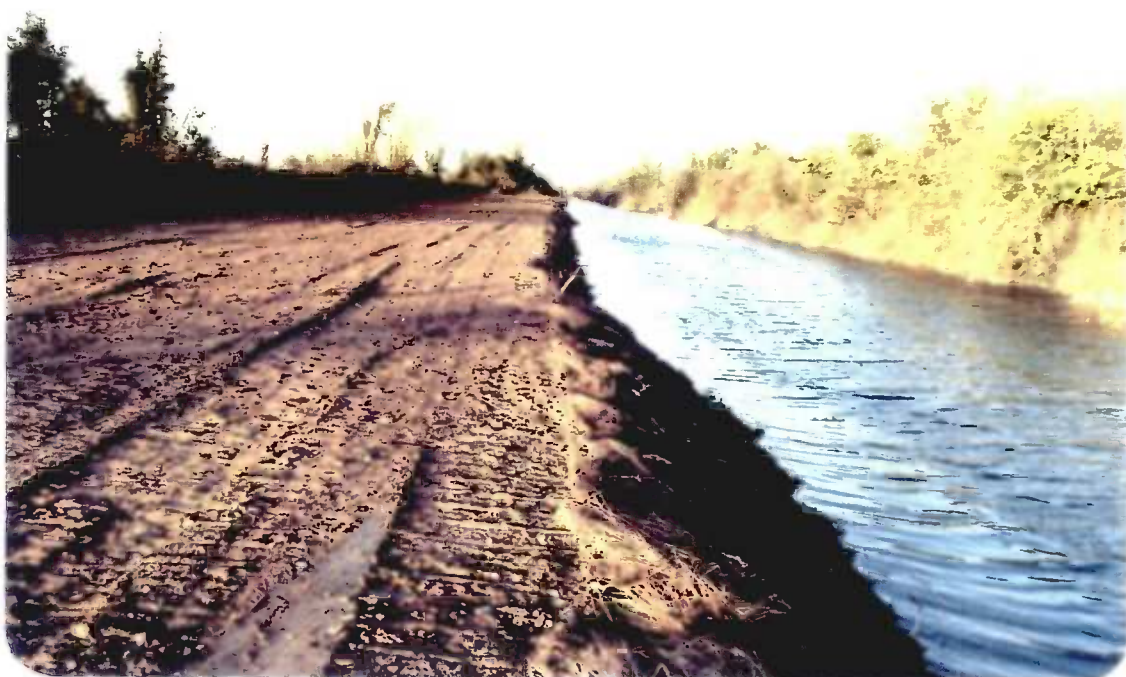
Plate 58: 9th January 1992. As for plate 57.

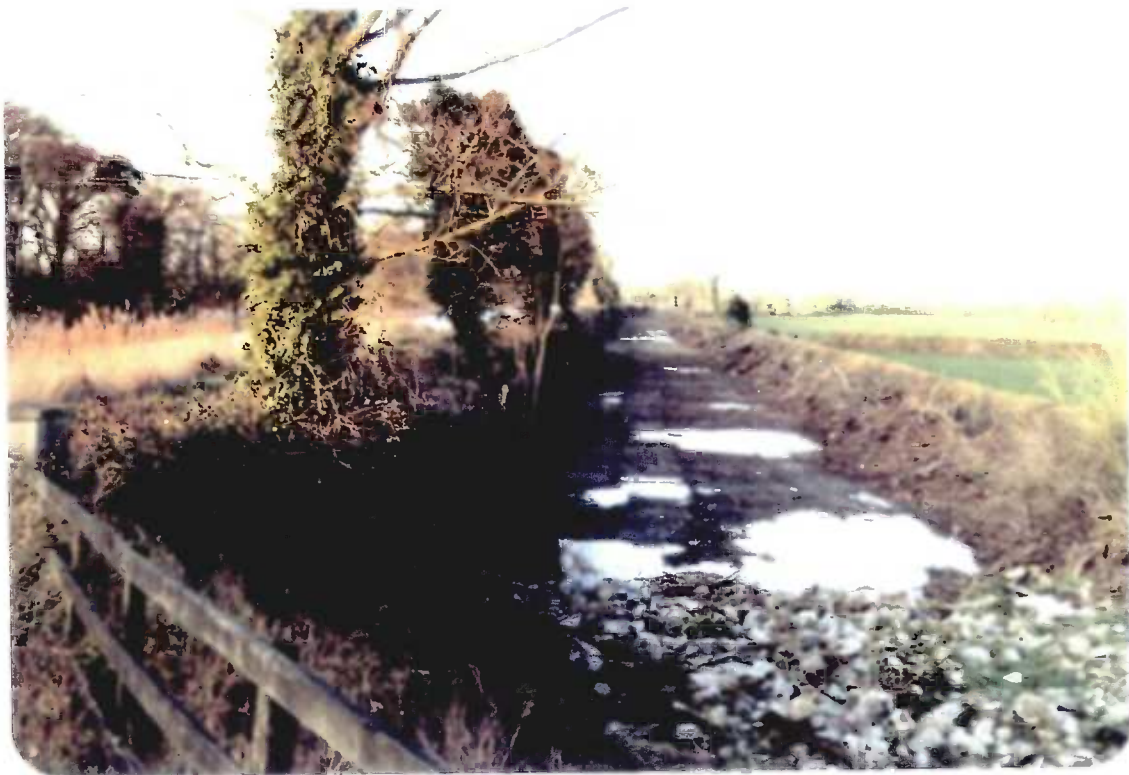
Plate 59: 9th January 1992. km B37 View north from Ballymanus Bridge along the east bank of the Barrow Line. The canal is to the left of the picture. There is a road between it and the cleared stretch. In September 1991 this stretch supported a diversity of trees and shrubs including Hazel, Ash, and Guelder Rose.

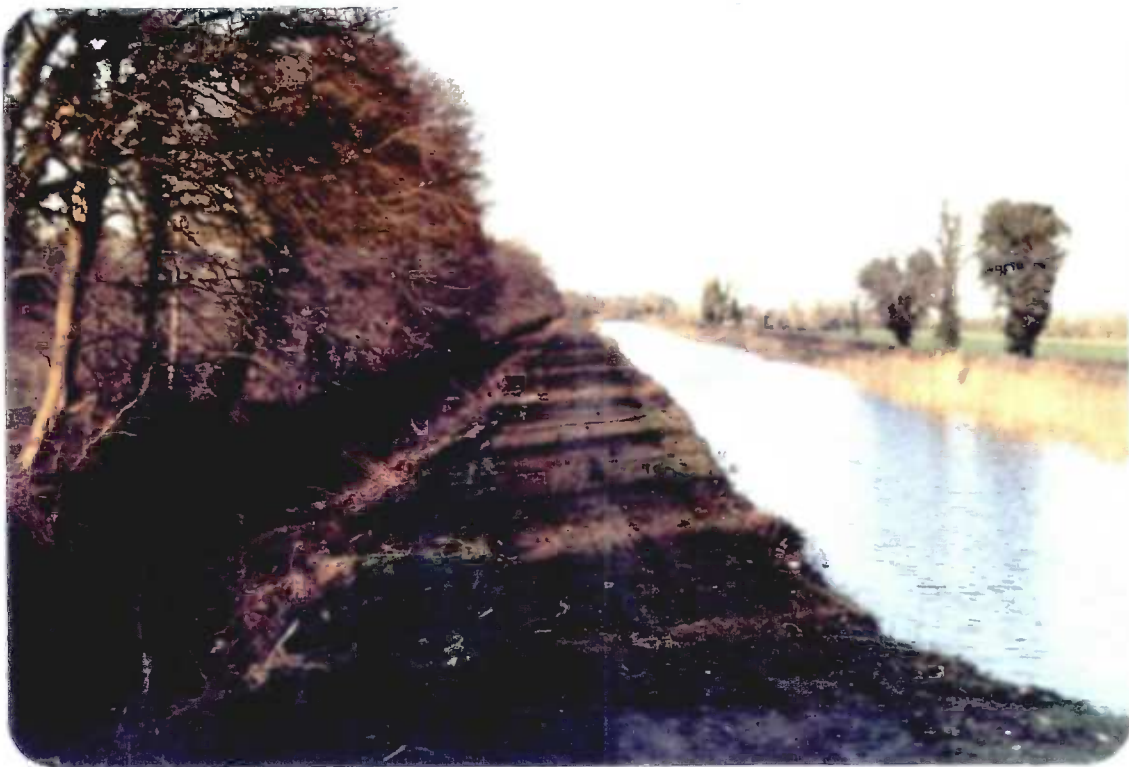
Plate 60: 9th January 1992. km B37 Looking north along the west bank of the Barrow Line at Ballymanus Bridge. This photo shows a view of the opposite bank to that shown in Plate 59. This bank has to be clayed in order to raise it. The clay should be covered with topsoil to facilitate revegetation which stabilizes the bank.
