FLORENCE M. HURLEY

**Descriptive and photographic report**  
**on**  
**Ballynahinch Tower House**  
**and adjoining structure**  
**with mortar analysis**

**Ballynahinch,**  
**Recess,**  
**Connemara,**  
**Co. Galway**

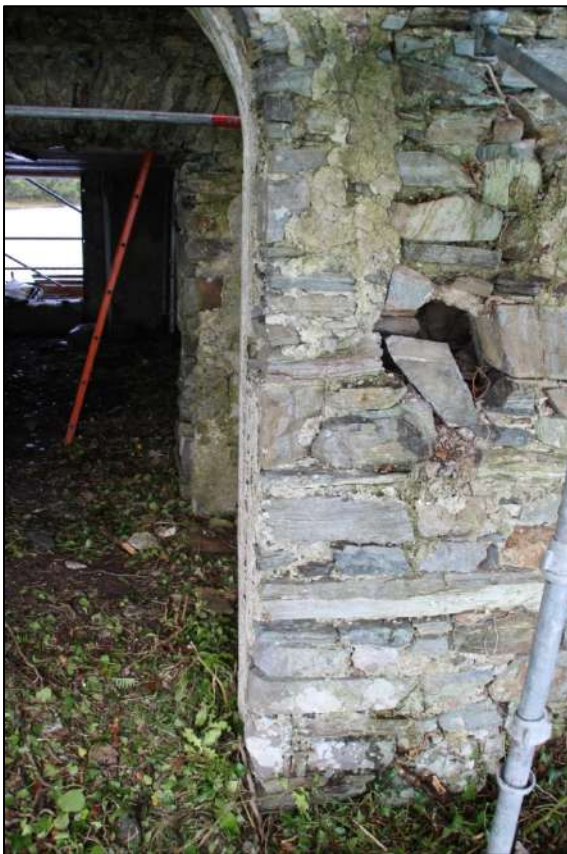
Pl. 5 Northern side of doorway. Note void.

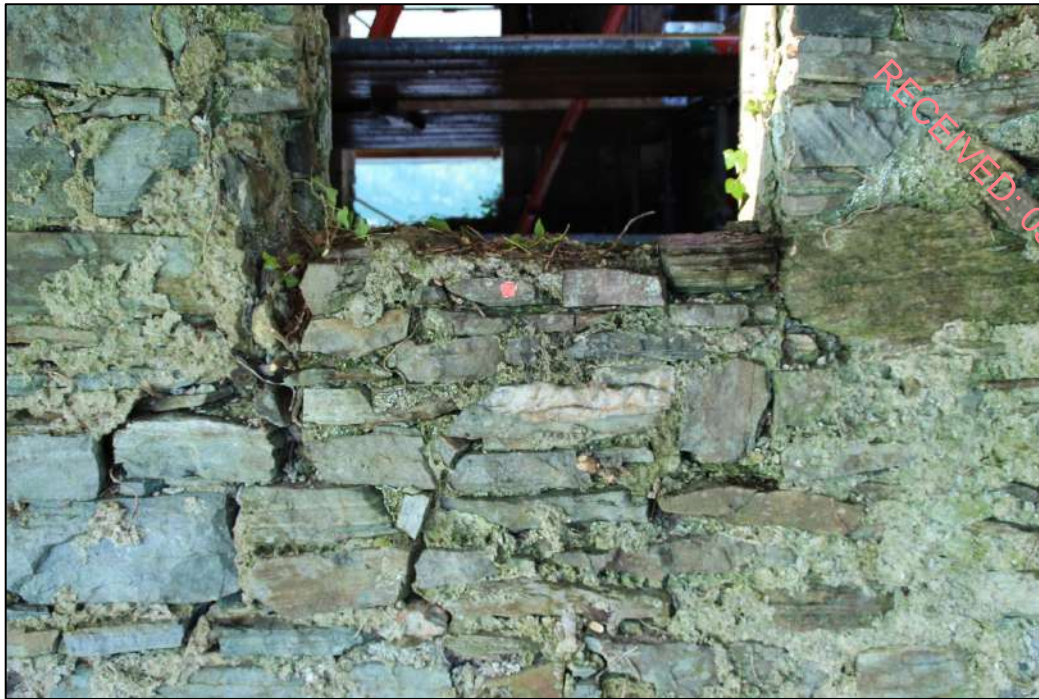
**Pl. 9** Infilled area at base of window

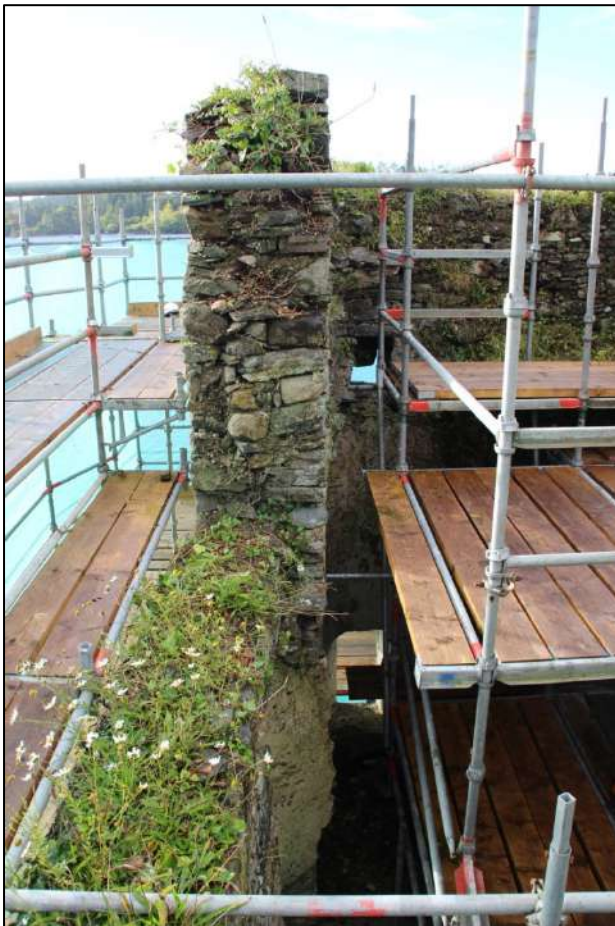
**Pl. 12** The altered north-east corner of the tower house. The wall in section is also part of the rebuilding phase.

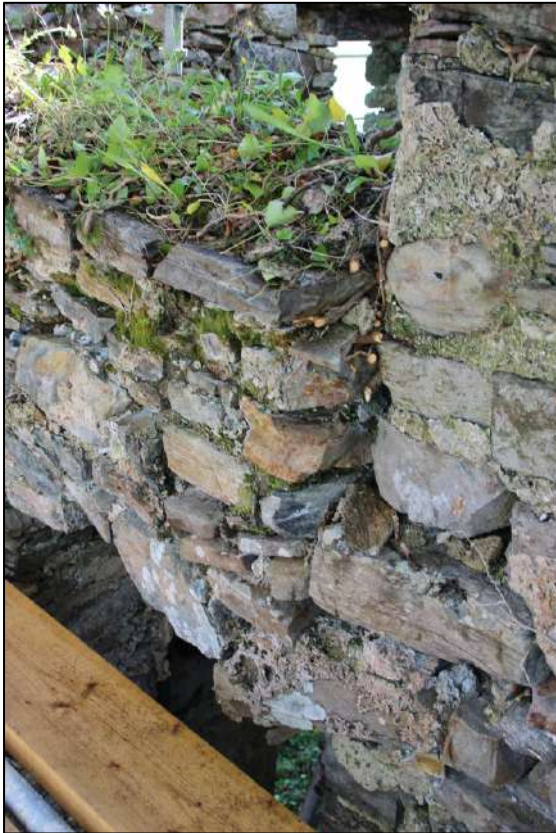
**Pl. 14** Poor bonding between the original fabric of the tower house on right and later masonry on left.

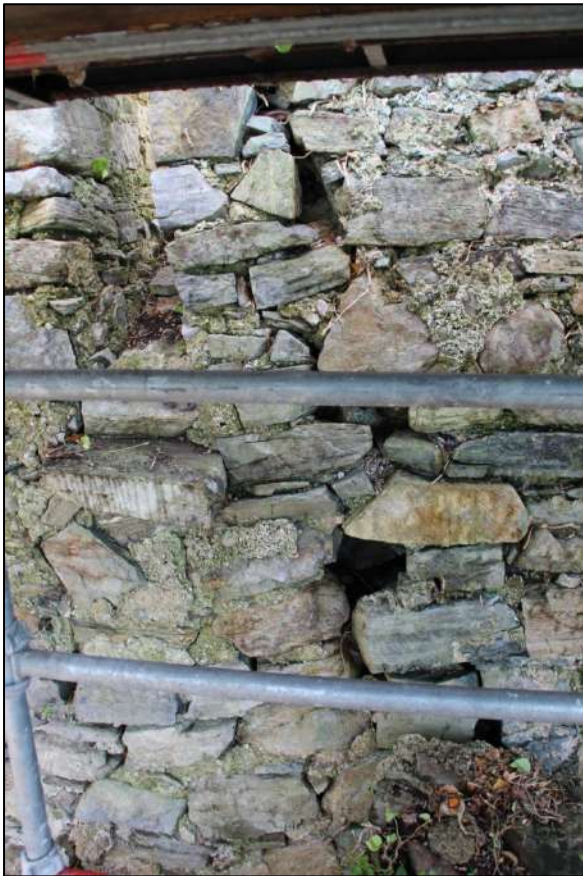
**Pl. 15** Large void on northern side of tower house.

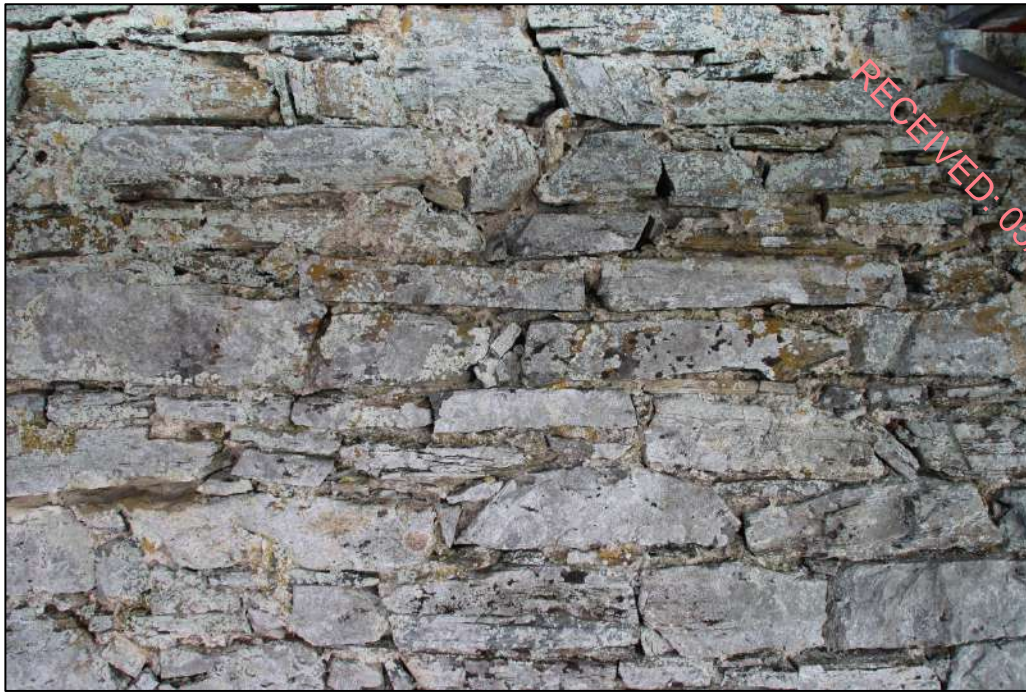
**PI. 29** A thin render coating is present on parts of the tower house.

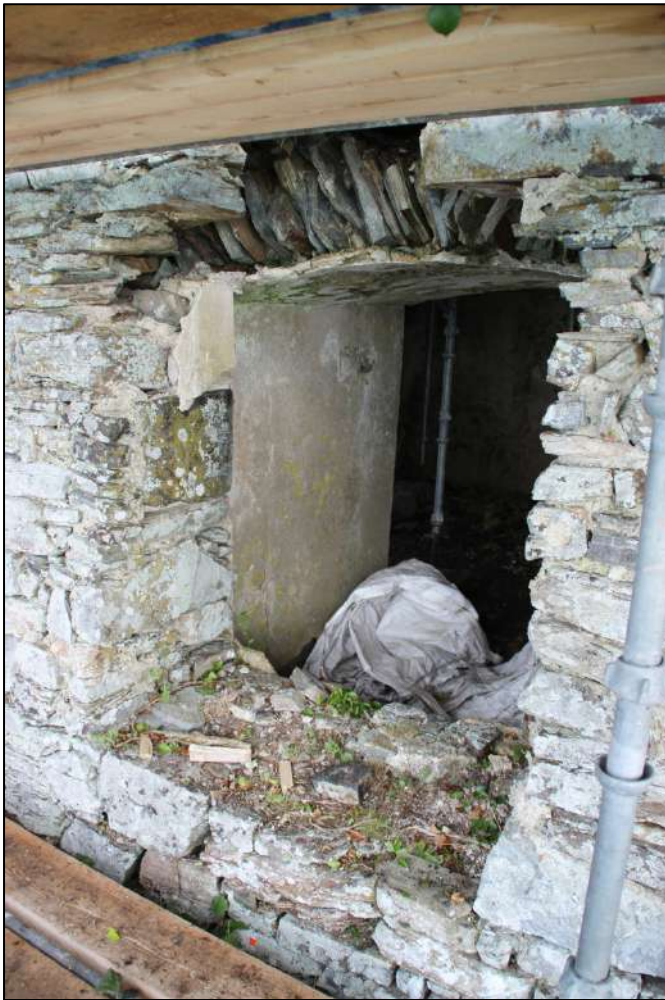
**Pl. 33** The western side of the southern window, ground floor.

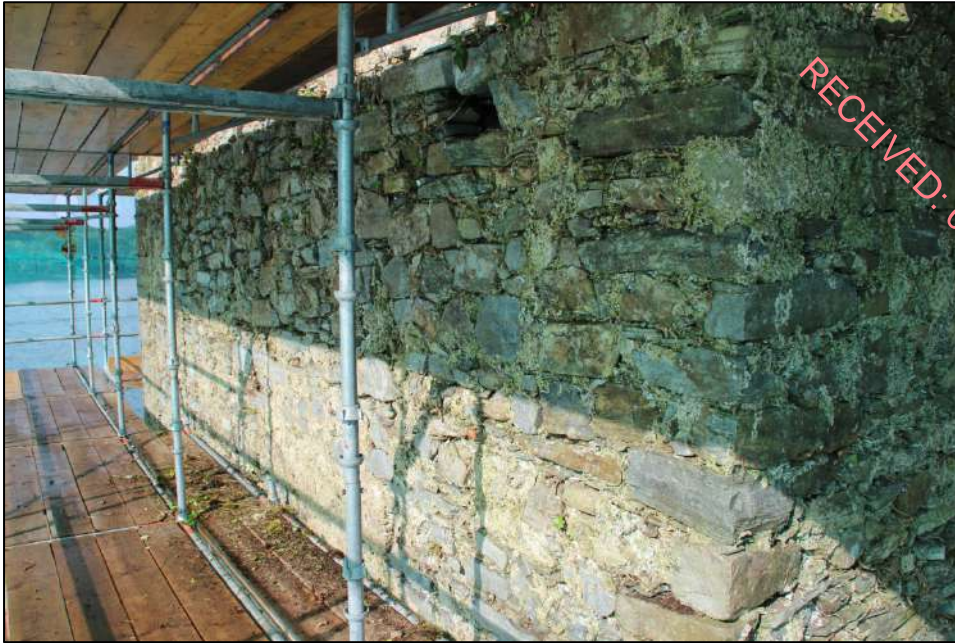
**Pl. 39** The upper part of the southern elevation. Note the remnants of the external mortar finish

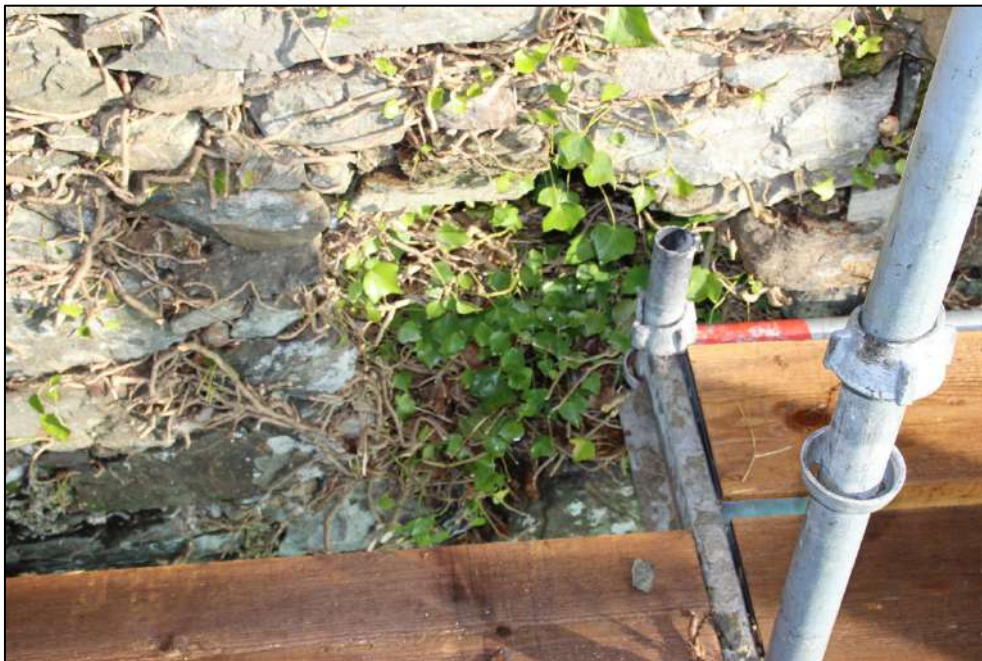
**Pl. 42** Small irregular opening at second floor level, southern side of the tower house.

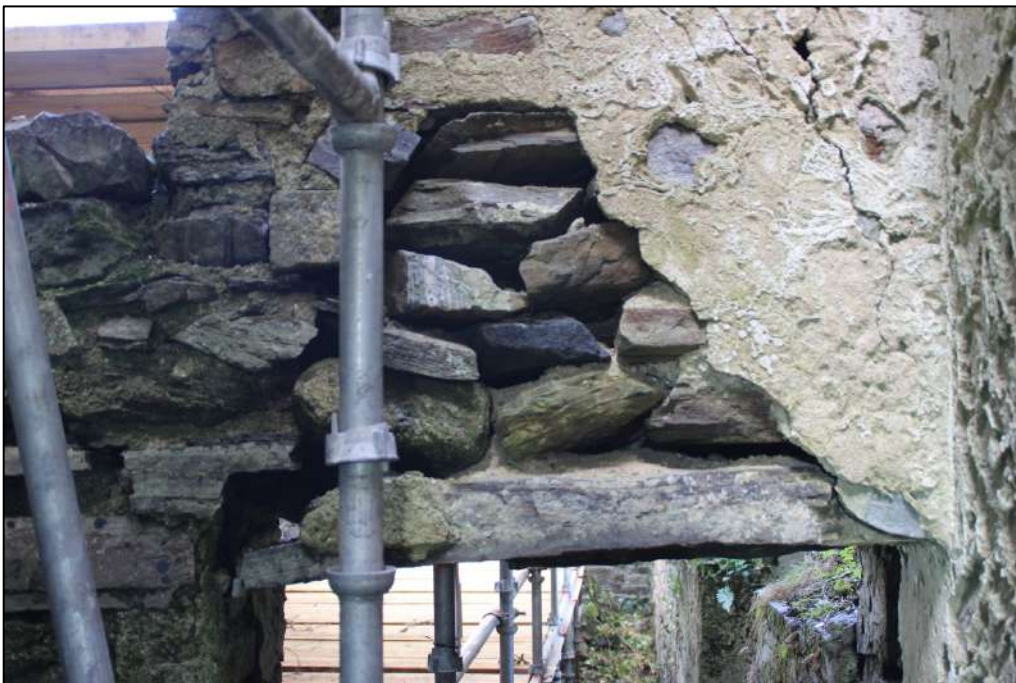
A doorway was also created at ground floor level from the entrance lobby into the industrial building. This is flat headed and is currently in a very poor condition as the masonry above the lintel is loose.

**Pl. 47** This is the structurally weak lintel over the door leading from the entrance lobby of the tower house into the industrial building. The wall overhead was rebuilt when the north-east corner was altered.

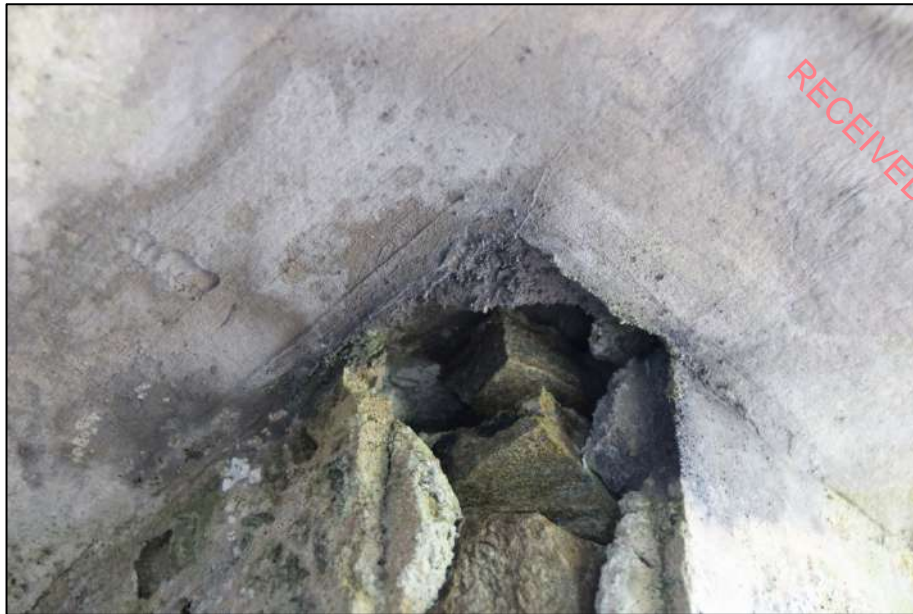
**Pl. 52** Scar of the corner beading on the outer edge of the western embrasure on the ground floor

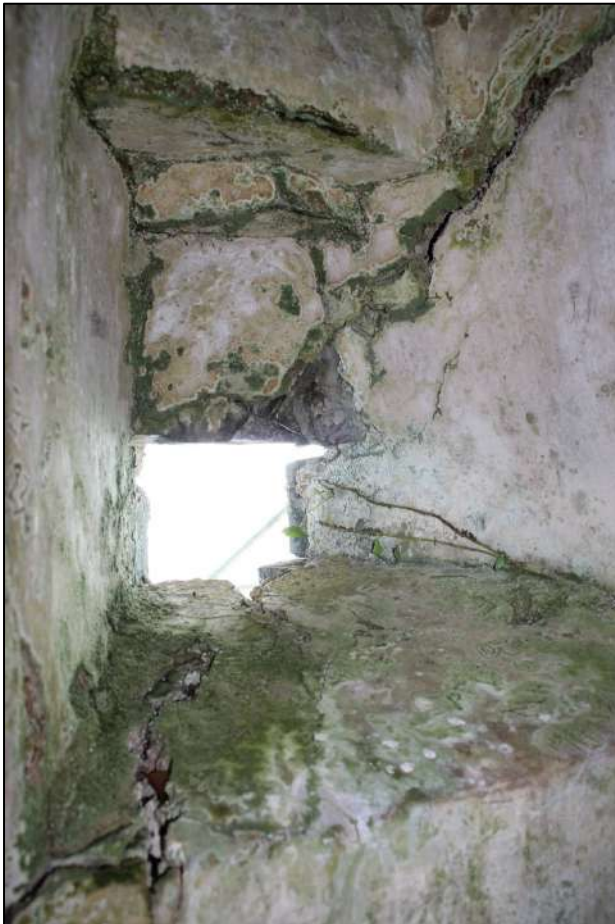
**Pl. 70** View down the garderobe shaft. There is no evidence of an exit chute.

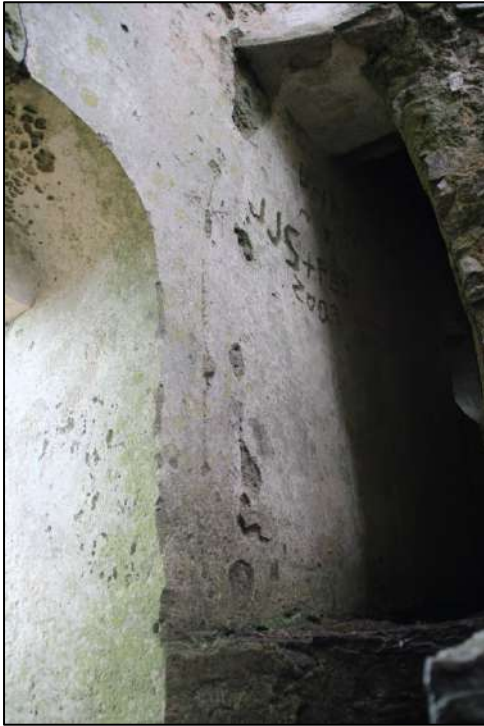
**Pl. 71** This is the only means of allowing light and ventilation into the latrine area. The splayed ope allows in the maximum amount of light while still sheltering those using the garderobe.

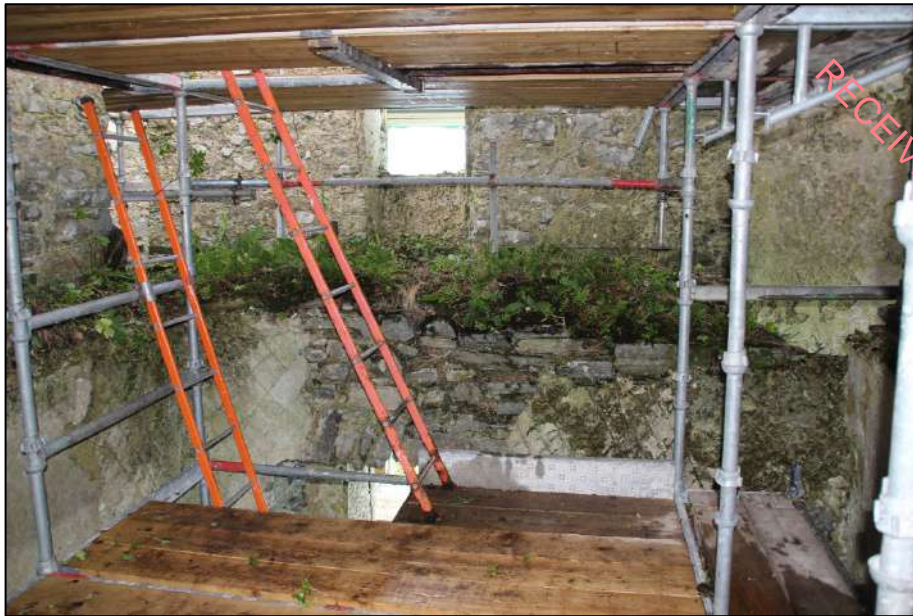
**Pl. 73** The location of the first floor lobby. It is presumed that there was some form of partition separating this from the main room at this level.

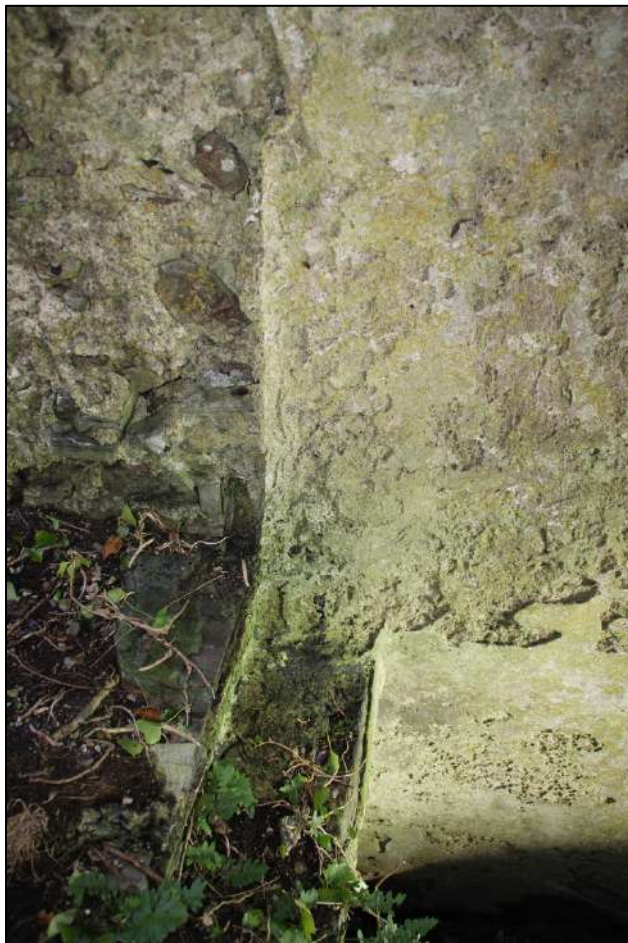
**PI. 74** View looking towards the lobby from the main room at this level. Floor level would have been where the vegetation begins.

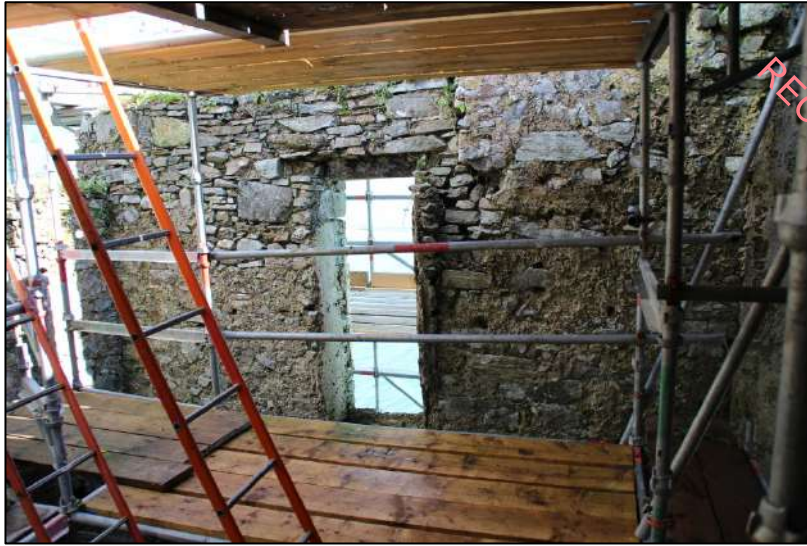
**PI. 75** This division between the plaster surface and the unplastered area to the left is at the top of the steps and marks where the lobby proper began.

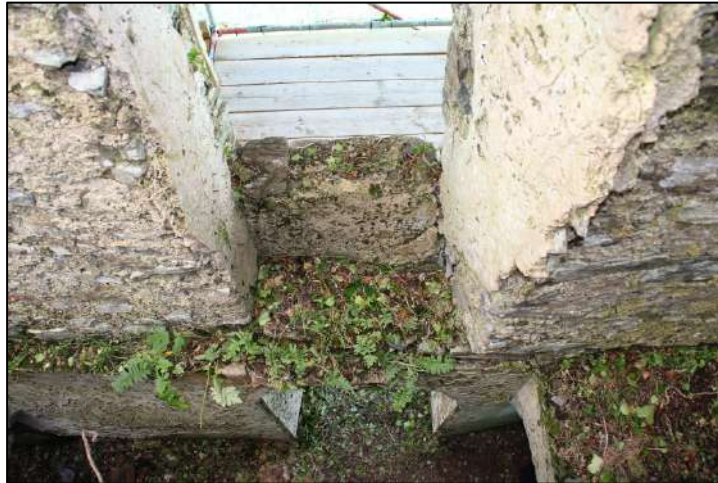
**Pl. 76** The eastern window in the first floor lobby. The wall on the left of the window is the result of later rebuilding.

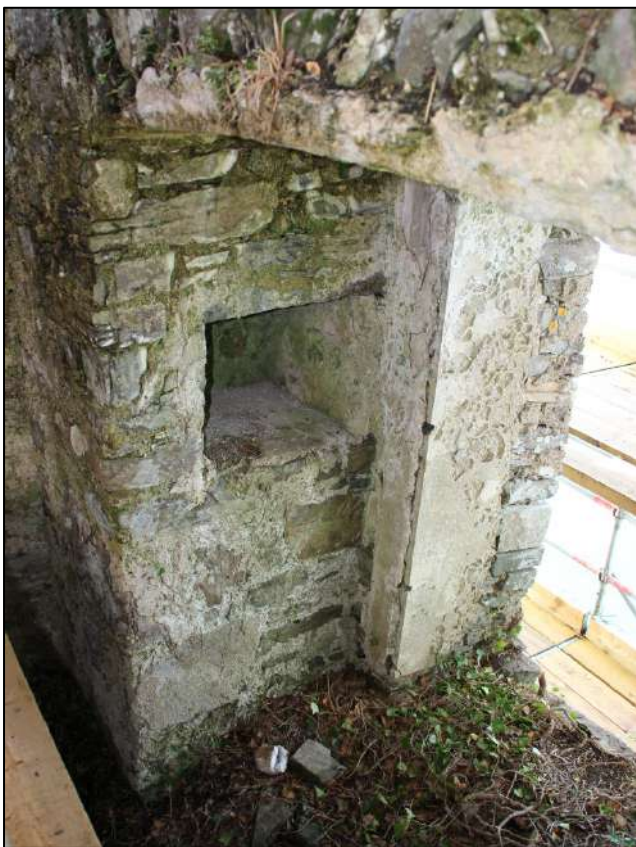
**Pl. 82** Base of fireplace. Note the bricks in the base of the hearth.

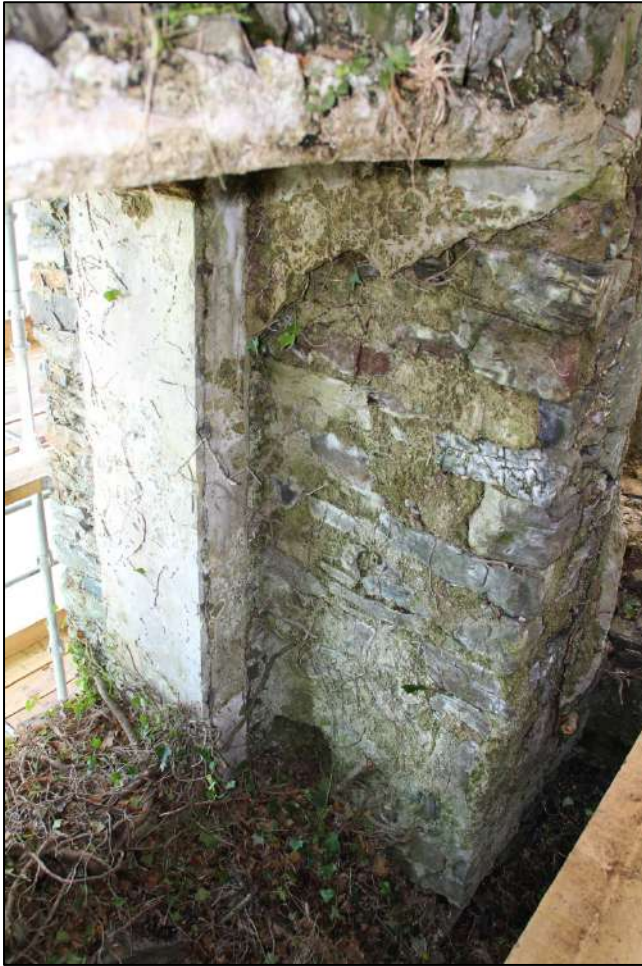
**Pl. 83** Wall cupboard in the southern side of the western embrasure, first floor.

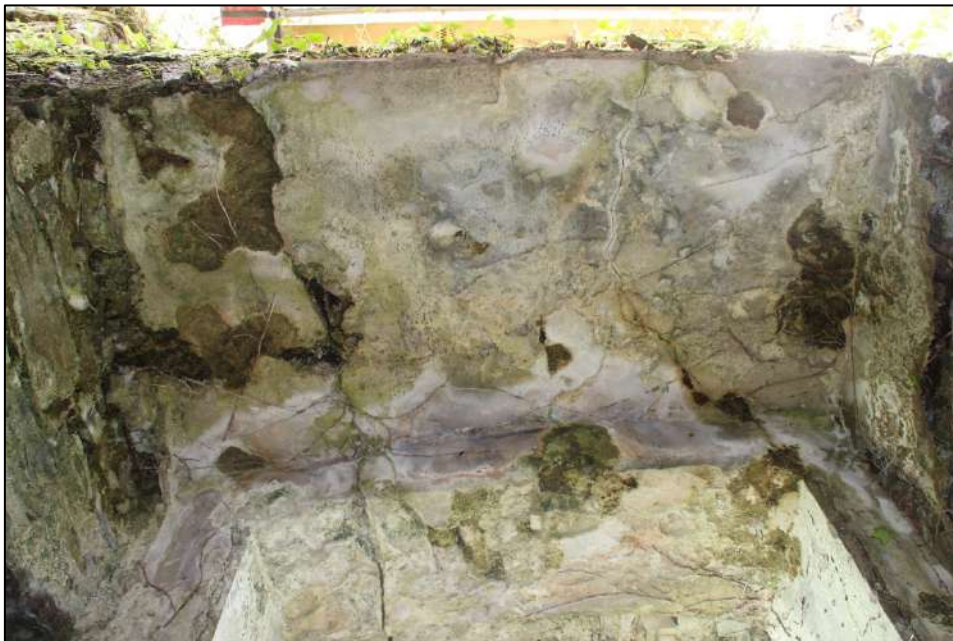
**Pl. 84** The northern side of the western window embrasure, first floor. There is a small section of plaster remaining on the upper part of the feature near its top.

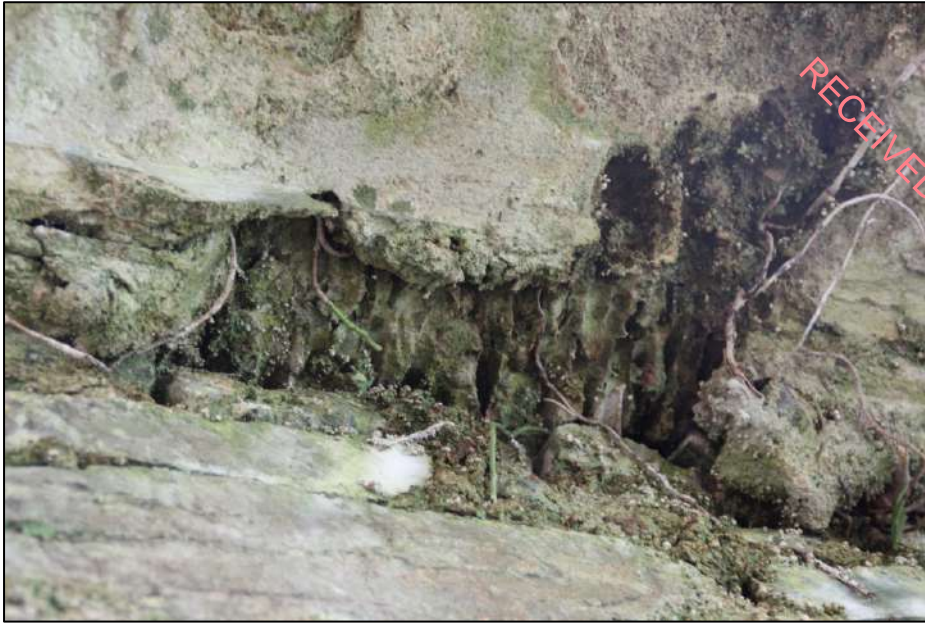
As was found on the western embrasure on the ground floor chamber, traces of wickerwork centring are also present in this embrasure, on the southern side of the soffit. This measured 0.27m by 0.17m. The plaster coat on this part of the embrasure was in relatively good condition. Only a small section of the plaster on the sides of the embrasure survives on the northern side.

**Pl. 85** View of the plastered soffit of the western window embrasure. Traces of the impression of wickerwork centring are present on the extreme left.

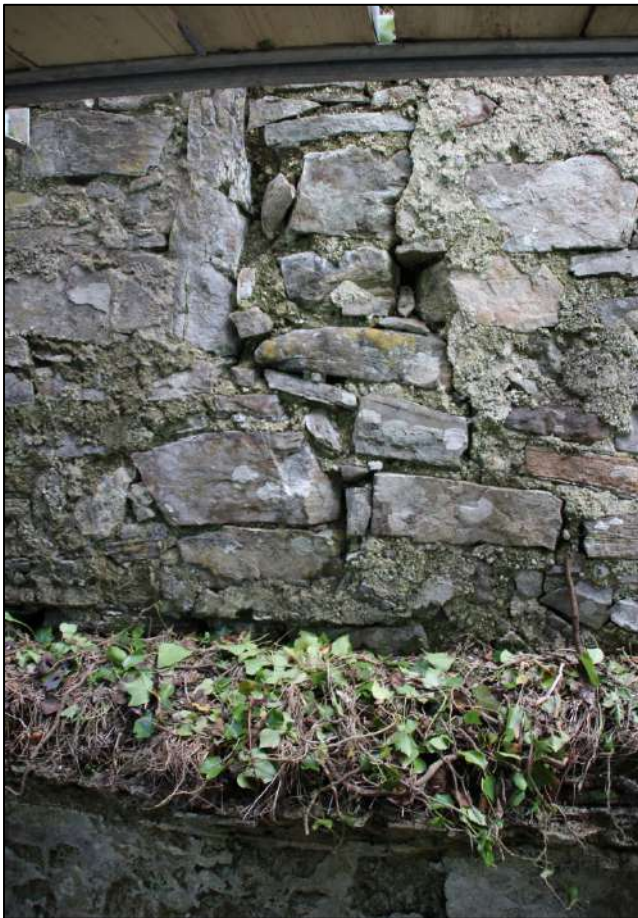
**Pl. 86** Impression of wickerwork centring, southern side of the western window embrasure, first floor.

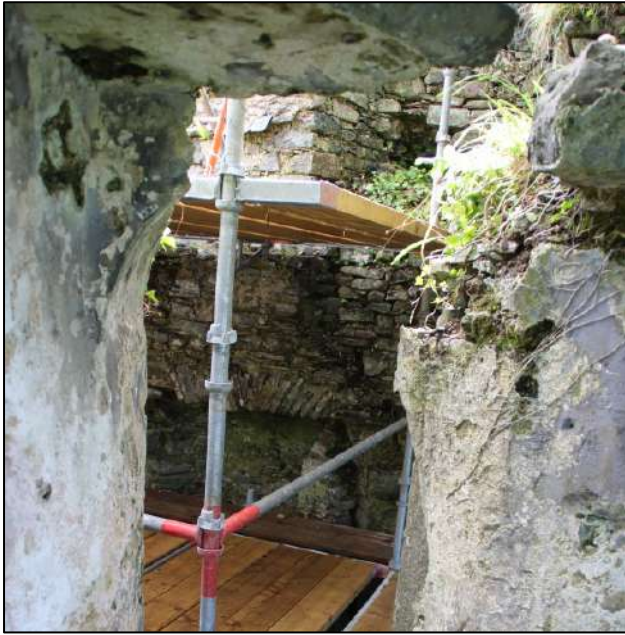
Pl. 89 The difference in levels between the floor of the main chamber, represented by the linear scar in the masonry and the higher level of the 'oriel' chamber floor.

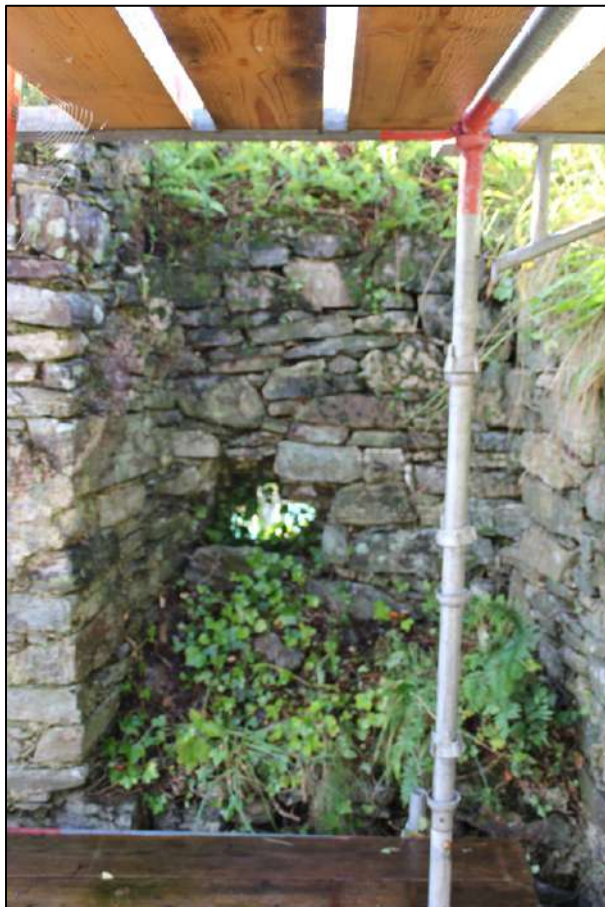
**Pl. 100** The weatherslated panel in the north-western corner of the second floor. This is laid sloping towards the interior of the building. The opening in the masonry on the left exposes the 'oriel' chamber.

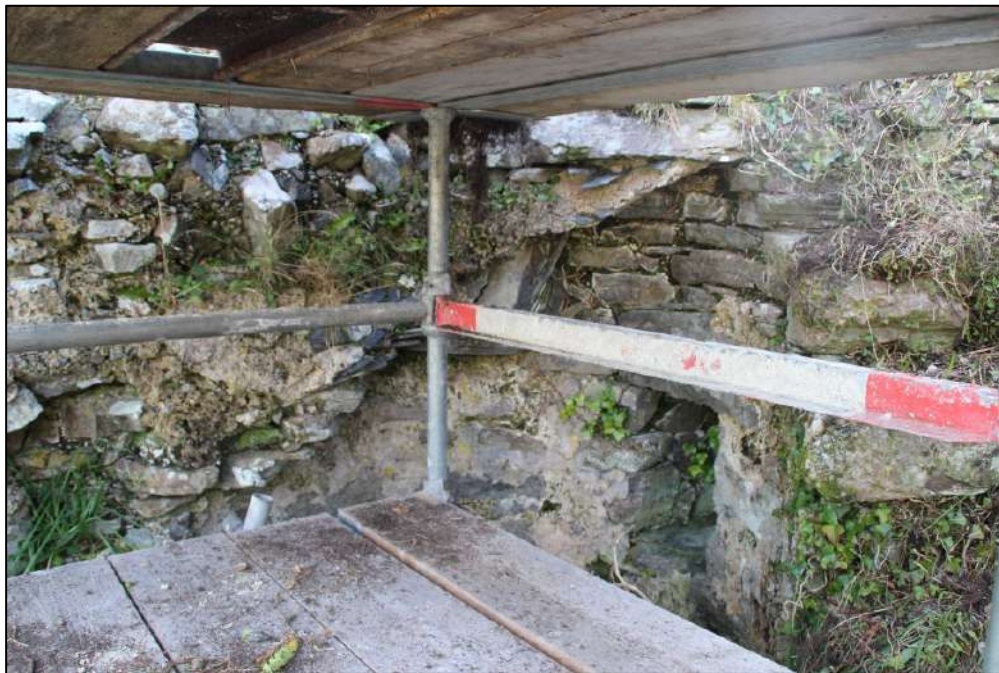
**Pl. 102** View of the second floor looking east. The irregular masonry on the centre right of the photograph marks the location of the roof cap of the stairwell.

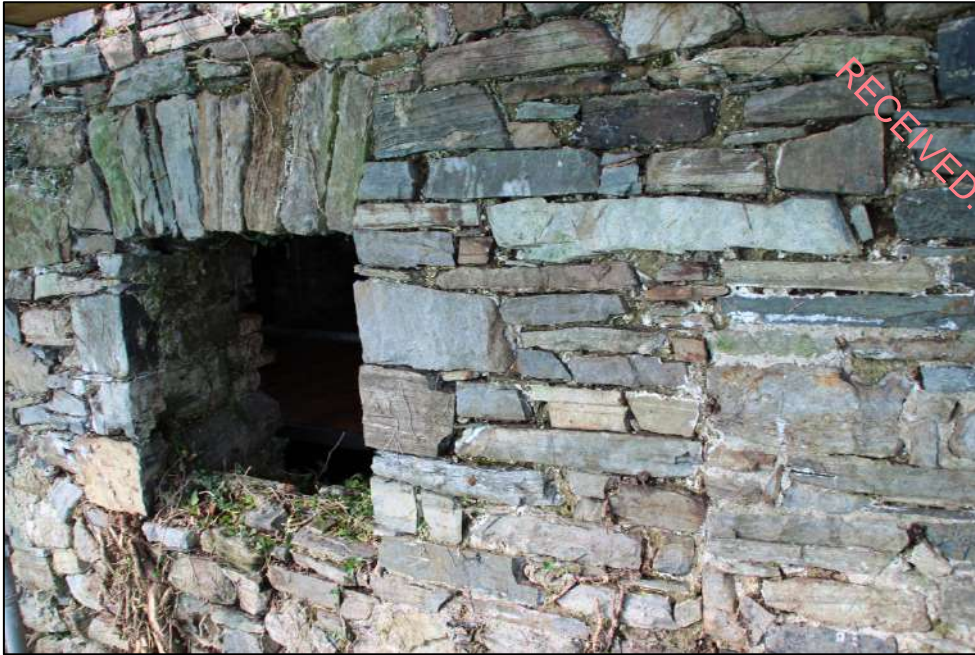
**Pl. 104** Blocked doorway converted into a slit opening on the eastern side of the ground floor of the industrial building. Note the use of brick in the infill.

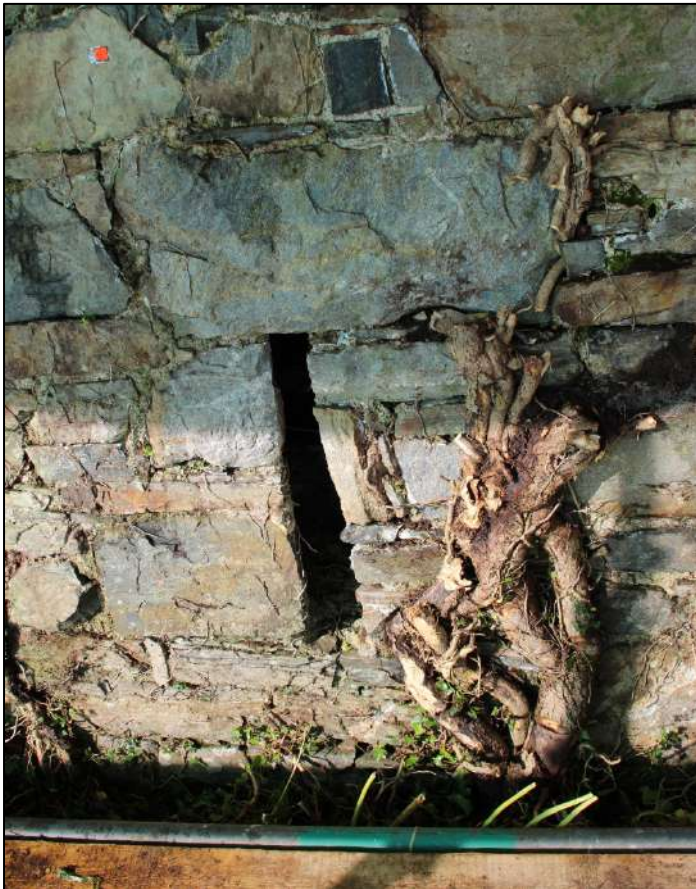
**PI. 105** Window on the ground floor of the eastern side of the industrial building. The vertical break in the masonry on the right of the window, indicates that a slit opening was going to be placed here with the linear pale stone forming its lintel.

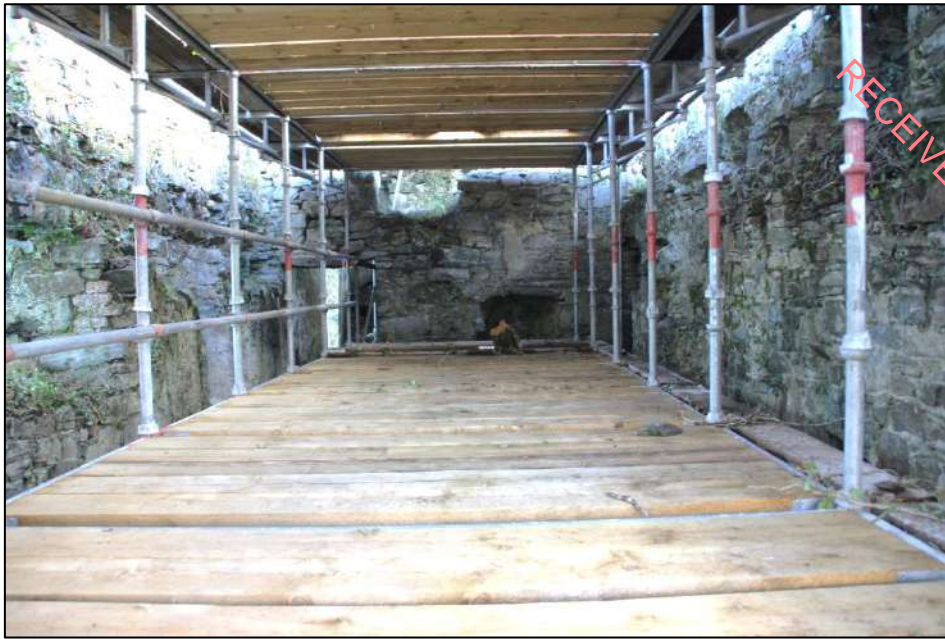
**Pl. 118** View of the southern end of the large (eastern) room of the industrial building. The doorway on the left leads into the tower house lobby, that on the right leads to kiln 1. The fireplace just right of centre appears to be inserted. The doorway in the top of the photograph is part of the later rebuilding of the north-eastern corner of the tower house.

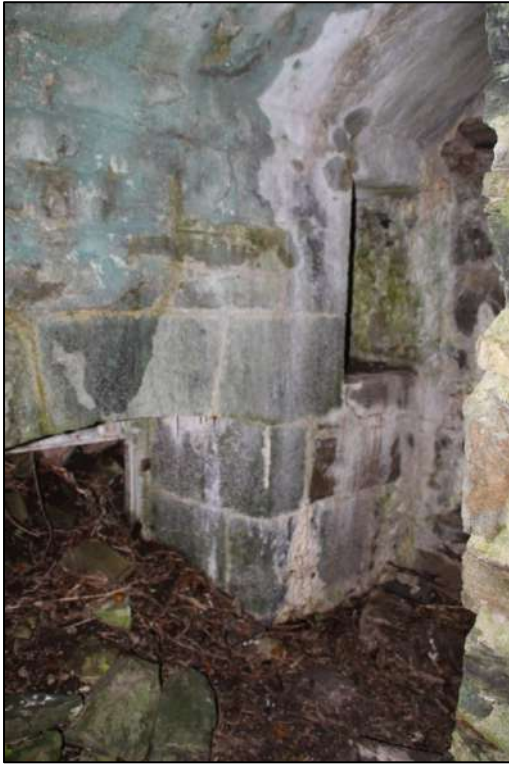
**Pl. 130** Kiln 1 looking at the drawing hole. Two iron hinges are present on the right hand side of the inner doorway. The poking hole in inner part of the kiln is full of debris. The quality of the masonry here is excellent. At the top right can be seen the access opening to the back of the kiln.

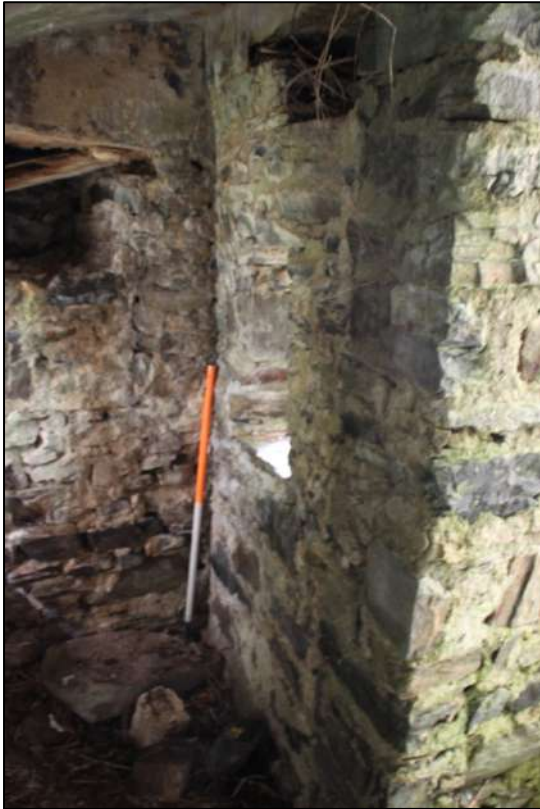
The northern wall of this area also shows signs of alteration. High on the northern wall is a void where some stones have come loose. The upper part of this contains the remains of a timber lintel and further down the wall traces of a window opening can be seen. This would have been present when there was only a single kiln, this one. The construction of kiln 2 on the other side of this wall meant that the window was filled with stone. This opening would have been 0.66m wide by c. 0. 70m high. The lower part of this has been obscured by dirt.

**Pl. 132** possible blocked window opening on the northern wall of kiln 1. This has the remains of a timber lintel overhead with the vertical break in the masonry on the right hand side marking one side of the feature. This was sealed by the construction of kiln 2 directly behind the wall.

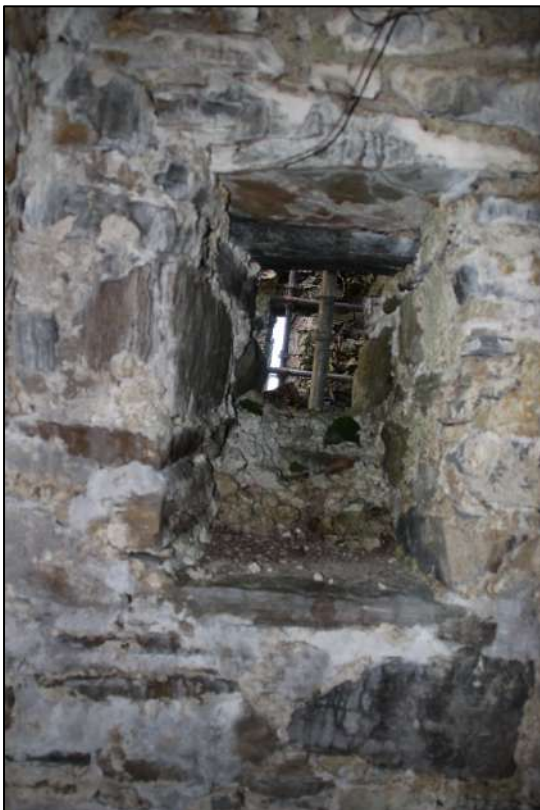
**Pl. 133** The inner side of the wall separating kiln 1 from the large room to the east. Note the vertical break in the masonry on right of photograph.

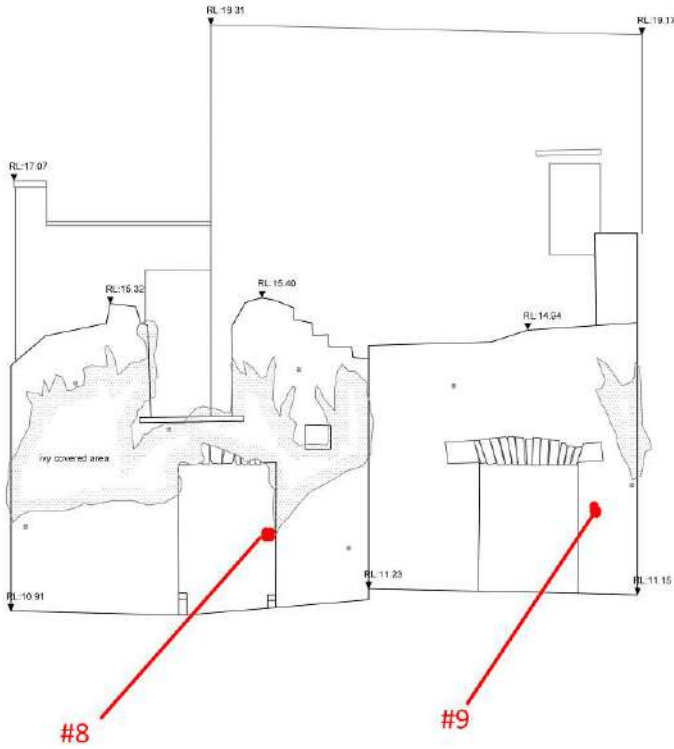
### Location of Mortar Samples #8 and #9

Sample 9 – Industrial building, 19th century, north elevation, earth mortar.
