**Conservation Report and  
Architectural Impact Assessment  
For  
Planning Application for Proposed Extension and Alterations to  
Aghadoe House, Knoppoge, Aghadoe  
Killarney, Co. Kerry  
For  
NOMIS AMO Ltd**

Mary O'Connell  
B.Sc. B. Arch. MRIAI  
RIAI Grade II Accredited Conservation Architect

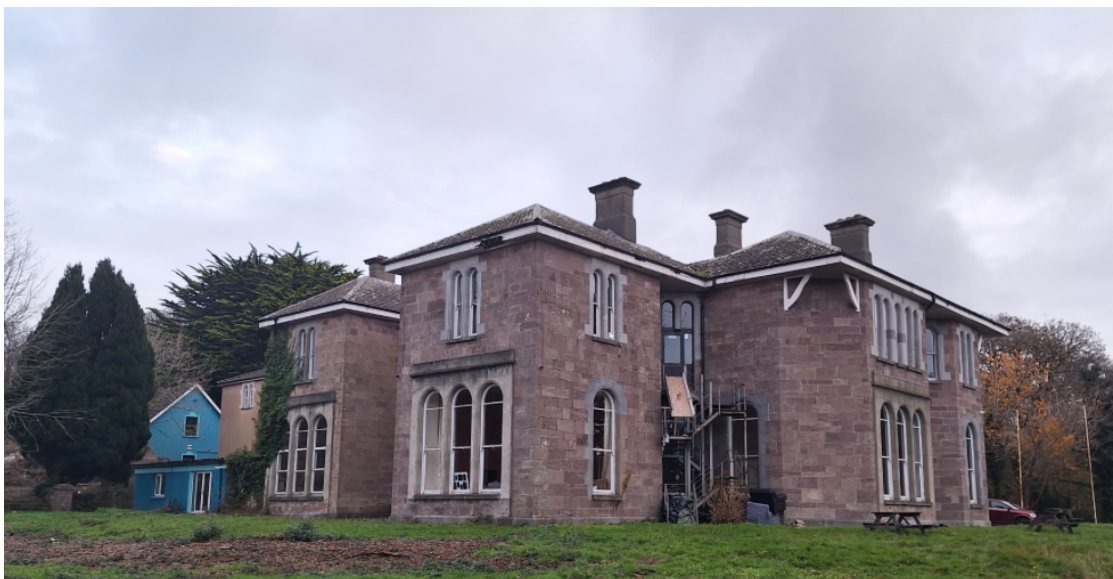
The Triple-arch arcade to the entrance porch (with some structural cracking) with limestone balustrade detailing overhead, along with timber one-over-one pane sliding sash windows and a nine-panel door with fanlight.

There is a Two-bay two-storey side elevation to south-east with two-storey box bay window and three-bay two-storey elevation to south-west with single-bay two-storey return to rear and single-bay two-storey projecting pavilion block to south-west corner. A later external escape staircase along with alterations to the original 1<sup>st</sup> floor window ope were installed.

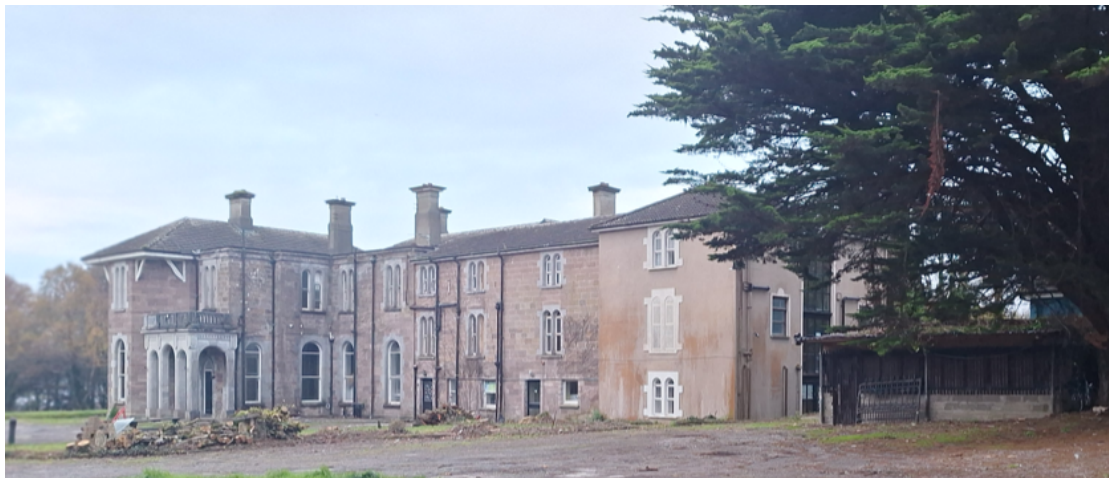
There are pitched and hipped profiled concrete tile roofs with deep overhanging boxed eaves to south section, rendered chimneystack with cornice, and having some cast-iron hoppers and downpipes.

There are a significant number of soil vent pipes and plumbing pipework on the external face of the building servicing the later various sanitary facilities installed for the hostel accommodation requirements.

The external walls are of a Pink sandstone ashlar stone with limestone plinth and entablature. There are Round-headed windows with flush limestone surrounds (some have replacement concrete) and a mix of limestone and mainly concrete sills, paired at first floor. There are a series of triple windows with rusticated replacement cement surrounds.

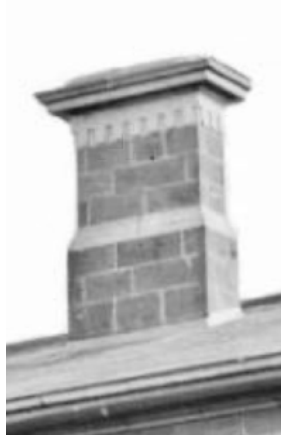
Original chimney detail

As a reference the chimney to the g lodge (in poor condition) retains th detail.

Currently the remaining chimneys h a cementitious render applied and a in poor condition with leaks eviden the attic areas (refer to Appendix 2 Timber Condition Survey)

- suitable repairs to the chimneys and associated flashings including removal of the cementitious plaster, examination and repair of brickwork (replacement of perished bricks), necessary repairs to flues and lining, inspection of existing cappings and where concrete cappings, replacement with limestone cappings to match original details.
- repairs to the existing roof and suspended floor timbers as per timber condition report recommendations,
- repairs to the older timber sash windows and replacement of any damaged timber lintels or timber supports to later concrete lintels,

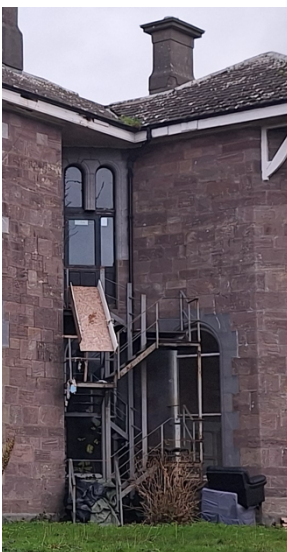
It is assumed this were replaced after the 1922 fire w replica concrete surround within the depth of the e external ope with cill heights to match the other ba windows omitting the door and the original stone a forming the ope exposed.

- There are a number of limestone cills remaining how the majority of cills in place are concrete cills partic to the ground floor windows.
- A number of windows have part replacement concr surrounds to the existing limestone surrounds. Agai assumed these were installed to replace damaged limestone after the 1922 fire

- An external fire escape stairc was introduced to the southeas elevation for the hostel use with associated alterations to the ori 1<sup>st</sup> floor window.

It is proposed to reintroduce the original fenestration design with door arrangement to the bay window to the southwest elevation along with the reintroduction of a limestone surround in lieu of the replacement concrete surrounds as per the documented evidence of the Lawrence Photos of 1885-1914.

- repairs to the stonework including where possible replacement of later concrete cills and surrounds w limestone and repointing in a suitable lime mortar where necessary,
- repairs and reinstatement of original cast iron rainwater goods and removal of later exposed ventilation and sewer pipework from the external facades.
- repairs to stonework to the Entrance Portico incorporating structural repairs to the significance cracks in evidence with the use of helibar pins etc.

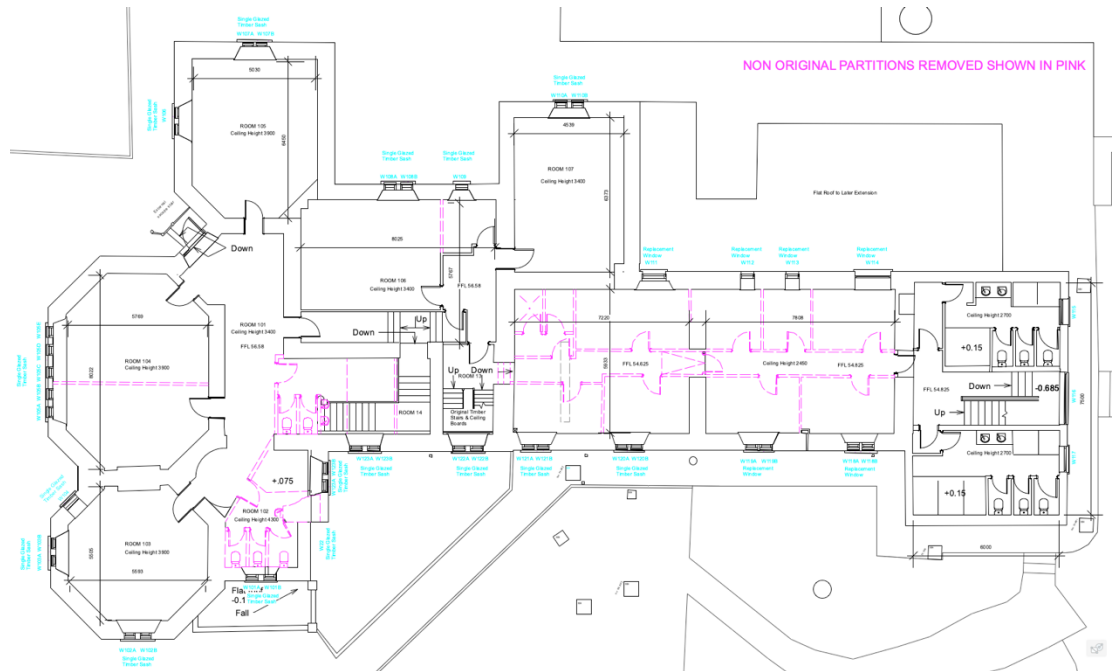
Existing 1<sup>st</sup> floor plan layout

The Ground Floor has a replacement concrete floor throughout with a section of timber floorboards to part of the kitchen area.

This corresponds with the location of the part of the vaulted brick basement underneath. Often in such instances, timber floors are installed on battens or joists on top of the vaulted masonry.

The subfloor beneath the timber floors will require careful detailed opening up and investigated to confirm if there is a timber sub floor and determine their true condition.
