2 INTRODUCTION

Ecology Research and Solutions have undertaken extensive bat surveys on a private dwelling in Aghadoe, House, Knoppoge, Aghadoe, Killarney, Co. Kerry. The building is a protected structure. It is listed in the Kerry County Development Plan 2022-2028 Record of Protected Structures (RPS) under the reference number 2130661. The building has recently changed ownership, with the new owners to seeking to carry out conservation and renovation works on the building, in order to make it their family home. Along with extensive internal works and demolitions, there are planned upgrades and rebuilds to the many roofs of the building, to rectify that damage that has occurred over the years due to a lack of maintenance.

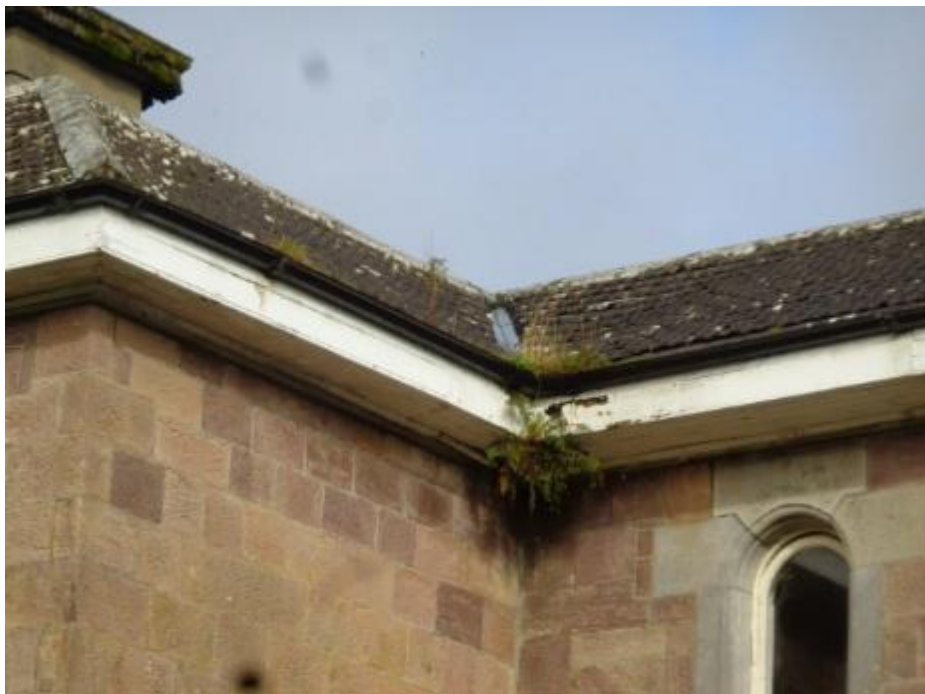
2)

Photos 4-8 show a selection of photos of the valleys and hip which have excessive water egress. This will require complete replacement in the affected areas. This is very prominent in the areas which require complete replacement.

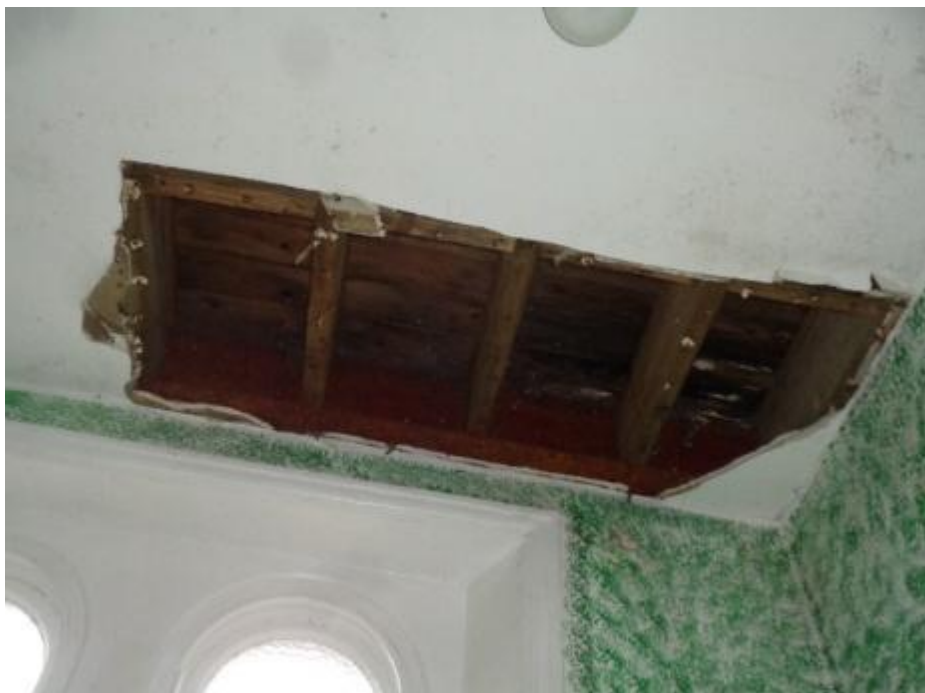
4)

A lot of the cause of valleys leaking has been lack of maintenance. The rotting of the fascia & soffits has continued to the rafters & joists as shown in photos 9 & 10.
