## Conservation of Ballybrennan Church for Wexford County Council

### METHOD STATEMENT – CMF 2026 STREAM 3

January 2026  
Rev. 1

Job No. 26002

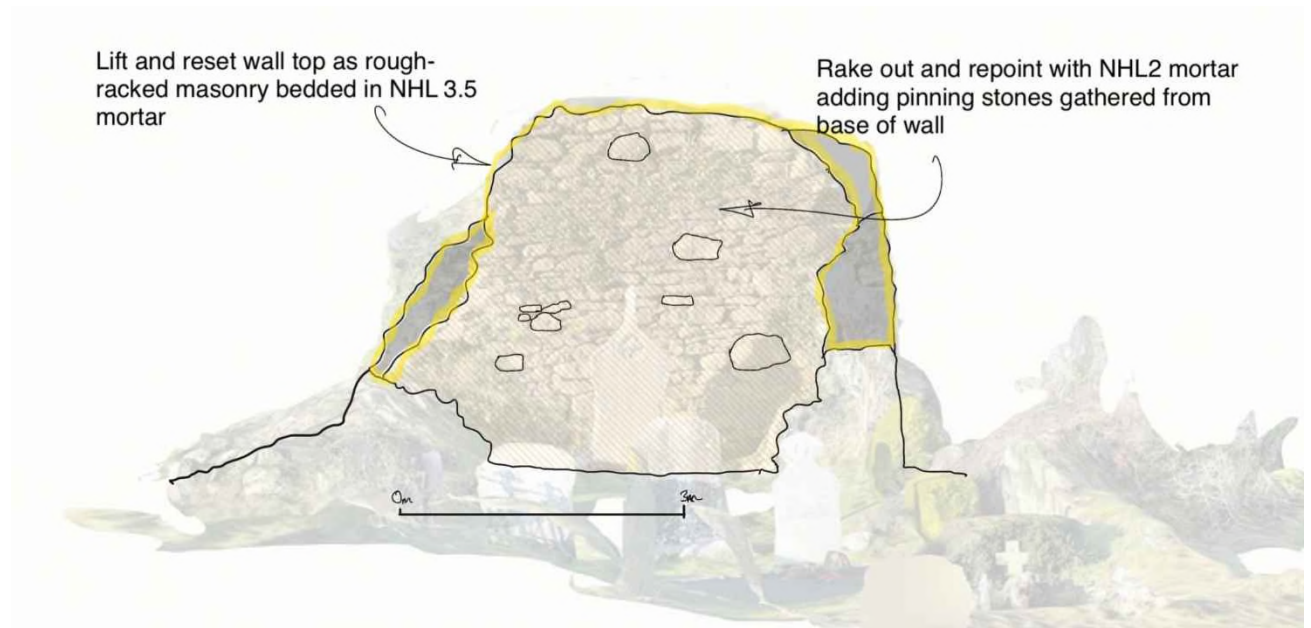
*West Gable Inner Face*

| Building Components and Condition | | | | | | | |
|---|---|---|---|---|---|---|---|
| 2. | West Gable Internal | Sandstone Rubble Masonry Wall. Internal corners are missing. | Light ivy growth on the inner face. Loss of face masonry at the internal corners particularly on the south corner exposing the wall core of the returns. | CC 2 | Collapse of the masonry. | Secure the exposed core as rough racked masonry bedded in lime mortar. Remove the light ivy and vegetation repoint the eroded joints with lime mortar throughout. | UC 2 |
