Application for Derogation Licence

**Russell Environmental and
Sustainability Services Limited**

BAT SURVEY RAILPARK

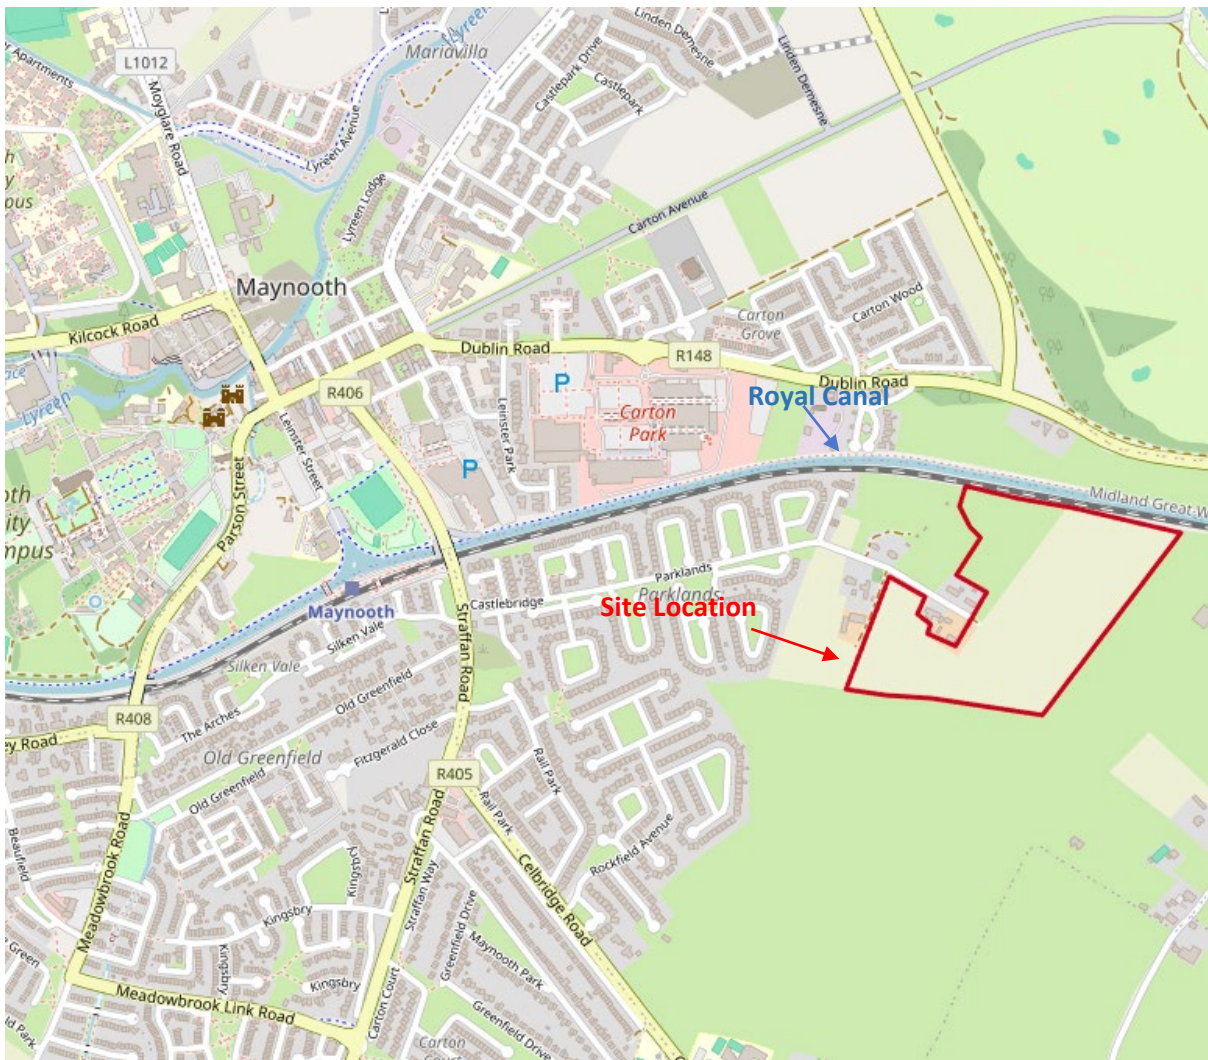
Figure 1 Site location (EPA, 2024)

The site is located at Railpark, Maynooth, County Kildare. The proposed residential development is to take place on a greenfield site adjacent to the Railpark residential housing estate, located off the R406 Straffan Road. The northern boundary of the site is adjacent to the Midlands Great Western Railway main line, to the north of which is the Royal Canal (Figure 1).

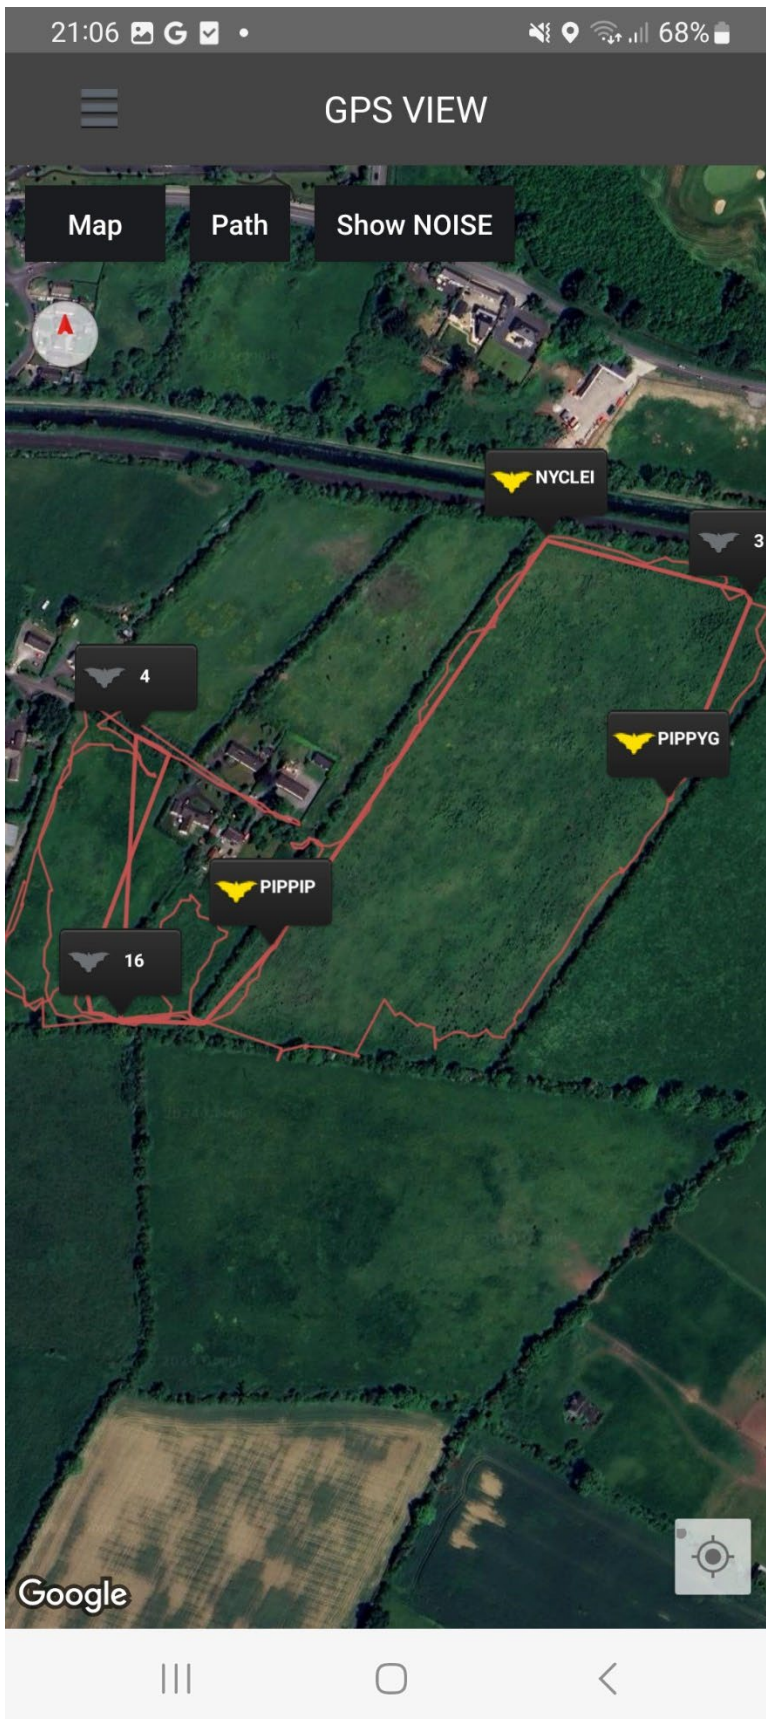
Appendix iii – Sonar Readings

During the dusk to dawn survey, there were a number of bats observed flying in the fields, along and in the hedgerows/treelines of the site. This activity was also recorded by both bat detectors and recorded by the Echo Touch meter as detailed in Appendix iii. All three species of bat were detected (both visually and recorded by sonar readings) emerging from the aforementioned hedgerows/treelines at dusk and re-entering at dawn.

NB: Path only shows those recordings from the Echo Touch 2 pro Meter, not the Fledermaus Detector
