CONSERVATION METHOD STATEMENT for Historic Structures Fund 2024

Project Title: **ST JOHN'S CHURCH, KILL, CO KILDARE**

ROOF REPAIRS

Client: Naas Union of Parishes

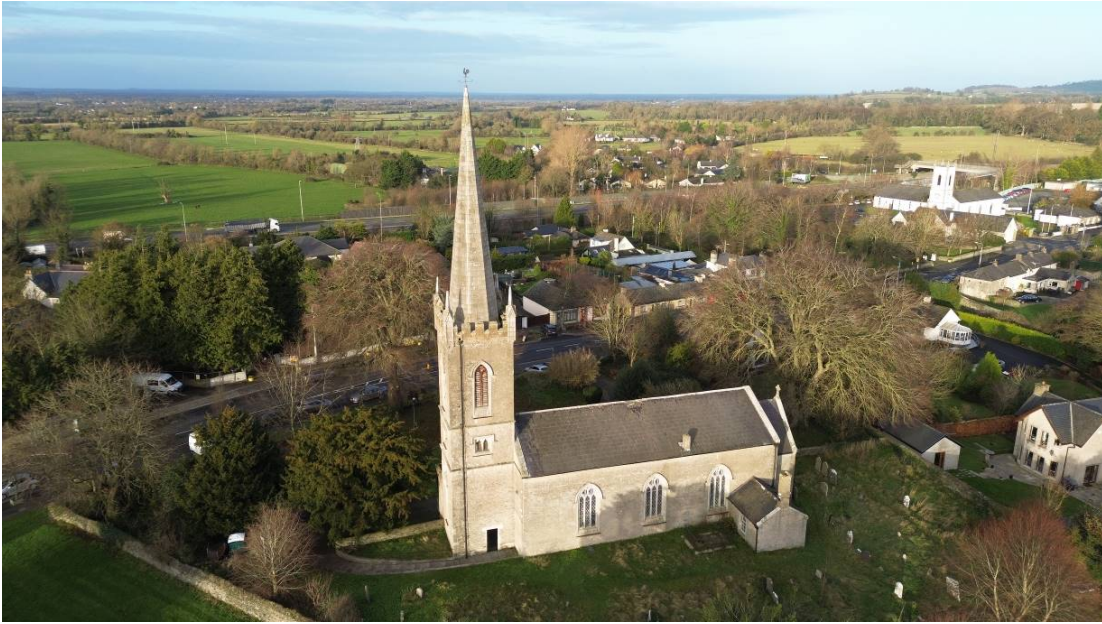
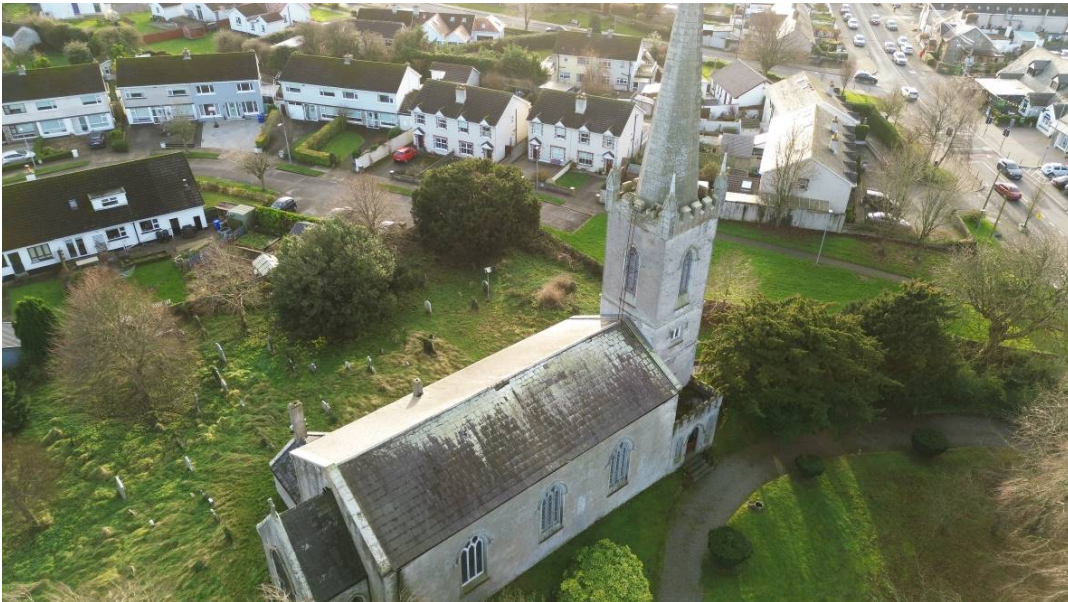
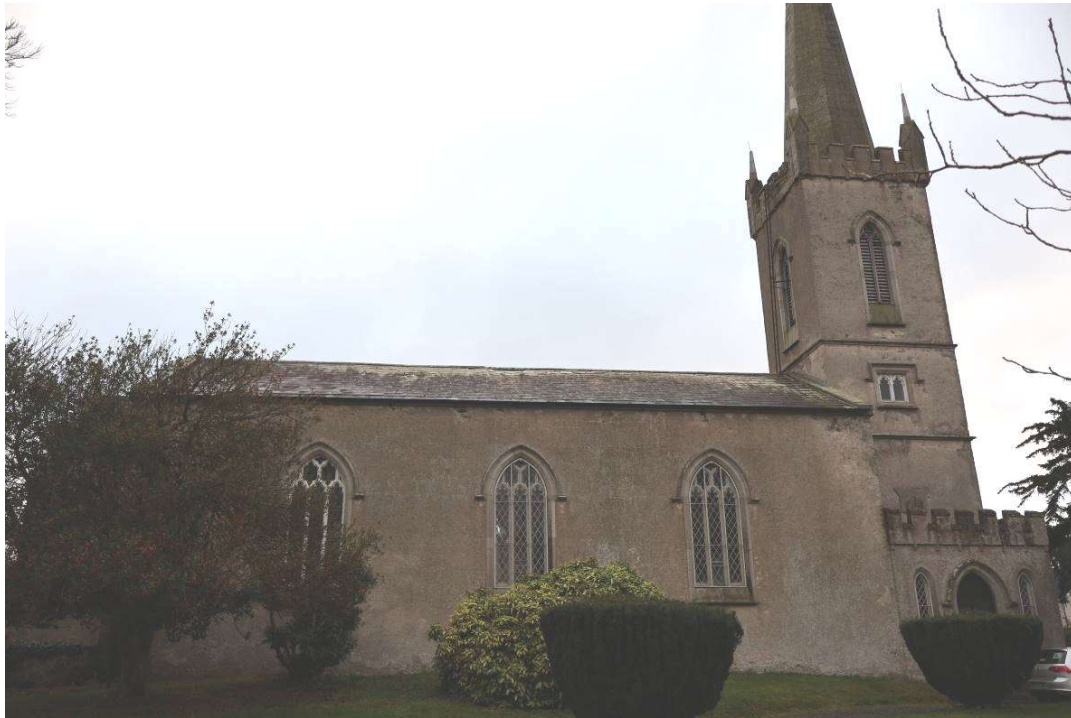
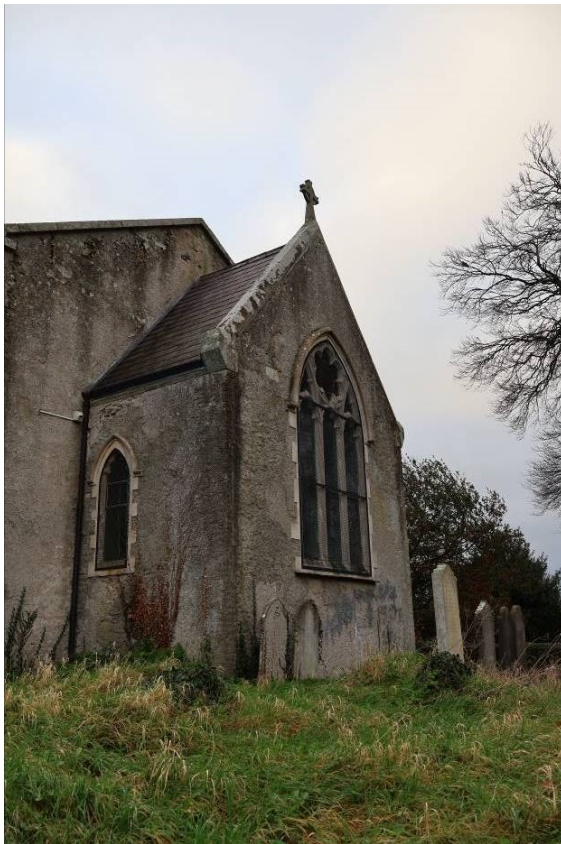
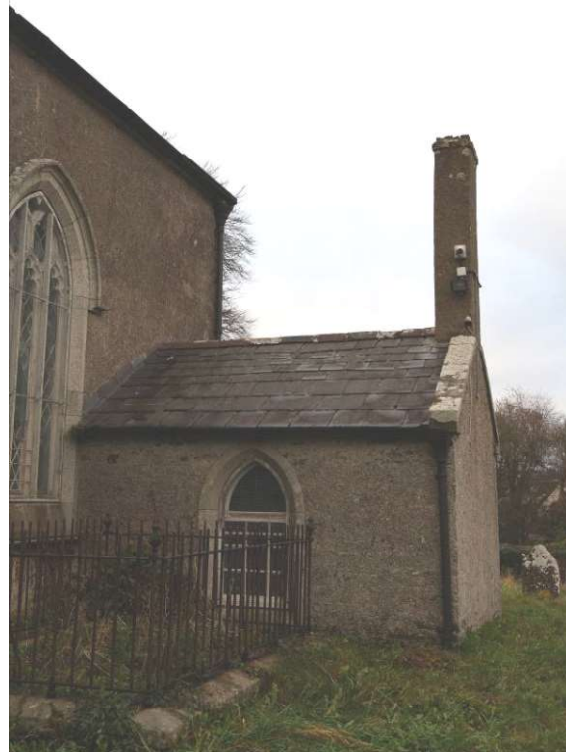
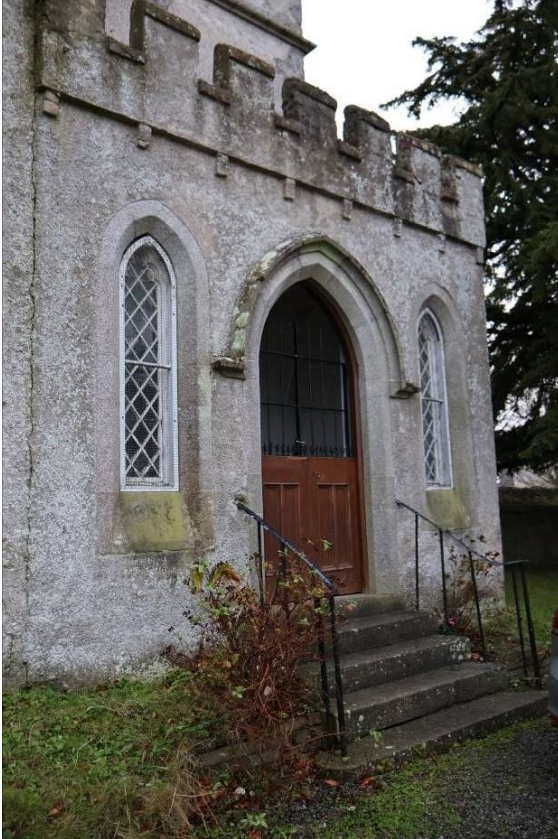
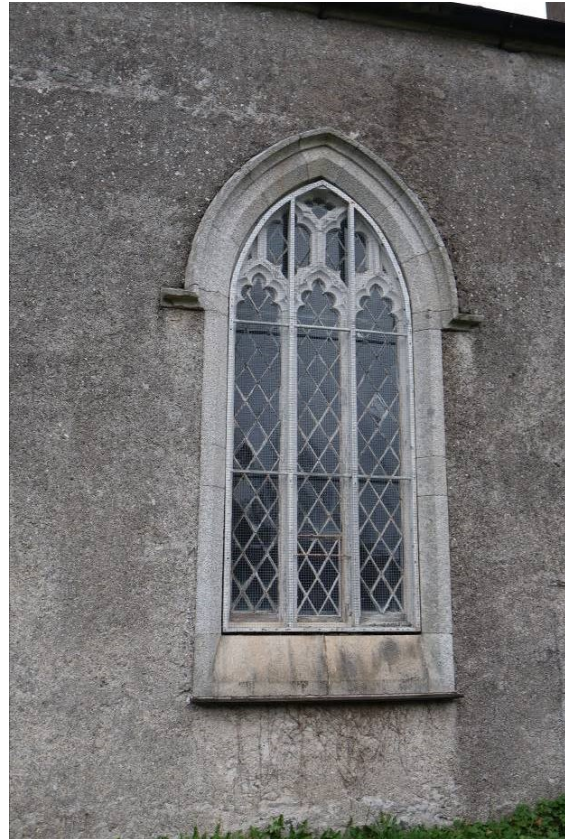
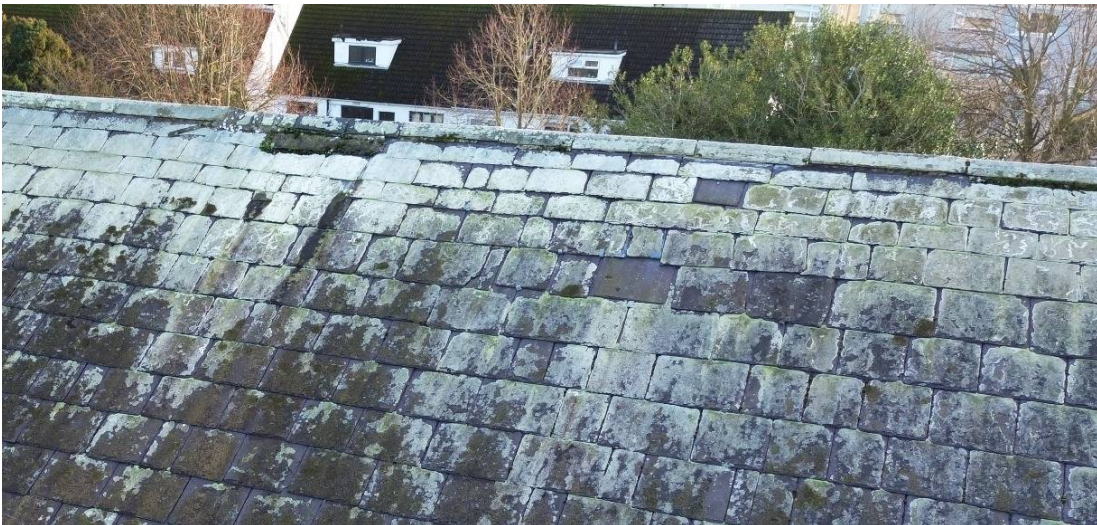
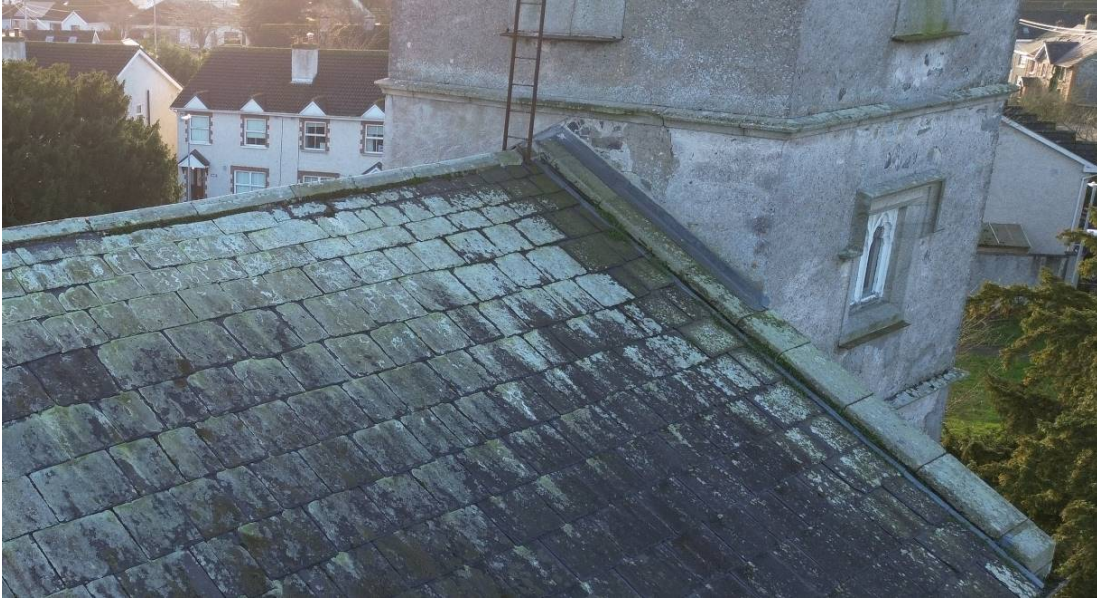
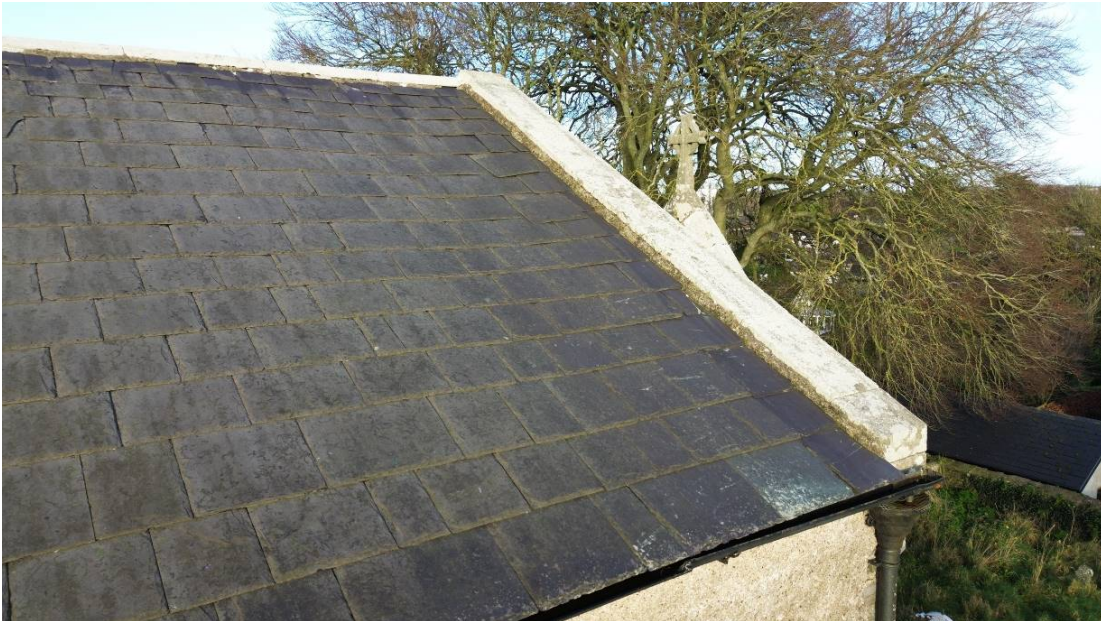
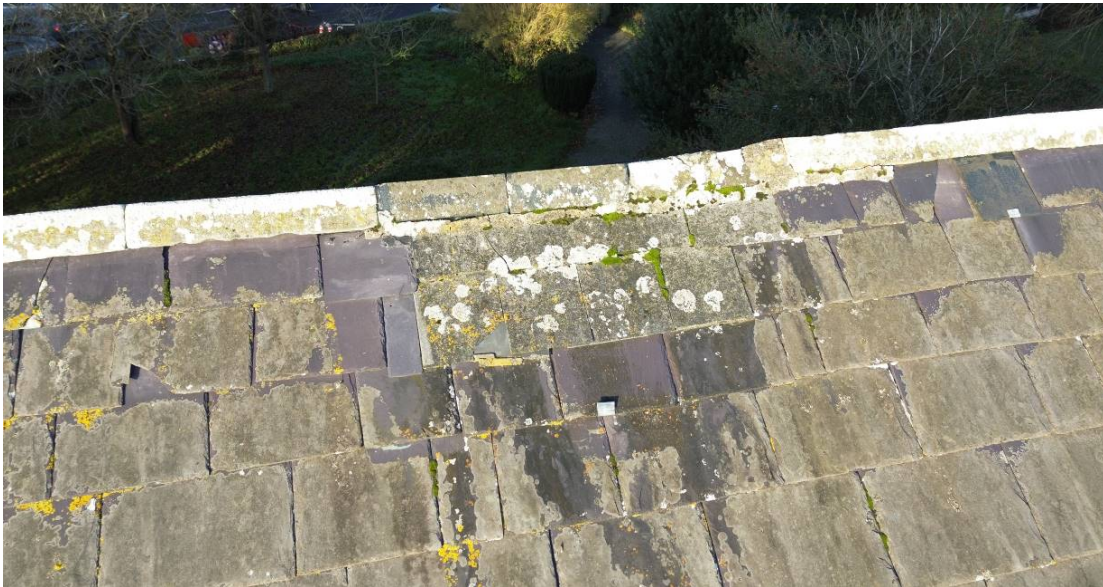
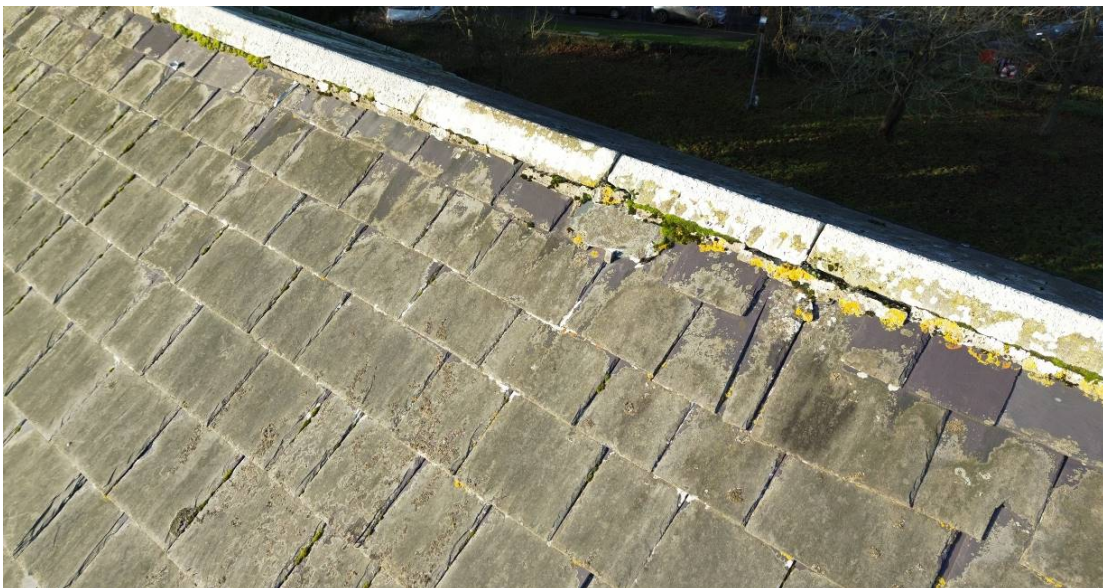
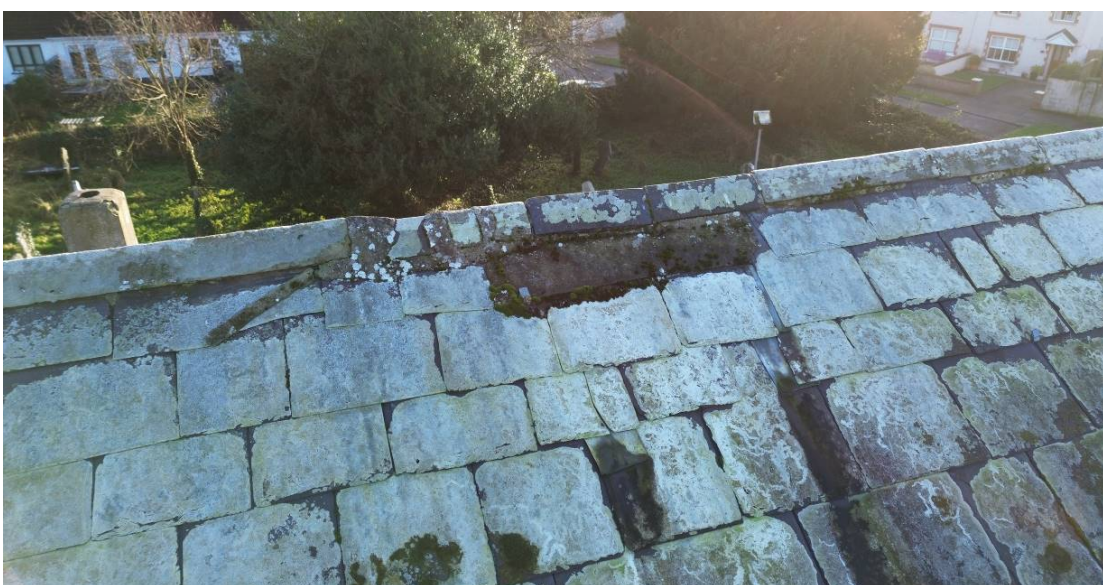
- Roof: There are a number of areas with slipped slates across both slopes of the roof showing nail failure and other slates are damaged and cracked. Some areas have been repaired and slates have been clipped when slates have slipped/fallen and re-slating of the roof is now overdue.

- Re-slating main roof, re-using any sound existing slates with shortfall made up with new/salvaged welsh/blue bangor slates.
- Carpentry repairs to timber roof structure if necessary, new battens and new breather membrane.
- Lifting and re-laying of existing clay ridge tiles, with damaged/broken tiles replaced with new to match existing.
- Inspection of existing gutters and downpipes, particularly in north-east corner. Make any repairs necessary to stop water ingress into building including replacing damaged sections where necessary.
- Repairs to chimney at eaves on south slope including lead flashings, repairs to render and flaunching and fitting of clay flue cap.
- New lead flashings to barge stones at east end of main roof, with formation of secret lead gutter detail to match existing at west end junction with tower.

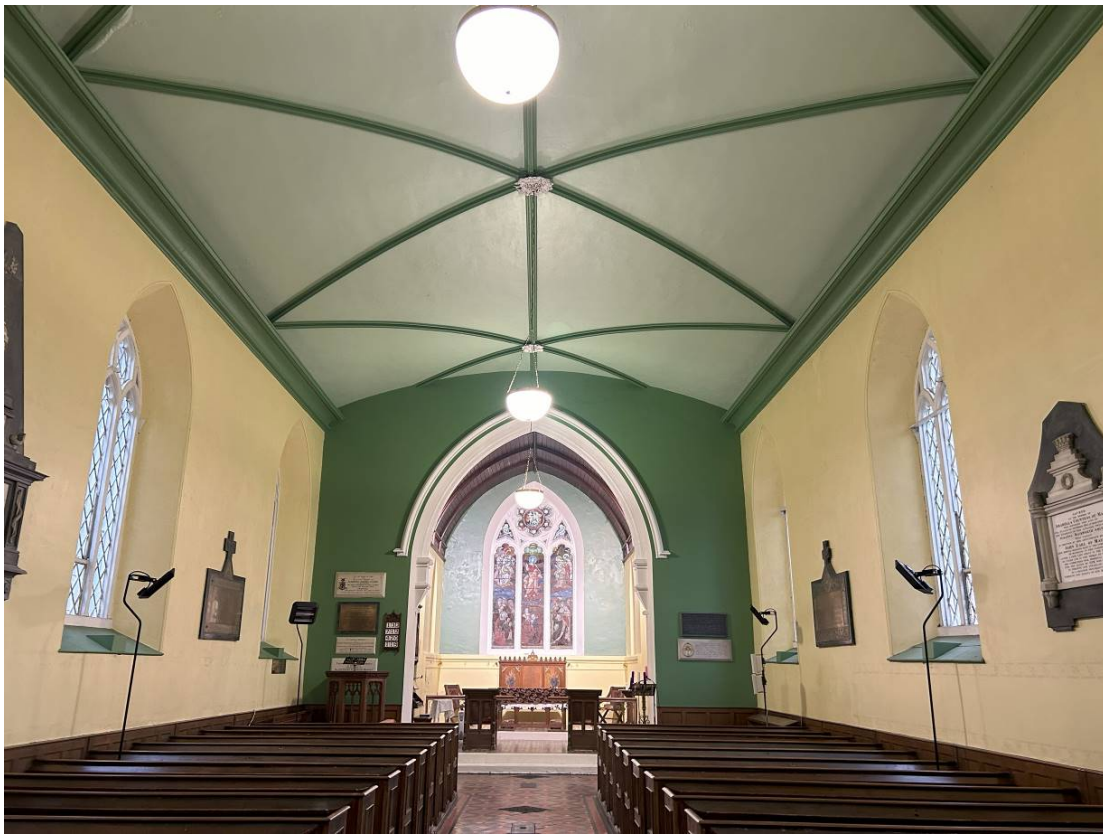
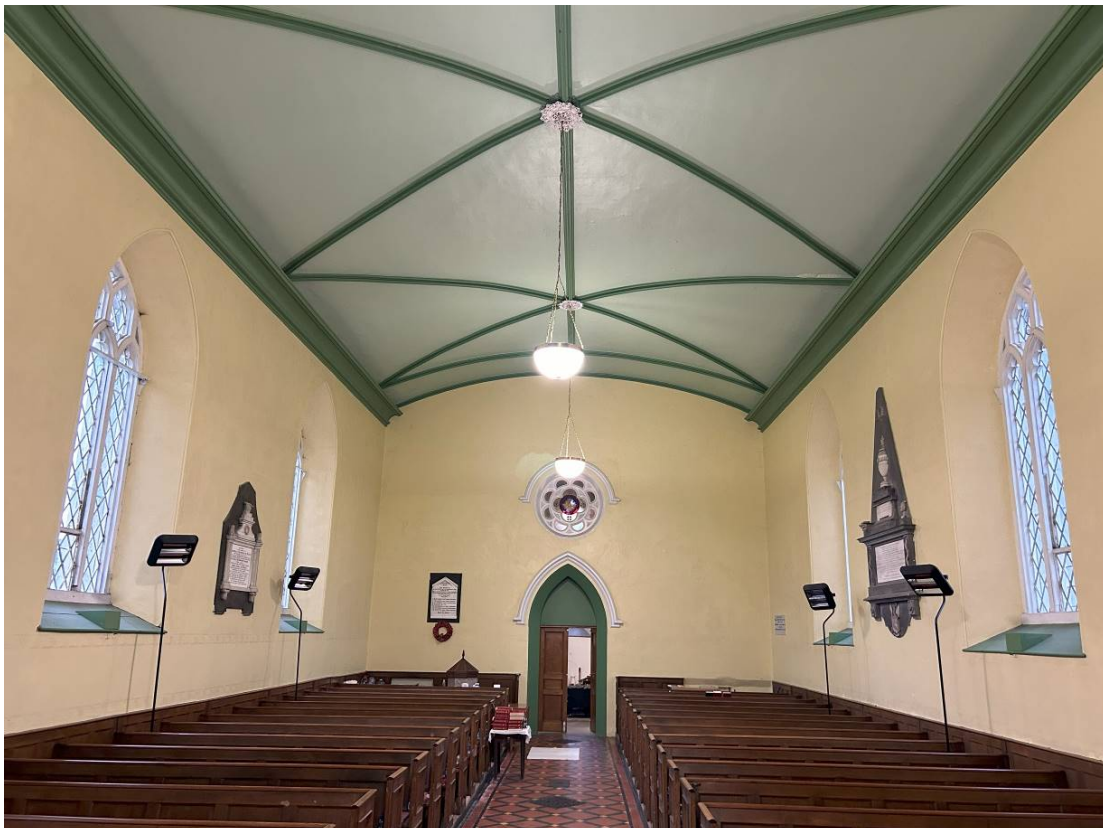
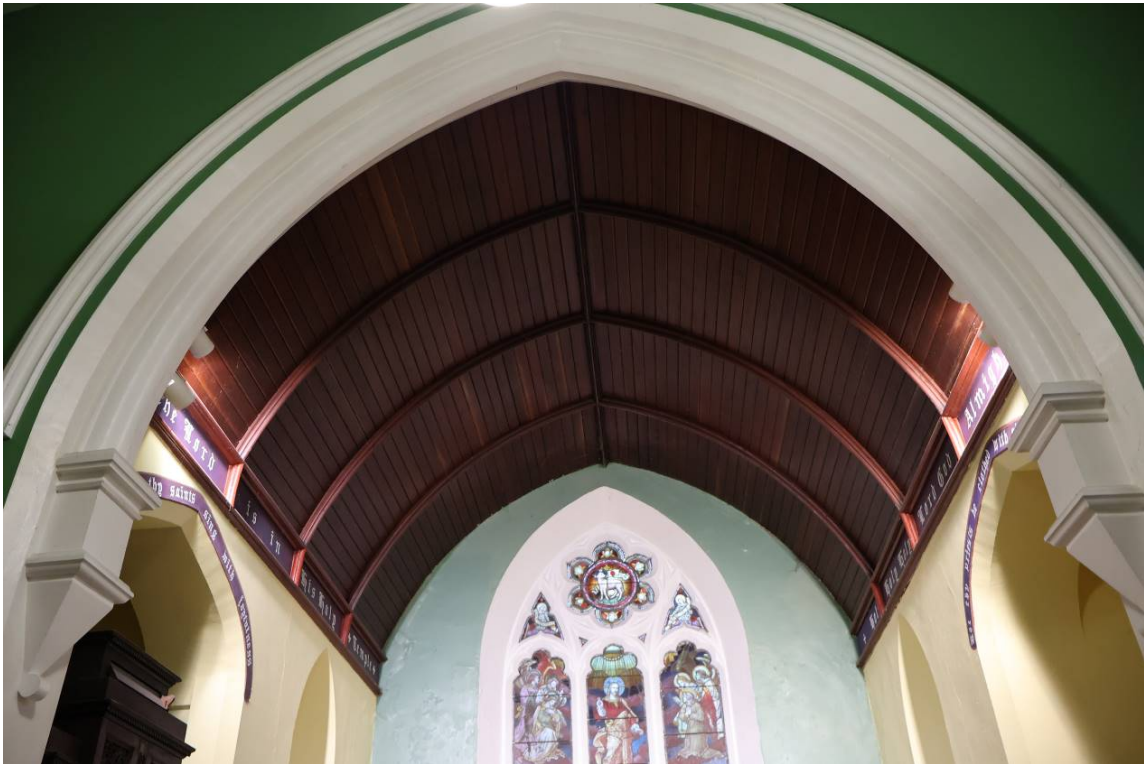
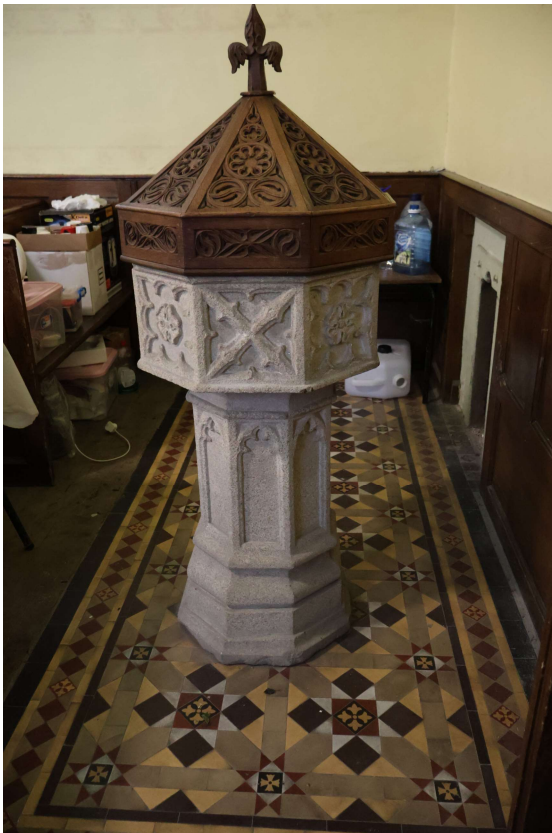
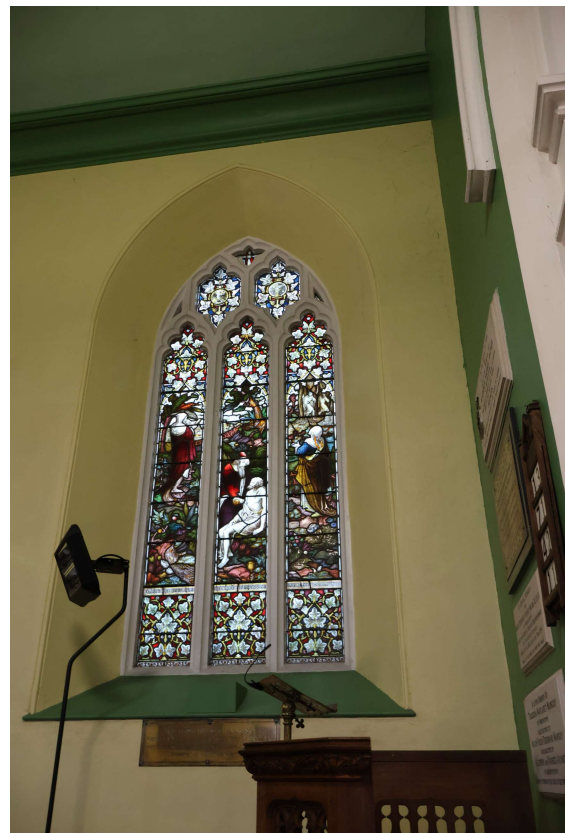
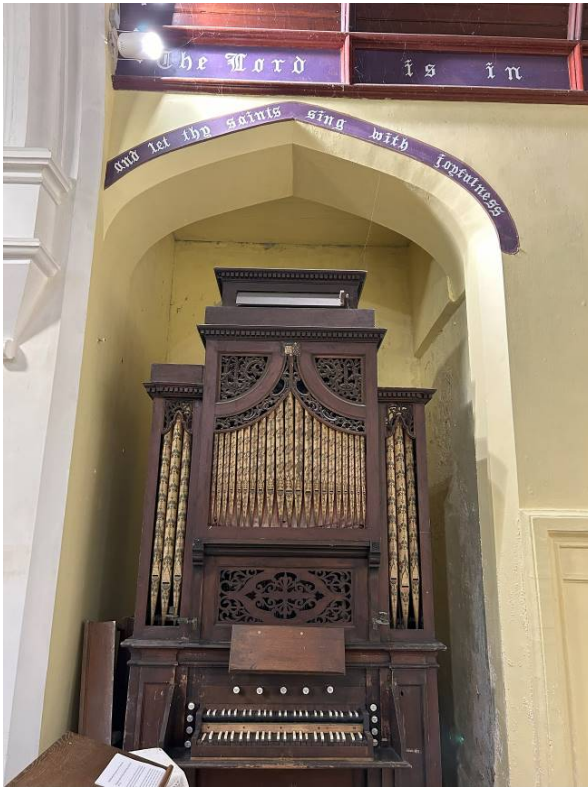
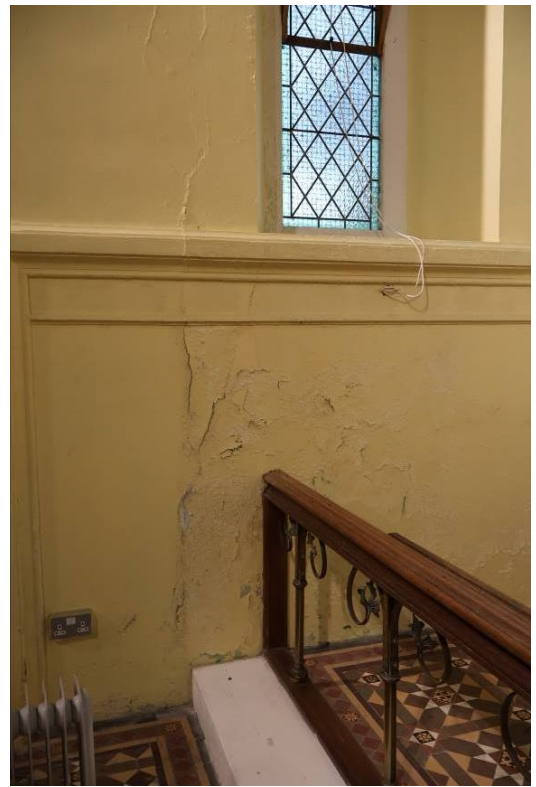
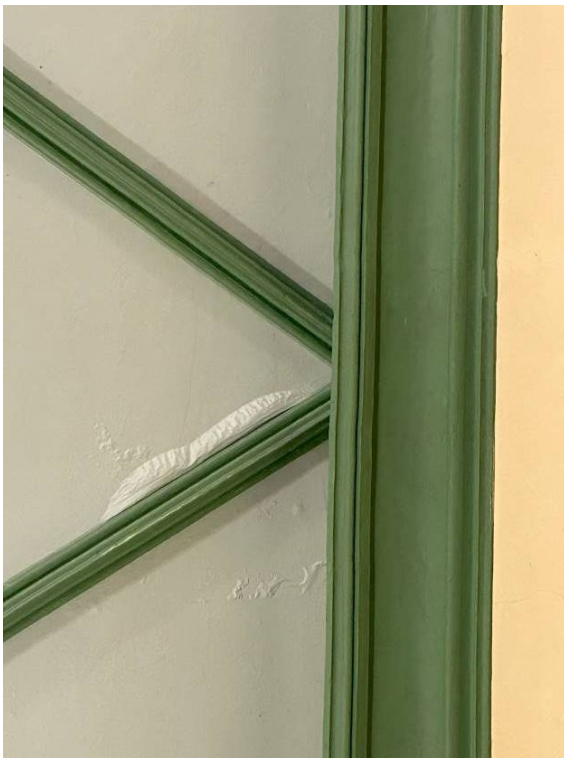
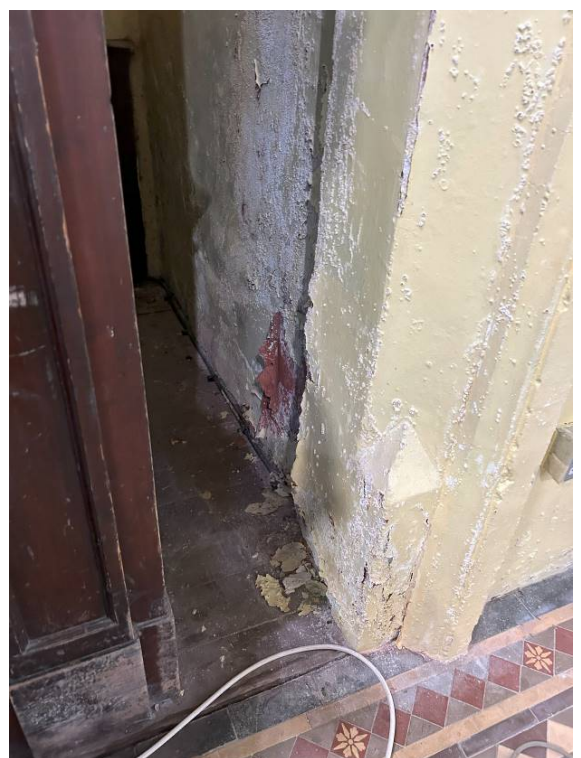
Interior

- Gutters have been repaired/replaced in the past but there is an issue with the gutter/downpipe at the north east corner of the nave where water is staining the exterior of the church and moisture damage is visible to the interior of the church with areas of paint damaged/flaking including on the wall beside the organ.

- Existing gutters and downpipes to be inspected and any damaged/broken sections to be repaired or replaced.
